Mount Nansen Mine Site, Yukon

Mill Area Geochemical Characterization
Summary of 2010 Field Investigations

Lorax Environmental Services Ltd.

December 2010

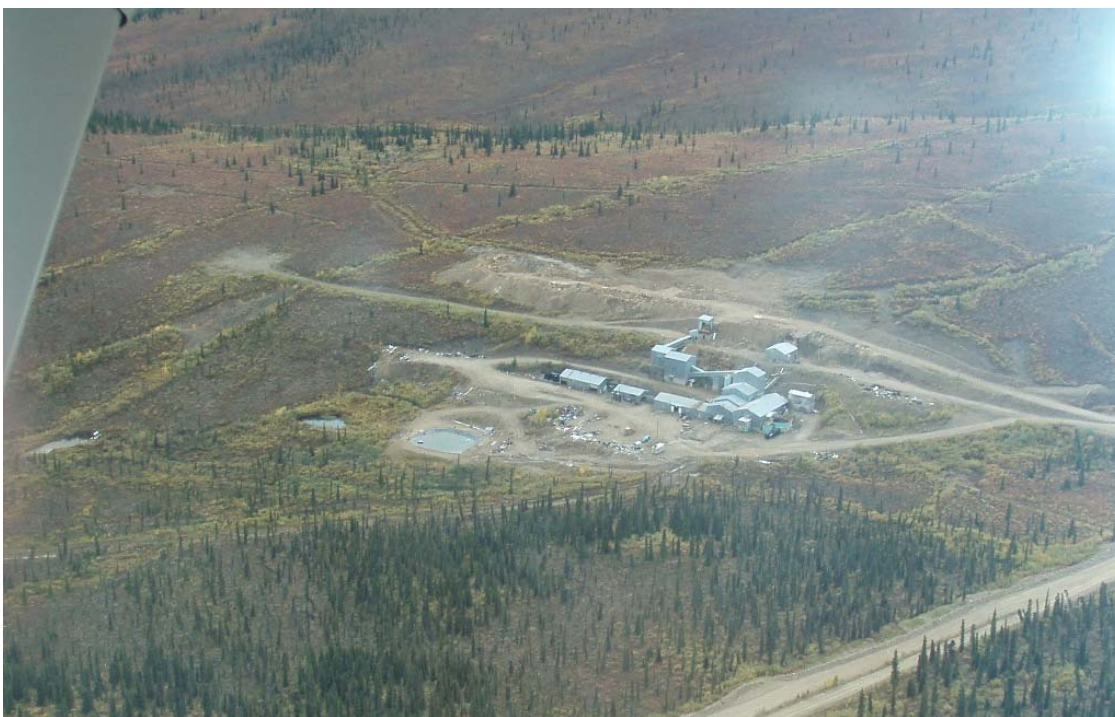
Figure 2-2. View of mill site from the air, looking southwest. Photo taken August 2008.

Three ponds are also visible in the photograph in Figure 2-2, and in Figure 2-1. Based on late 1980's airphoto images, all three ponds appear to have been used in some way during the early mining phase, likely for capturing and settling of tailings.

The left-most and centre ponds in the photograph (Ponds #1 and #2 respectively) are earthen berm structures, are well overgrown with vegetation. Remnants of an equipment house, possibly used to house a pump for recovering process water, is still visible at Pond #1. The right-most Pond #3 is today geomembrane lined, and it is understood that it was utilized during the 1990's mining phase and in the years following mine closure. Dome Creek flows from right to left in the photo in Figure 2-2, at the toe of the embankment of the access road to the lower mill platform, and exits the photo at the lower edge of Pond #1.

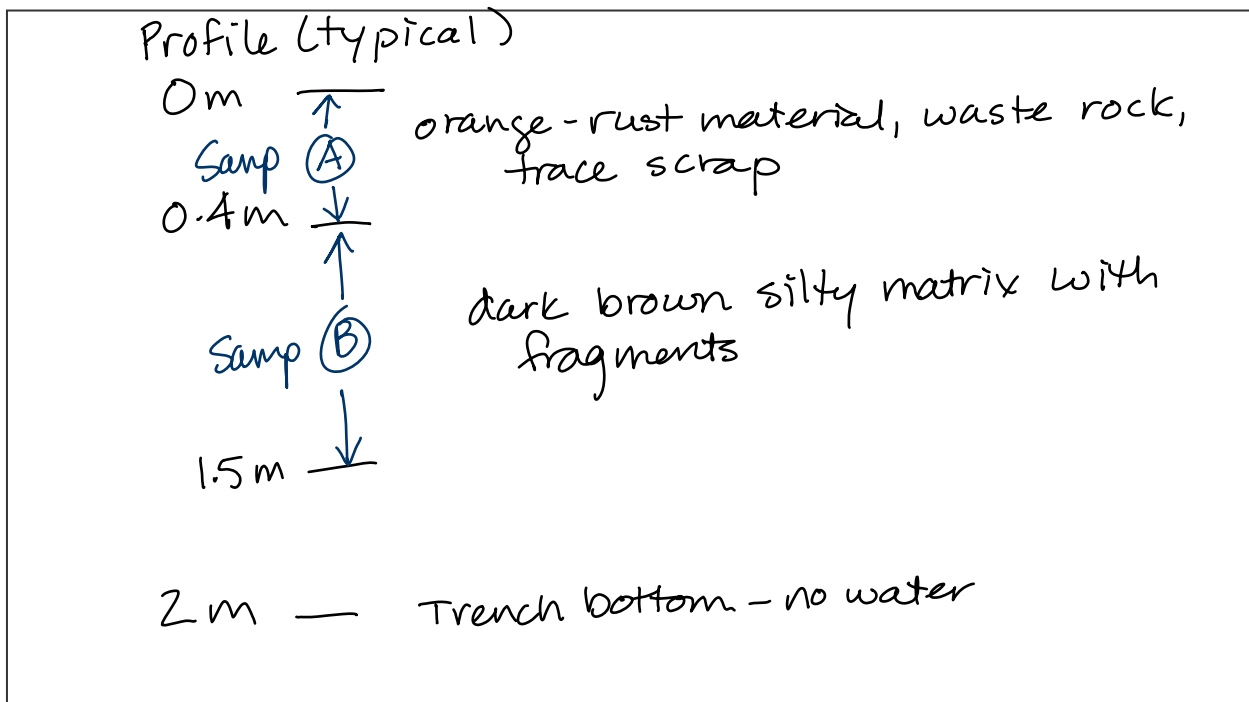
Photo No. 585	Date 4-Jul-10

No water intercepted in trench.

2 rock samples taken (photo 585)

Sample #	Sample Type	Description / Analysis / Other
MS-10-03A	Rock	0-0.4m depth. 60% intrusive and quartz fragments in tan-orange silt-sized matrix. Analyses – Std. ICP/ABA
MS-10-03B	Rock	0.4-1.5m depth. 60% quartz and amphibolite fragments in dark brown silt-sized matrix. Analyses – Std. ICP/ABA

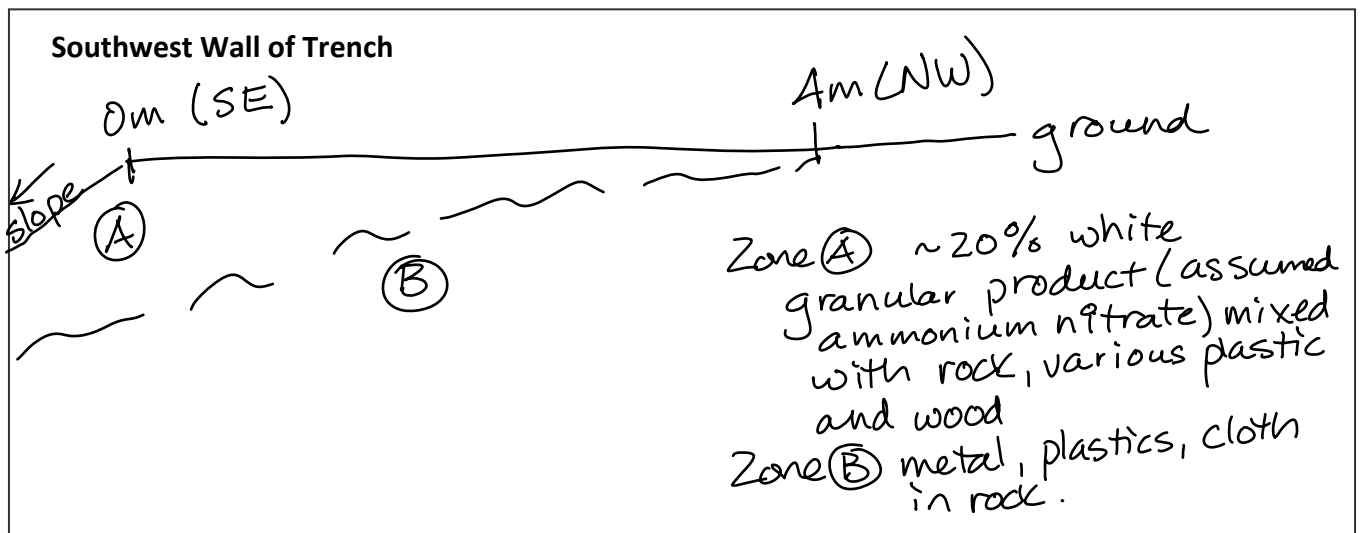
Trench oriented at 125°, approximately 1.5m deep. Old dump site, considerable proportion of refuse mixed with rock – plastics, metal, wood, paper, cloth.

Granular white product, originating from ~25kg paper sacks and possibly palletized with plastic wrap encountered at southeast end (crest of platform). Small amount of product was solubilized with deionized water to yield pH of 9.5 and conductivity of 8470 uS/cm.

No water intercepted.

1 static test sample taken.
