**GOVERNMENT OF YUKON**

# **Mount Nansen Tailings Dam**

## **Dam Safety Review**

307071-00856-00-SS-REP-0001

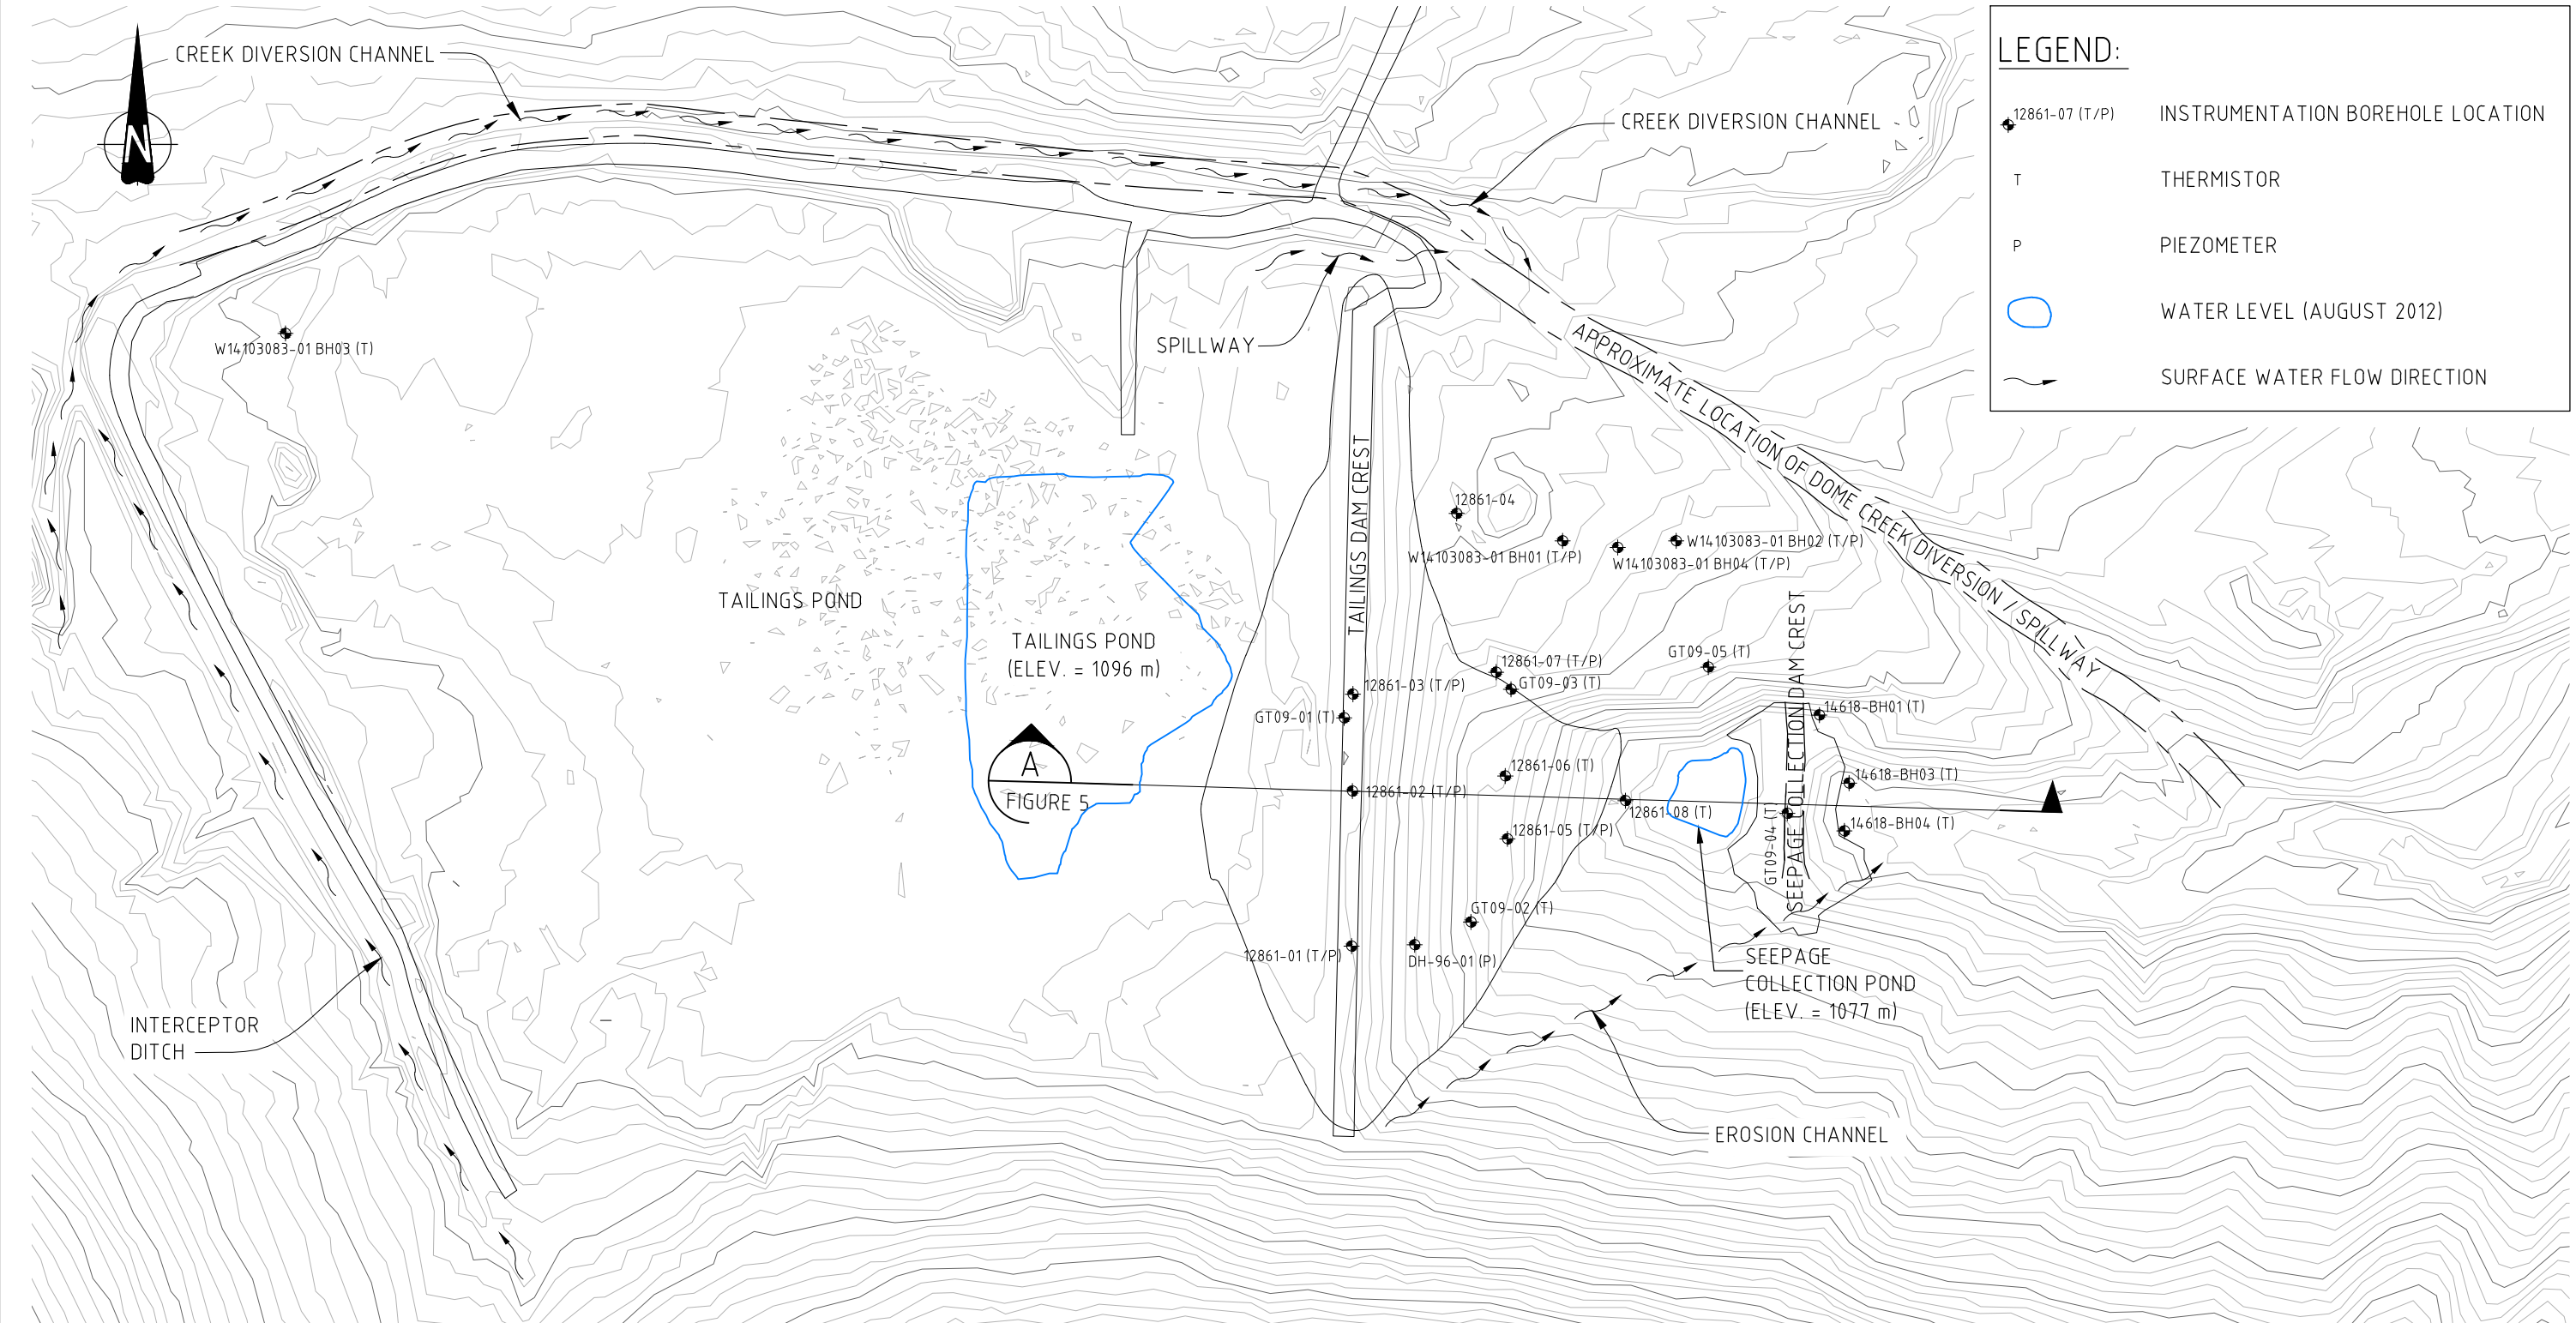
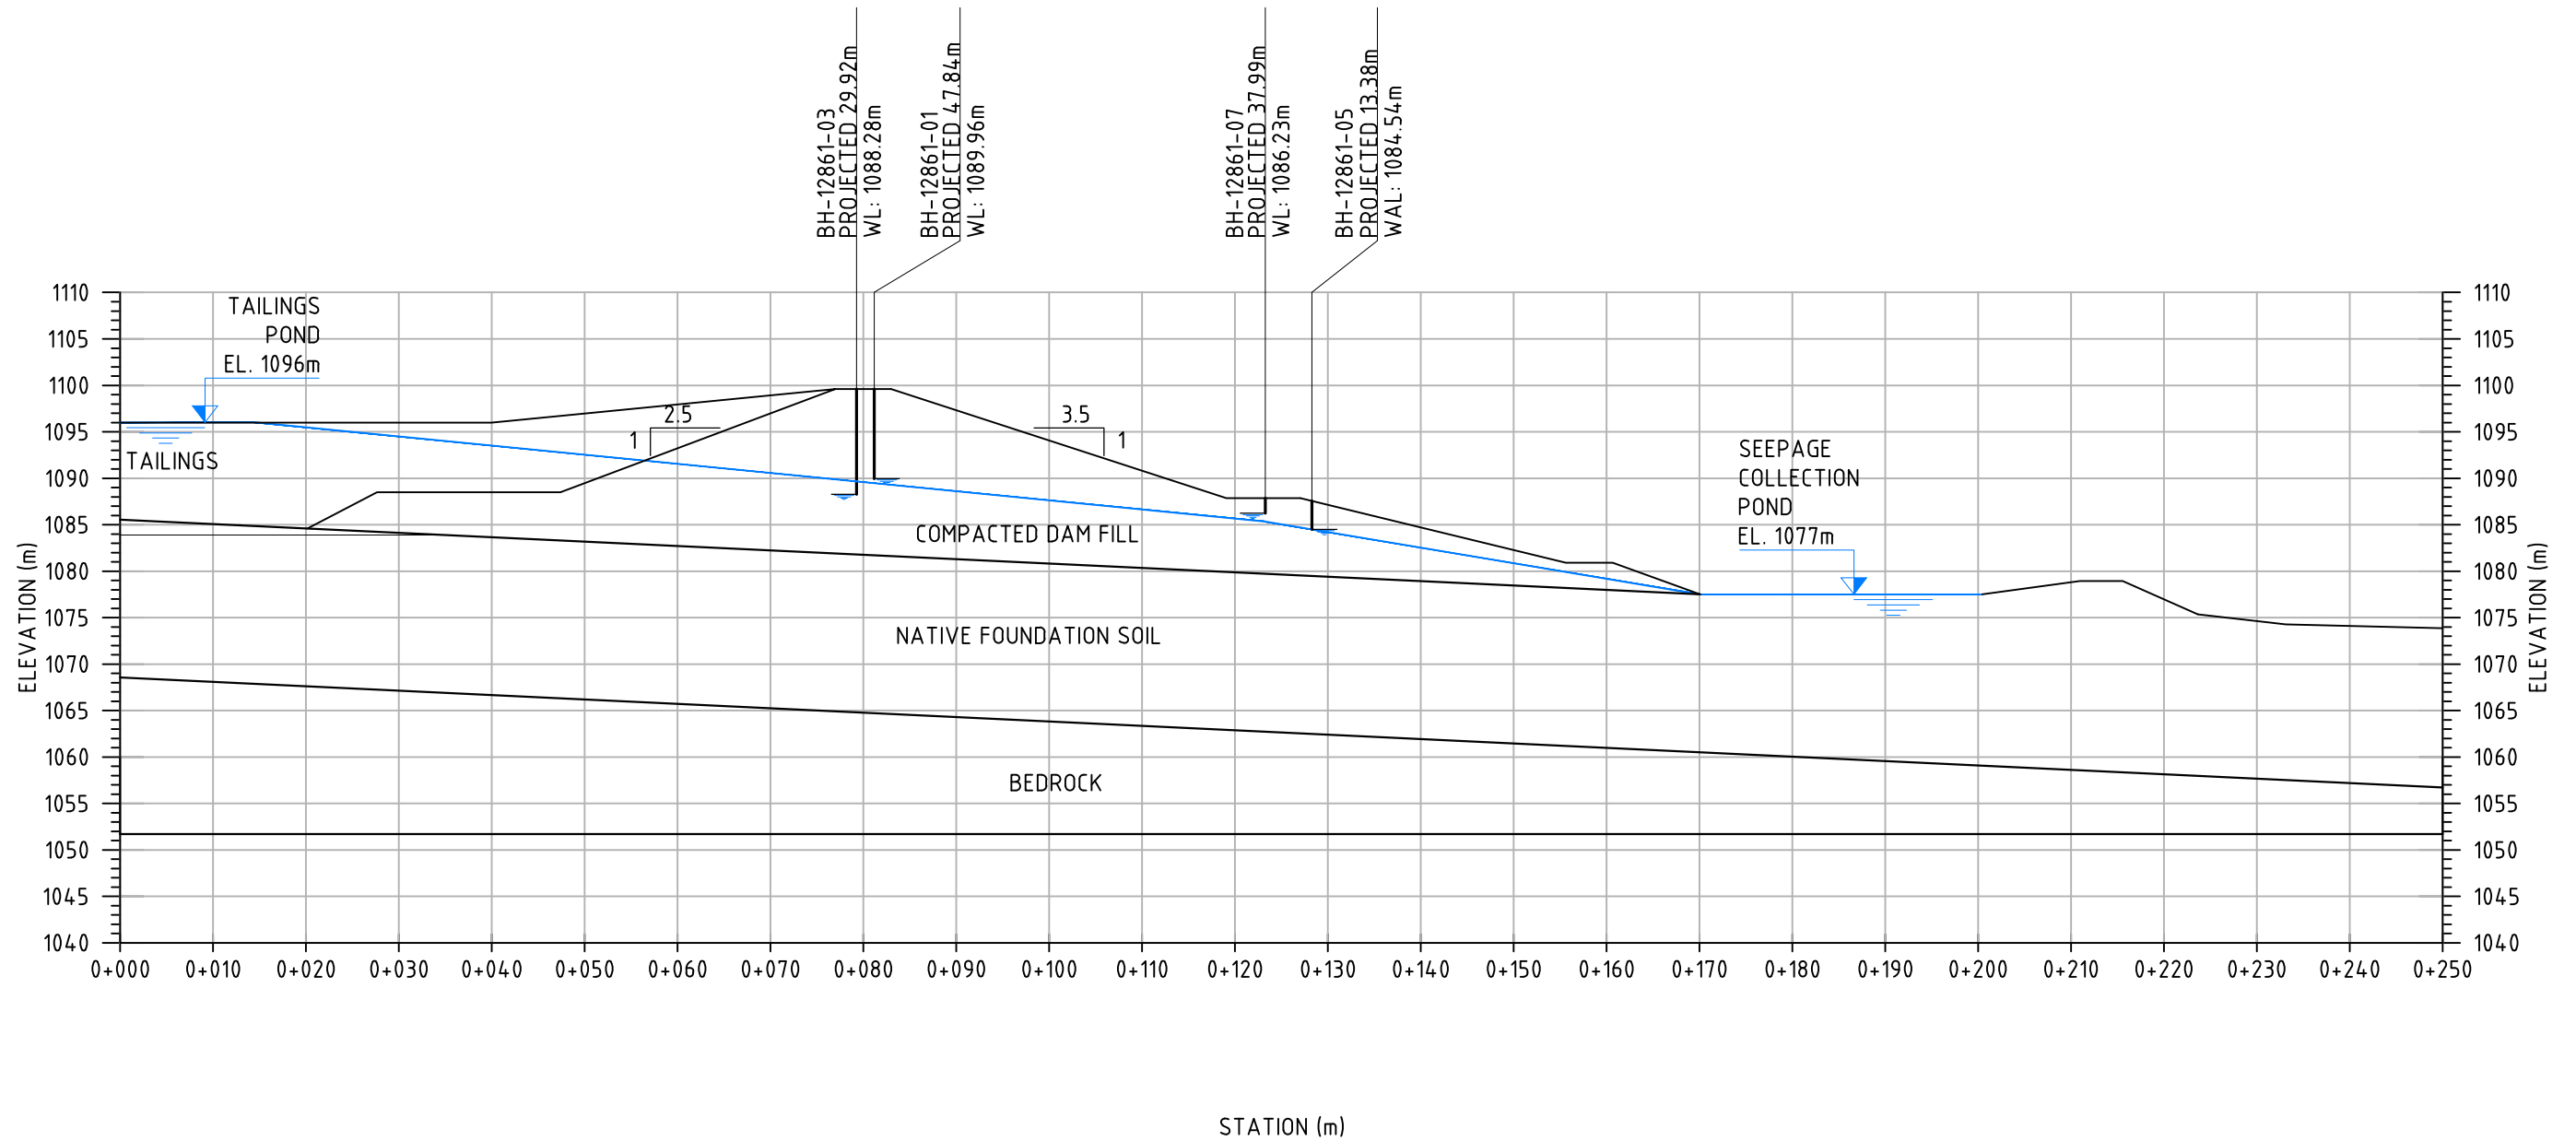
DRG No  
FIGURE 4

In the 2012 investigation, four boreholes were drilled (indicated as W14103038-01 BH-01 to BH-04 in Figure 4, Appendix 1), which supported the suspicion that surface water was travelling from the unlined Dome Creek diversion spillway underground along the top of permafrost through the unfrozen sand terrace below the tailings dam; however, due to the relatively shallow depth of permafrost (~3 m bgs) in the vicinity of the borehole located at the upper (west) end of the tailings impoundment where the Dome Creek diversion begins, it was considered unlikely that the original Dome Creek channel is hydraulically connected to the seepage collection pond by a subsurface flow path into or under the tailings impoundment.

The stability analyses were carried out for the downstream slope of the dam section with maximum height that, based on the available information from former stability analyses (Klohn-Crippen 1995, Klohn-Crippen 2000, EBA 2002), is the section in the proximity of borehole BH-12861-02 as shown in Figure 4, Appendix 1. The cross-section adopted is shown in Figure 5, Appendix 1. This topographic surface agrees with the LiDAR surface (BGC 2013), and the upstream slope profile (including the upstream berm) and the thickness of the native foundation soil (conservatively modelled as homogeneous sand, despite the presence of gravel layers) are consistent with the available information and previous assumptions (Klohn-Crippen 1995, Klohn-Crippen 2000, EBA 2002).
