**Mt. Nansen Mine Site Bridge Repair:  
Photo Log of sub-structure implementation  
October 2011**

**This document highlights the key modifications of the bridge sub-structure using photos and brief descriptions of each.**

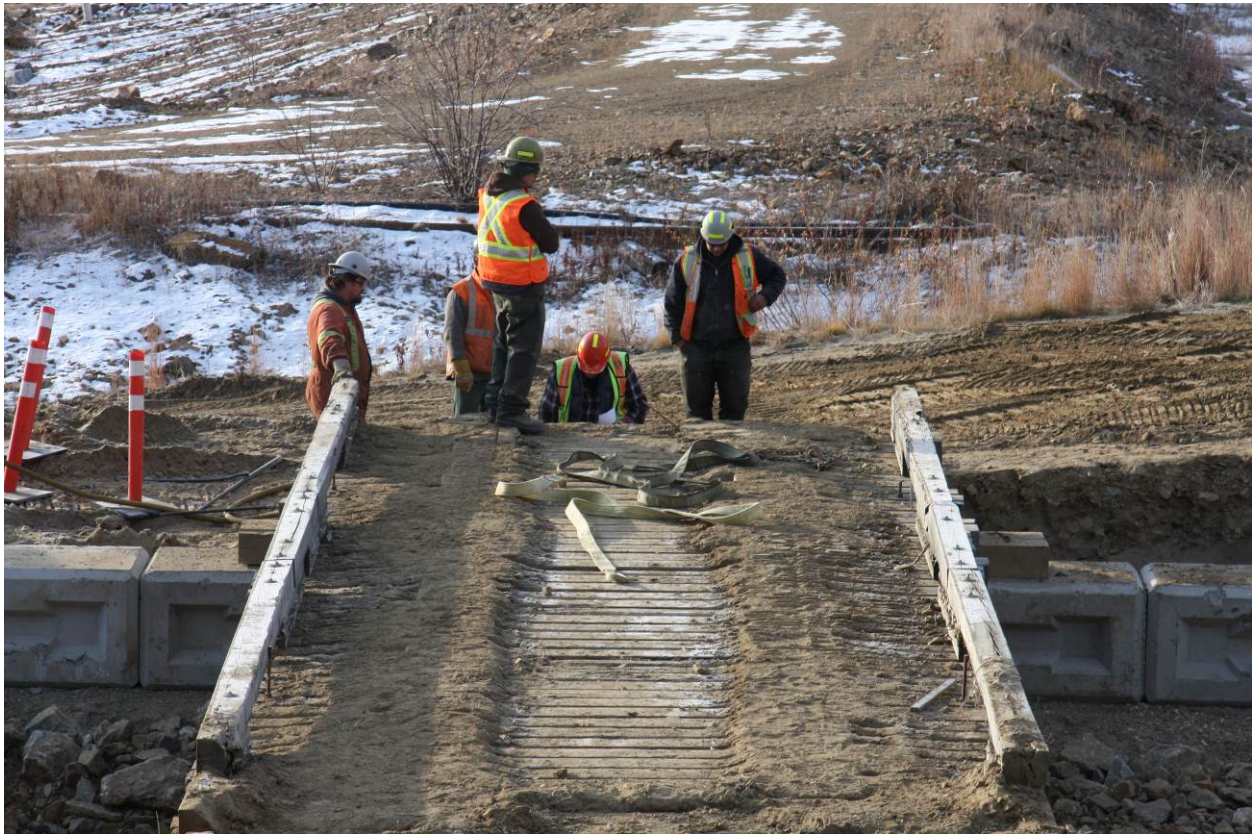
**Photo 1**

**This is the area where the bridge will be re-located. The area had been excavated, then had course material added and thoroughly compacted (existing material comprised mostly of sand)**
