Report To  
CYPRUS ANVIL MINING CORPORATION  
On  
1982  
PERFORMANCE MONITORING  
Of The  
DOWN VALLEY TAILINGS PROJECT  
Faro Yukon

February, 1983

822-2021

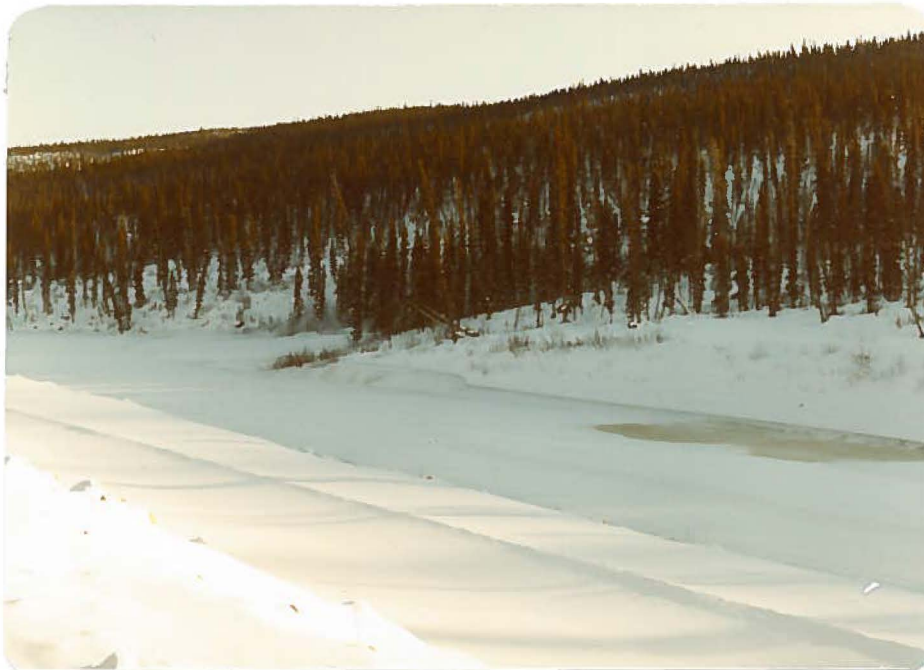
View looking S.E. at 1975 diversion near pumphouse.

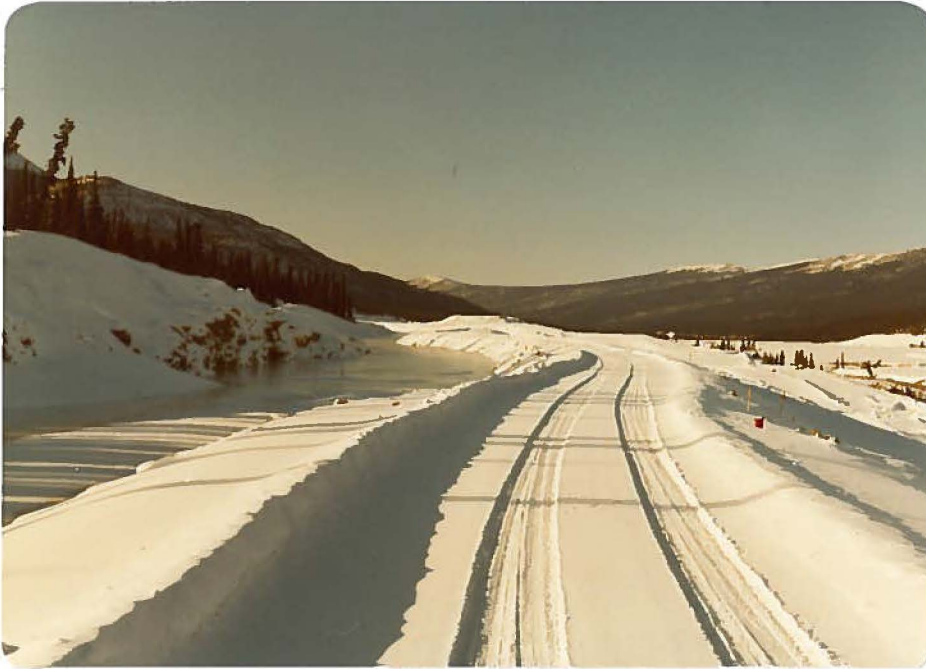
View looking west  
from about Sta  
0 + 400.

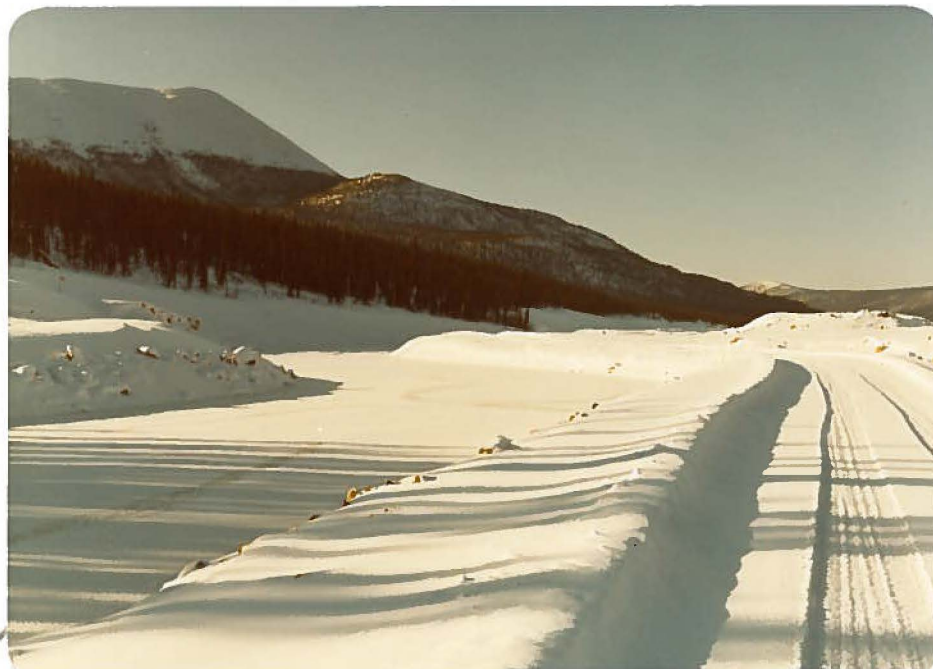
View looking west  
from about Sta  
1 + 100.

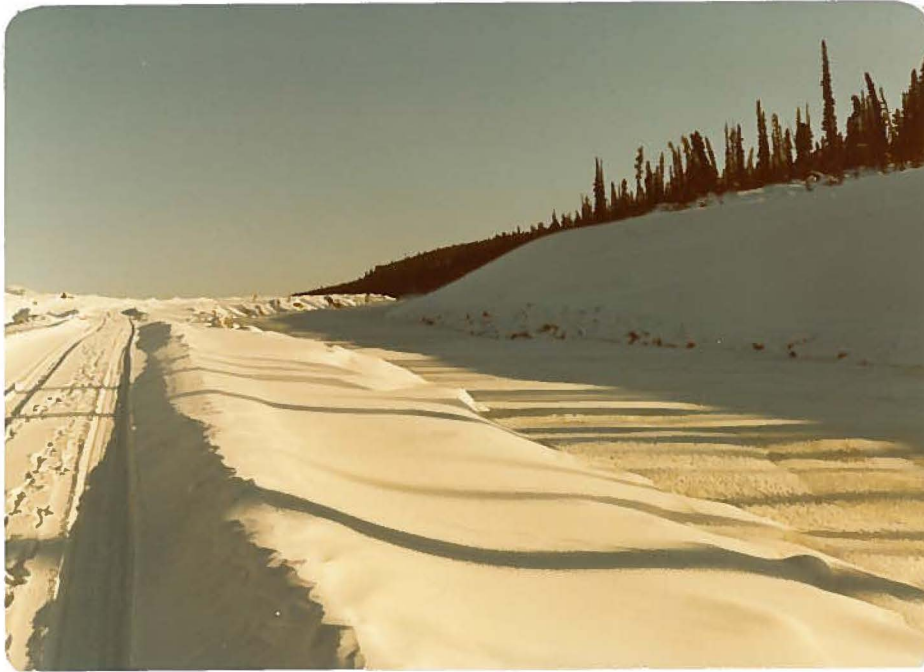
View S.E. from  
about Sta 3 + 200.

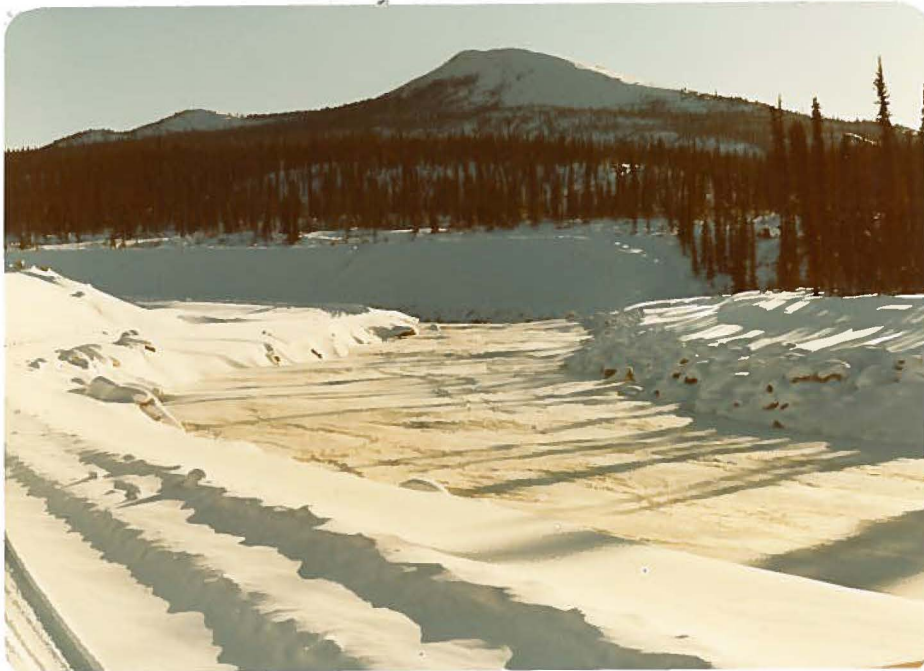
View S From  
about Sta 3 + 400

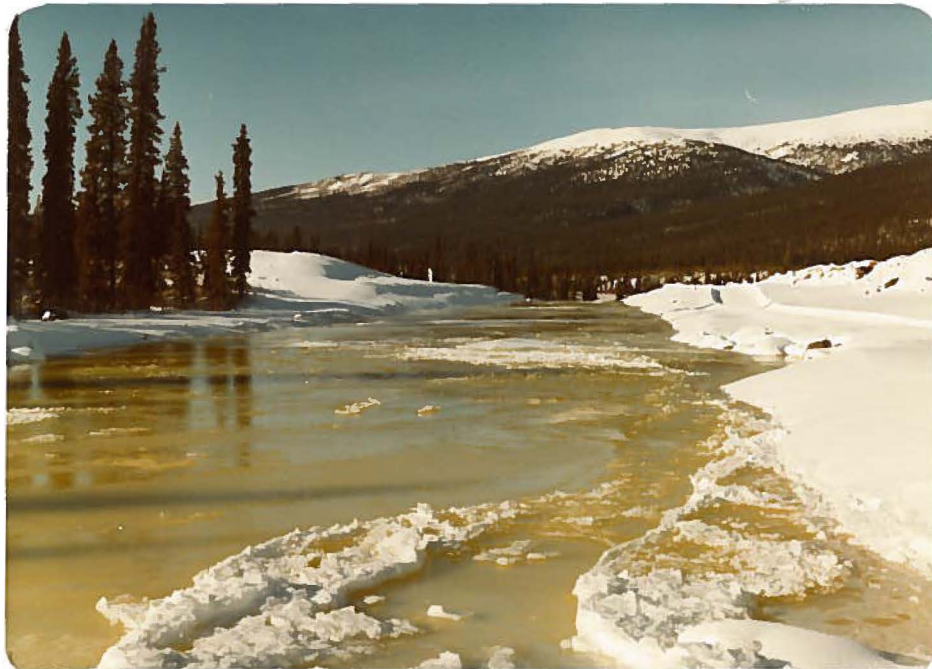
Icing of the canal occurred during the winter of early 1982 because of inconsistent mill consumption of water released from the water impoundment dam. In March, the canal had generally filled up to within 1.3 to 1.6 m of freeboard. The icing was especially bad between 3+420 and 3+480 at the start of the canal outfall 0.19% grade section where there was only 0.5 m of freeboard in March. To prevent overflowing of the dyke structure by the spring freshet a channel was ripped in the ice in the canal by Cyprus Anvil equipment and personnel in mid-April.

Icing accumulation from about Sta 3 + 500 to Sta 3 + 600.  
View looking N.W.

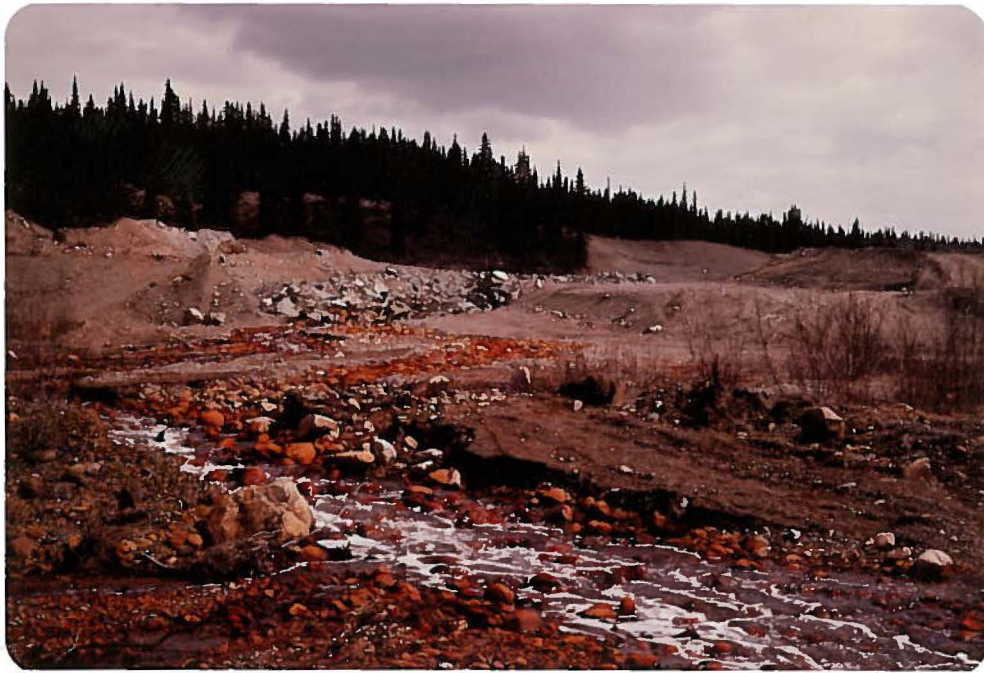
View east from end of decant/spillway (c. 1 June 1982). Note that decant flow over natural materials is not resulting in unacceptable erosion.

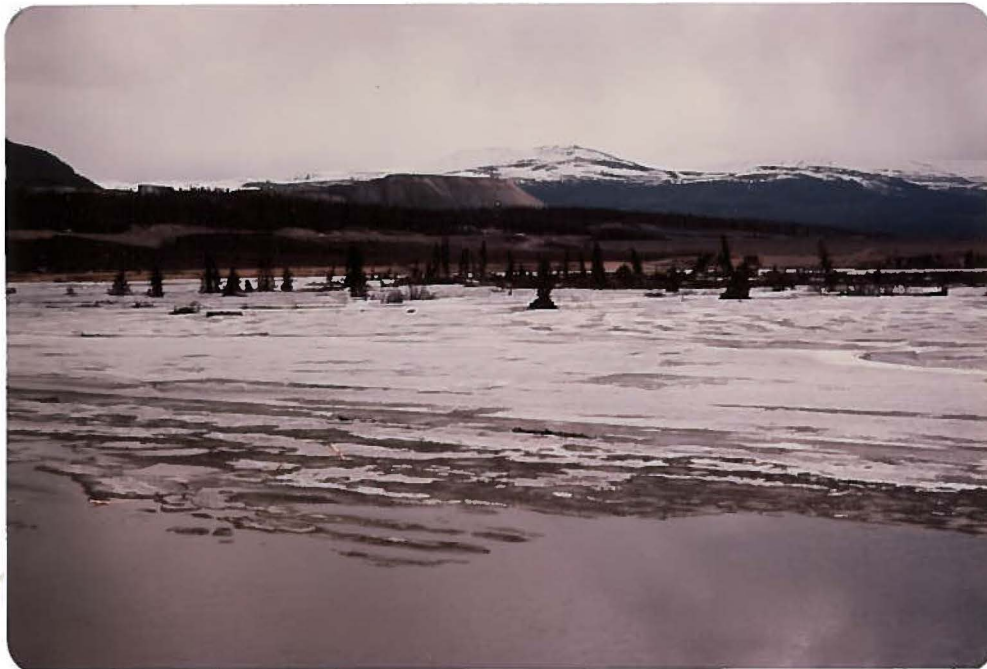
View NE from south abutment Int. Dam showing I.D. reservoir at full impoundment. Note that construction stakes in left foreground and trees have been jacked from the valley bottom by the reservoir ice surface due to winter impoundment.

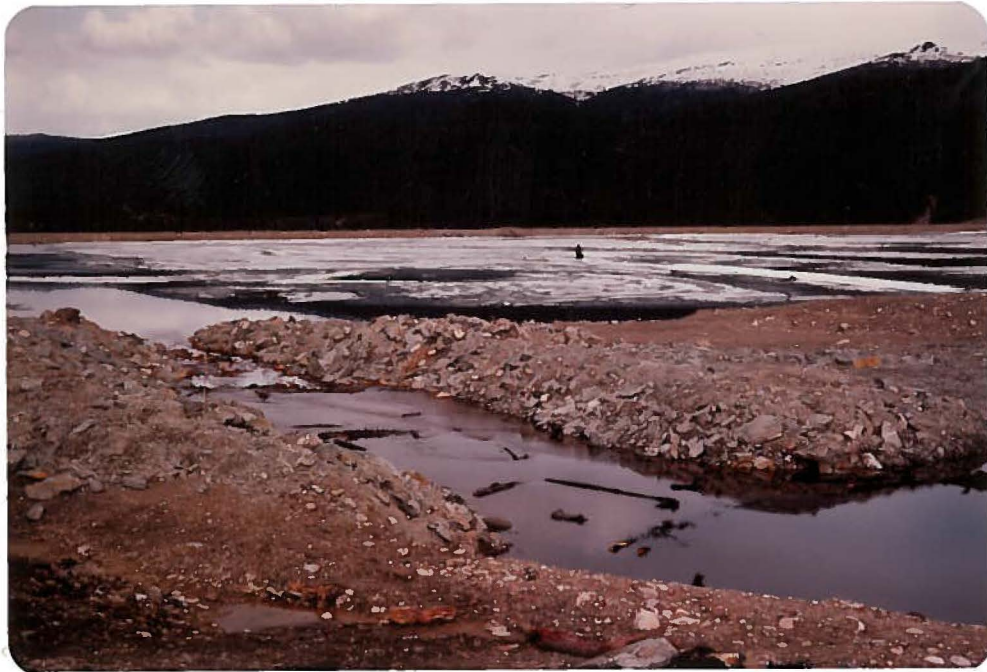
View NW showing Intermediate Dam decant/spillway function at full impoundment. CVD reservoir in the background (c. 1 June 1982)

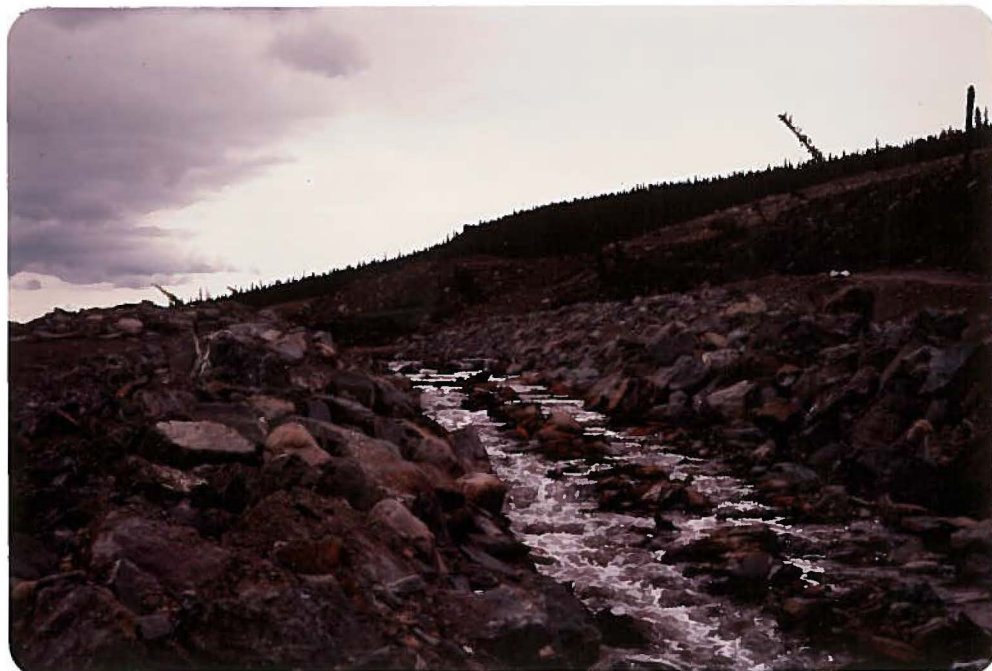
View SE of Intermediate Dam decant functioning at full impoundment.
