**ANVIL RANGE MINING CORPORATION  
INTERIM RECEIVERSHIP  
PHASE 1 BORROW SOURCE SURVEY**

**DELOITTE & TOUCHE INC.**  
Suite 1900, 79 Wellington Street West  
Toronto, ON M5K 1B9  
Canada

**STEFFEN ROBERTSON AND KIRSTEN (CANADA) INC.**  
Suite 800, 580 Hornby Street  
Vancouver, B.C. V6C 3B6  
Tel: (604) 681-4196 • Fax: (604) 687-5532  
E-mail: [vancouver@srk.com](mailto:vancouver@srk.com) Web site: [www.srk.com](http://www.srk.com)

AUGUST 2002

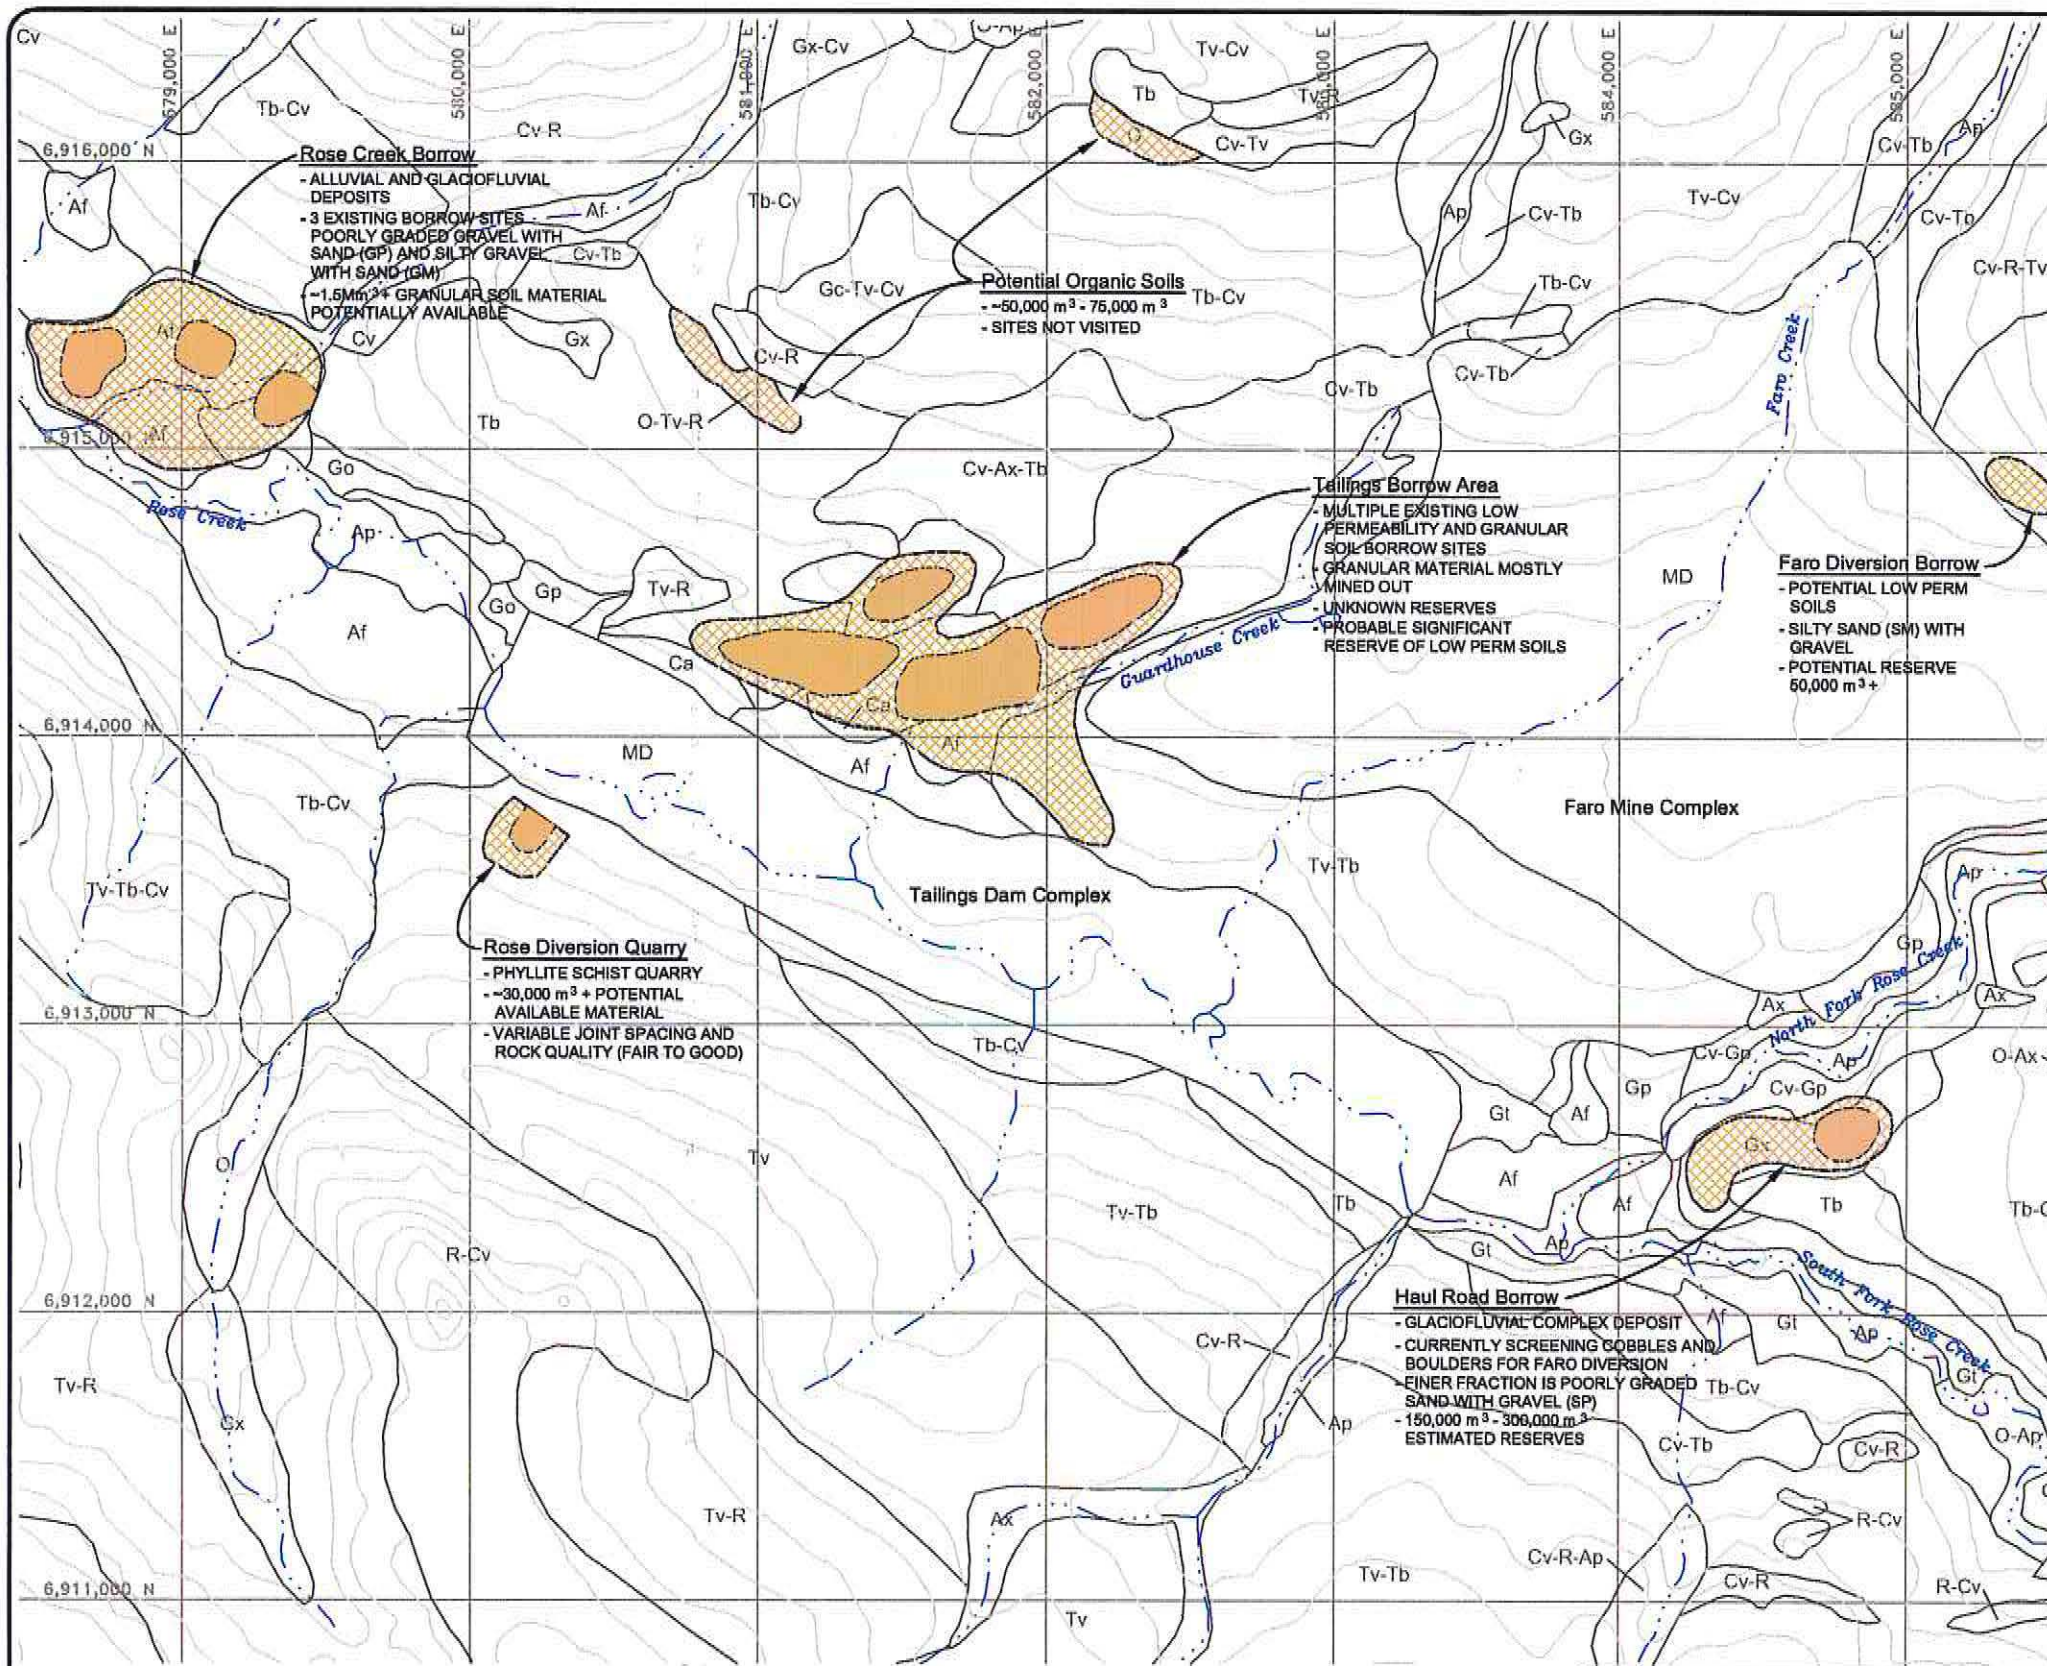
**FIGURE 2**  
**FARO MINE SITE**  
 Surficial Geology and  
 Soil and Rock Borrow Locations

The haul road borrow site is located just off the Vangorda-to-Faro haul road, near the North Fork Rose Creek rock drain outlet (Photo 1, Figure 2). Bond (2001) mapped the site as glaciofluvial complex (Gx). Local contractors are currently screening 10,000m<sup>3</sup> of cobbles and boulders (20, 40 and 60cm gradations) for lining of the Faro Creek diversion around the north side of the Faro open pit.

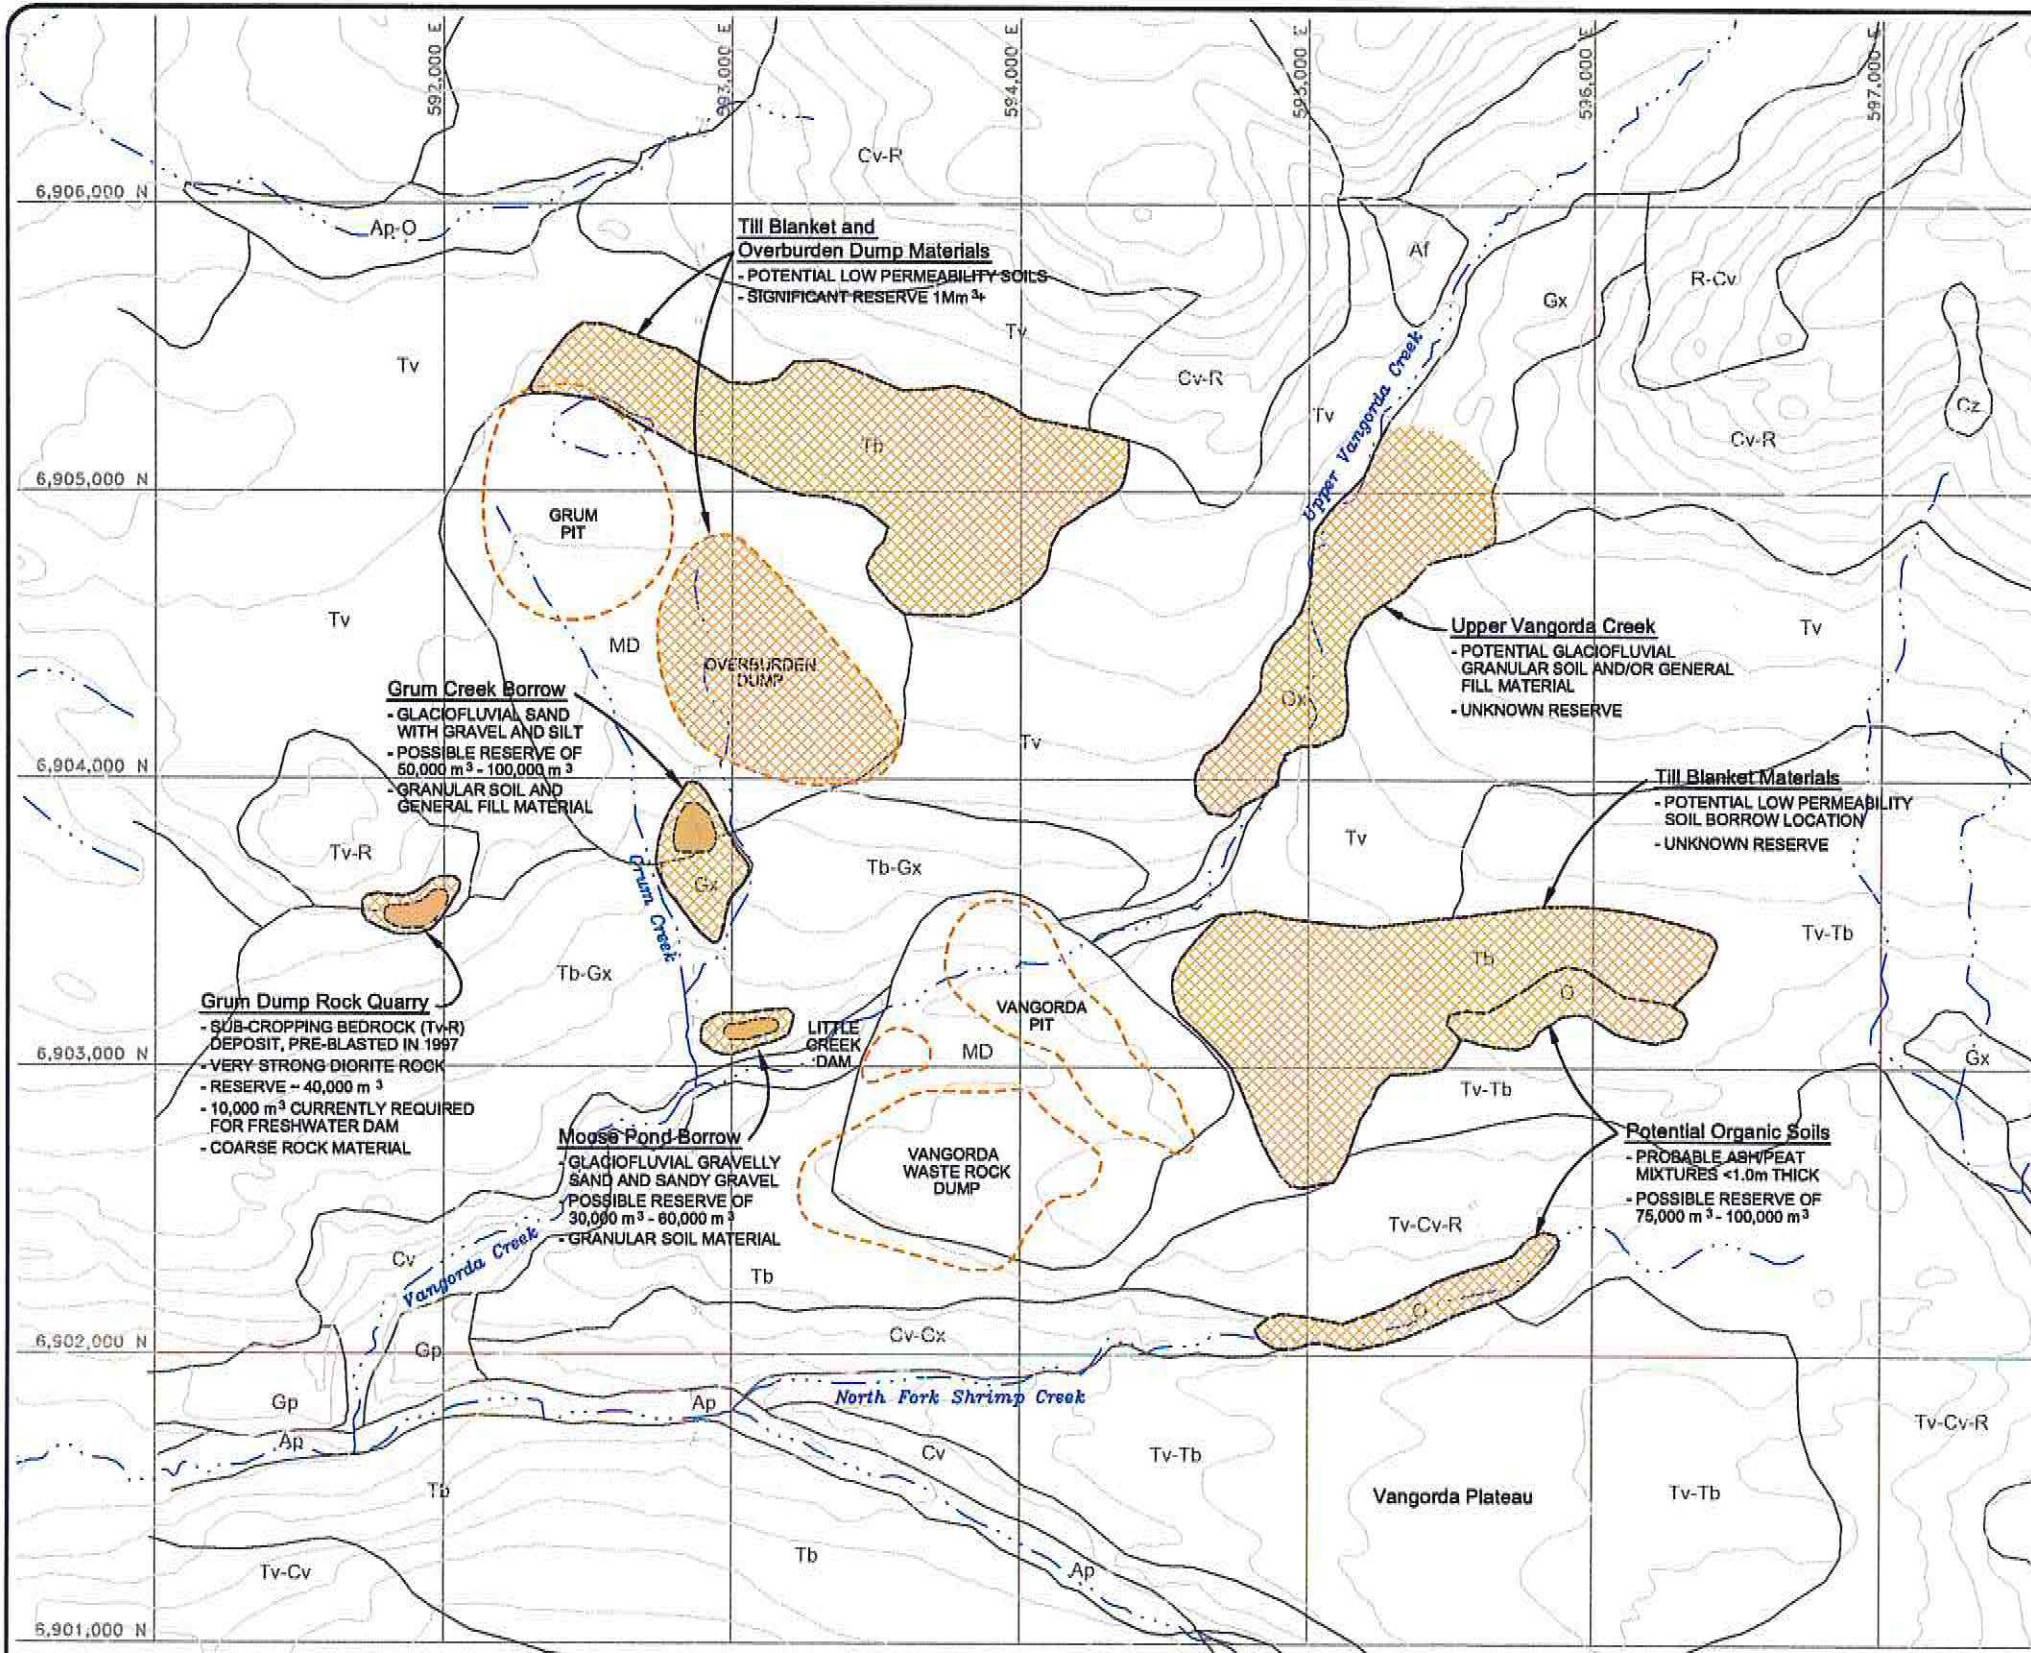
**FIGURE 3**  
**VANGORDA - GRUM AREA**  
 Surficial Geology and  
 Rock and Soil Borrow Locations

The Grum Dump quarry is located on the south side of the Grum Dump (Figure 3), which is in an area mapped as till veneer (<1m) overlying bedrock (Tv-R). The existing reserve was pre-blasted back in 1997 and a total of 10,000m<sup>3</sup> is currently being processed as graded riprap for the Freshwater Supply Dam spillway lowering project. The pre-blasted material has a relatively high fines content (approximately 20%) because the source, a diorite dyke, was originally 'sub-cropping' with some till cover (Photo 6). The material is high quality dioritic rock, which is dark grayish green (with brown iron stained surfaces), slightly weathered, and very strong. The angular clasts range from gravel to large boulder (2m) size and are currently being screened as required for the Freshwater Supply Dam work (Photo 6). It is difficult to estimate the available reserve but there may be a further 30,000m<sup>3</sup> of useable riprap-grade rock (excluding the currently required 10,000m<sup>3</sup>).

The Grum Creek borrow site is located within the Grum Creek catchment on the eastern margin of the Grum waste rock dump (Photo 7, Figure 3). This area is mapped as complex glaciofluvial deposit (Gx). Lab results show that the material consists of well graded sand with gravel and silt (SW-SM). This deposit extends over an approximate area of 50,000m<sup>2</sup>. With a probable average thickness of 1 to 2m, there may be further available reserves of between 50,000m<sup>3</sup> to 100,000m<sup>3</sup> in this area. These materials may be suitable for use as granular soils and/or general fills.

Low permeability soil deposits in the Vangorda-Grum area include the Grum overburden dump stockpile (mostly till material) and two extensively mapped areas of till blanket (Tb), referenced as East Vangorda and North Grum, as shown on Figure 3. These materials generally consist of gravelly silt and silty gravel with minor clay and are probably suitable for use as construction covers over waste materials. The Grum overburden dump contains in excess of 1Mm<sup>3</sup> of stockpiled till material.

Complex glaciofluvial materials are mapped in upper Vangorda Creek, approximately 300m up from the Vangorda flume headworks (Figure 3). This area was not visited during the recent Phase 1 site visit, but may contain a significant reserve (500,000m<sup>3</sup>+) of material suitable for use as granular soils and general fills.
