March 23, 2010

Phase 1A Geotechnical Slope Stability Assessment of the East Wall of the Grum Pit, Faro Mine, Yukon

Project Number: 09-1426-0021

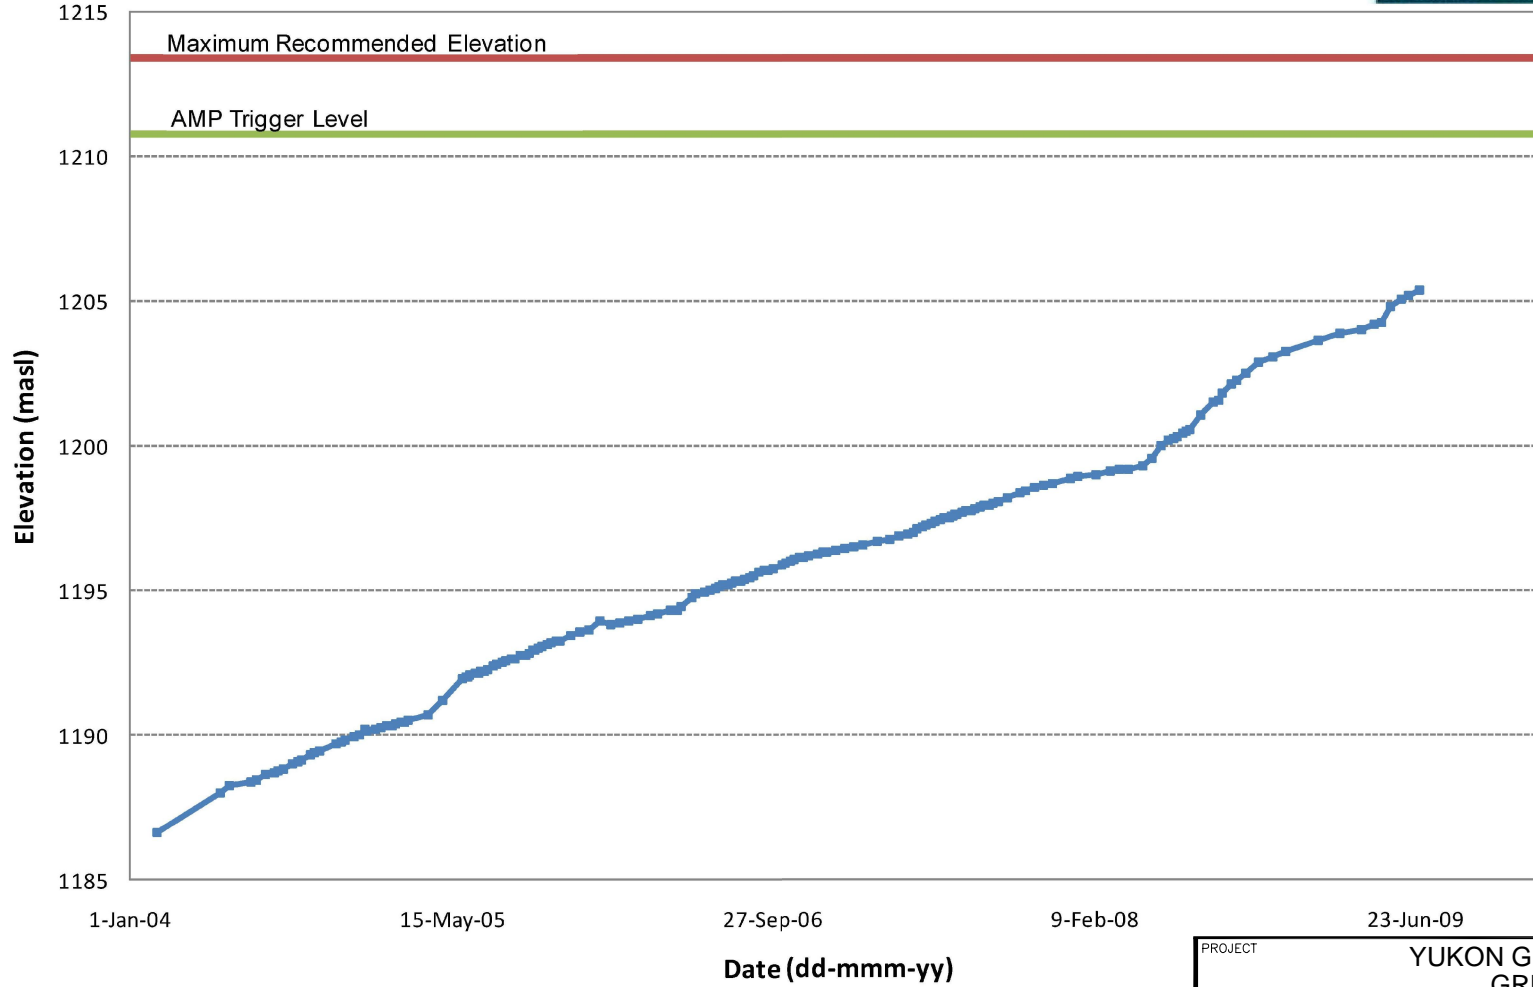
PROJECT		YUKON GOVERNMENT GRUM PIT FARO, YUKON			
TITLE		IN-PIT LAKE WATER LEVEL			
PROJECT No.		09-1426-0021		PHASE No. 2000	
DESIGN	LP	05NOV09		SCALE	NTS REV. --
CADD	NS	05NOV09		FIGURE 5	
CHECK	AVC	23MAR10			
REVIEW	AVC	23MAR10

- Based on Figure 5, the pit lake elevation increased from the 1,187 meter elevation in February 2004 to the 1,205 meter elevation in June 2009. The volume of water that has entered the pit during this 64 month interval between February 2004 and June 2009 is approximately 2,159,257 cubic meters. Based on these volumes, the average rate of water into the pit is 33,740 cubic meters per month.

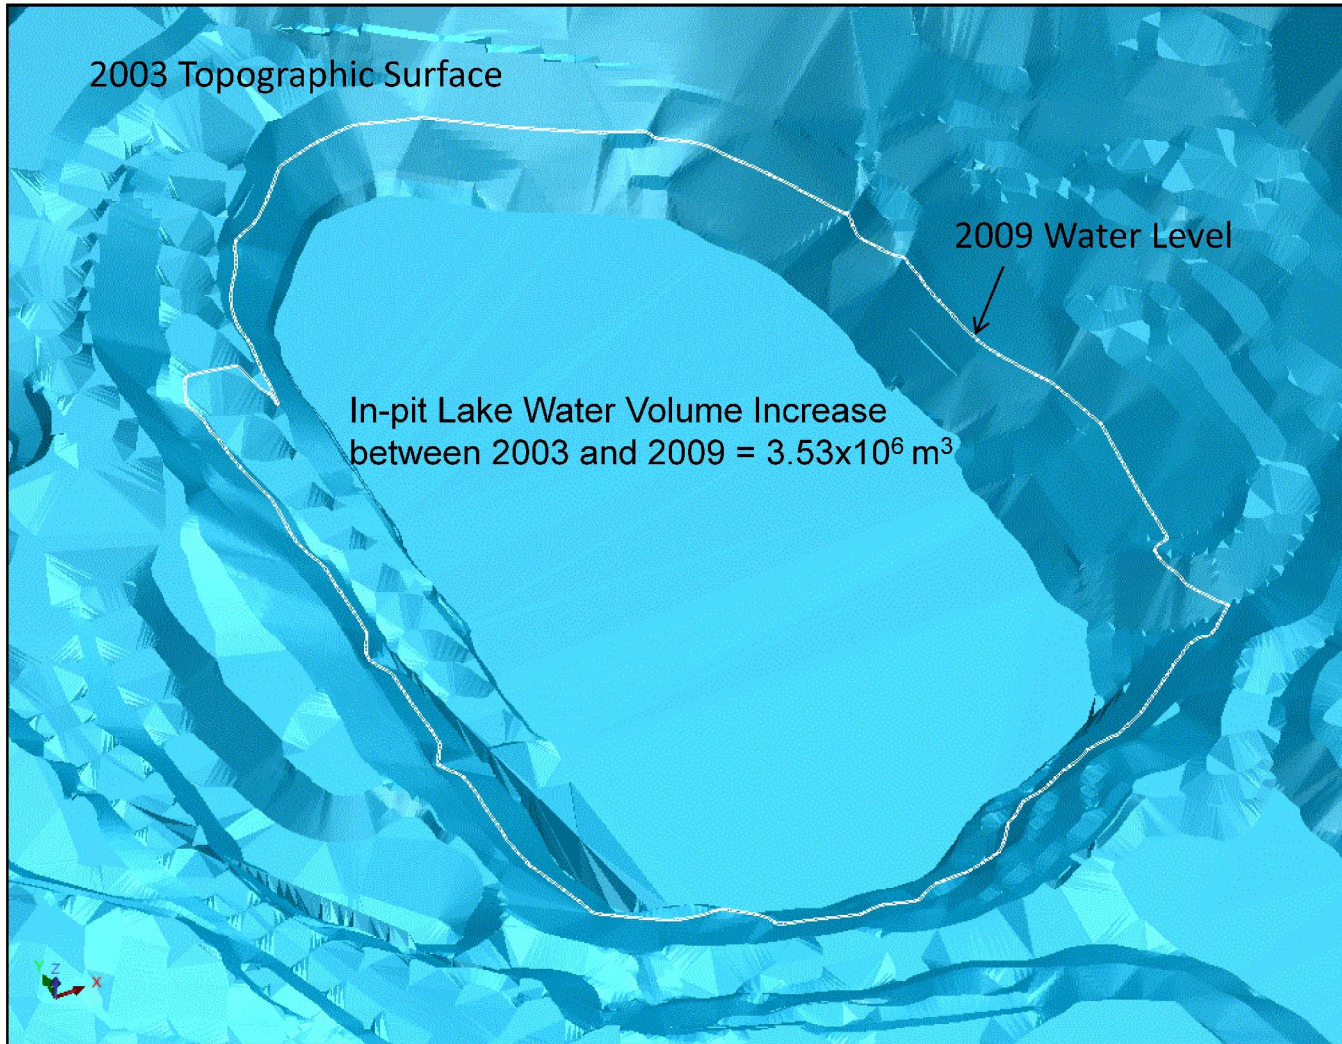
PROJECT		YUKON GOVERNMENT GRUM PIT FARO, YUKON			
TITLE		IN-PIT LAKE WATER VOLUME INCREASE (2003 - 2009)			
PROJECT No. 09-1426-0021		PHASE No. 2000			
DESIGN	LP	05NOV09	SCALE	NTS	REV. --
CADD	NS	05NOV09	FIGURE 17		
CHECK	AVC	23MAR10			
REVIEW	AVC	23MAR10

The additional water volume accumulated in the pit lake since 2003 has been calculated as approximately 3.5×10^6 cubic meters, as shown in Figure 17. During this period, the lake level has increased by approximately 20 meters. This increase of water accumulated in the pit is significantly greater than the estimates of the ground volume that appears to have moved since 2003. Consequently, it would appear that the impact of ground movement on the increase of the lake elevation since 2003 has been marginal.

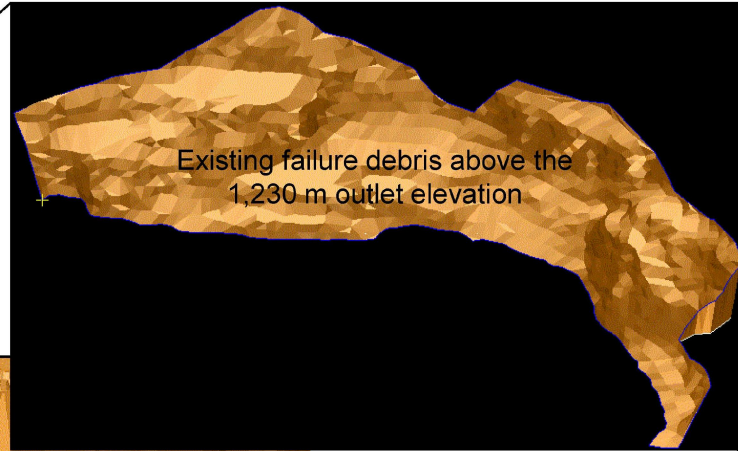
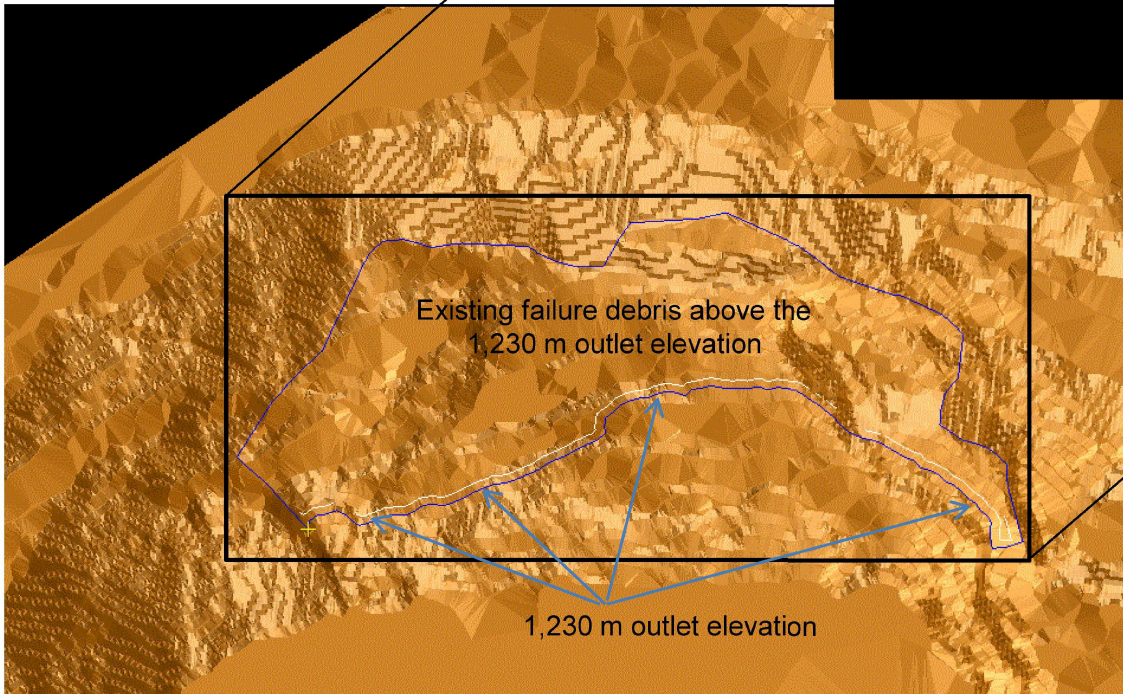
PROJECT No. 09-1426-0021			PHASE No. 2000	
DESIGN	LP	05NOV09	SCALE	NTS
CADD	NS	19NOV09	REV.	-
CHECK	AVC	23MAR10	FIGURE 18	
REVIEW	AVC	23MAR10

- However, the volume of existing failure debris that is above the pit ultimate outlet elevation would displace and reduce the remaining volume in the pit between the outlet level and the current lake level. The estimated volume of existing failure debris above the outlet elevation at the 1,230 meter elevation is approximately 483,969 cubic meters. The outline of this approximate volume is shown on Figure 18. This is approximately 10 percent of the 4.5 million cubic meters of storage volume that remains below the pit outlet elevation.

Volume of existing failure debris above the 1,230 m outlet elevation = 483,969 cubic meters

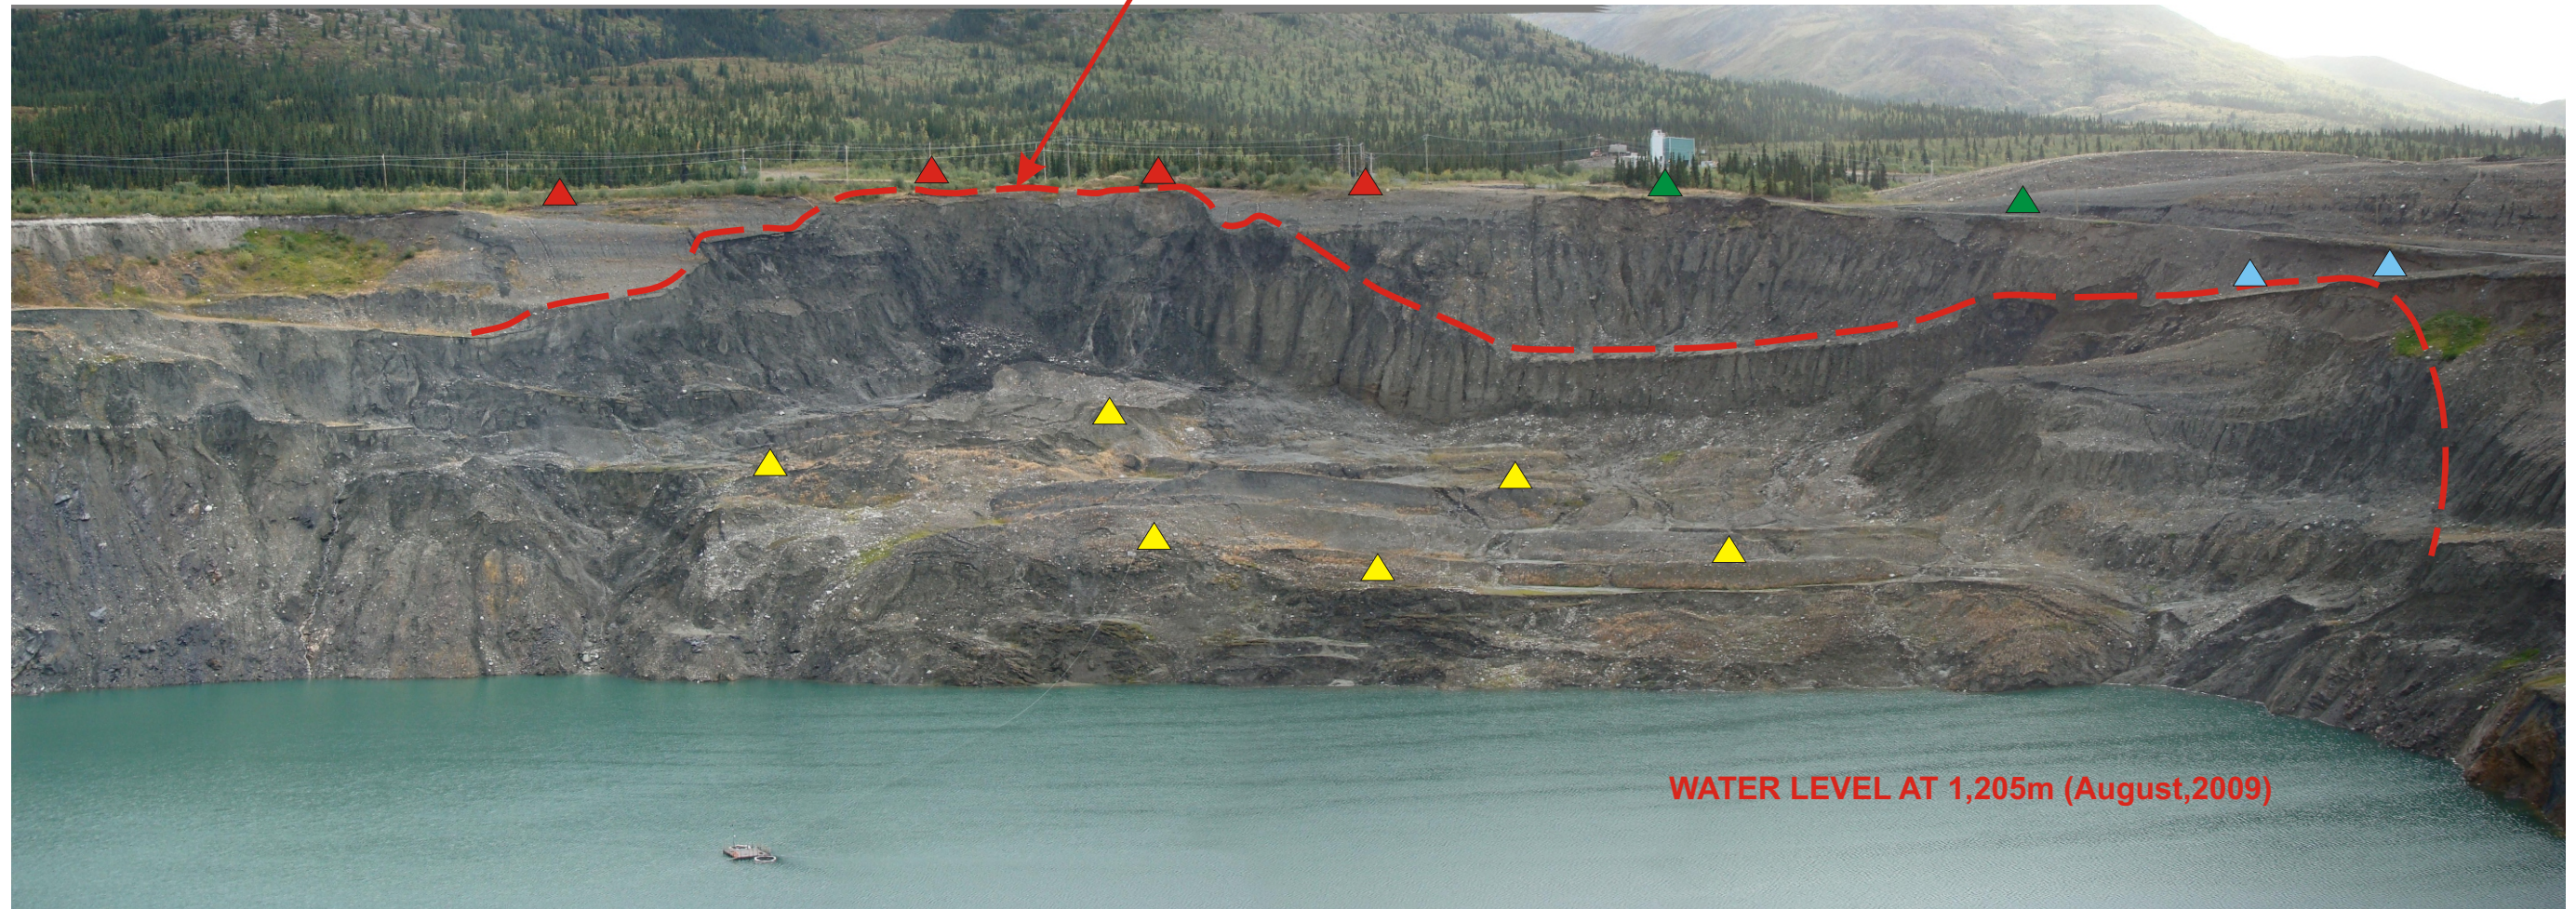
PROJECT	YUKON GOVERNMENT GRUM PIT FARO, YUKON			
TITLE	LOCATIONS OF RECOMMENDED SLOPE MONITORING PRISMS			
	PROJECT No. 09-1426-0021	PHASE No. 2000		
	DESIGN LP 03NOV09	SCALE	NTS	REV.
	CADD GG 03NOV09			
	CHECK LP 03NOV09			
	REVIEW AVC 23MAR10			
		FIGURE 19

Approximate limits of slope instability

The recommended locations of the proposed prisms are shown on Figures 19 and 20. The recommended survey prism locations are summarized below.

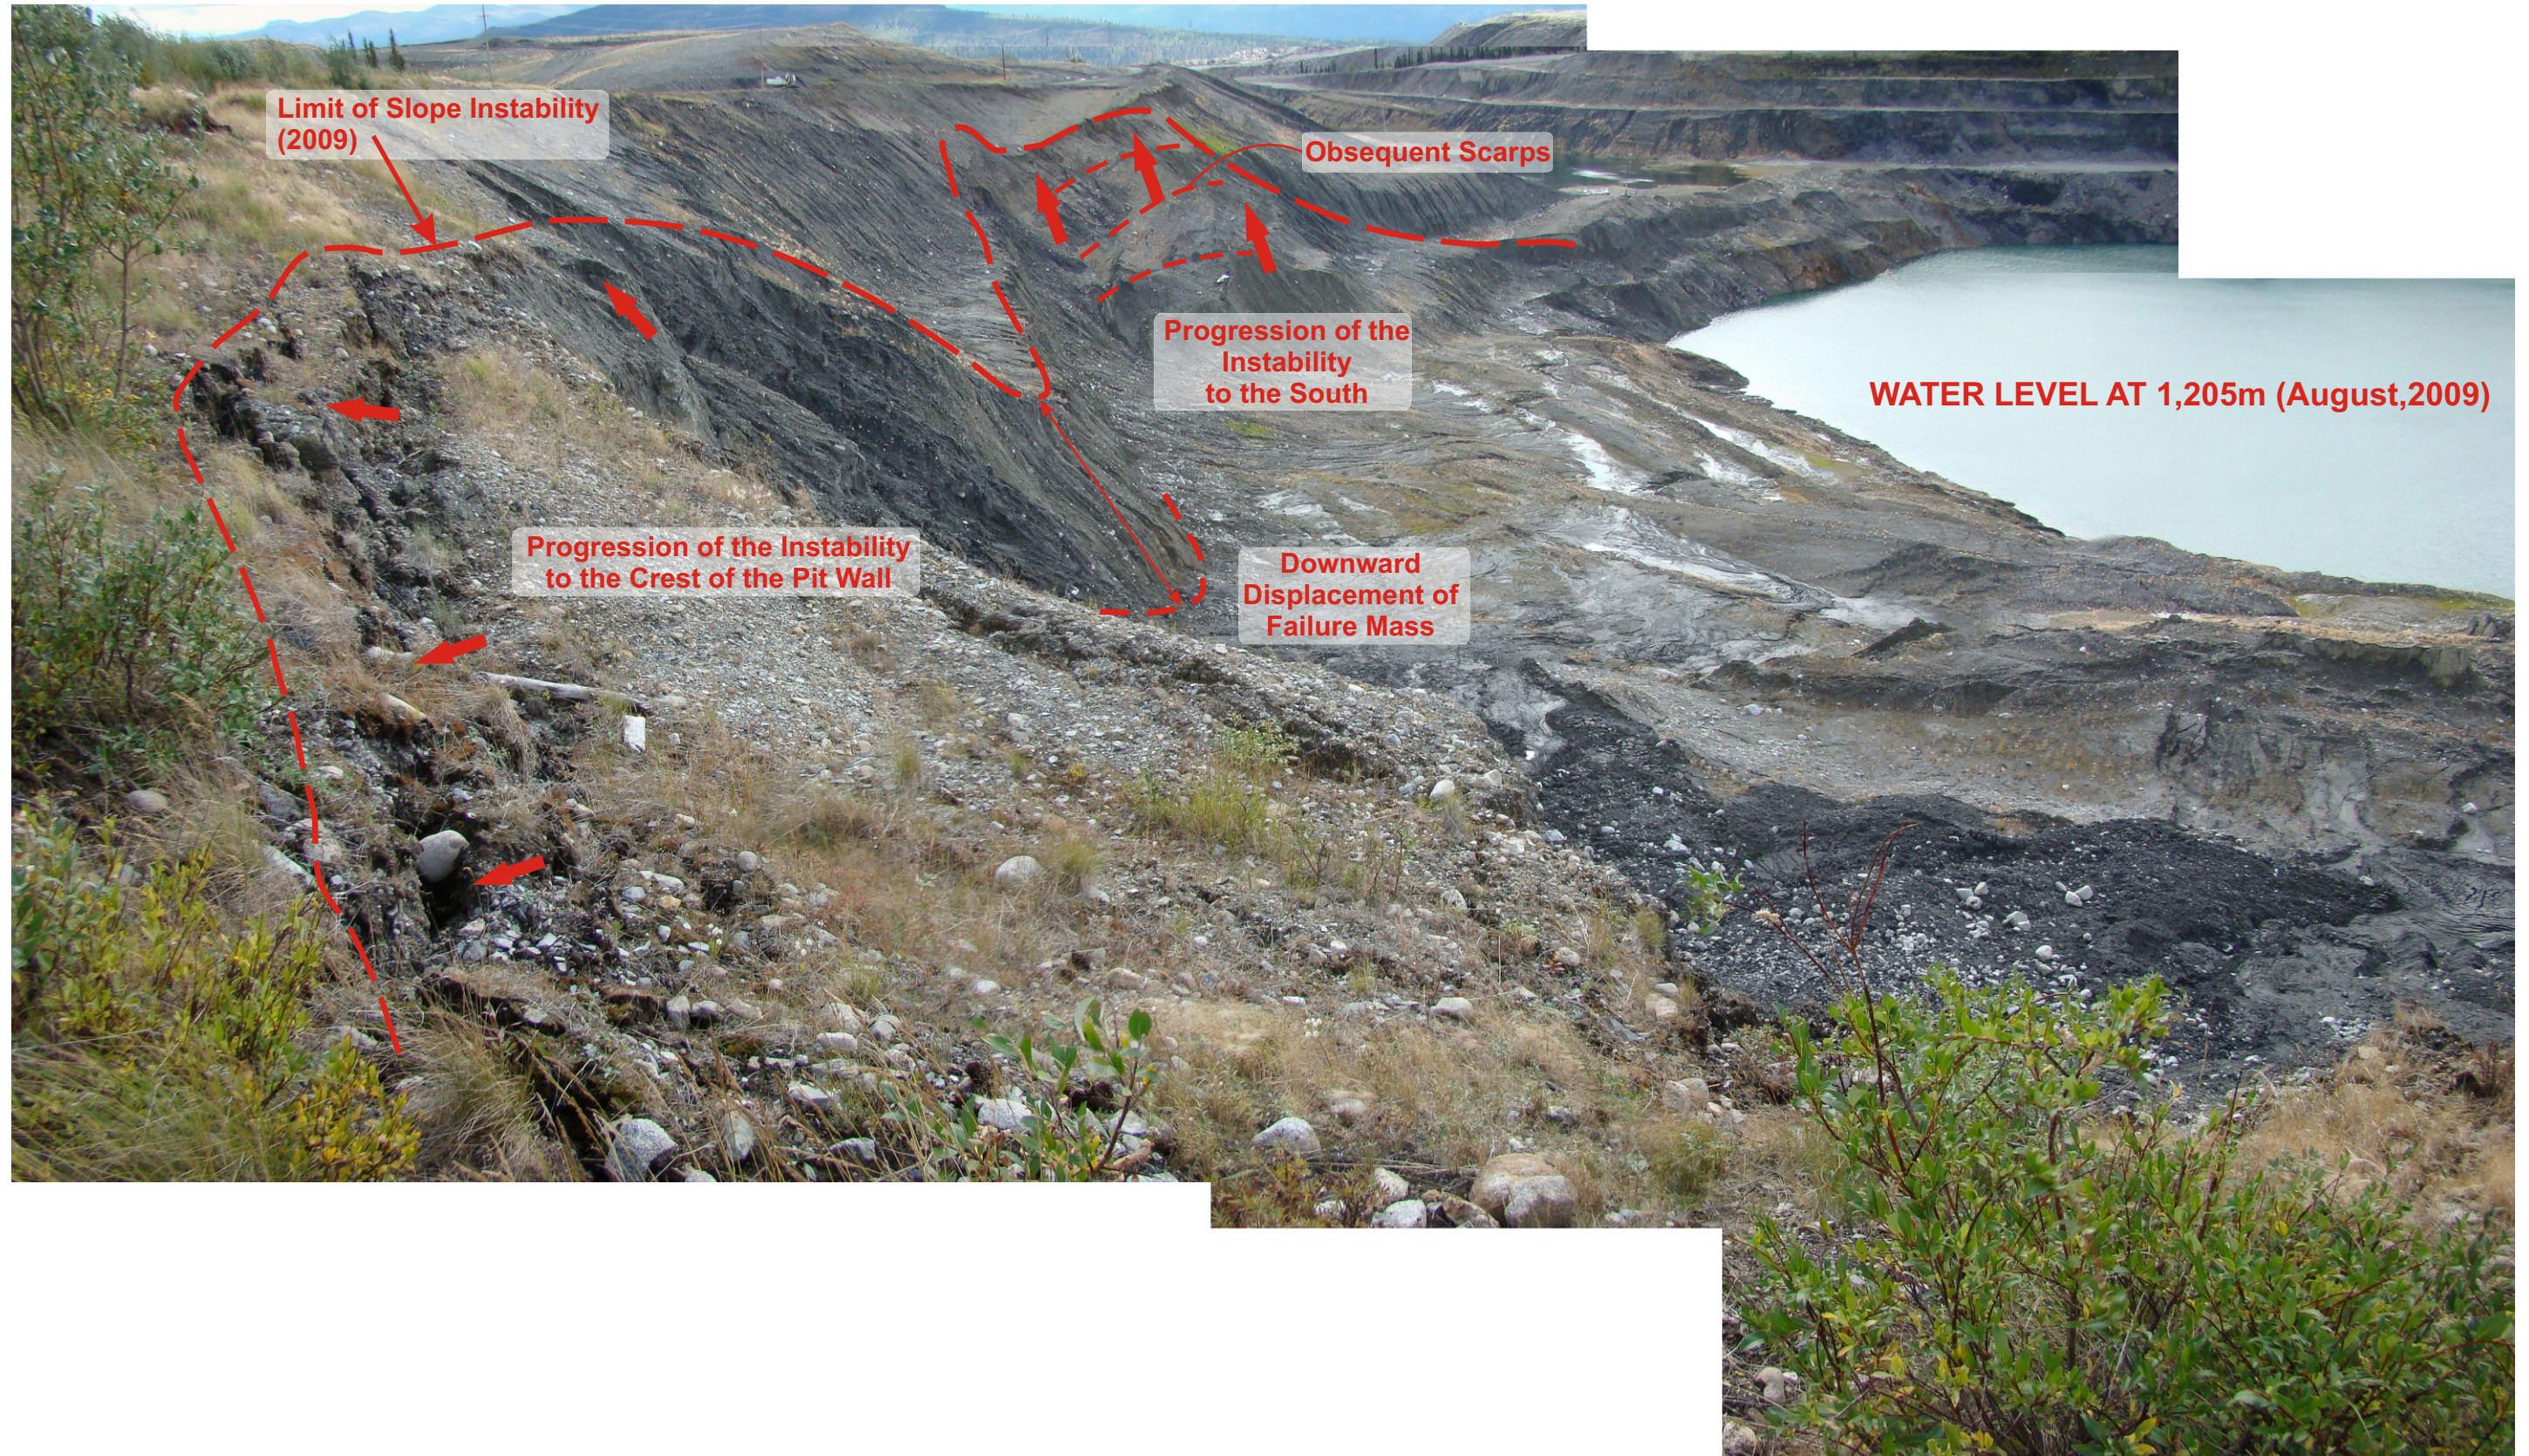
Photograph 8 : East wall instability. Crest of the pit wall looking south (2009).
