Assessment & Abandoned Mines
Ministry of Energy, Mines and Resources
FARO MINE COMPLEX
SITE-WIDE ELECTRICAL ASSESSMENT

INTERIM REPORT

Rev 0, Original Issue 31 August 2016
Rev 1, Minor Corrections Issued 29 November 2016

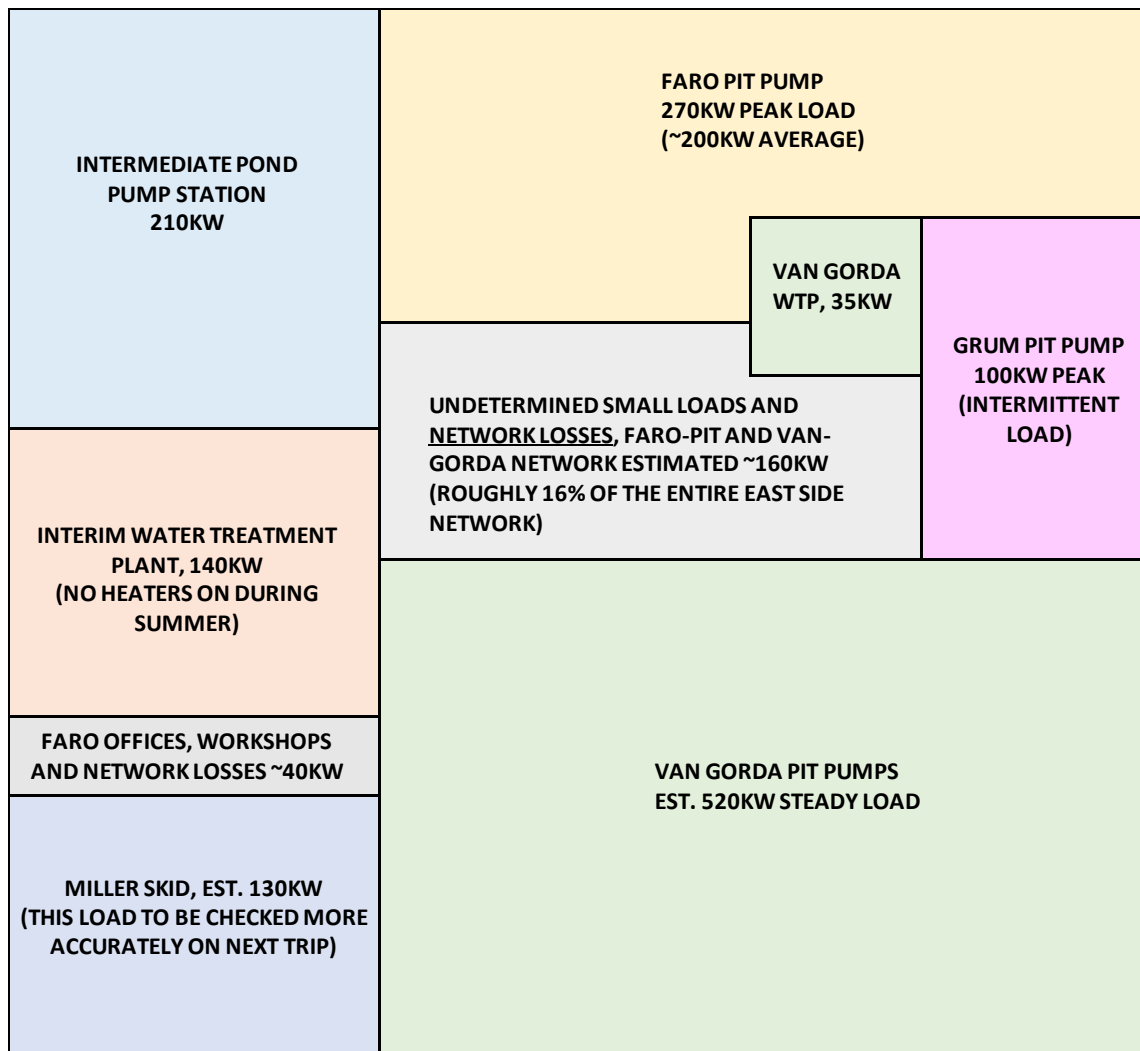
Graphical Breakdown of the Peak 1,600 kW Site Load Measured on August 25th, 2016

“West Side” Network on the Left totals to around 500kW, with the remainder of the site load going to the “East Side” Faro Pit and Van Gorda site.
