TECHNICAL MEMO

Date: November 28, 2009

Re: **Summary of Groundwater Monitoring Activities at the Faro Mine Complex for the 2009 Season**

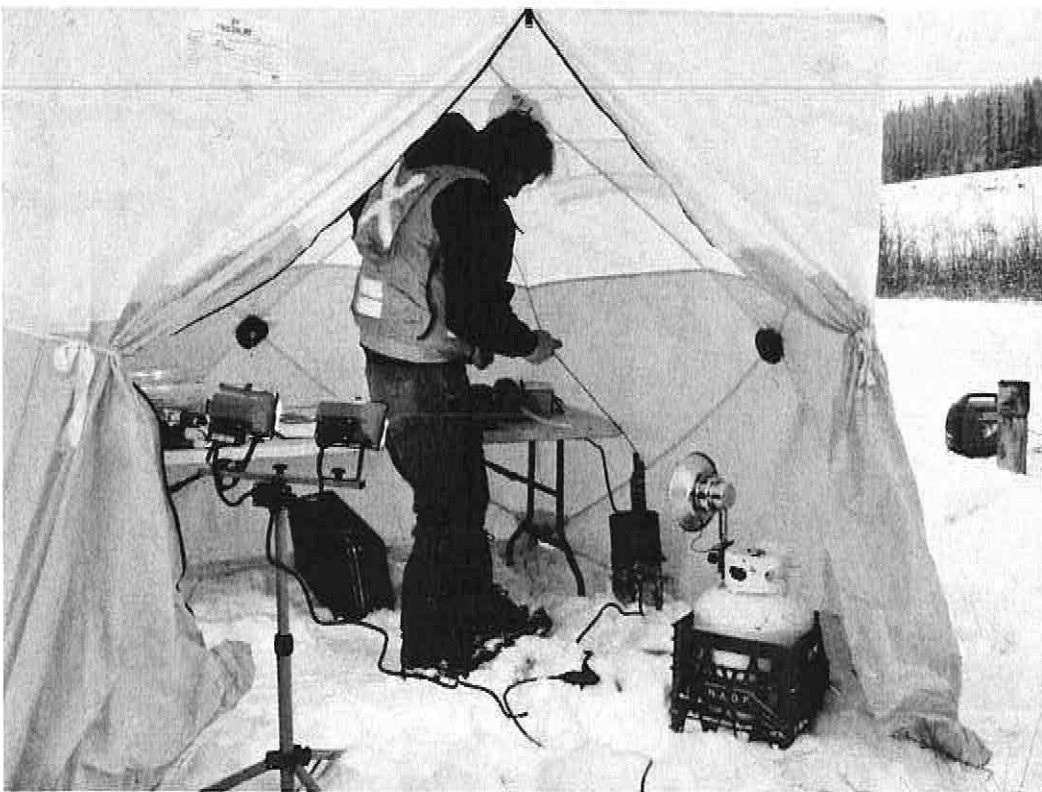
The repaired monitoring well, SRK09-SP5, Sept 11, 2009.

SRK05-SP5	The steel casing was broken and the well was damaged however the well was repaired by the September sampling, although a protective steel casing is still required.
X16B	AECOM was going to use their down-hole camera to check the well construction competency but due to a malfunction with the unit, photos could not be obtained.
X18B	The depth to bottom has changed significantly suggesting that the well has sloughed in at some point, DTB on Sept 6 was 10.76 m whereas it should be around 23 m. There is good yield however it is questionable whether the water being sampled is originating from the required and designed depth.
