Vangorda Creek Diversion Design of Emergency Spillway and Recommendations for Flume Upgrade

*Project Reference Number:
SRK 1CD003.62*

October 2004

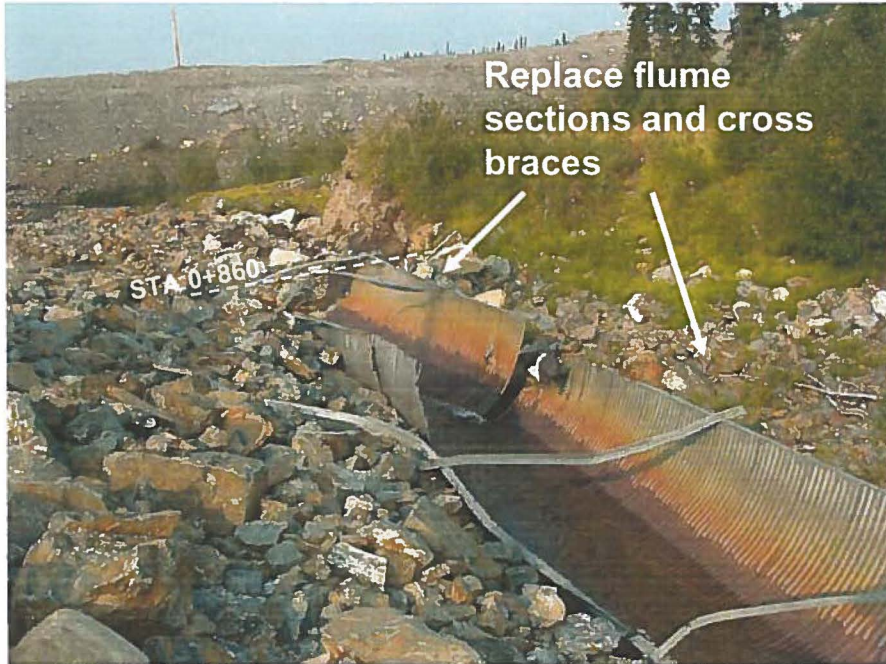
Photo 1: STA 0+860

Photos of the flume sections that will be replaced or repaired are shown in Appendix A.

- Remove the old flume sections between STA 0+460 and 0+640;
- Replace damaged flume sections and cross braces;
- Repair flume sections and replace anchor plates where applicable;
