DELOITTE AND TOUCHE INC.  
AS INTERIM RECEIVERS FOR  
ANVIL RANGE MINING CORPORATION

1998 ANNUAL ENVIRONMENTAL REPORT  
FOR WATER LICENCE IN89-002  
VANGORDA PLATEAU

MARCH 1999

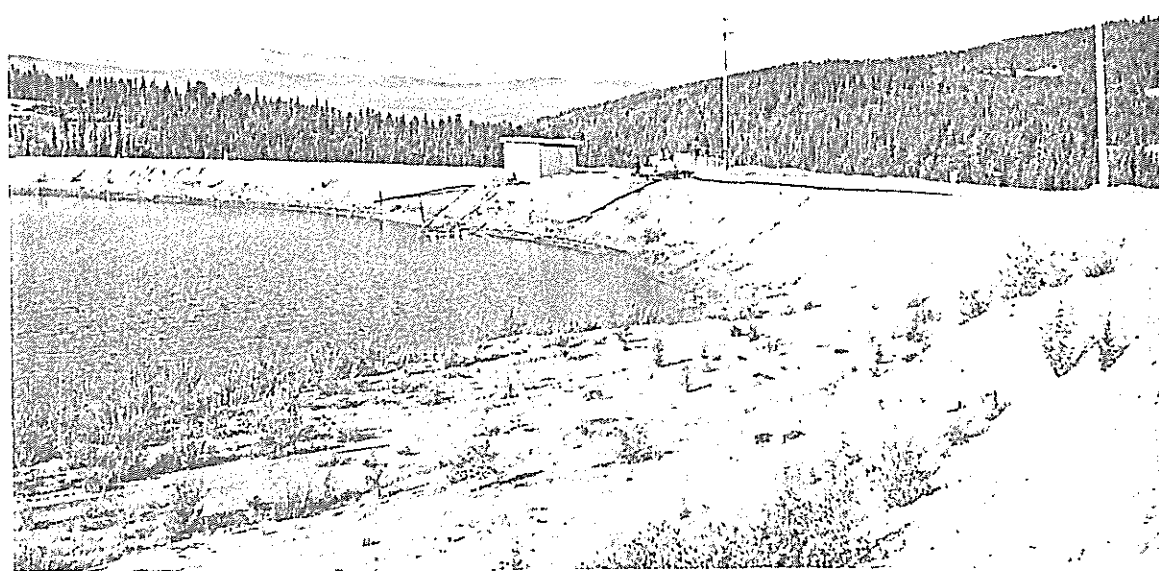
Photo 8 - Little Creek Dam.

There was no evidence of any slides or sloughing, nor signs of any cracks or movement along the crest of the dam (Photo 8). Runoff from the eastern approach road continues to cause erosion of the road embankment sideslopes. Two erosion gullies (Photo 10), which are in places 1m deep, have formed within several metres of each other. These gullies pose no immediate threat to the stability of the dam itself but if allowed to go unchecked could result in loss of a section of the road. Runoff has been allowed to flow over the slope through "punch outs" in the berm along the side of the road. An attempt has also been made to direct runoff from the approach road over the downstream side of the approach road (Photo 11).

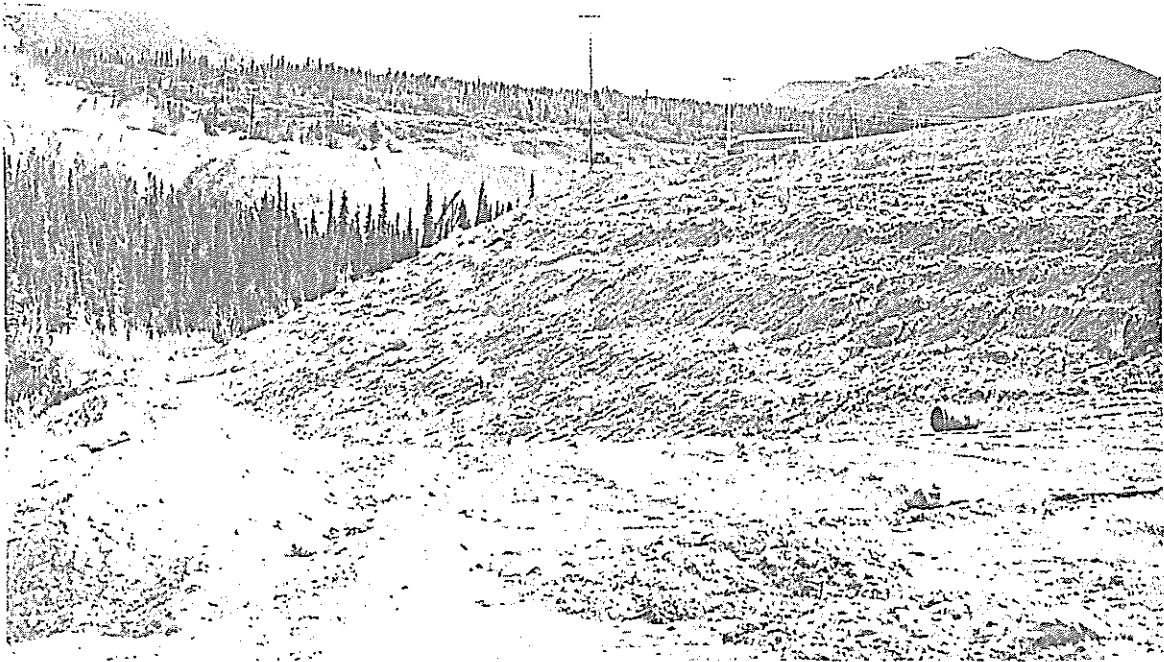
Photo 9 - Downstream slope of Little Creek Dam.

The downstream face of the dam (Photo 9) shows little evidence of surficial movement, bulging or instability. The loose, uncompacted material at the toe of the dam, which was deposited during the construction of the dam in 1991, shows signs of continued erosion.

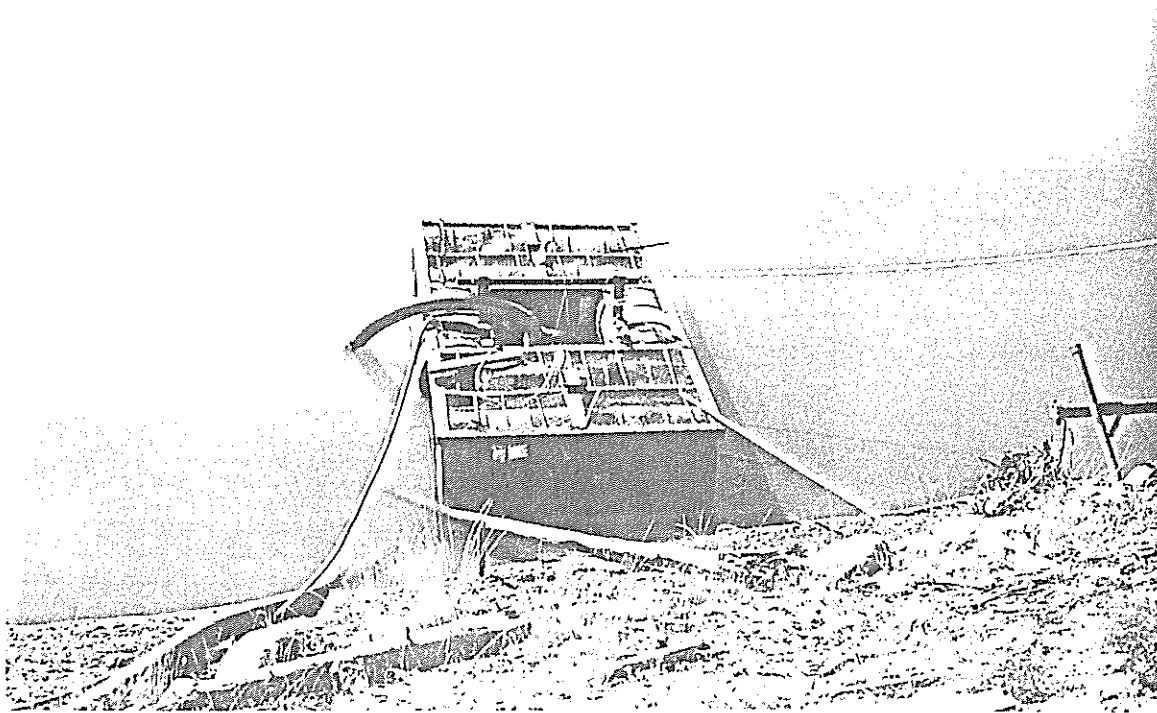
Photo 12 - Pumping system to Vangorda pit.

Water is currently being pumped directly from a floating raft on the pond to Vangorda Pit (Photo 12). The treatment plant is not in operation.

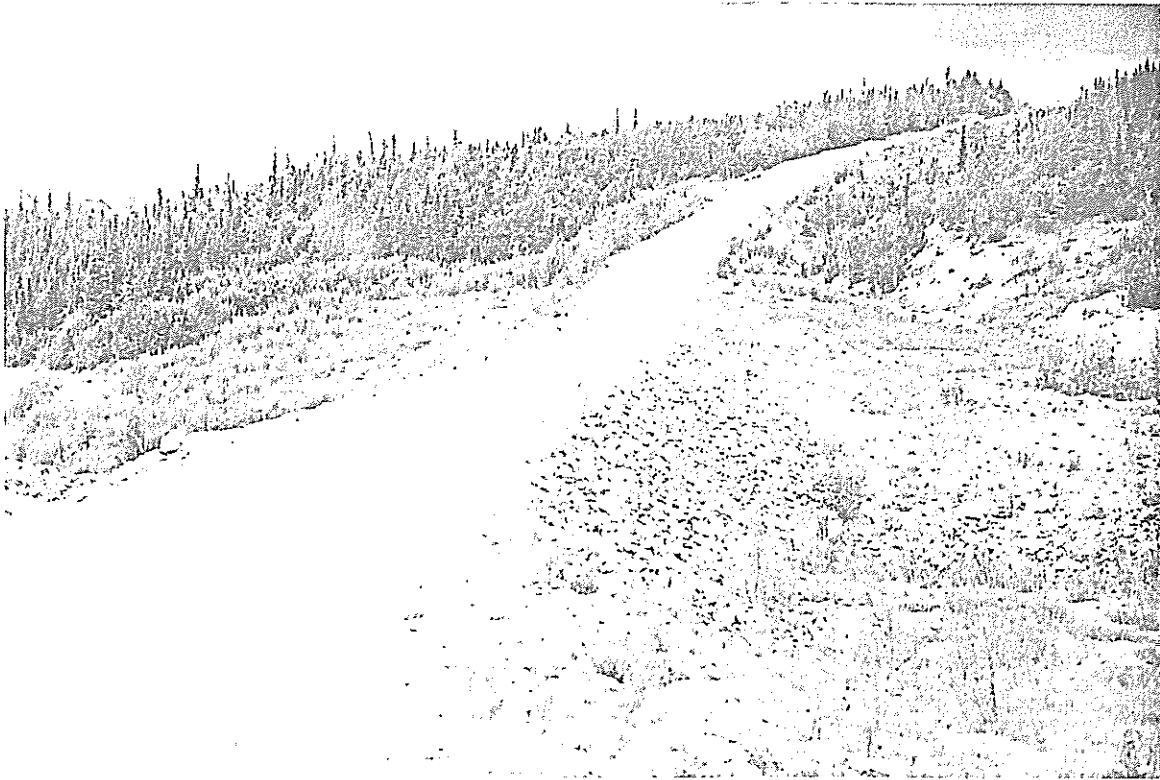
Photo 13 - Headworks of Vangorda Creek Diversion.

The crest of the dam at the headworks of the Vangorda Creek Diversion shows no signs of settlement or cracking. There is no evidence of instability or surficial movement on either of the upstream and downstream faces. Some riprap has been lost above the inlet to the CMP at the headworks of the diversion (Photo 13 and 14) exposing the underlying geotextile. Furthermore, riprap has begun to collect in the channel and around the trash rack at the inlet to the CMP narrowing the entrance. The pipe itself appears to be sound.

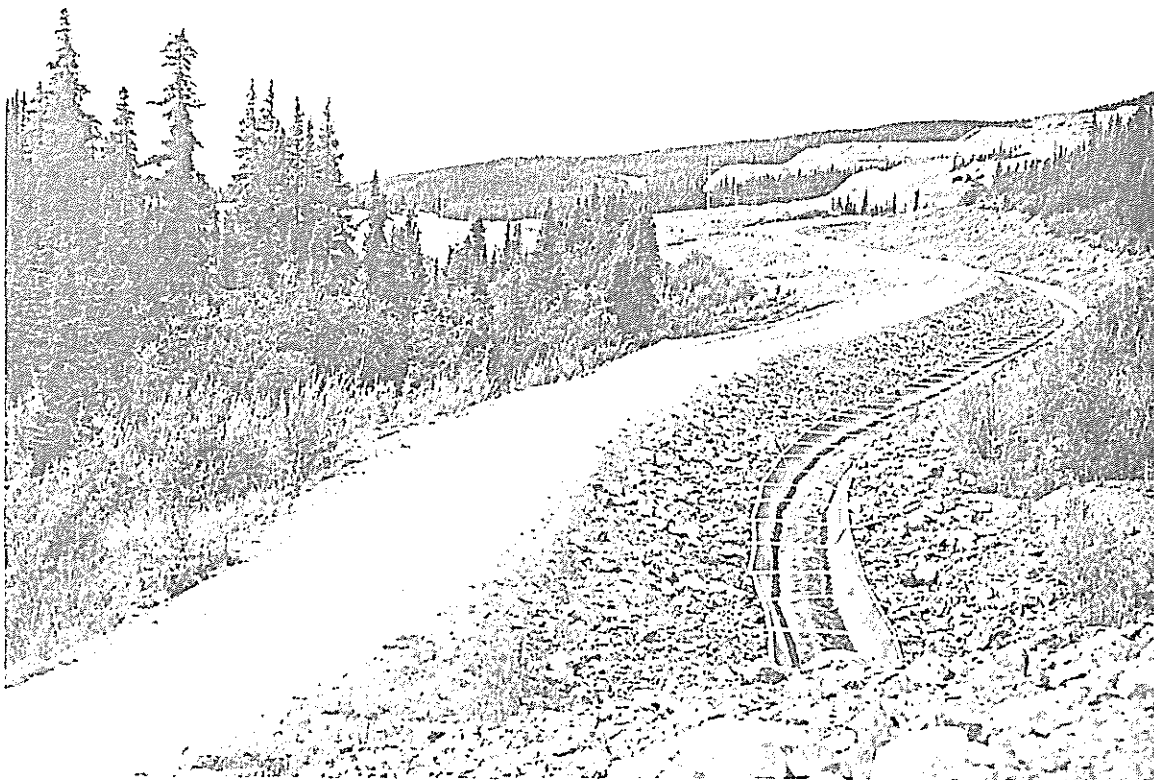
Photo 15 - Upper reaches of Vangorda Creek Diversion.

The half-round culvert in the upper reaches has performed well (Photo 15) but the flume does not weather well along the lower reaches (Photo 16). The cross bars are badly bent and the flume is buckled in places. In several areas along the flume, riprap has settled to below the lip of the culvert (Photo 17). The potential still remains for slide debris at certain locations along the channel to enter the flume.

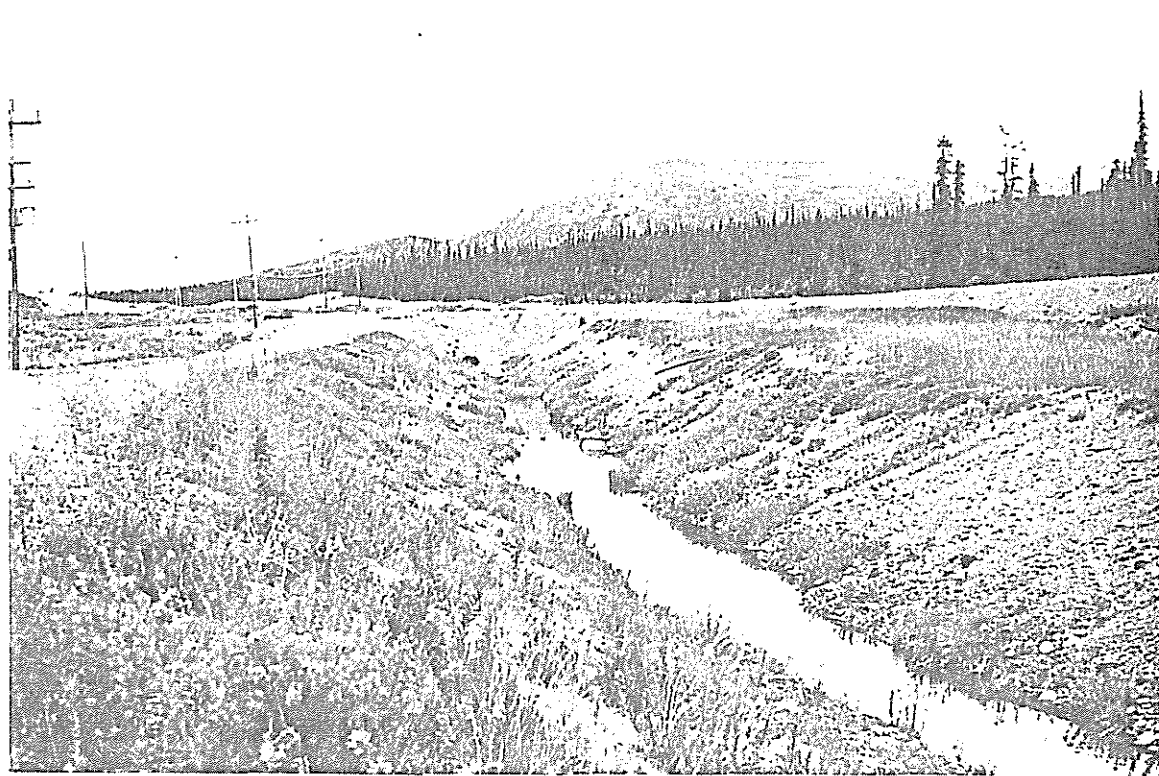
Photo 22 - Middle reach of Grum intercepter ditch.

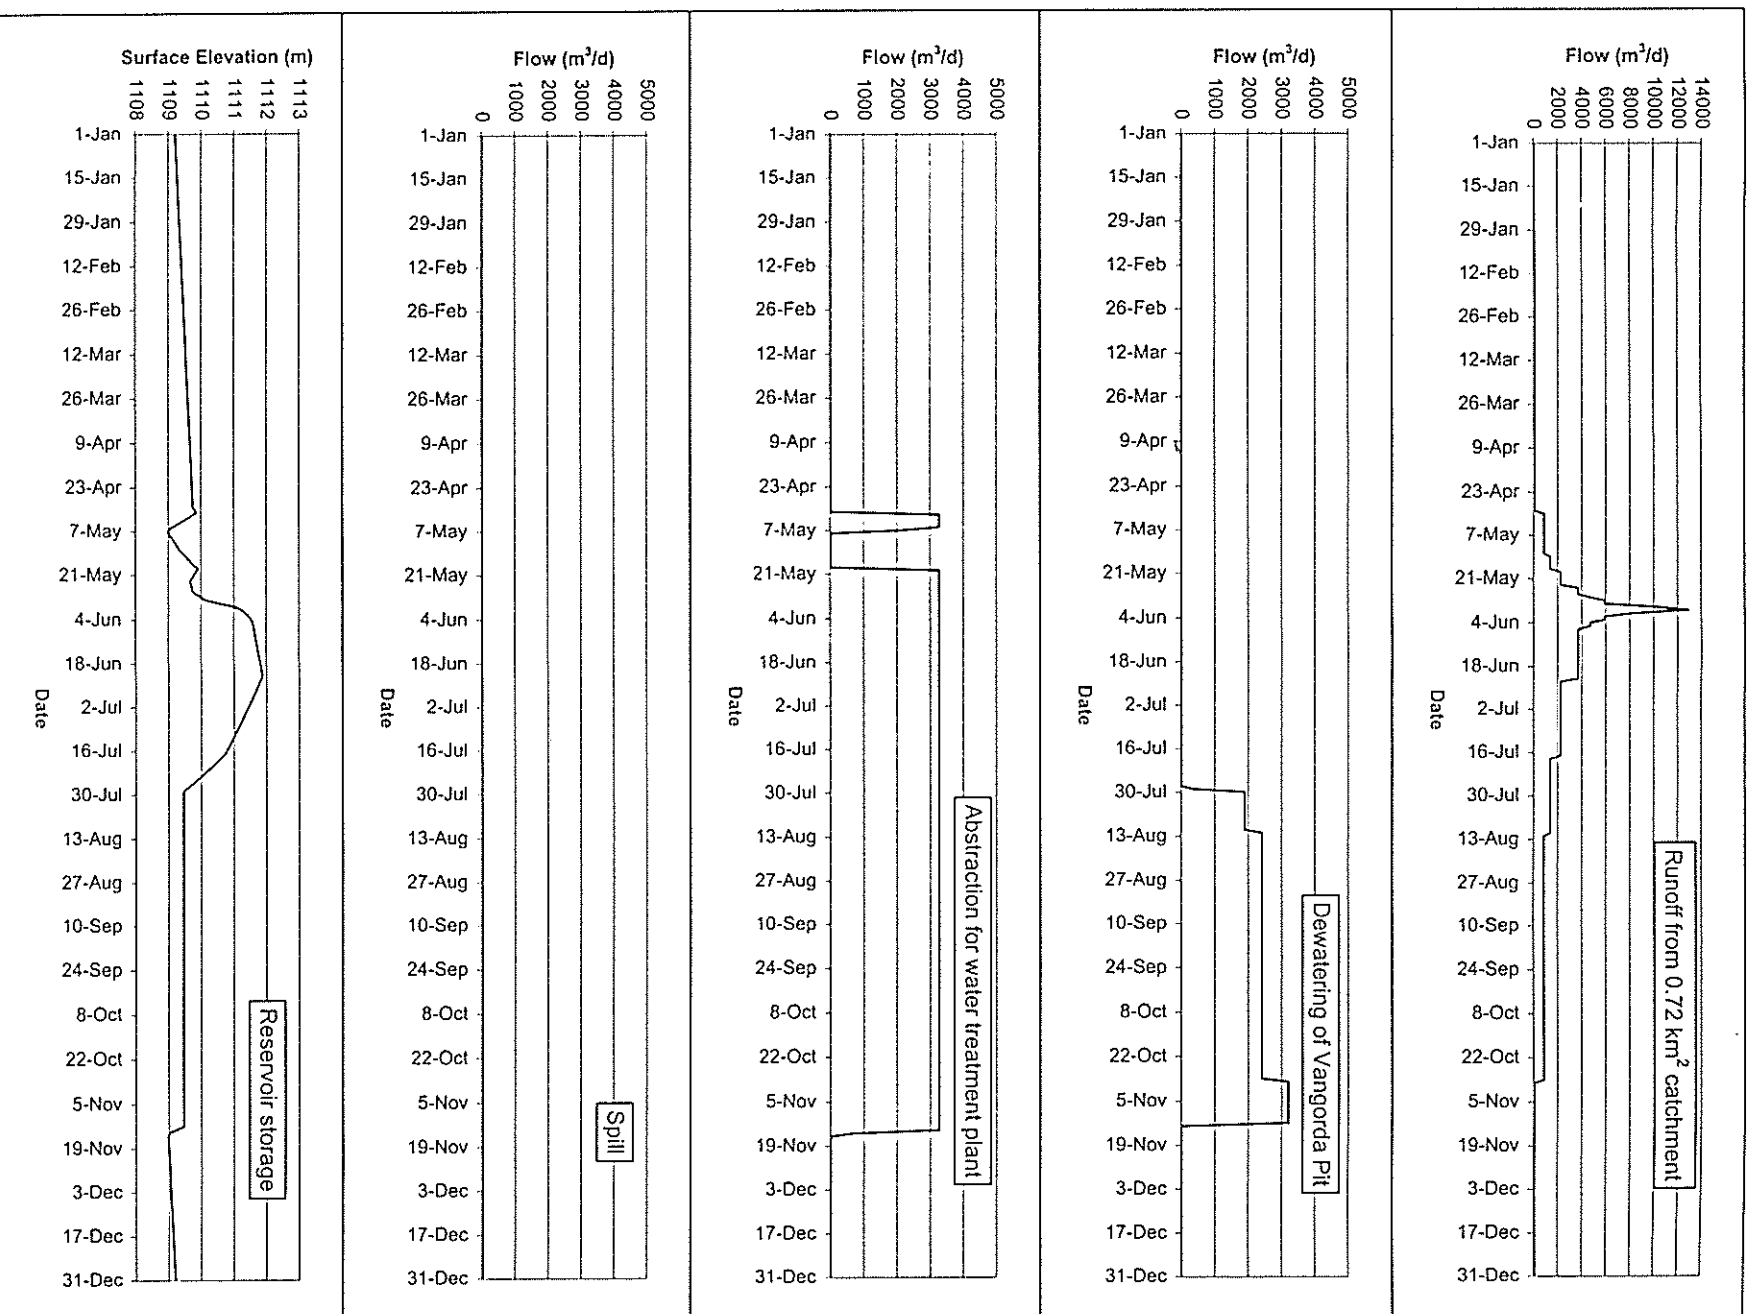
Figure 5 Simulated Behaviour of Little Creek Dam during an Extreme Wet Year  
(Best Estimate of Wet Year with a Return Period of 200 Years)

Figure 5 indicates how the pond would behave during the passage of the best estimate for the 200-year wet year. As indicated by the two bottom graphs, no spillage would occur during this event. It should be noted, however, that during the peak inflow

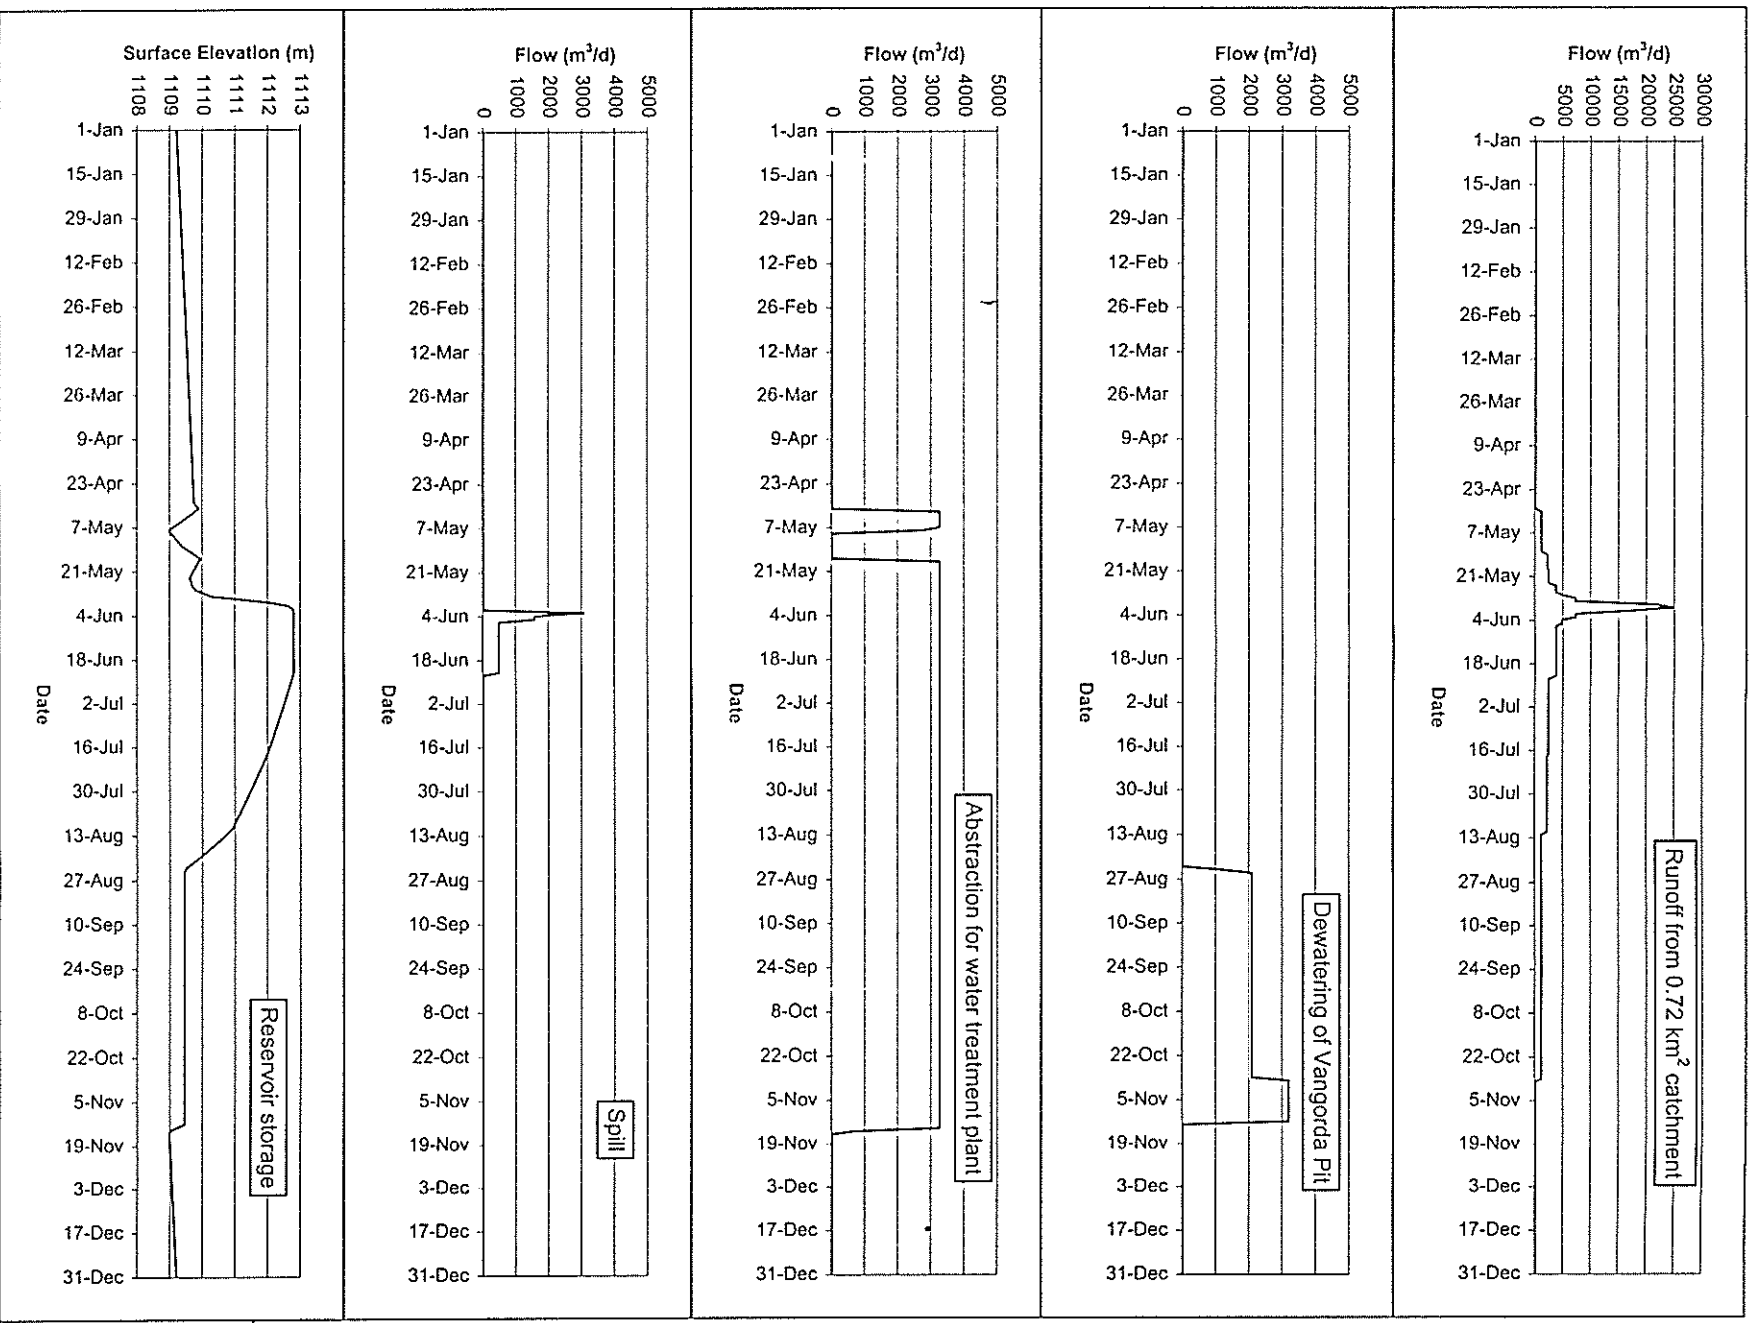
Figure 6 Simulated Behaviour of Little Creek Dam during an Extreme Wet Year  
(Conservative Estimate of Wet Year with a Return Period of 200 Years)

The spreadsheet model was also run using the "conservative estimate" hydrograph. Figure 6 shows the simulated behaviour of the pond using the more extreme estimate of the 200-year wet year. As shown the lower two graphs, the water level in the reservoir would rise to the spillway invert elevation (1112.8 m), allowing a small amount of spillage to occur.

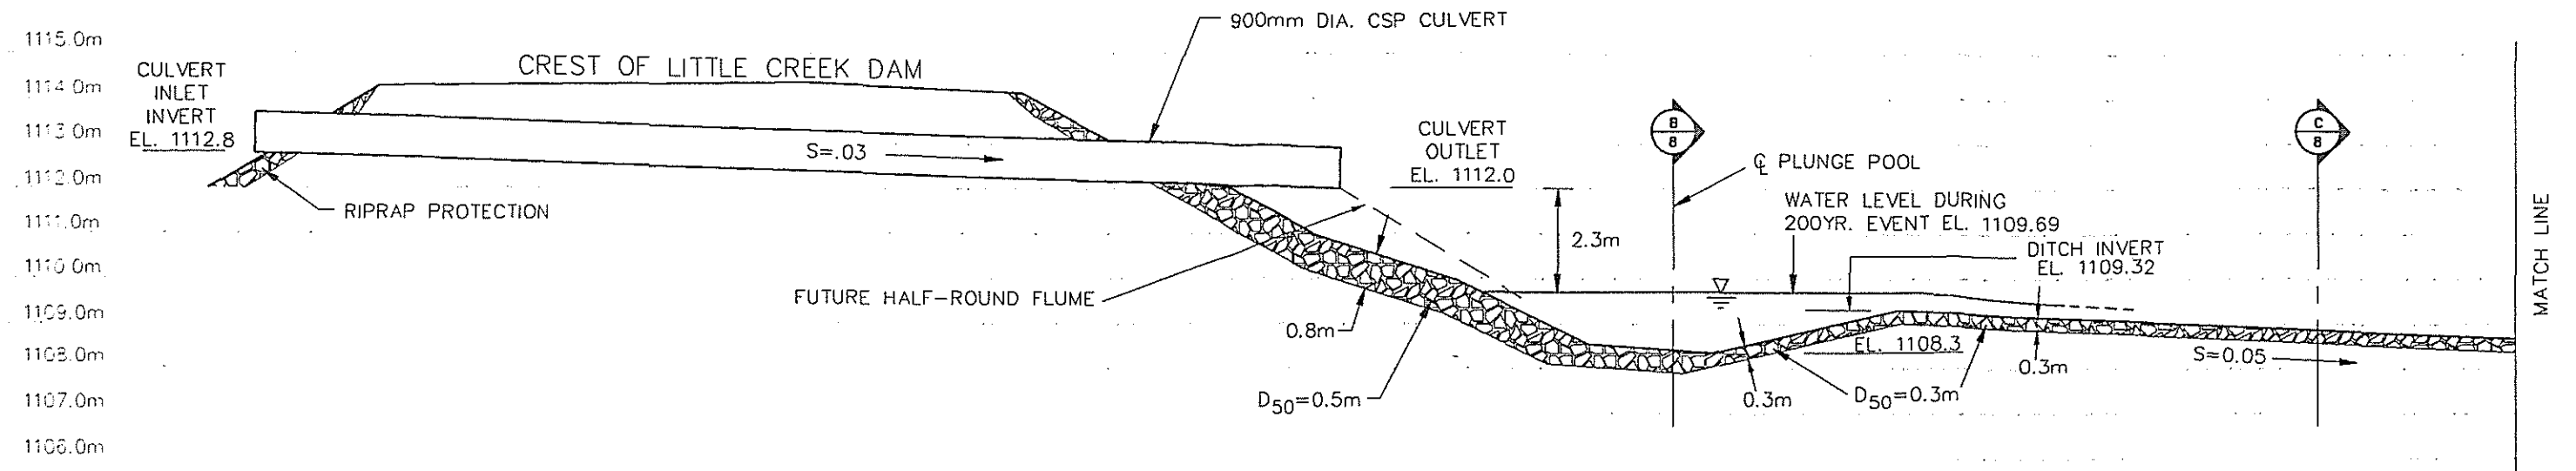
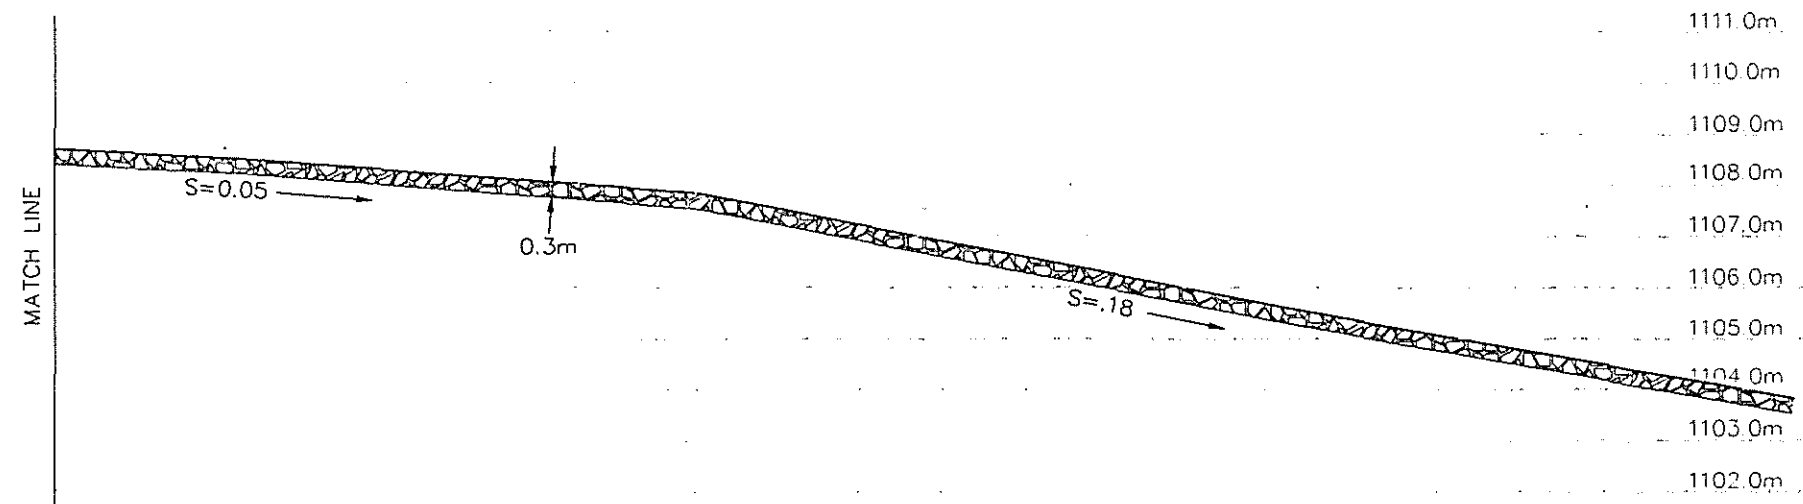
FIGURE

As-constructed details of the plunge pool are shown on Figures 7 and 8.

The as-constructed configuration of the plunge pool and ditch is shown on Figures 7 and 8

As a result of the design changes to the plunge pool, any flow through the culvert would impact the riprapped sideslopes of the plunge pool before contacting the ponded water. This could cause erosion of the riprap and possible erosion of the toe of the dam. Although, DTI placed additional oversized riprap in this area, DTI should also consider installation of a half-round flume, which would be attached to the outlet culvert to convey flow directly into the plunge pool (see Figure 7). Modifications to the culvert may be required prior to the flume installation. Details of this flume would be finalised during the next inspection by SRK in 1999.

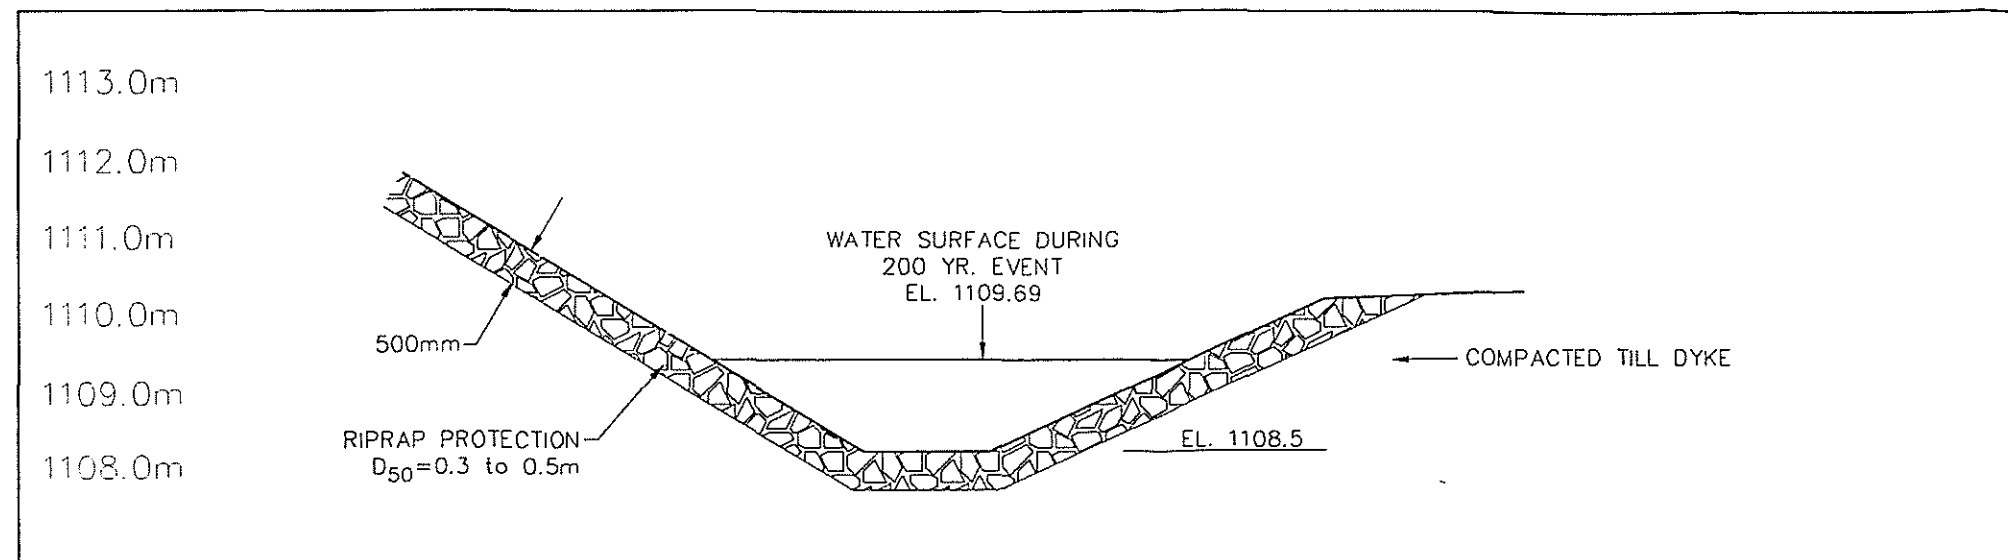
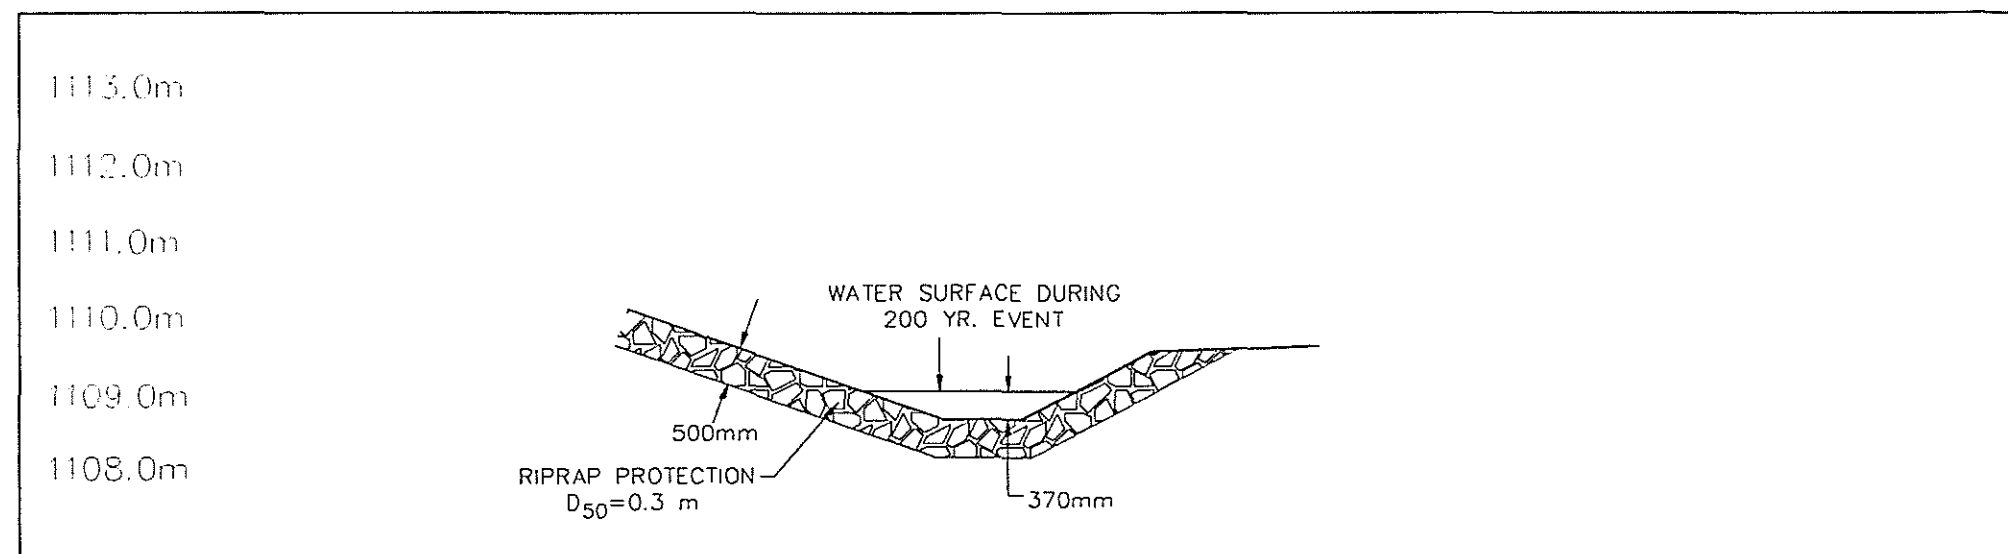
An outlet channel was also designed to take flow from the plunge pool away from the toe of the dam and direct the flow into an area that would minimise erosion without the need for a costly flume or riprapped channel down to Vangorda Creek. The as-built channel has an invert at the plunge pool outlet of El. 1109.32m. The ditch runs initially for a distance of about 26m at a grade of 5 percent. The ditch then steepens to a grade of 18 percent. The entire ditch has a base width of about 1 metre and is protected with riprap. Details of the ditch are shown in Figure 8.
