**2002 Vangorda Plateau Annual
Environmental Report
Water Licence IN89-002**

Reference: GLL 22943 date: March, 2003

**2002 ANNUAL INSPECTION
WASTE AND WATER MANAGEMENT FACILITIES
VANGORDA MINE
YUKON TERRITORY**

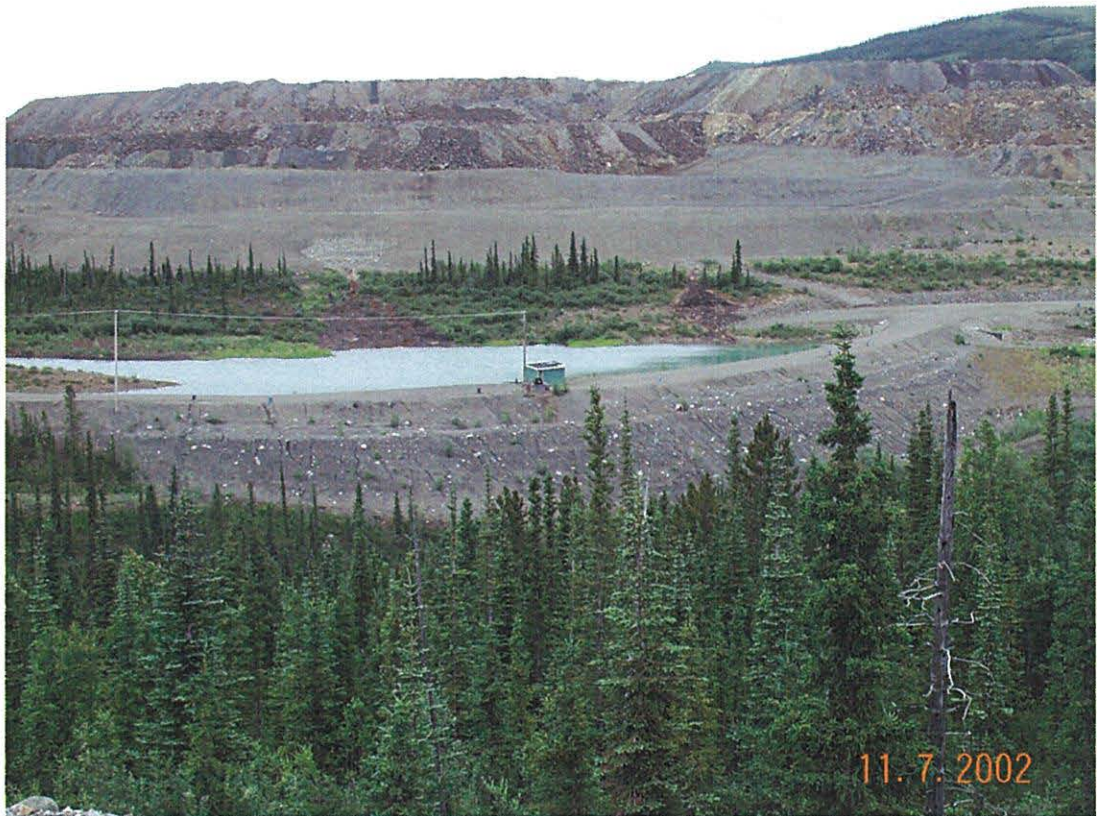
- Vangorda Waste Rock Containment Facility (Photo 1) including the seepage collection system ;
- Little Creek Dam;
- Vangorda Creek Diversion;
- Sludge Pond Embankments at the Water Treatment Plant,
- Grum Settling Pond;
- The Grum Interceptor Ditch; and
- The Sheep Pad Sediment Ponds below the Overburden Stockpile.

Photo 1: Vangorda Waste Rock Containment Facility with Little Creek Pond in the foreground

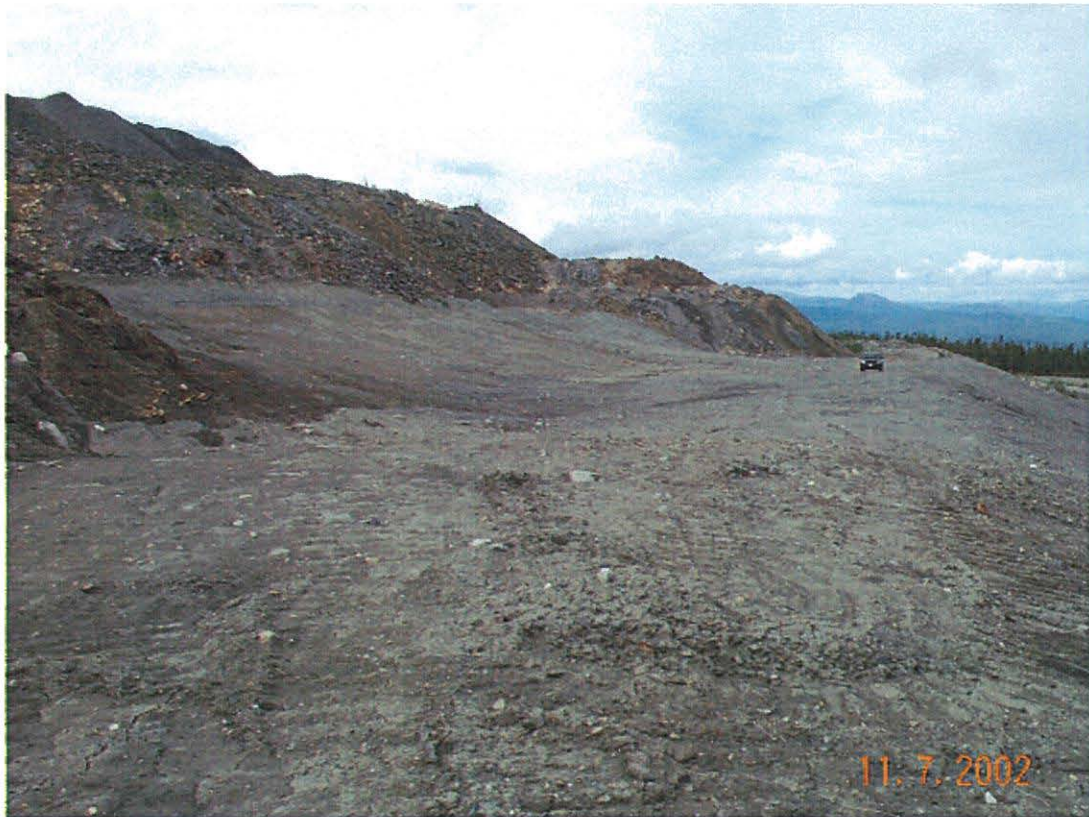
Following an the inspection on July 12, 2001, SRK considered the existing diversion ditch to be inadequate and believed there was a high degree of risk of further subsidence in the short term, which would have a negative impact on the structural integrity of the starter dyke. Furthermore, it was our opinion that it was very likely that the #6 drain will be blocked off by the subsidence. Consequently, SRK recommended to DT that remediation of this area be initiated during the 2001 construction season. DT completed the remediation between August and September, 2001 (Photo 2, 3 and 4). The work involved:

Photo 3: Recontoured section of the Till dyke on the north side of the Vangorda waste Dump

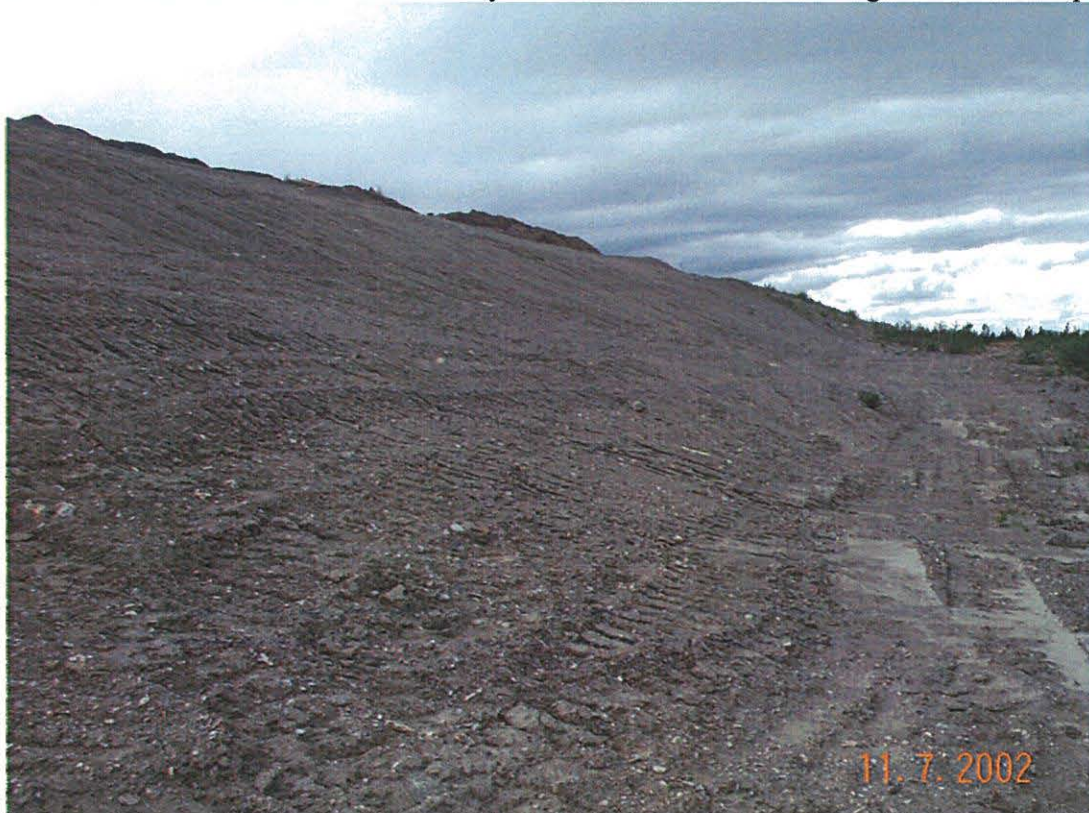
Photo 4: Resloped areas of the Starter Dyke

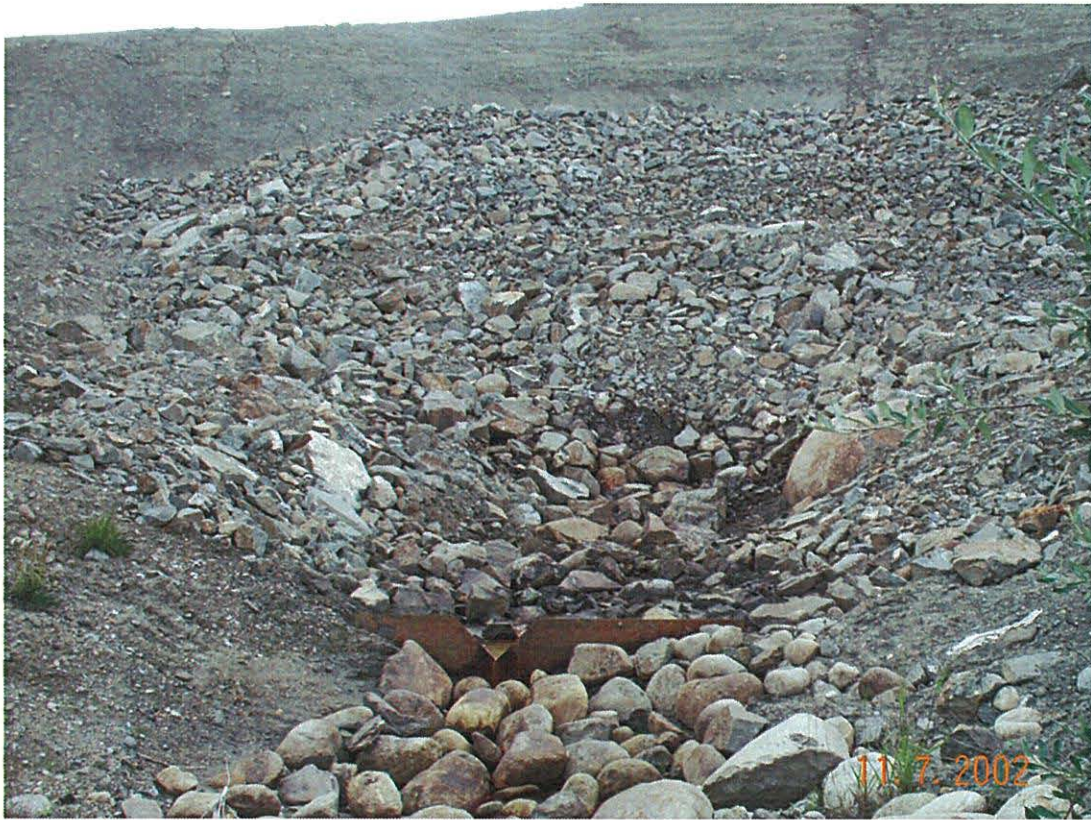
During this year's inspection, seepage flow was observed at Weirs 2 (Photo 11), 3 (Photos 9 and 10), 5 (Photo 6) and 6 (Photo 5). The flow in each of the weirs varied from a trace to less than 0.5L/min.

- Regrading the upper surface of the till stockpiles above the starter dyke to improve drainage;
- Removing the saturated soil at the bottom of the slope above the #6 drain;
- Placing geotextile filter fabric and a shotrock buttress half way up the slope above drain #6 (Photo 5).

Photo 5 : Drain #6 at toe of the starter Dyke on North side of Vangorda Waste Dump

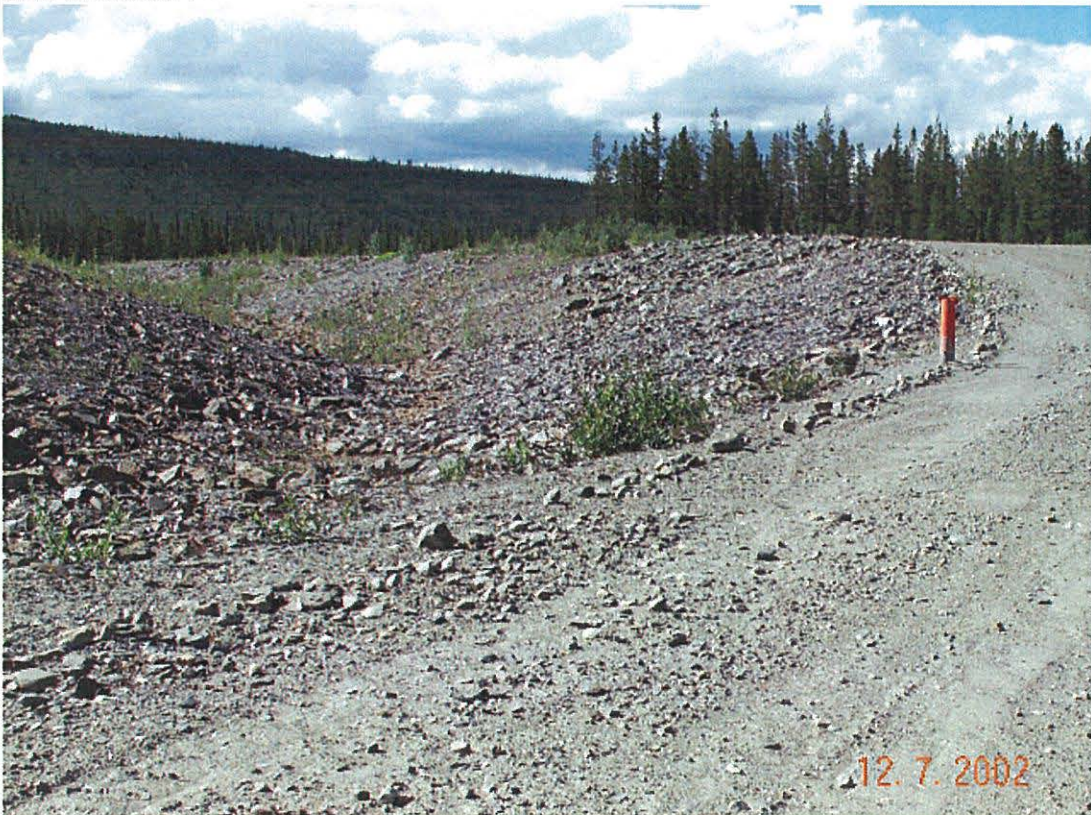
The seepage channel around the Vangorda Waste dump (Photo 8) is functioning normally and no instability of the sideslopes of the seepage channel was observed. Staining along the base of the ditch indicated that there had been some flow in the channel during in 2002. During the inspection, however there was no measurable flow observed in the ditch.

Photo 8: Vangorda Seepage Collection Ditch

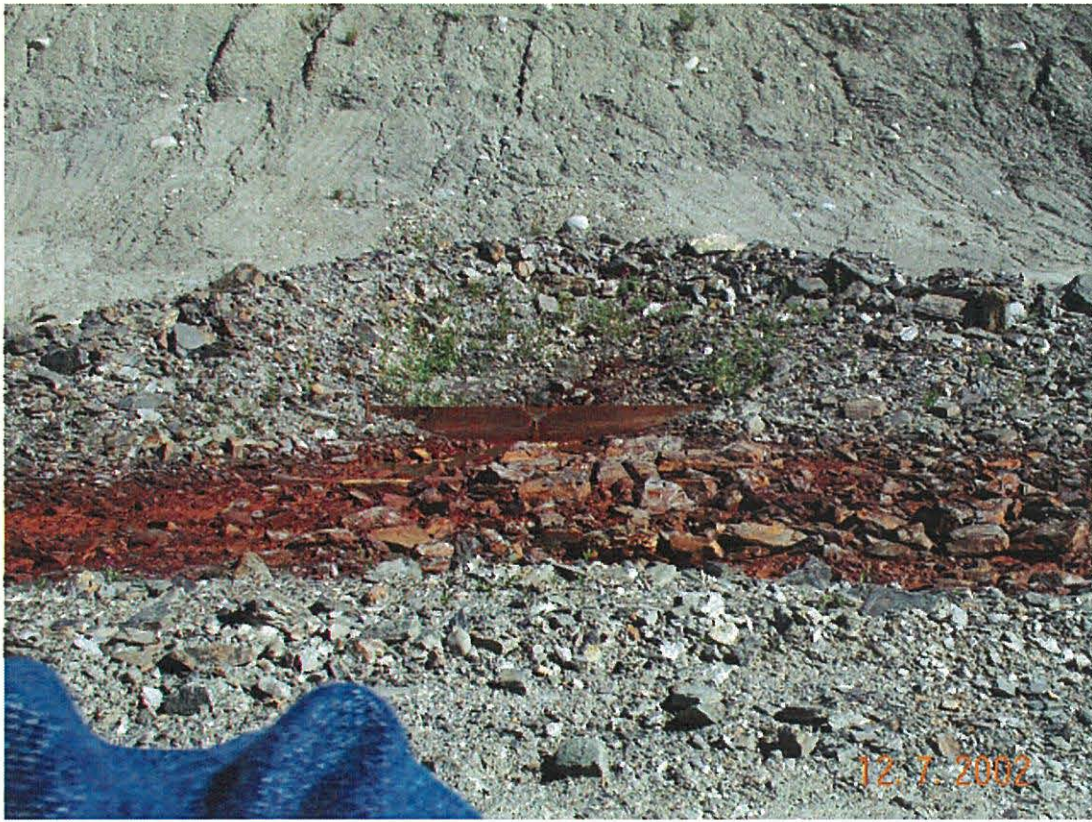
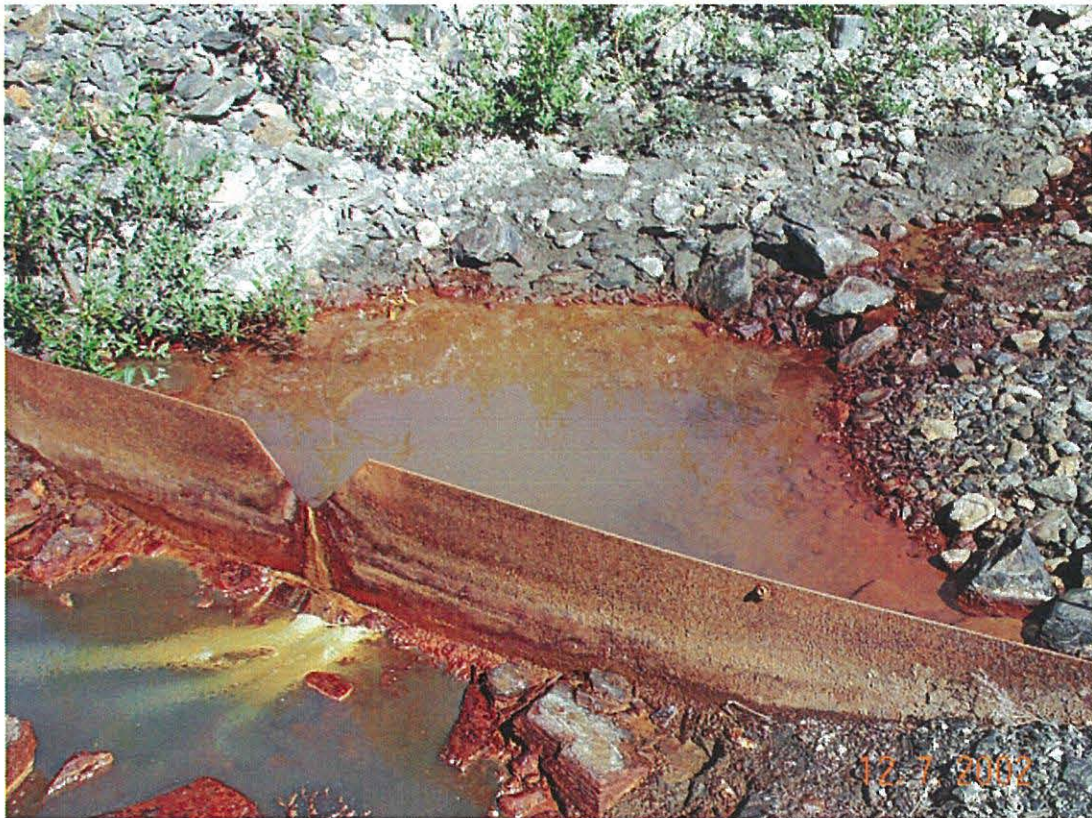
Photo 9: Weir 3

Photo 10: Weir 3

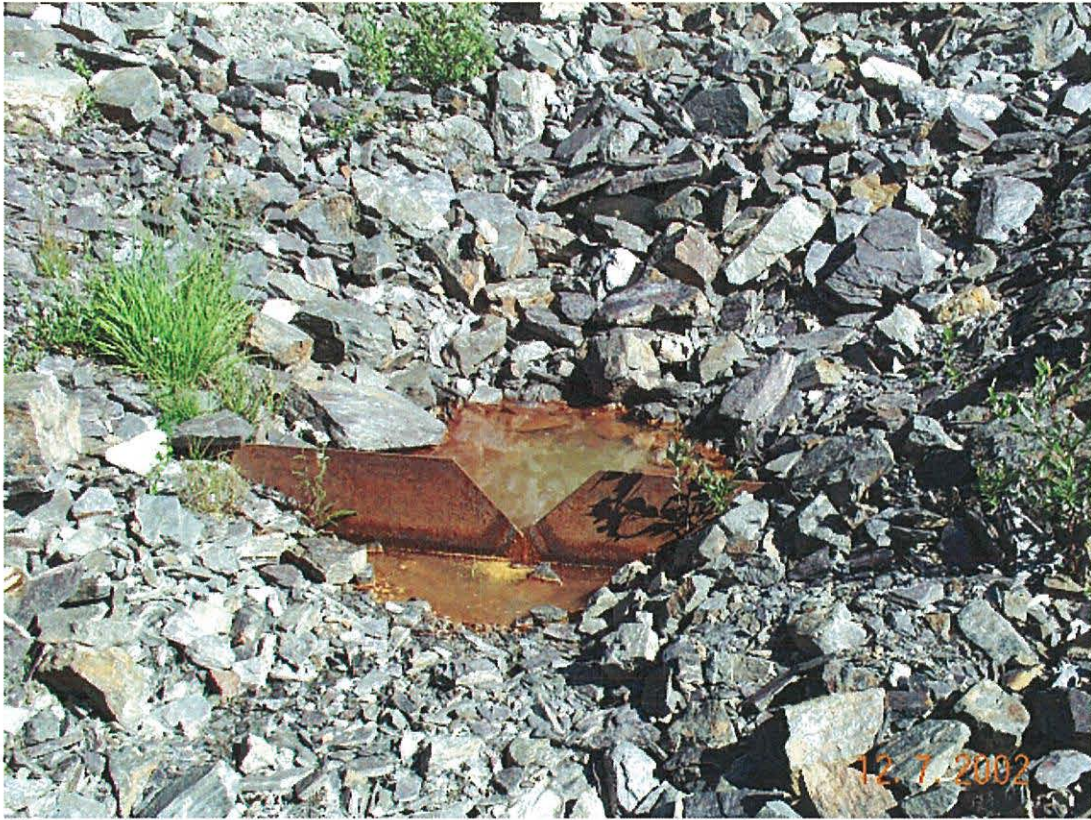
The sideslopes of the till starter dyke remain susceptible to erosion. There is one area that lies just below the 1994 resloping and till cover placement that is particularly susceptible to erosion (Photo 12). Runoff concentrates in-between the till cover and the resloped rock causing erosion gullies and silt spill into the seepage channel at the toe of the dyke.

Photo 12: Erosion gullies at toe of till cover on south side of the Vangorda Dump

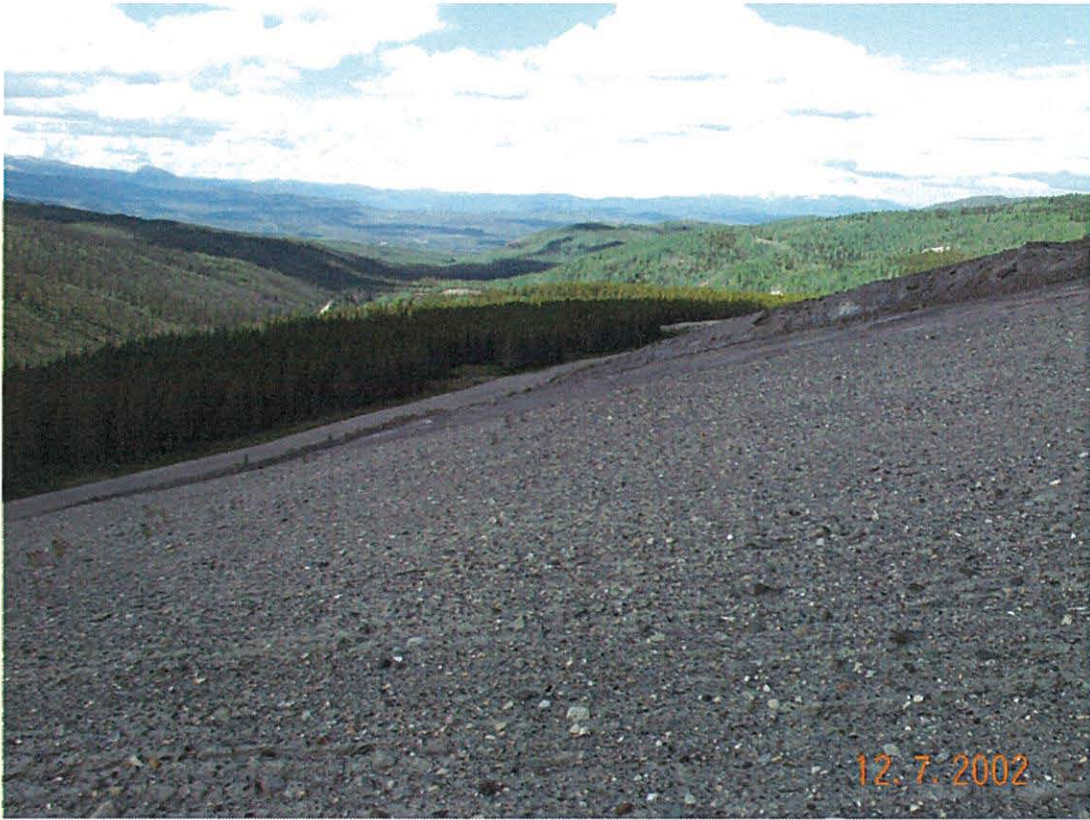
The 2m thick till cover installed in 1994 continues to perform well (Photo 13).

Photo 13: Till cover over waste rock on the resloped section of the Vangorda Waste dump

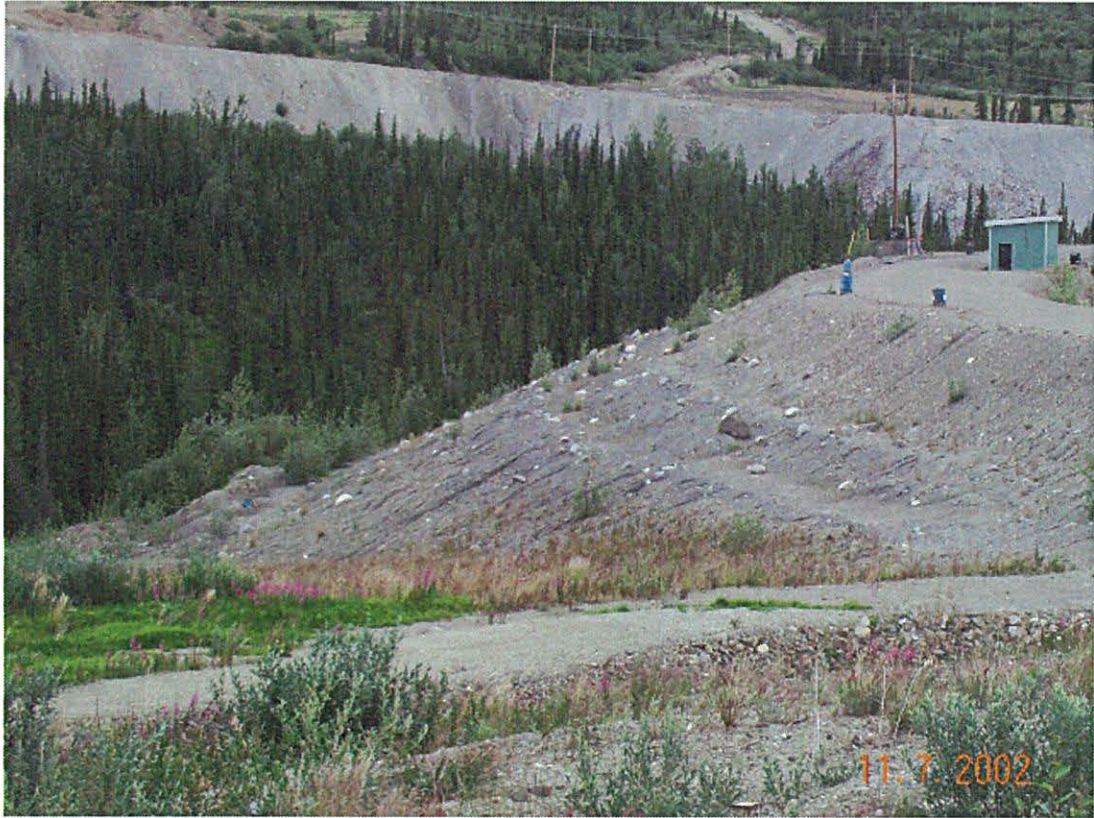
Photo 15: Downstream slope of Little Creek Dam

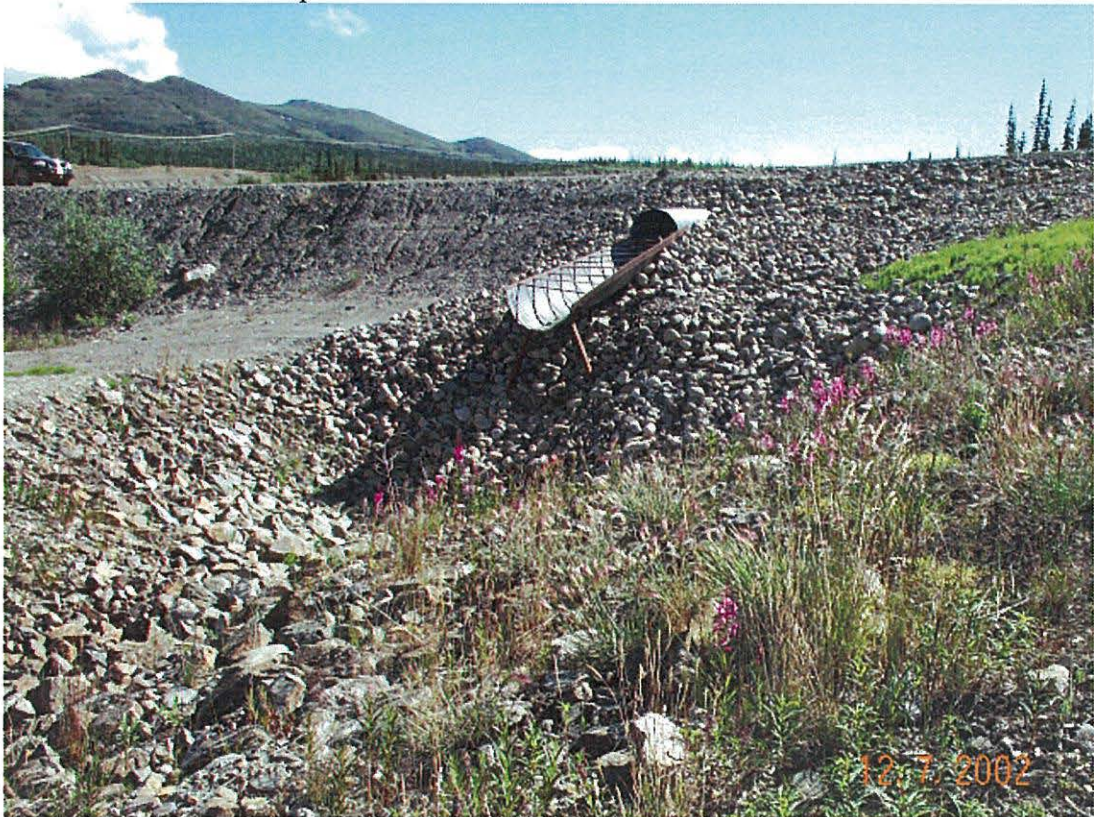
Photo 16: Emergency Spillway at Little Creek Dam

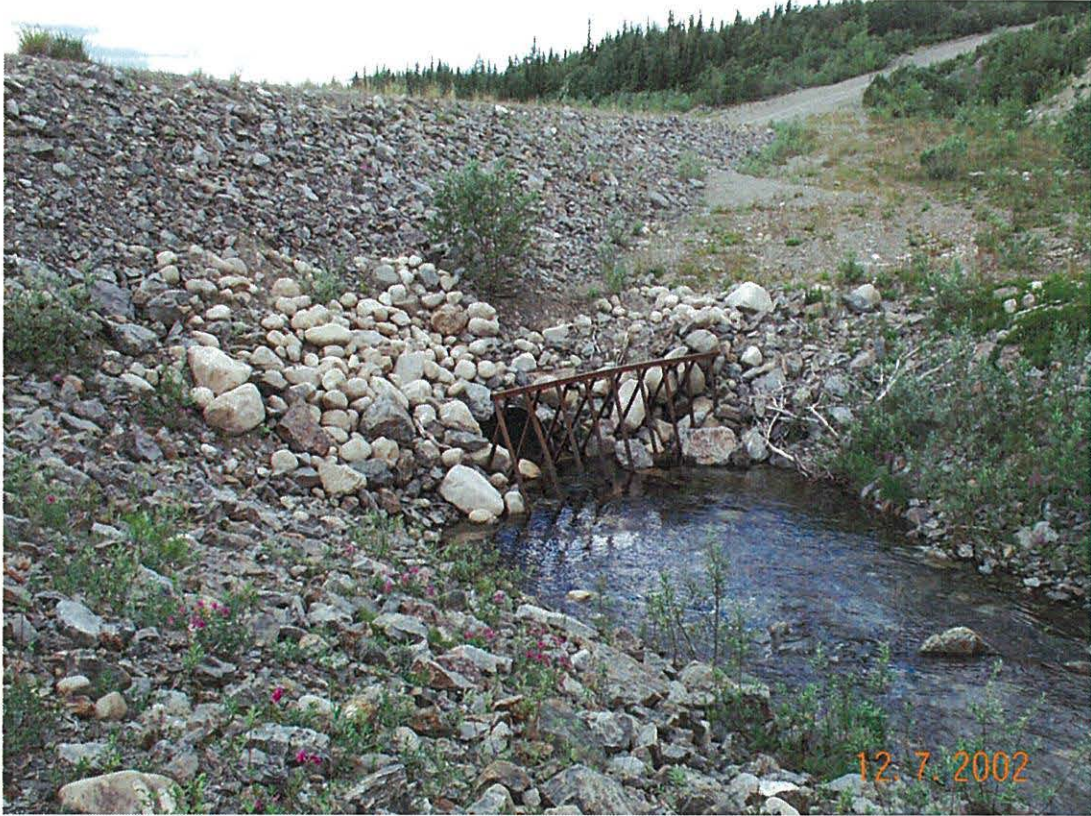
Photo 17: Trash rack at headwaters of the Vangorda Creek Diversion.

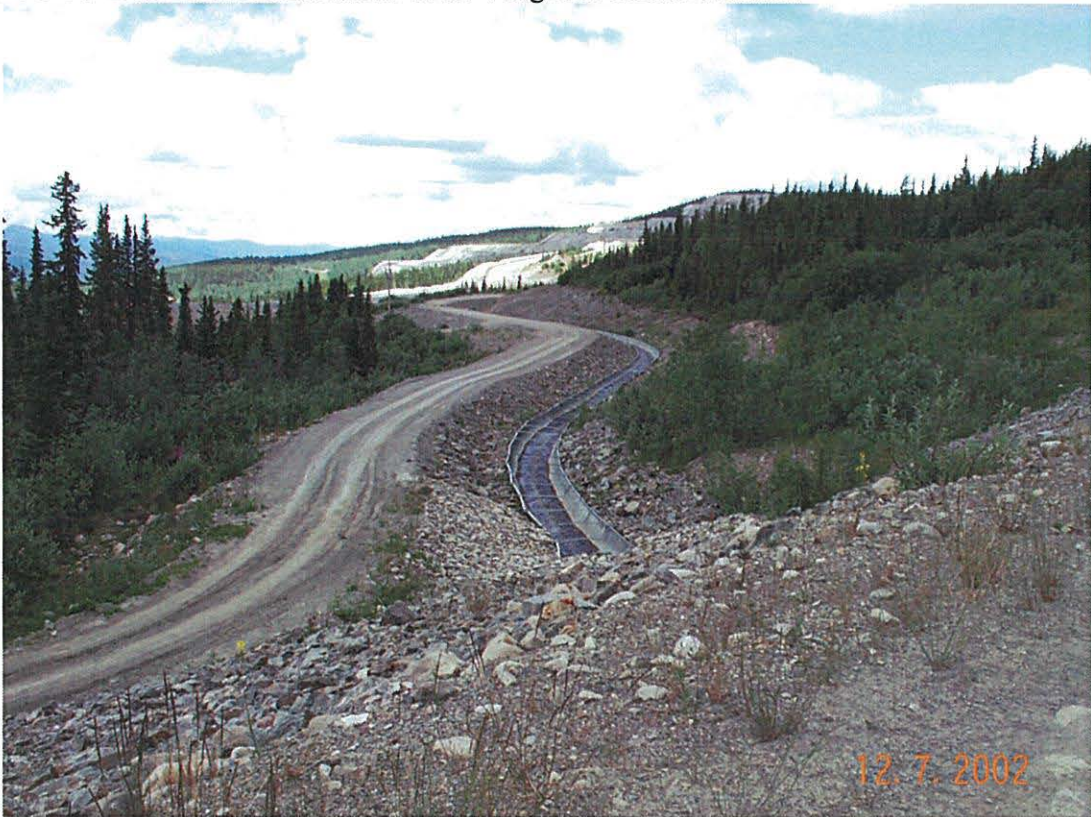
Photo 18: Upper Reaches of Vangorda Creek Diversion

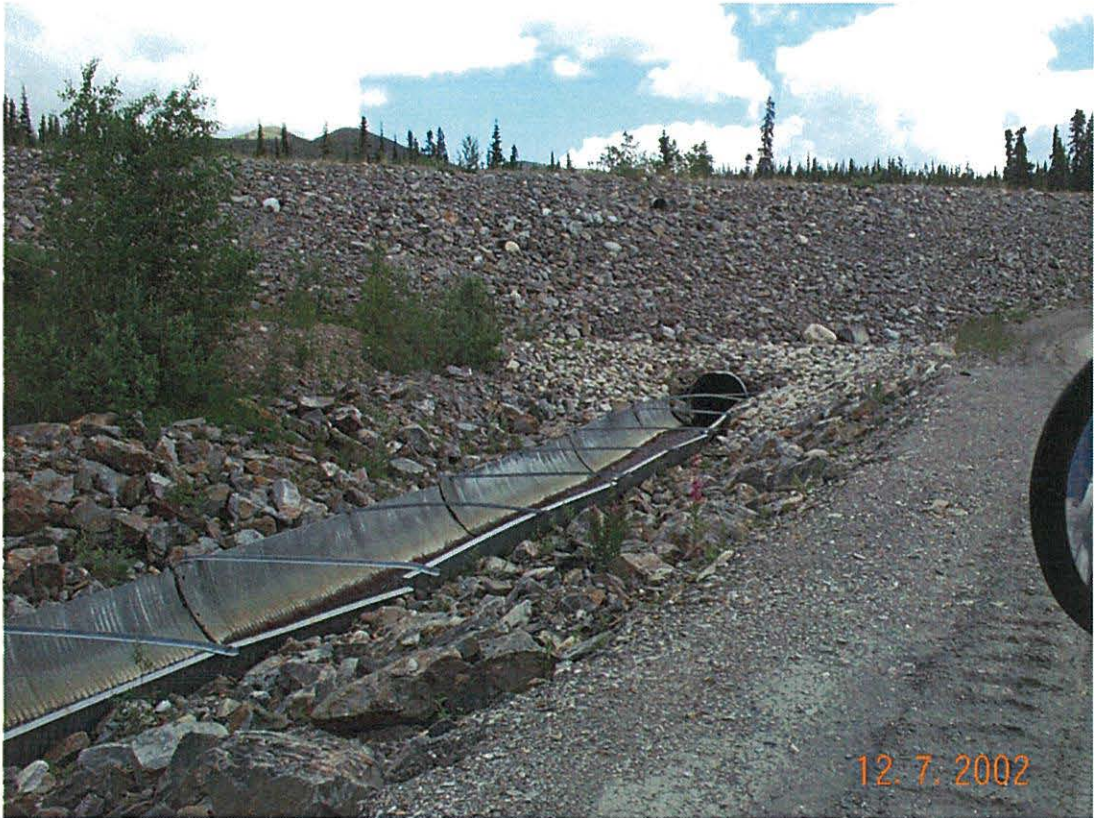
Photo 19: View of the headworks of the Vangorda Creek diversion

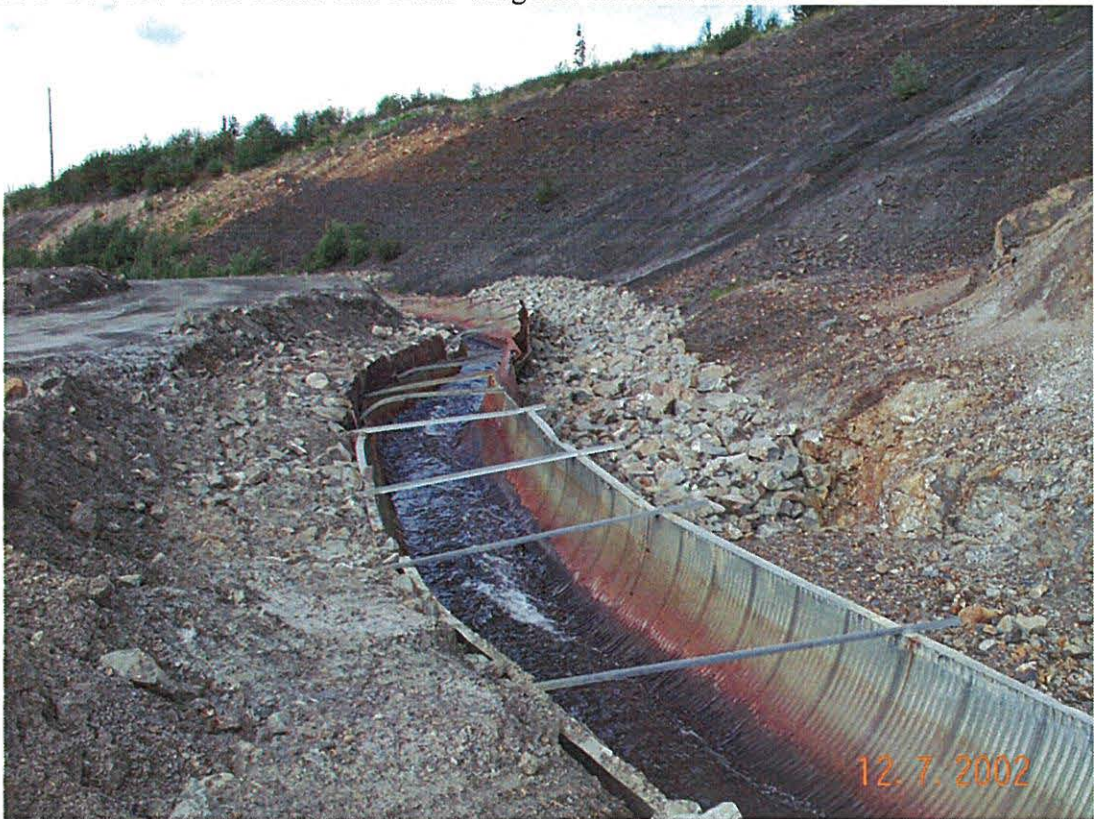
Photo 20: Middle reaches of the Vangorda Creek Diversion

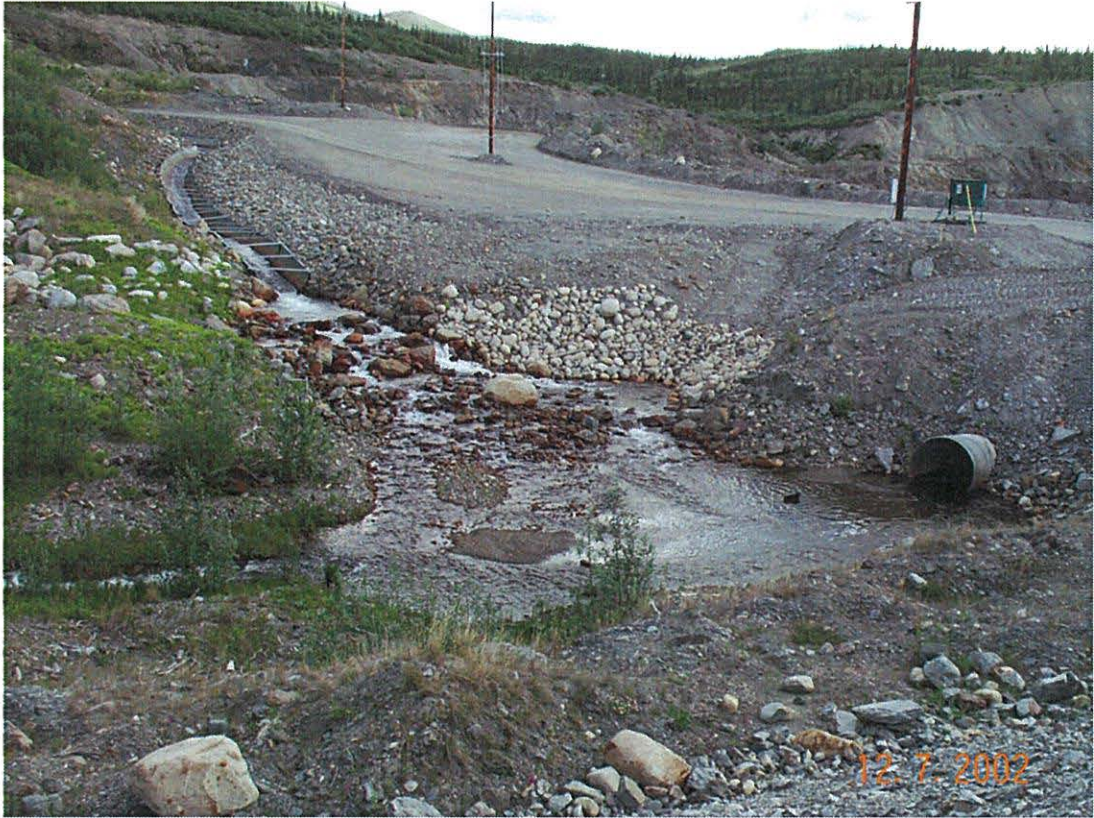
Photo 21: Plunge Pool on Vangorda Creek Diversion

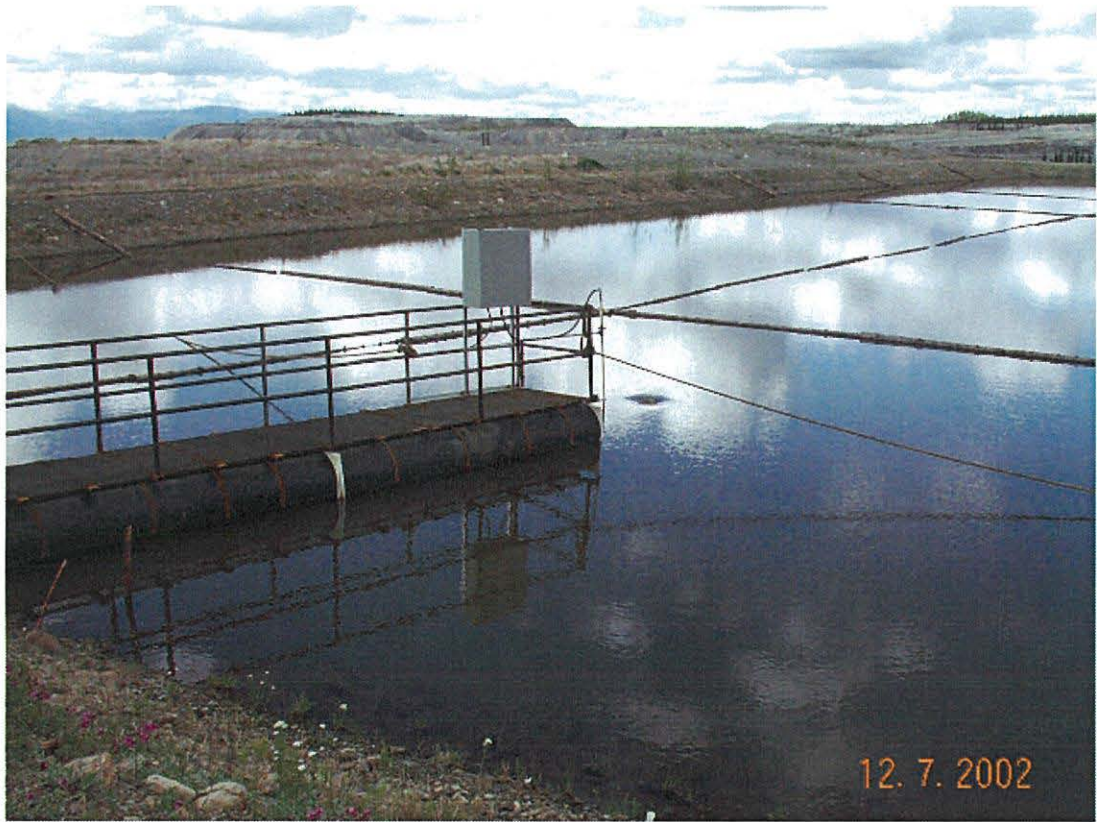
At the time of our inspection, the water level in the sludge pond was about 2m below the crest of the embankment (Photo 23).

Photo 23: Walkway and intake pipe at the Water Treatment Plant Sludge Pond

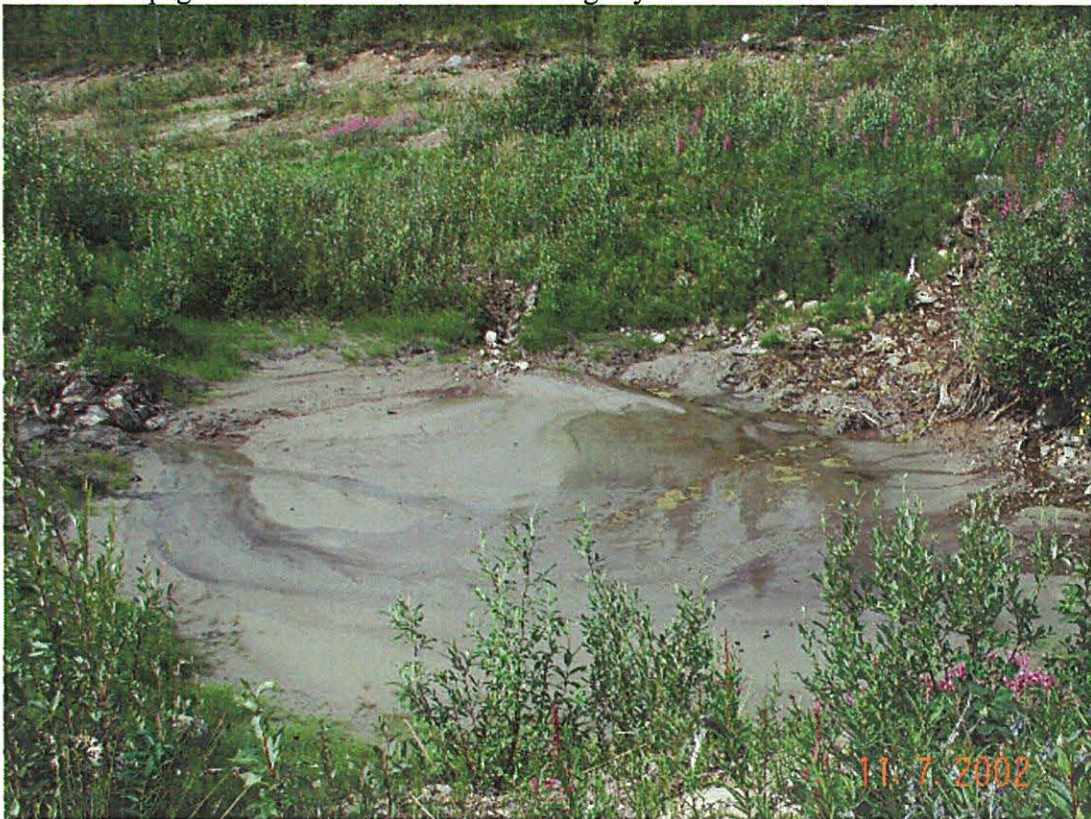
In 1995, the mine constructed a sediment trap on a tributary (A) of Grum Creek (see Figure 2) to enable sampling of the V15 sampling station. The location of this trap (Photo 26) and V15 are shown on Figure 2. Sampling from V15 was intended to monitor the seepage from the sulphide waste located within the Grum Dump.

Photo 26: Sediment basin at the toe of the Grum Dump

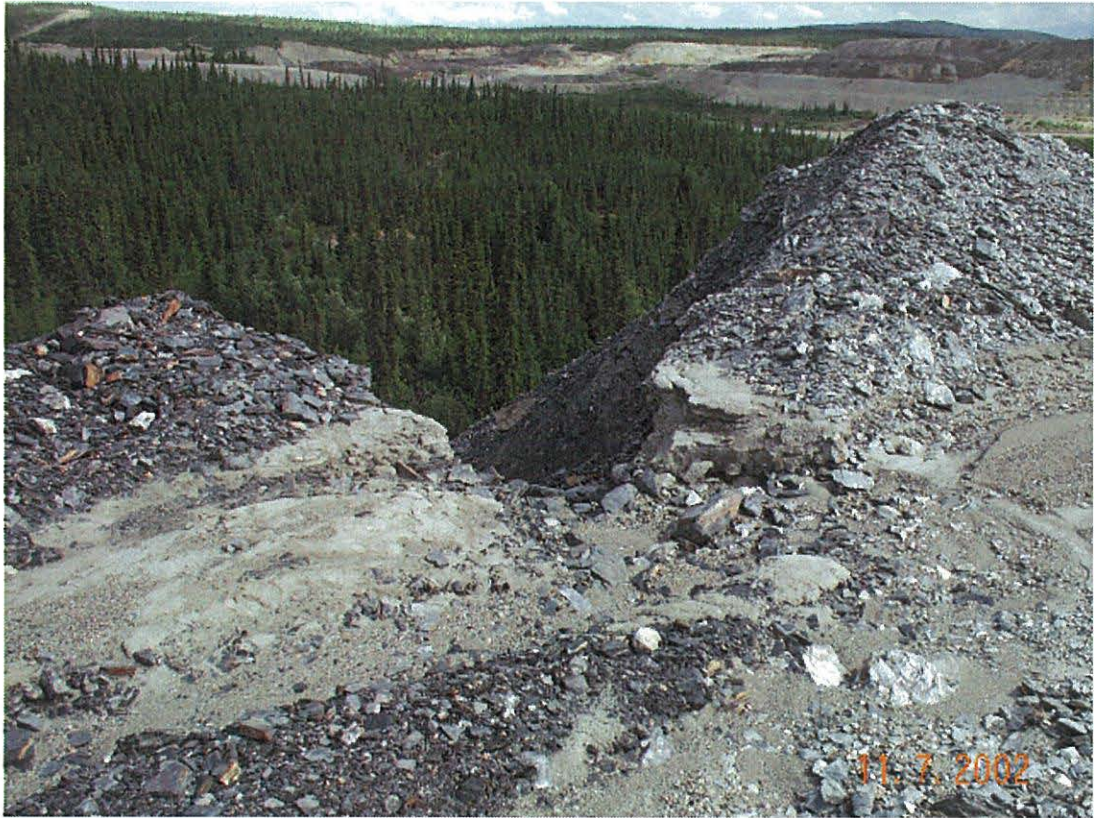
During the July 11 and 12, 2002 site inspection by SRK, two erosion gullies (Photo 27) were identified on the slopes of the lowest bench of the Grum Dumps (Photo 28). It is our understanding that these gullies had formed several years ago and had contributed to the sediment that is visible in the bush below the dump (Memorandum GLL, June 25, 2002).

Photo 27: Erosion gully in lower bench of the Grum waste dump above Seep #1

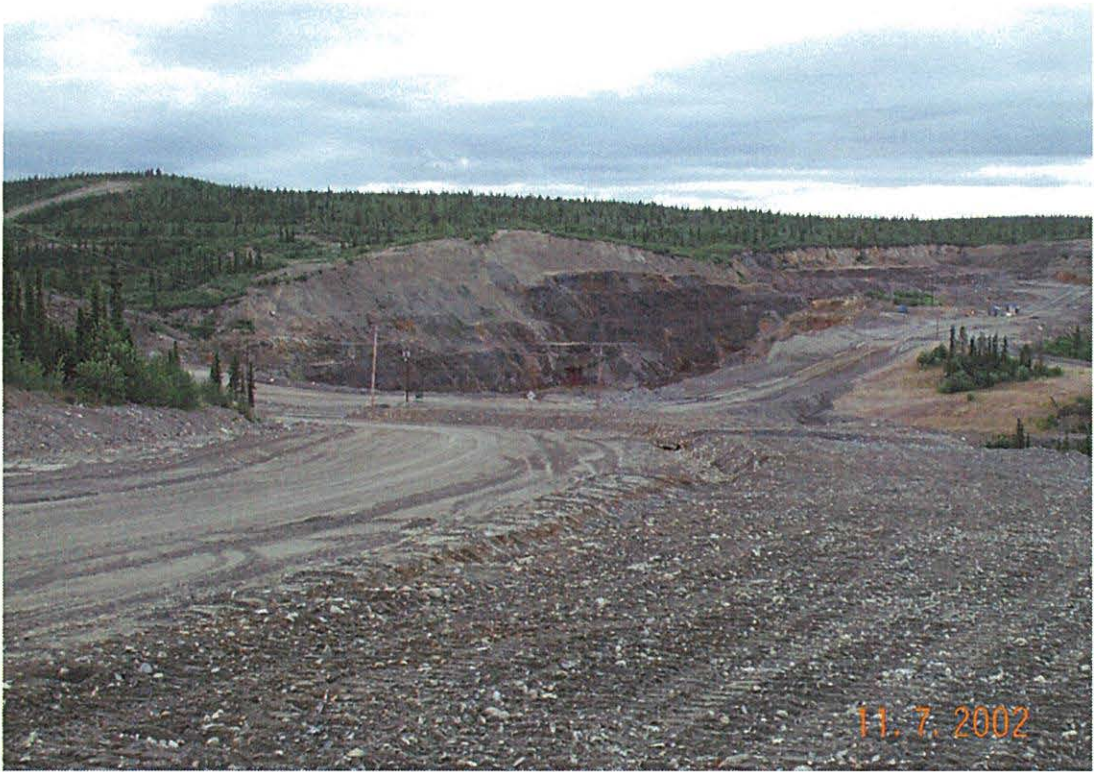
In January of this year, DT cleaned out the sediment from the trap on tributary A, which was at full capacity and last year initiated a work program to provide better control of the runoff onto the Grum Dump. This work involved the construction of a diversion ditch (Photos 29 and 30) along the main haul road adjacent to the Grum Dump. The ditch is intended to divert runoff away from the dump and into the Vangorda Pit, in an attempt to reduce further erosion of the dump slopes.

Photo 29: New water collection ditch along haul road

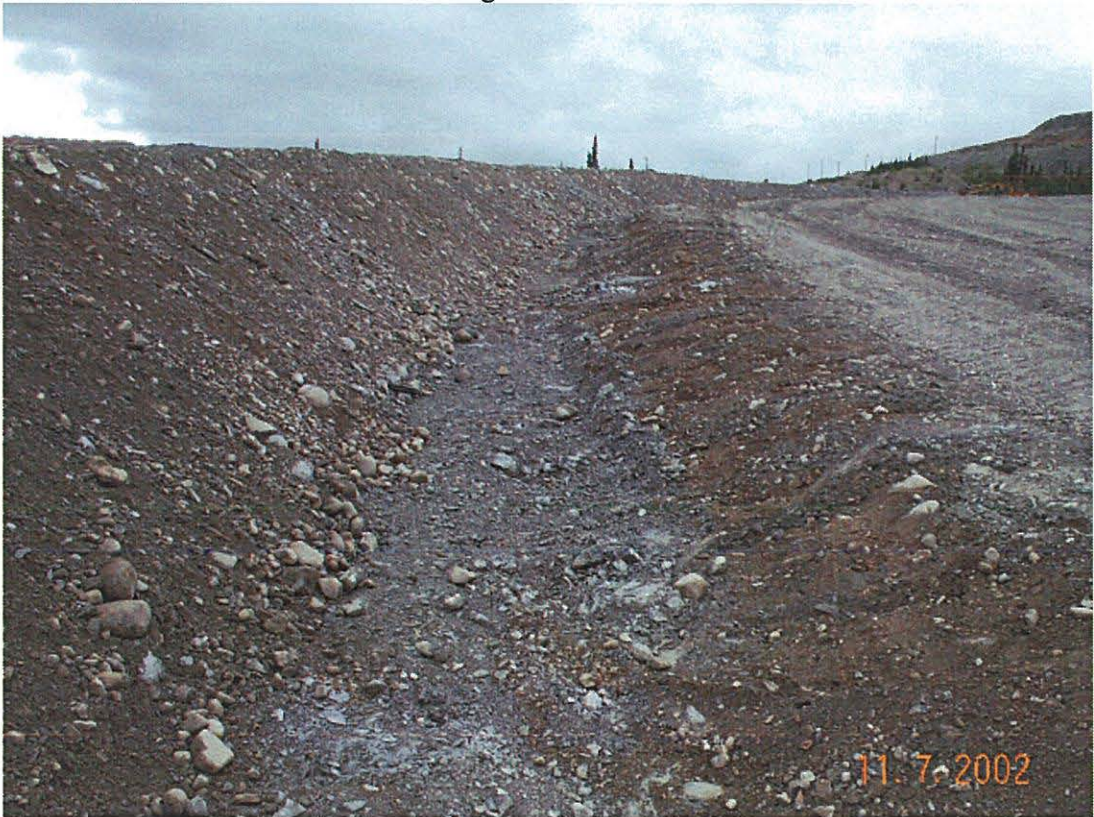
Photo 30: Collection Ditch along the Haul Road at Vangorda

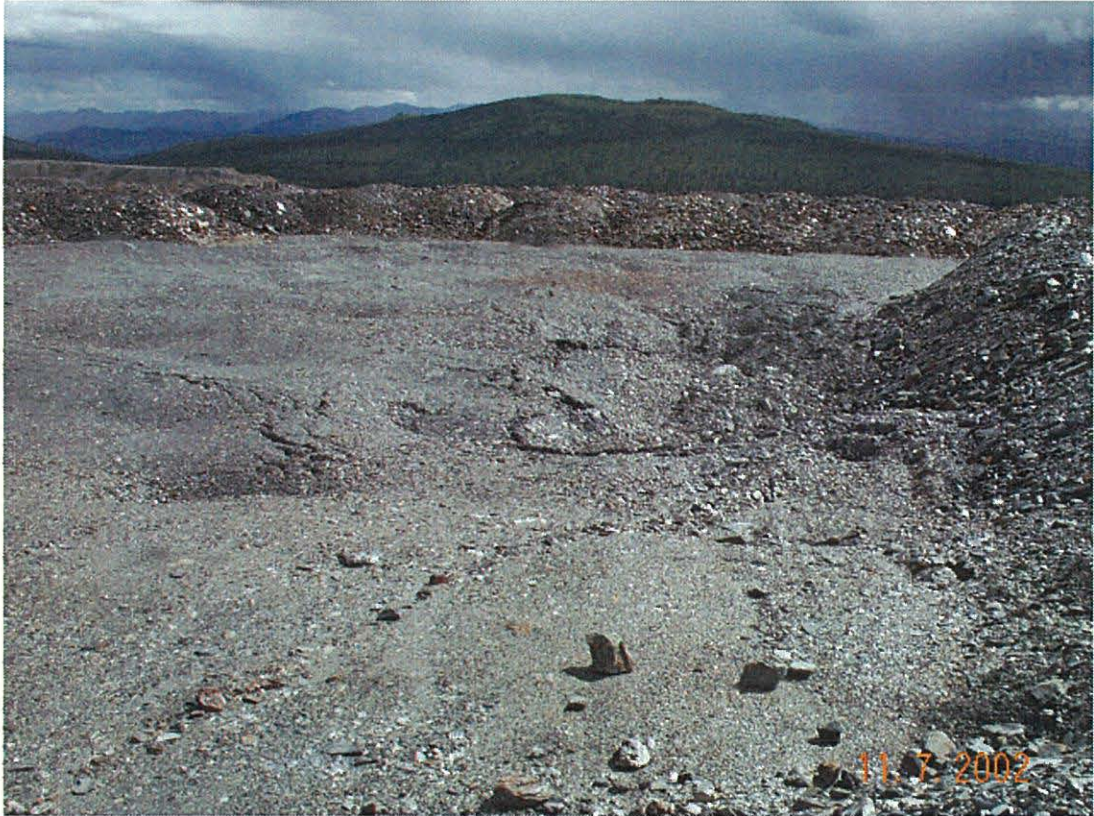
During our inspection, SRK also noted an area on one of the benches of the Grum Dump that had experienced some settlement (See Photo 28 and 31).

Photo 31: Settlement of the waste rock on Grum Dump
