**VENUS MINE TAILINGS**

**Study of Remedial Options**

PB 6535 0101

MARCH 1994

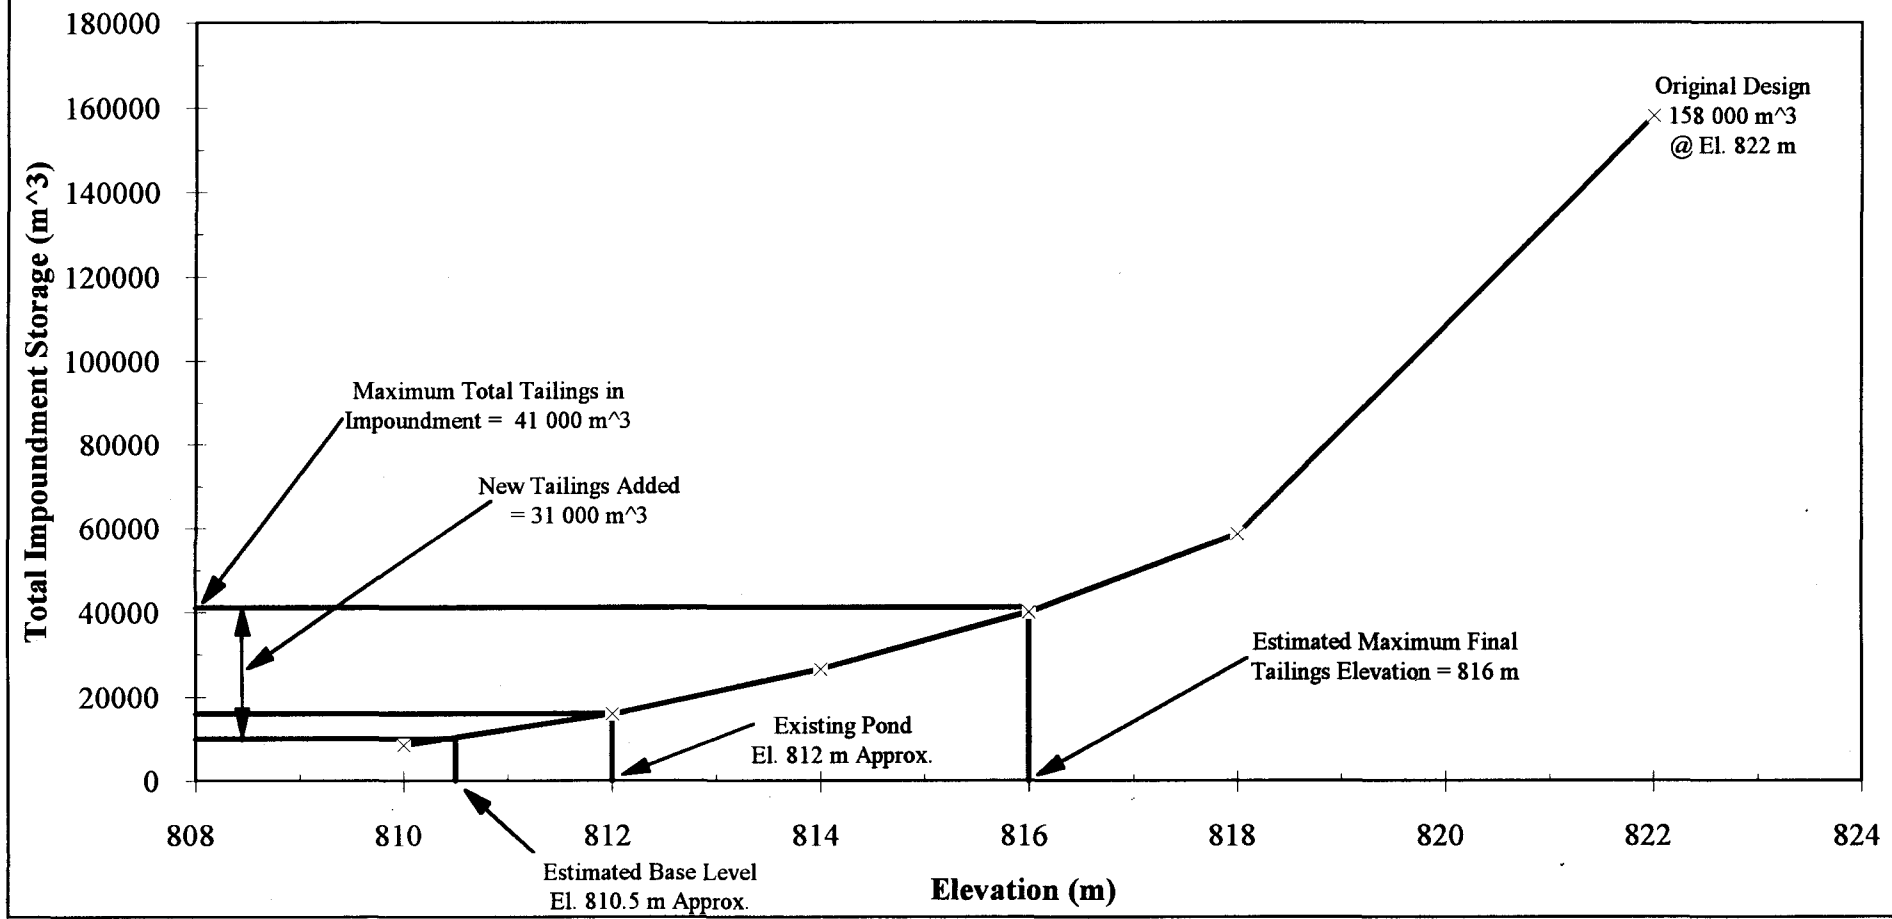
**Figure 4 'New' Venus Mill Site  
Tailings Impoundment Storage - Elevation Curve**

The impoundment is formed by the tailings dam (built to El. 823 m) at the downstream end, and a saddle between two rock ridges at the upstream end. Allowing for 1 m of freeboard, the maximum storage capacity is about 158 000 m<sup>3</sup>. This volume includes 26 000 m<sup>3</sup> of fill which was borrowed from within the impoundment for construction of the tailings dam. This fill was excavated from the flanks of the creek valley. An approximate storage-elevation curve for the impoundment is shown on Figure 4.

At the time of the site inspection the water level in the impoundment was at about El. 812 m (less than one third full). It is understood that approximately 800 tons of tailings may have been deposited in the impoundment in previous operations. From Figure 4, the elevation of the base level of the impoundment is estimated at El. 810.5 m, 1.5 m below the estimated water level. The actual elevation of the pond and the base level should be confirmed for final design.
