**REPORT ON THE ENVIRONMENTAL
CLEANUP AND RECOVERY OF
DERELICT BARRELS FROM WATSON LAKE,
YUKON TERRITORY**

NOVEMBER 23, 1994

**FTI PROPOSAL NUMBER: P-1583
DIAND CONTRACT NUMBER: 94-0076**

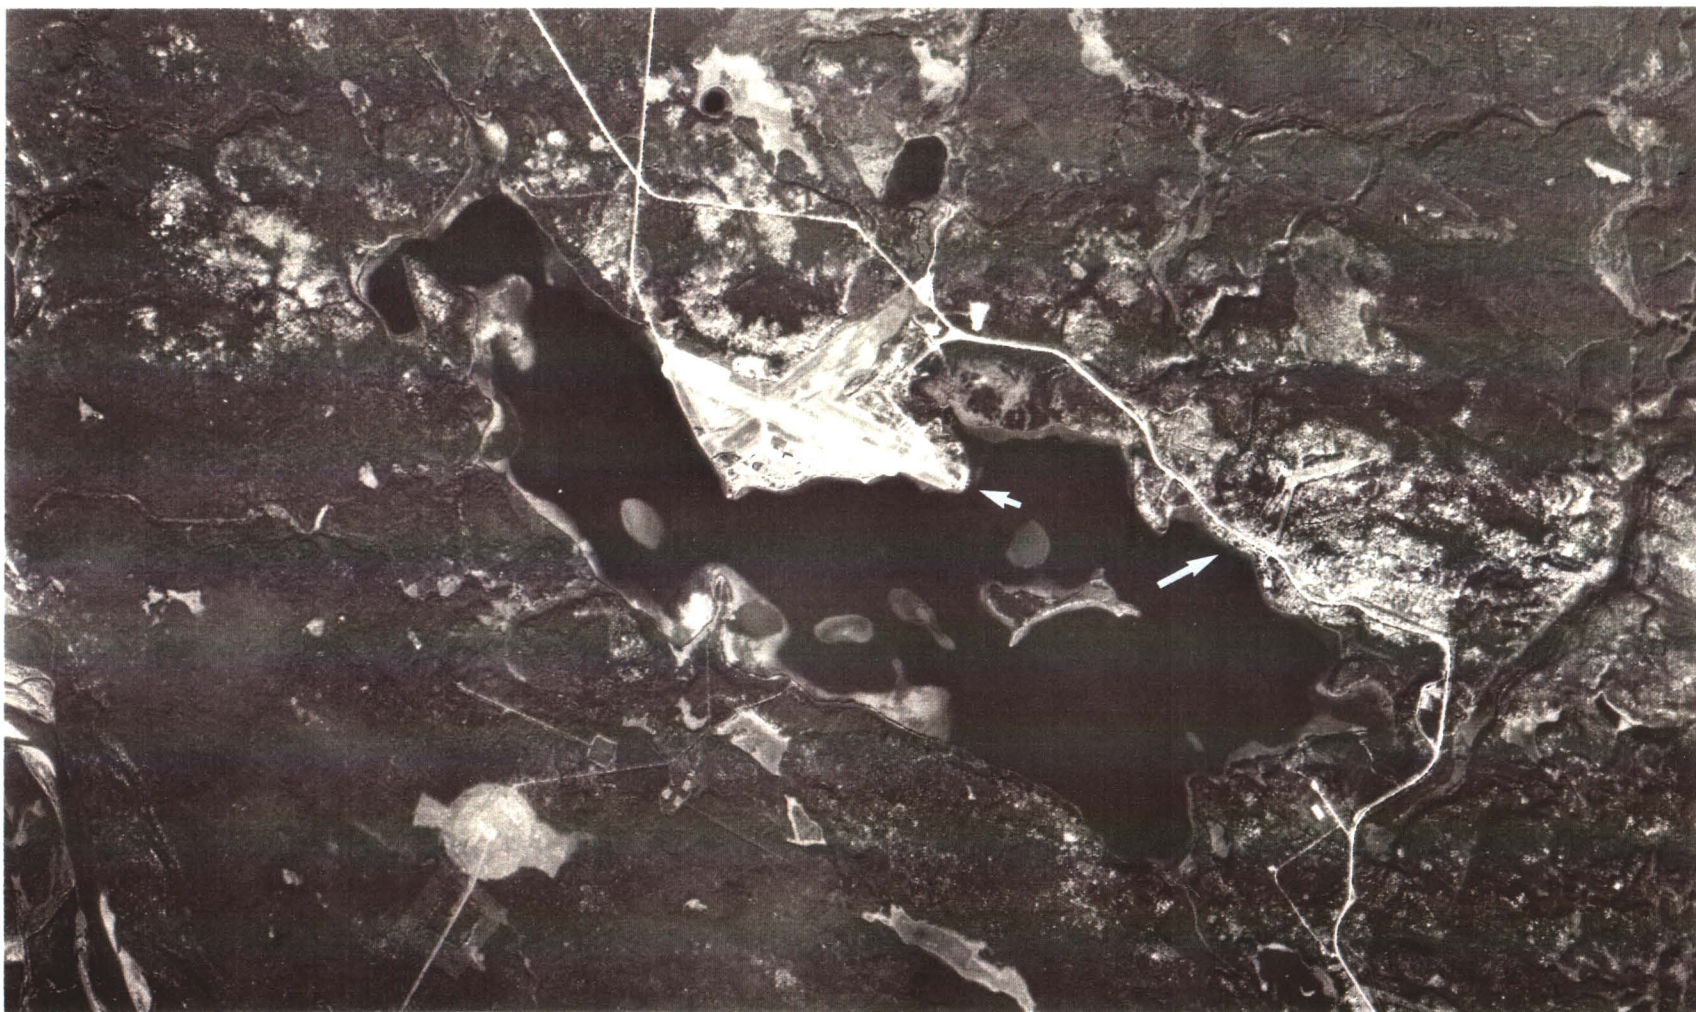
The Watson Lake Airport and the B.C. Forest Service's Initial Attack Base (for fighting forest fires) are located along the north shore of the lake. In addition, a number of cottages and permanent residences can be found along the northeastern shore, see Photograph No. 1.

PHOTOGRAPH NO.1: Aerial photograph of Watson Lake taken on September 18th, 1980 at a scale of 1:50,000. Note the location of the airport on the north shore of the lake and the small island in the southeastern section of the lake. Also note the residences along the northeastern shore (longer arrow) and the location of the B.C. Forest Service's Initial Attack Base (shorter arrow).

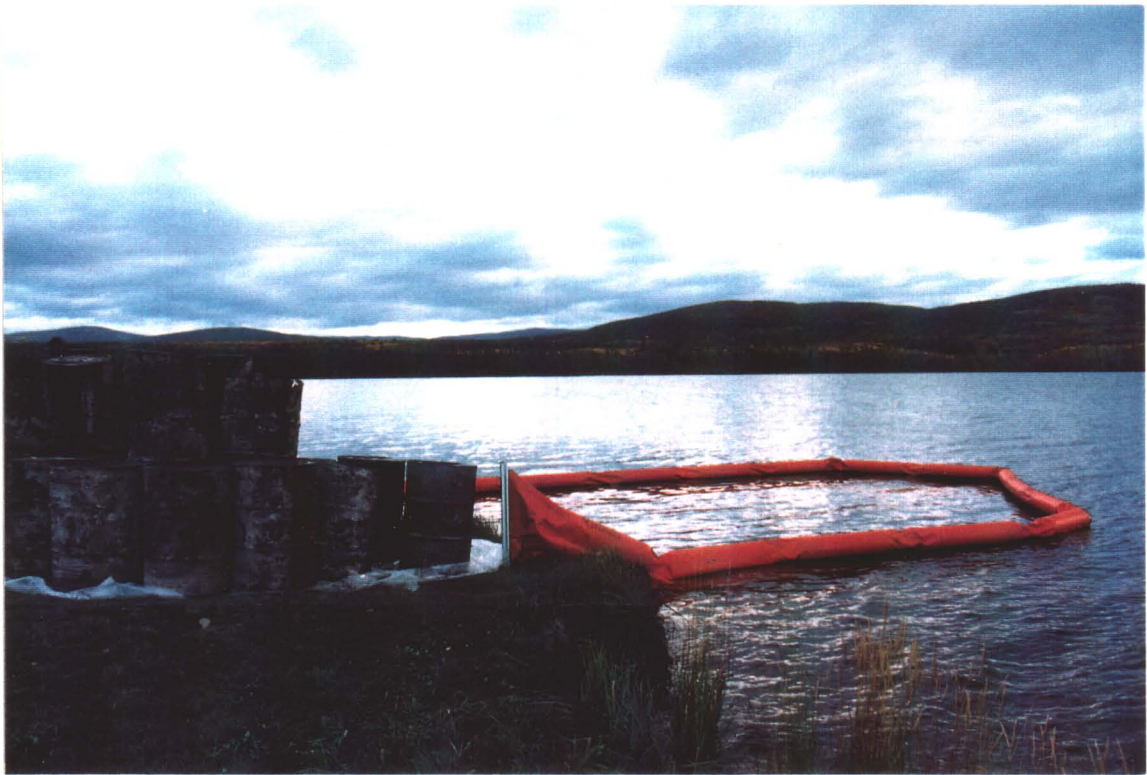
The first step in the procedure was the deployment of marker buoys indicating the approximate length and width of the Initial Attack Base barrel dump site. Next, a 33 m by 1 m spill boom was deployed in order to encompass a section of shoreline where the greatest water depth or steepest sub-surface slope was located, see Photograph No. 3. Each end of the spill boom was fixed onshore with steel pipes hammered into the ground while the outer perimeter of the boom was held in place with a series of offshore anchors.

PHOTOGRAPH NO. 3: Deployed spill boom adjacent to the shoreline at the Initial Attack Base, Watson Lake. Note barrels stacked for transportation to the DIAND storage site.

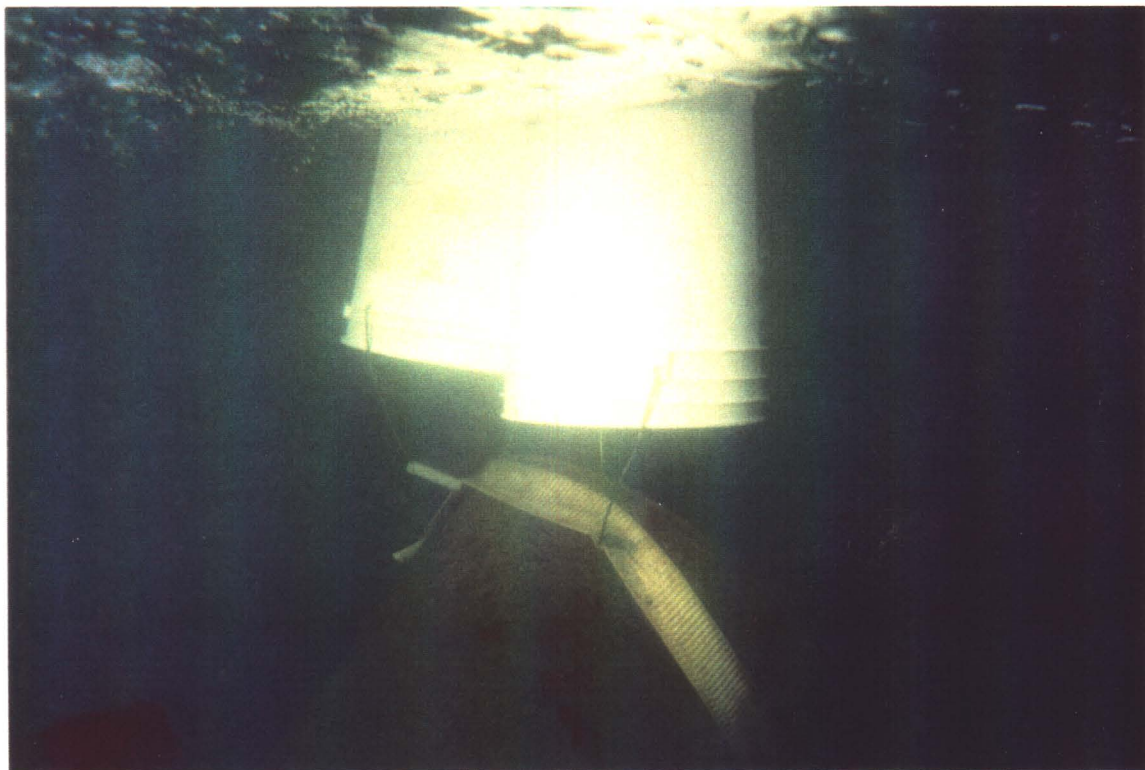
Two 22 litre buckets, attached to a lifting strap, were used to raise the barrels off the bottom in an upright position, see Photograph No. 6. While suspended in the water column the barrels were inspected for leakage and structural integrity, see Photograph No. 7. The barrels were then floated through the water column to inside the spill boom where the lift buckets were disconnected, see Photograph Nos. 8, 9 and 10.

PHOTOGRAPH NO. 6: Two 22 litre buckets and a lifting strap being used to raise a barrel to the surface.

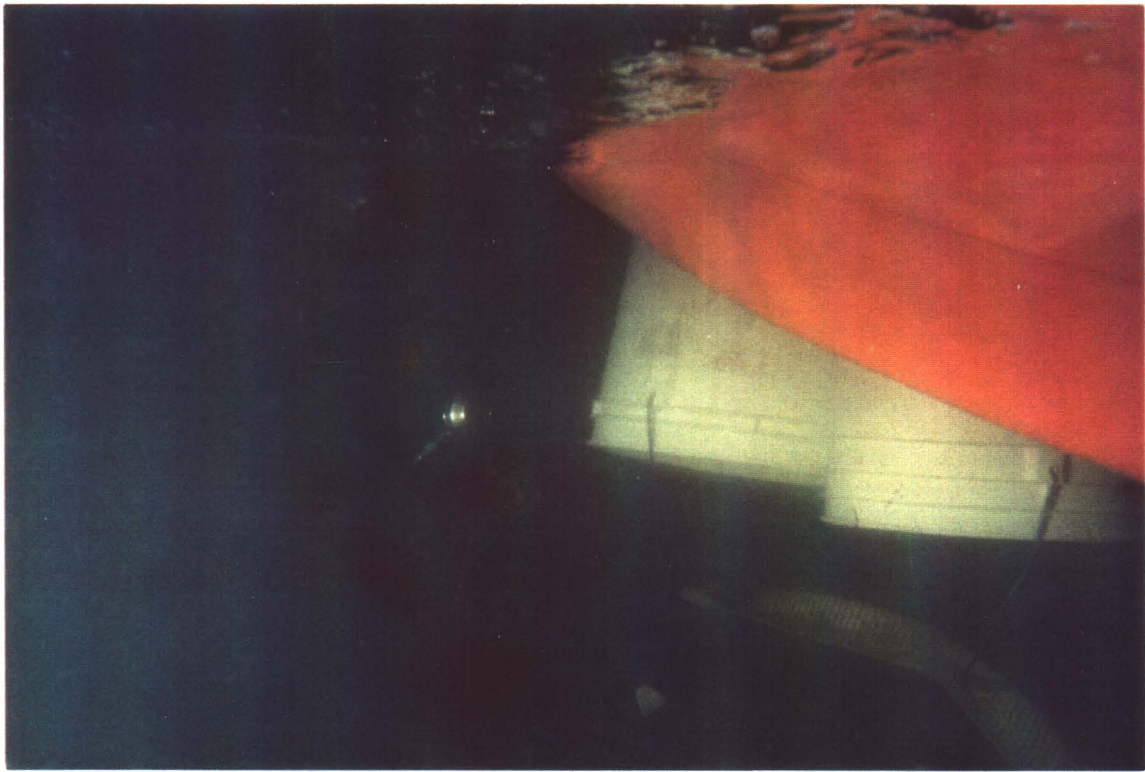
PHOTOGRAPH NO. 8: Diver bringing suspended barrels under spill boom.

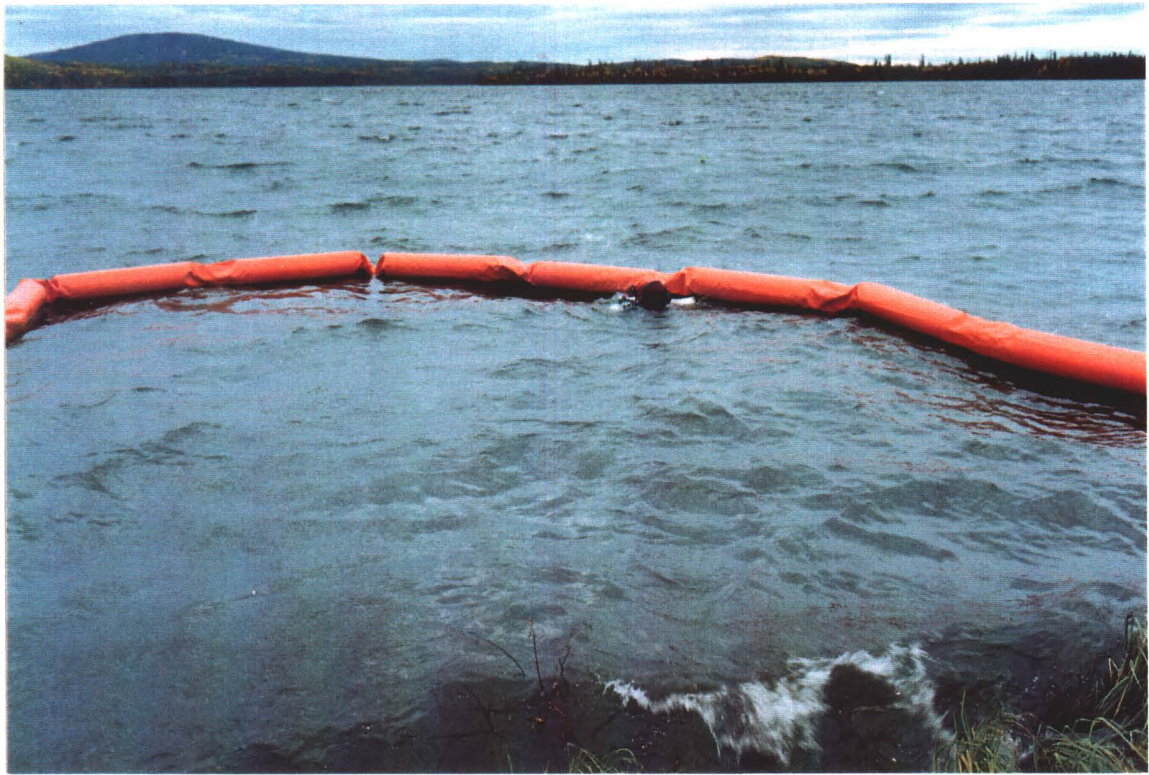
PHOTOGRAPH NO. 9: Diver delivering suspended barrel inside spill boom.

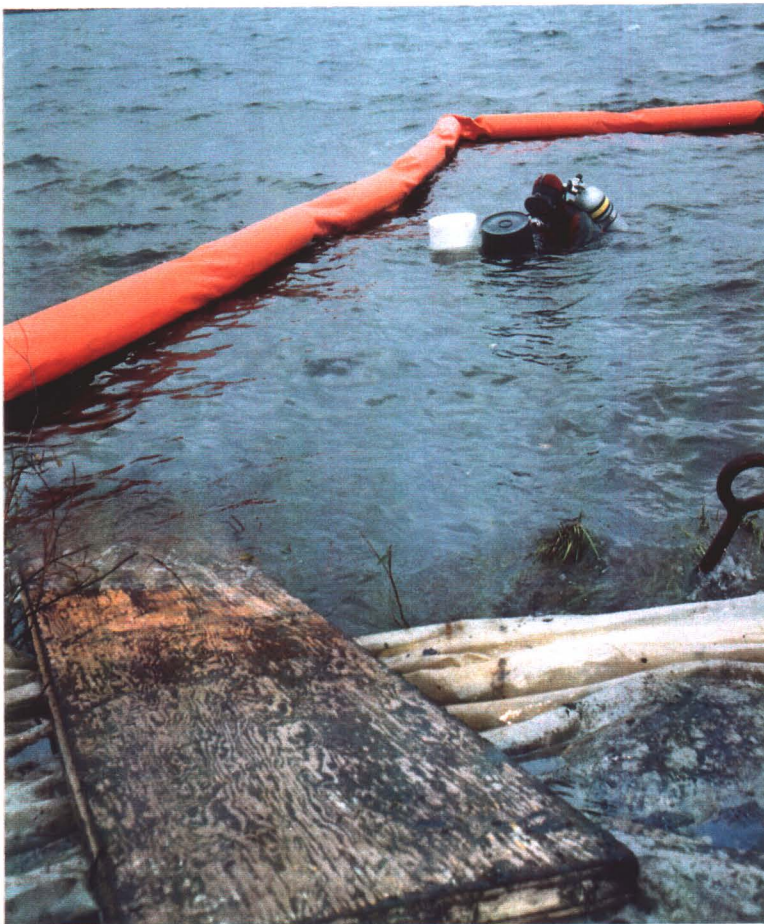
PHOTOGRAPH NO. 10: Diver disconnecting lift buckets inside spill boom prior to barrel removal from water. Note ramp used to roll/lift barrels out of the water up onto the plastic ground sheet.

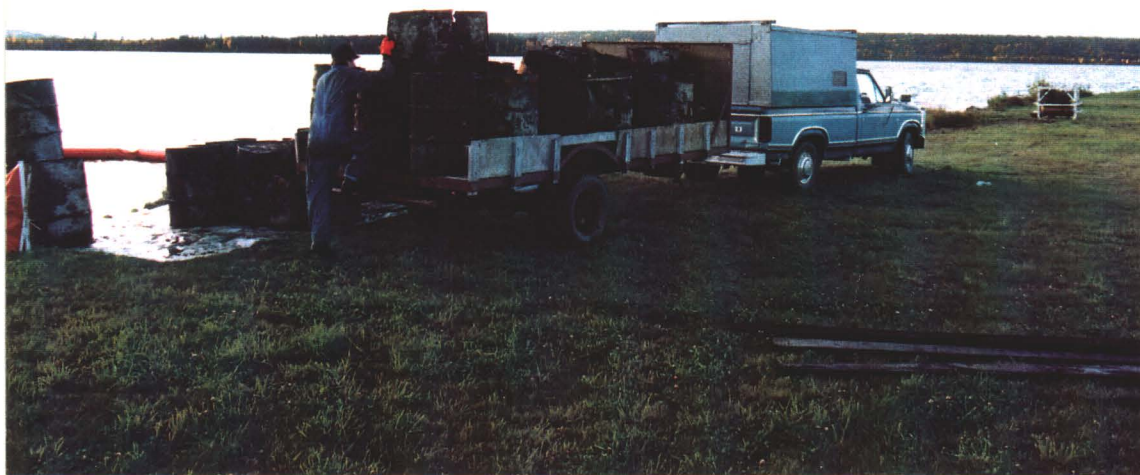
All barrels were transported to the specified DIAND storage site southeast of the airport using a pick-up truck and/or a trailer, see Photograph No. 11. None of the barrels leaked any significant amount of contaminants during their transport to the storage site.

PHOTOGRAPH NO. 11: Barrels being loaded onto pick-up truck and trailer for transportation to the DIAND storage site at the airport.

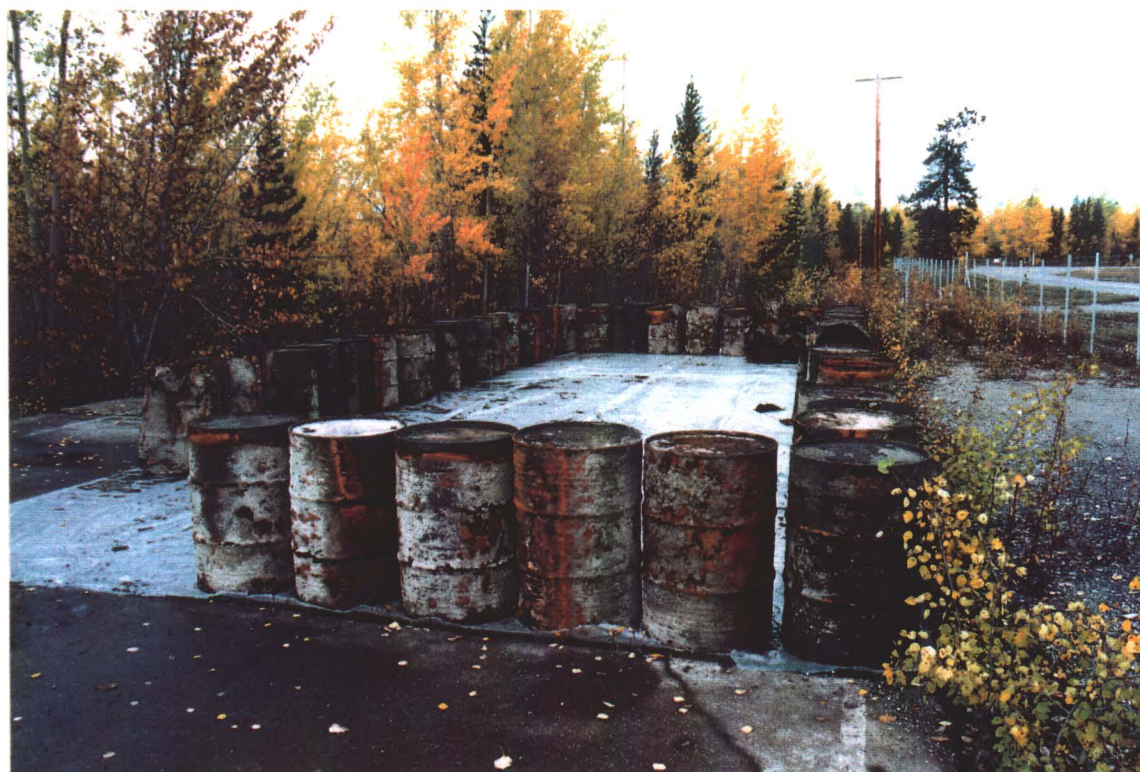
A concrete pad at the DIAND site was chosen as a suitable storage area as it would form a physical barrier between the barrels and the underlying soil. In addition, a plastic sheet was laid over the concrete pad prior to storage of the barrels in order to ensure that leaked contaminants did not pass through any cracks in the concrete and into the ground, see Photograph No. 12. In order to prevent rain creating a leachate from the barrels, plastic sheets were laid over top of the stored barrels, see Photograph Nos. 13 and 14.

PHOTOGRAPH NO. 12: DIAND storage site. Note plastic ground sheet laid on top of concrete pad.

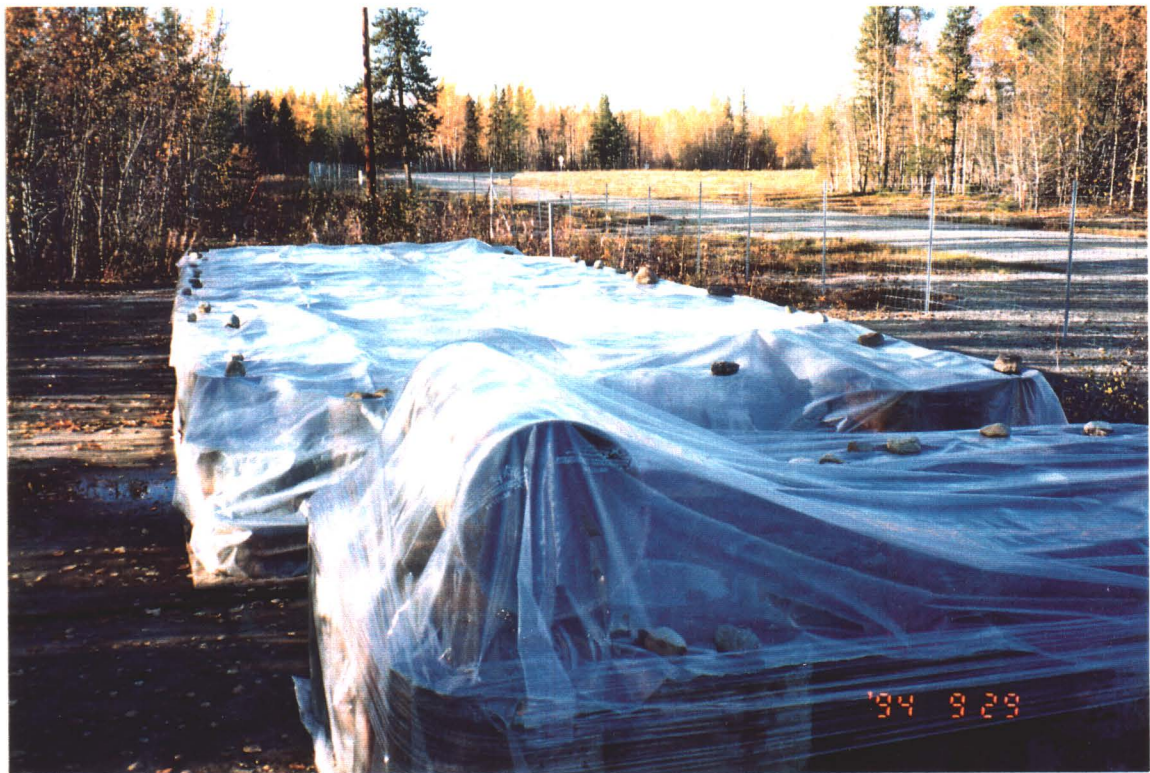
PHOTOGRAPH NO. 14: Barrel storage completed and ready for transport to be recycled or destroyed.
