# **An Environmental Study of the Aishihik Airstrip Yukon Territory**

**Prepared by the  
Environmental Sciences Group**

**Royal Roads Military College  
Victoria, British Columbia**

**© Indian and Northern Affairs Canada, Whitehorse, February 1995**

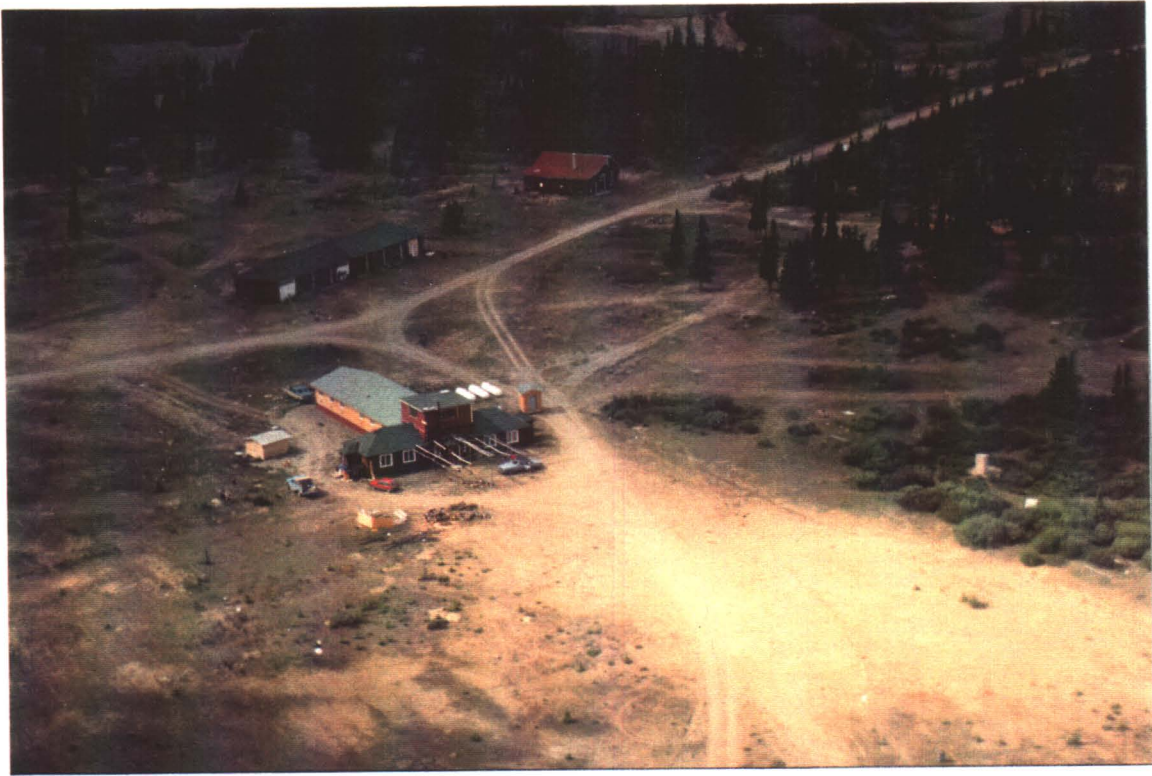
**Photograph V-1: Aerial view showing Airways Building, Garage and Powerhouse.**

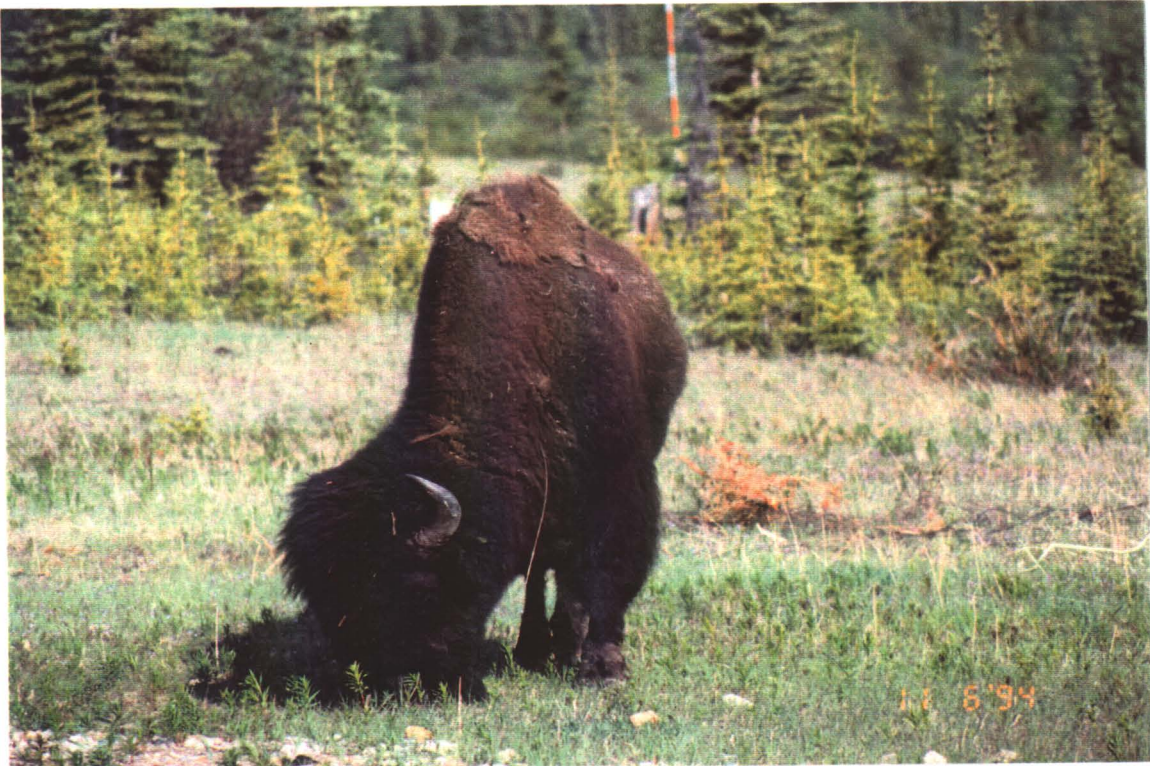
**Photograph V-2: Buffalo grazing next to the Airways Building.**

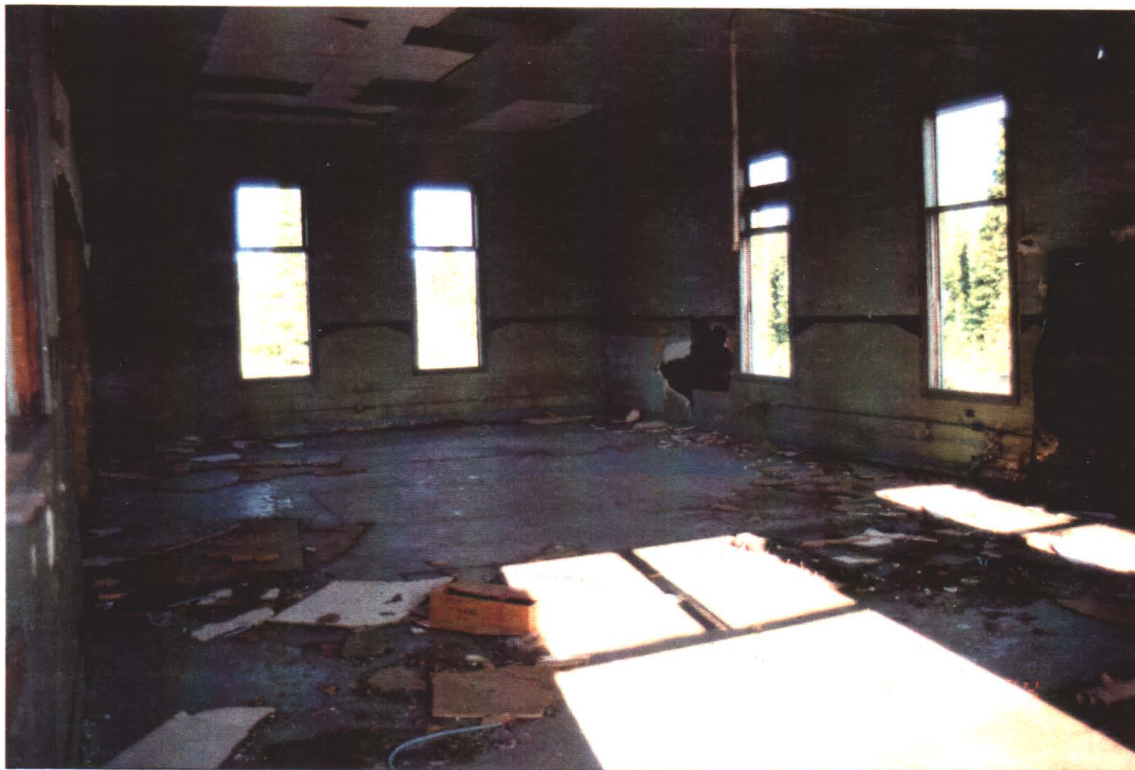
The floor and walls of the powerhouse are highly contaminated with PCBs and inorganic elements. Soil on the east and south sides of the powerhouse are also contaminated with PCBs. On the west side of the powerhouse, there is an underground storage tank containing diesel fuel. Next to the tank is a potable water well. The following actions are recommended regardless of the future use of the building:

**Photograph V-4: Inside the powerhouse in the room that contained the generators.**

- Remove all loose paint on the walls;
- sweep and vacuum the floor and place all material in a suitable container for PCB waste;
- coat the floor with a PCB decontamination agent (Sanisolv) and allow to stand for at least 30 minutes;
- sweep the floor again and place residue in a suitable container for PCB waste;
- wipe all surfaces with an oil absorbant material and again place this in a container suitable for PCB waste; and,
- repeat the solvent wash three times.

If the building is not required, it can then be demolished and buried. If the building is required, holes and cracks in the floor should be filled and the floor sealed with epoxy paint; also the walls should be painted.

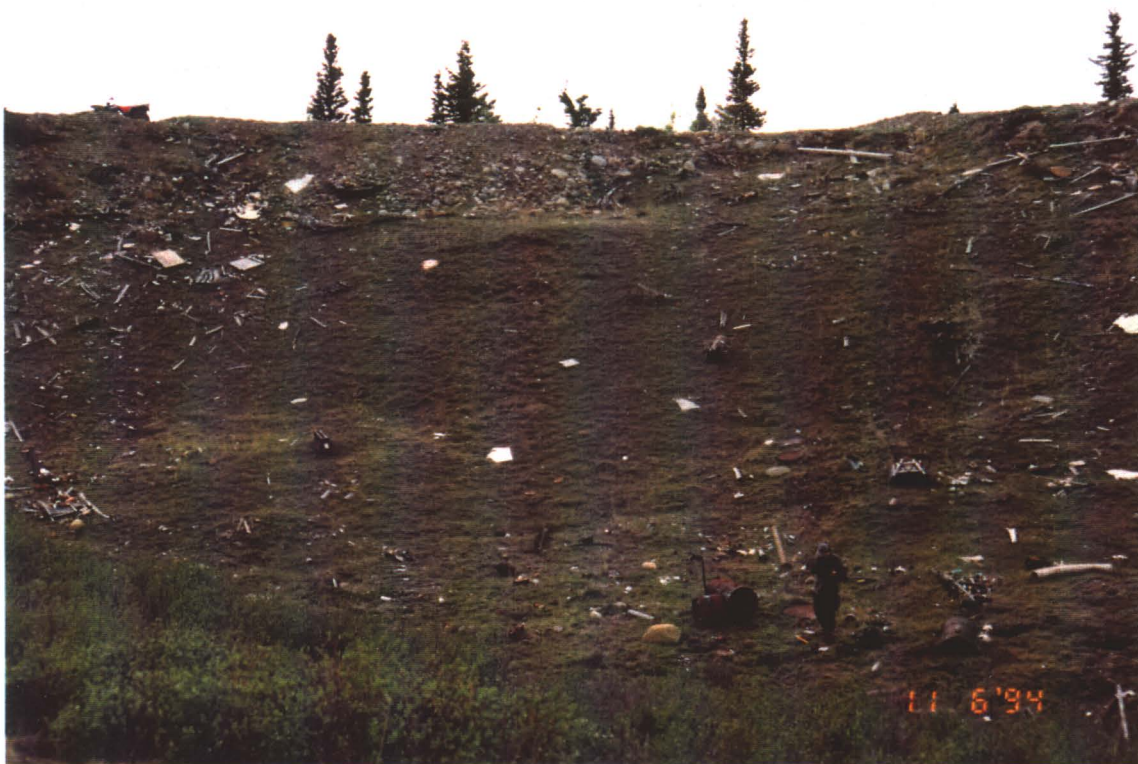
**Photograph V-8: General view of Dump Site 1, a transformer case can be seen half way up the hill.**

The three dump sites should be consolidated at Dump Site 2, the dump farthest to the west. All material at the dumps should be sorted into hazardous and non-hazardous material. The hazardous material must be removed from the site, and the non-hazardous material should be buried in the base of the depression at Dump Site 2 and covered with 1 m of clean fill. The landfill should be engineered such that water infiltration is minimized. The oil drums in the barrel cache should be removed, using the guidelines in the DEW Line Cleanup protocol for barrels.

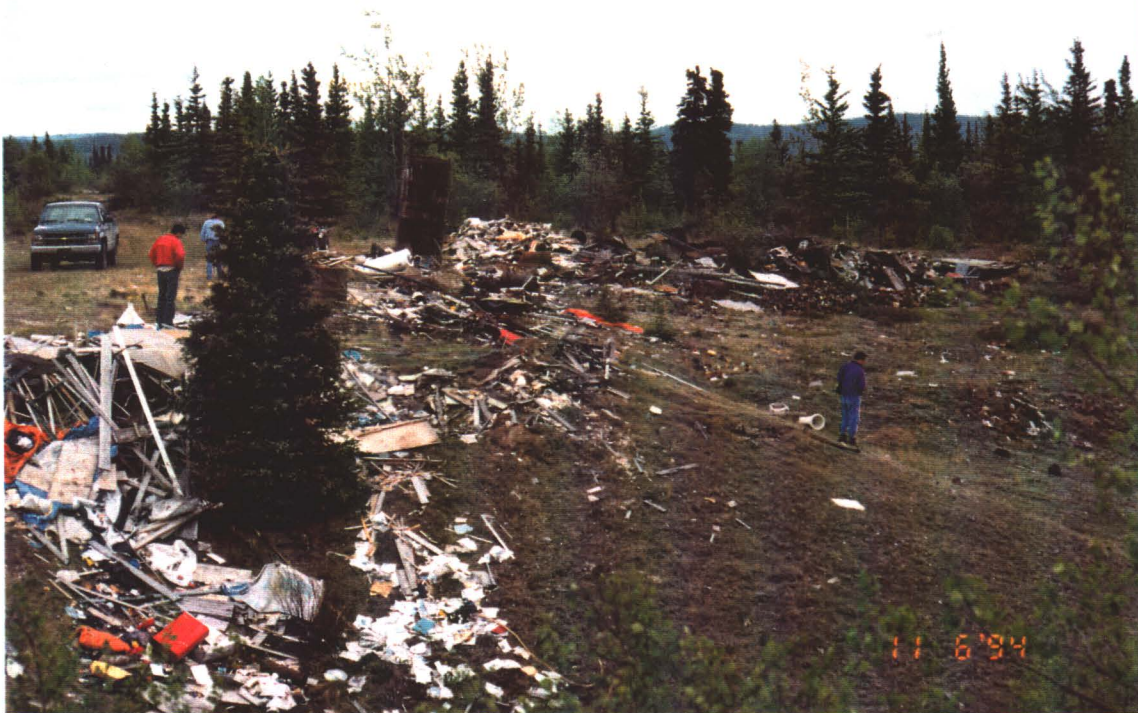
**Photograph V-10: Dump site 2 was the largest of the three dump sites and contained recent domestic garbage as well as very old debris.**

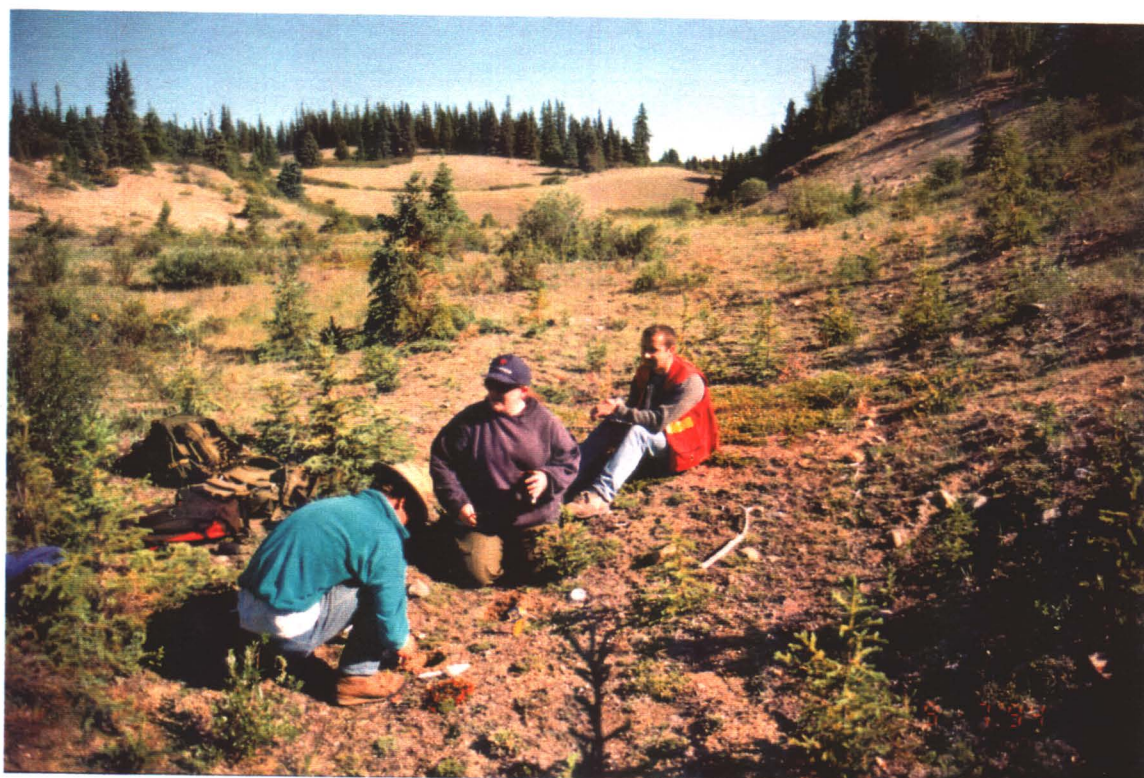
**Photograph V-16: The septic field was located in a shallow valley approximately 200 m west of the garage.**

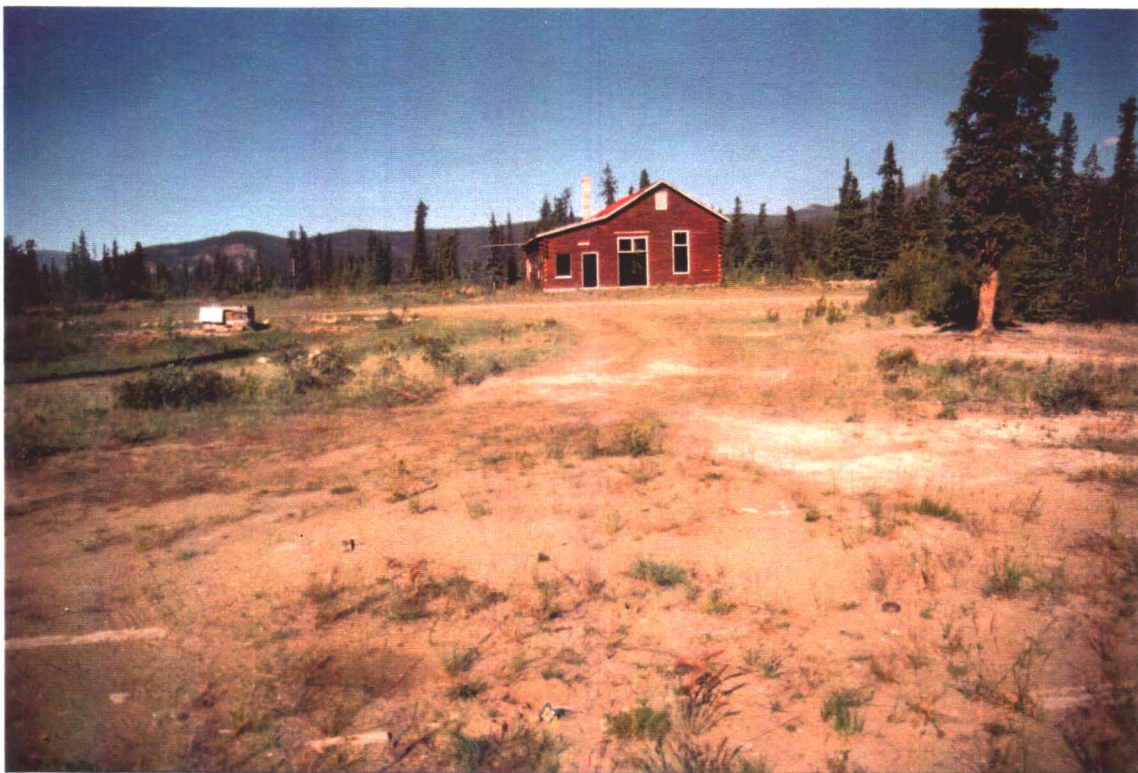
**Photograph V-17: The flat area in the foreground was the location of seven POL tanks. The powerhouse can be seen in the background.**

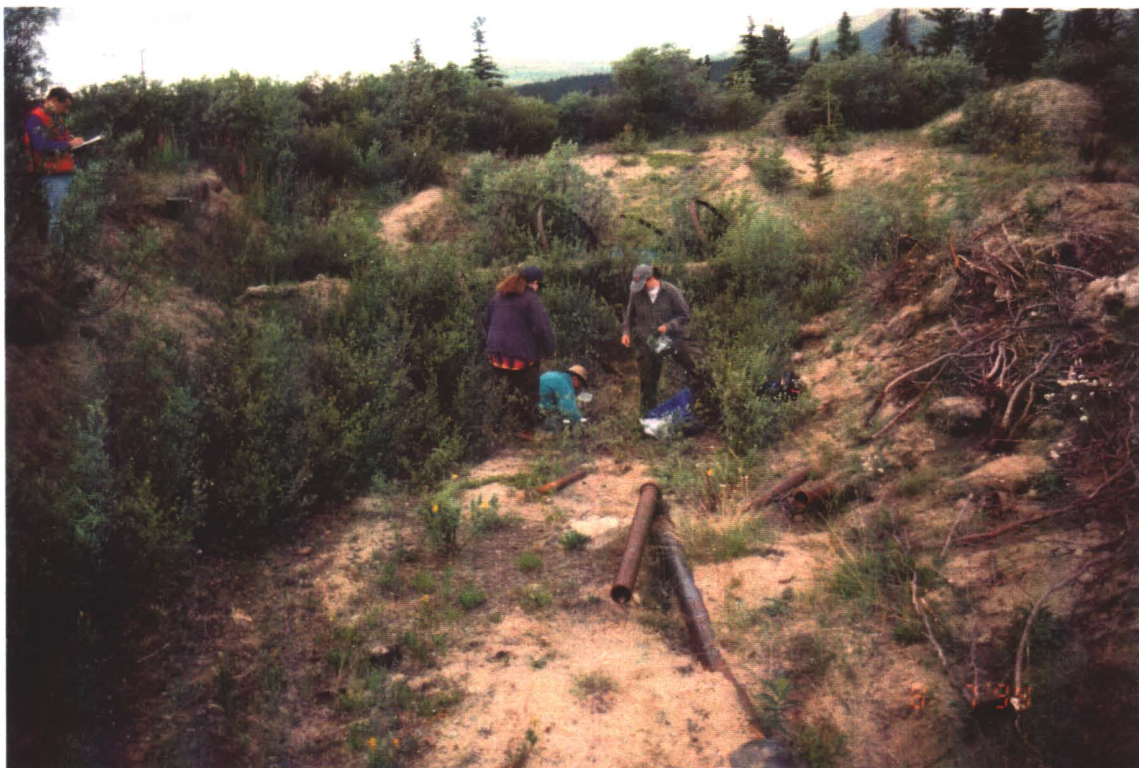
**Photograph V-18: The aircraft refueling points were located next to this small depression. The pipes and tank ribs can be seen in this area.**

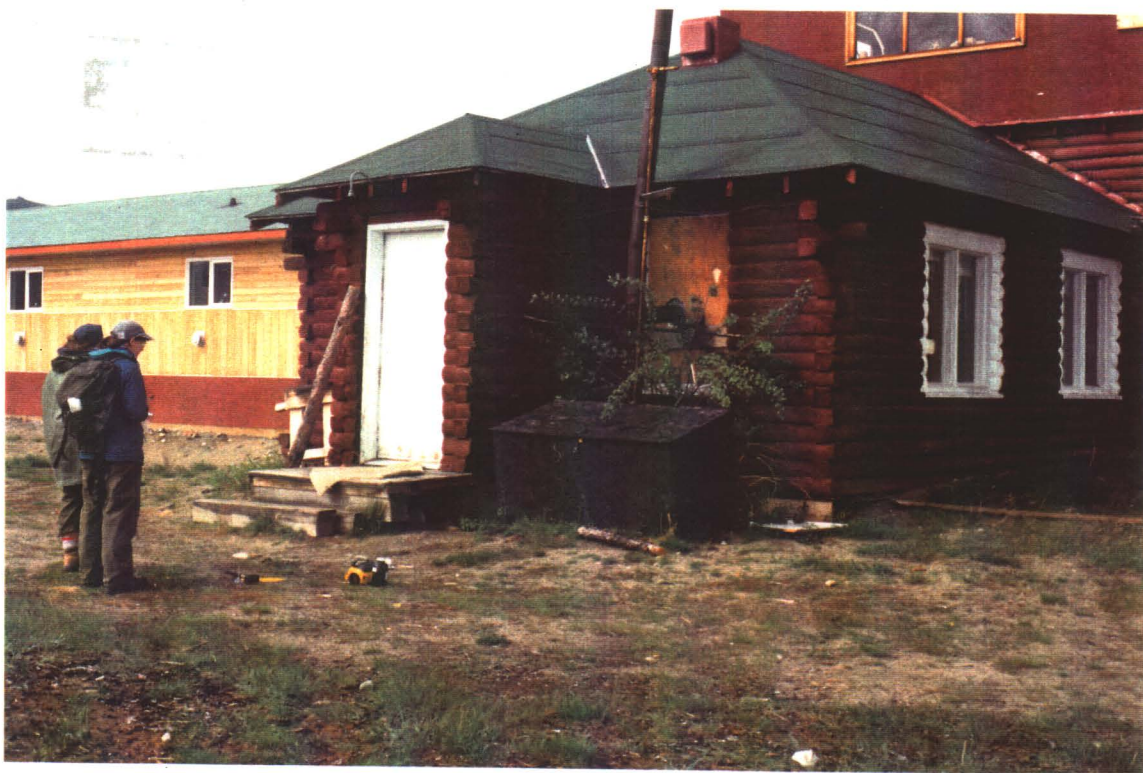
**Photograph V-19: The airways building was in good condition and was used to house summer field camps by the Champagne-Aishihik band.**

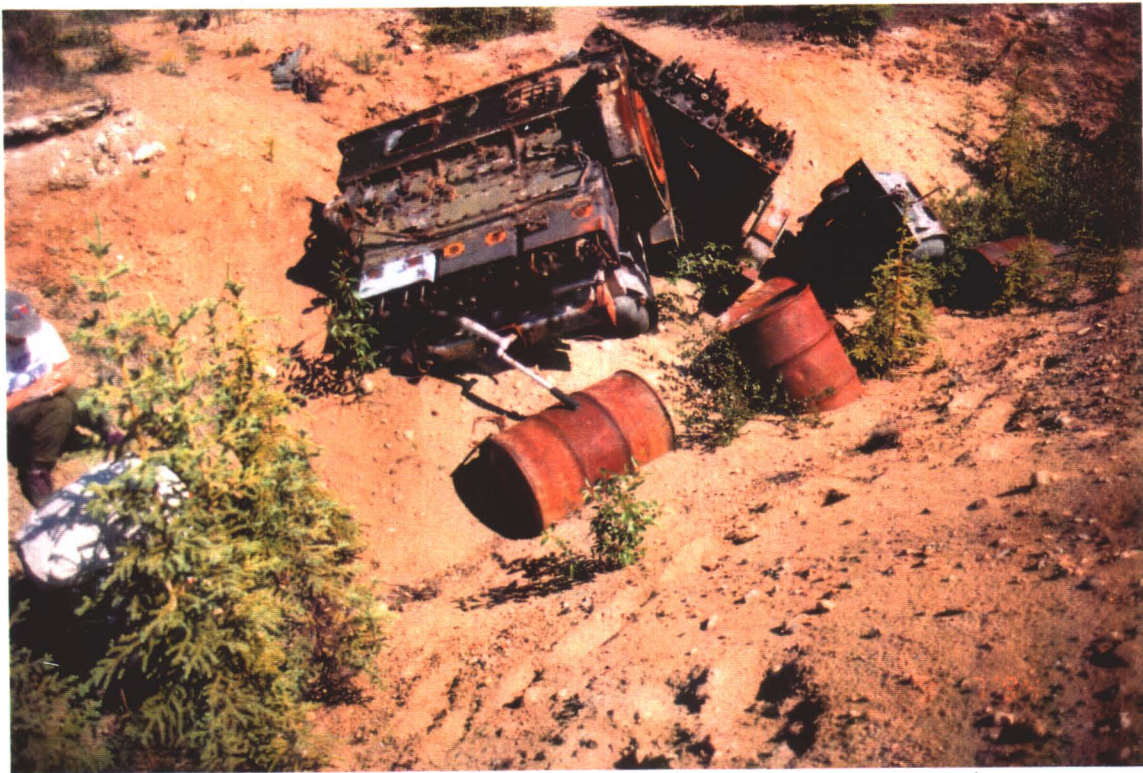
**Photograph V-21:** These generators and engines were found in a shallow depression outside the main gate to the airstrip.

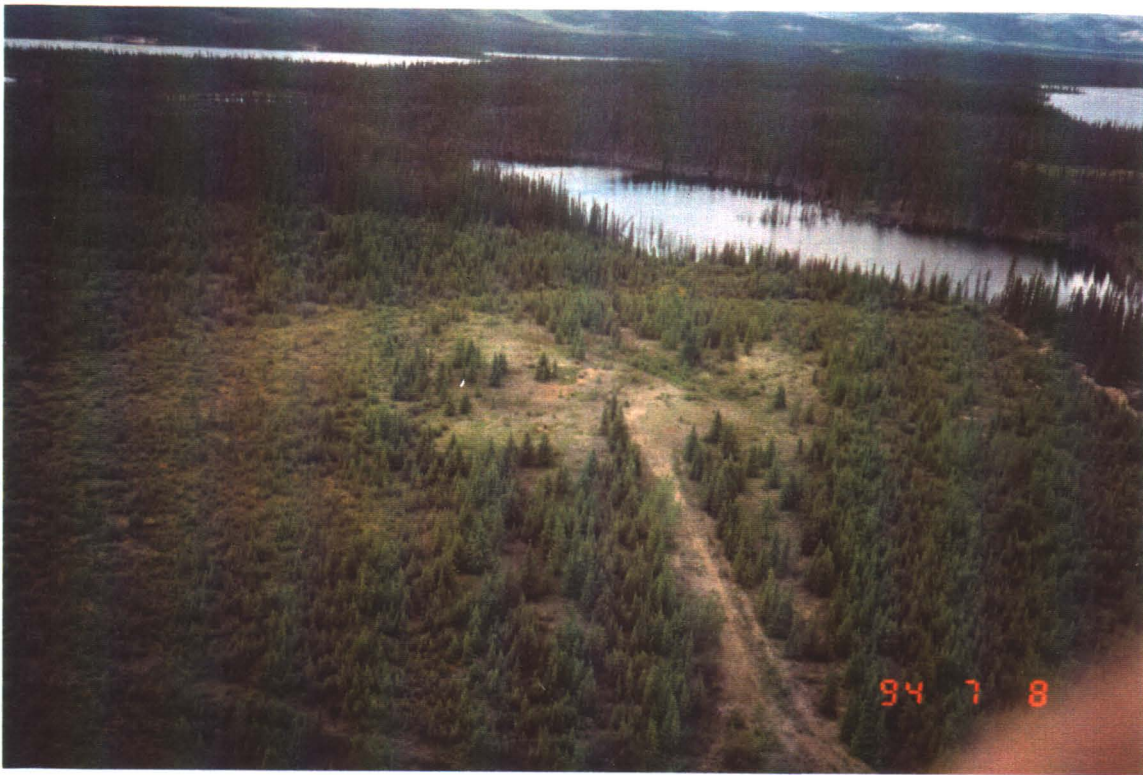
**Photograph V-23: The lower beacon site was located between the airstrip and the beacon site.**
