Preliminary Environmental Investigation

~~BC 96~~ **Site 30 - North of Burwash Landing**

~~HS 49~~ **Site 39 - Kathleen River Crossing**

~~HJ 11~~ **Site 44 - Marshall Creek Road**

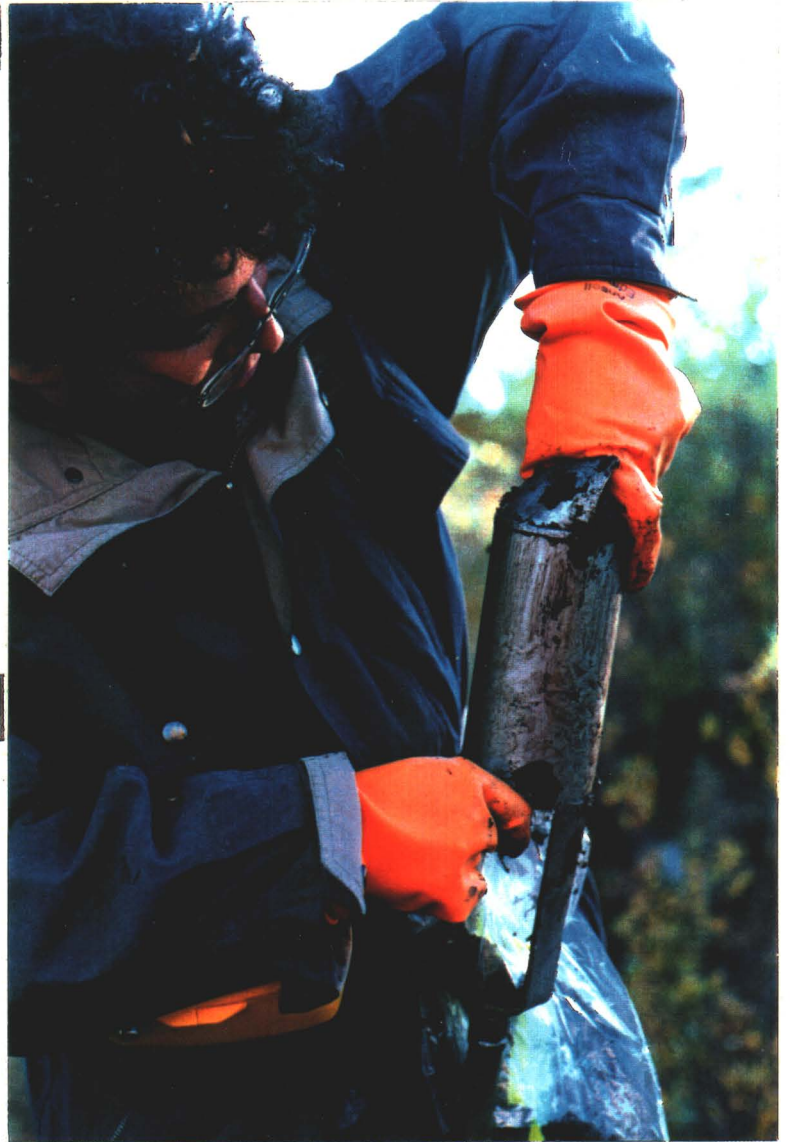
Photograph 30-P16: Removing portion of sample 30-S17 from auger.

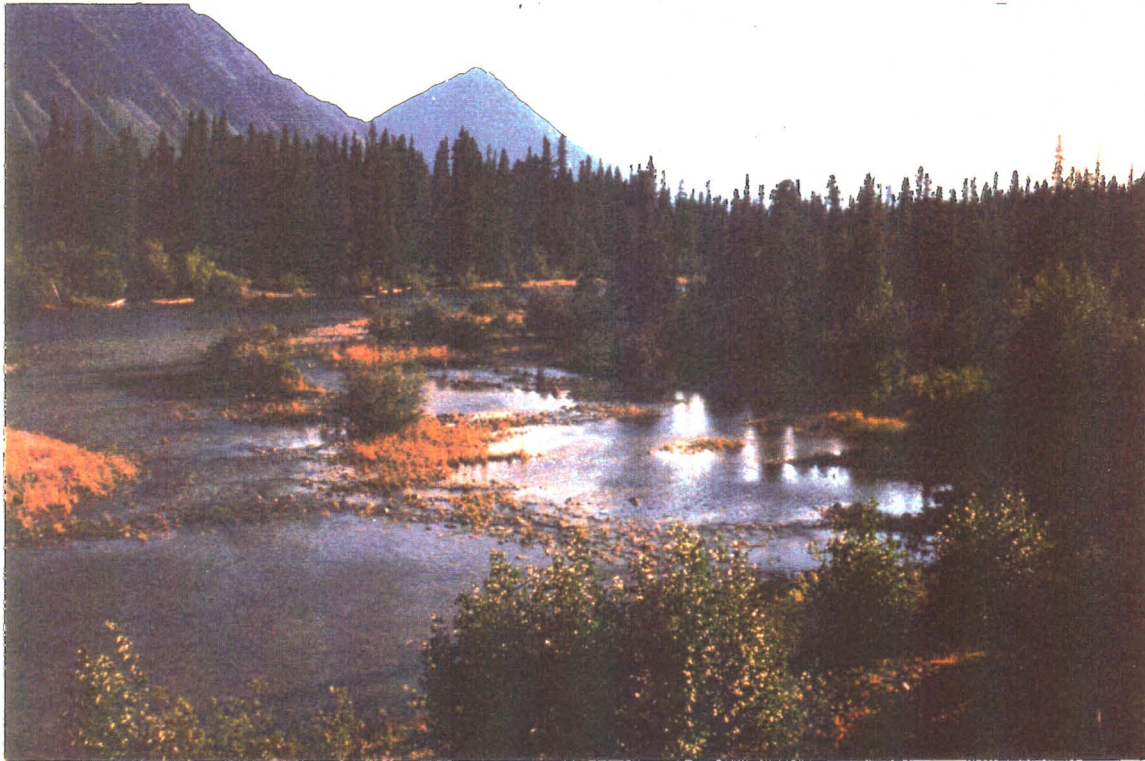
Photograph 39-P1: Upriver view of the Kathleen River as seen from the Haines Highway bridge over it. Site 39 is on the right.

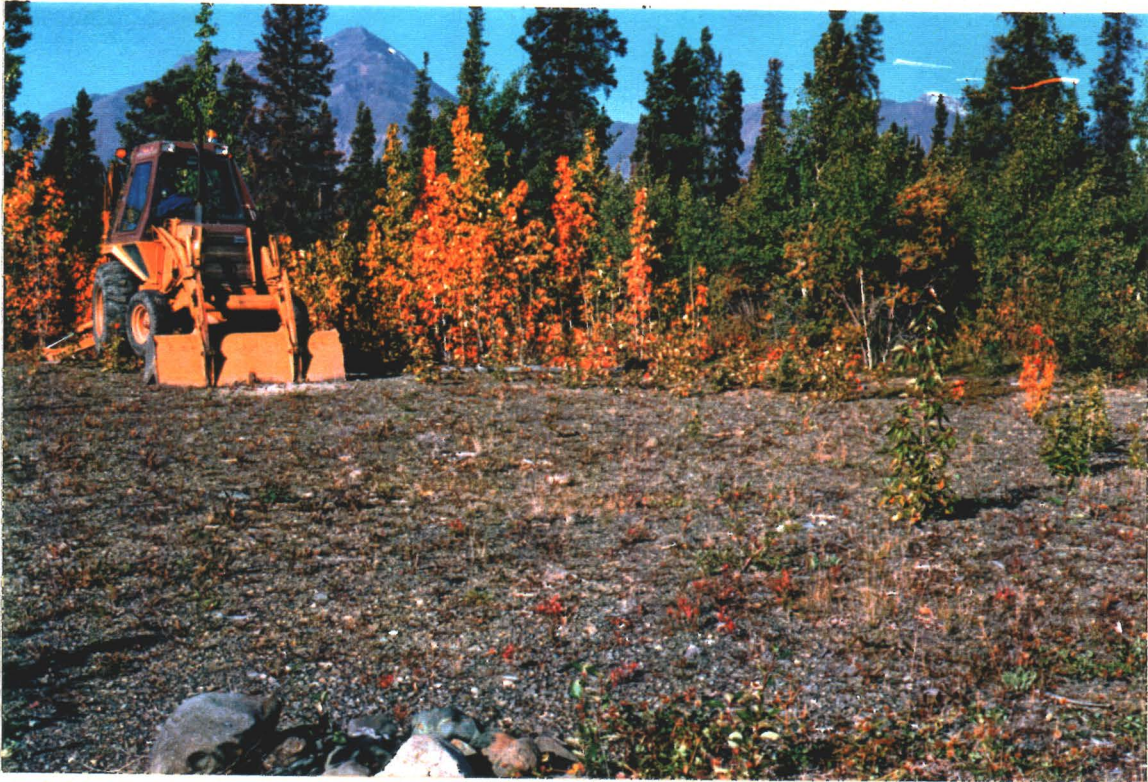
Photograph 39-P5: View of the mound centre looking southeast. Background shows 39-TP1 being excavated.

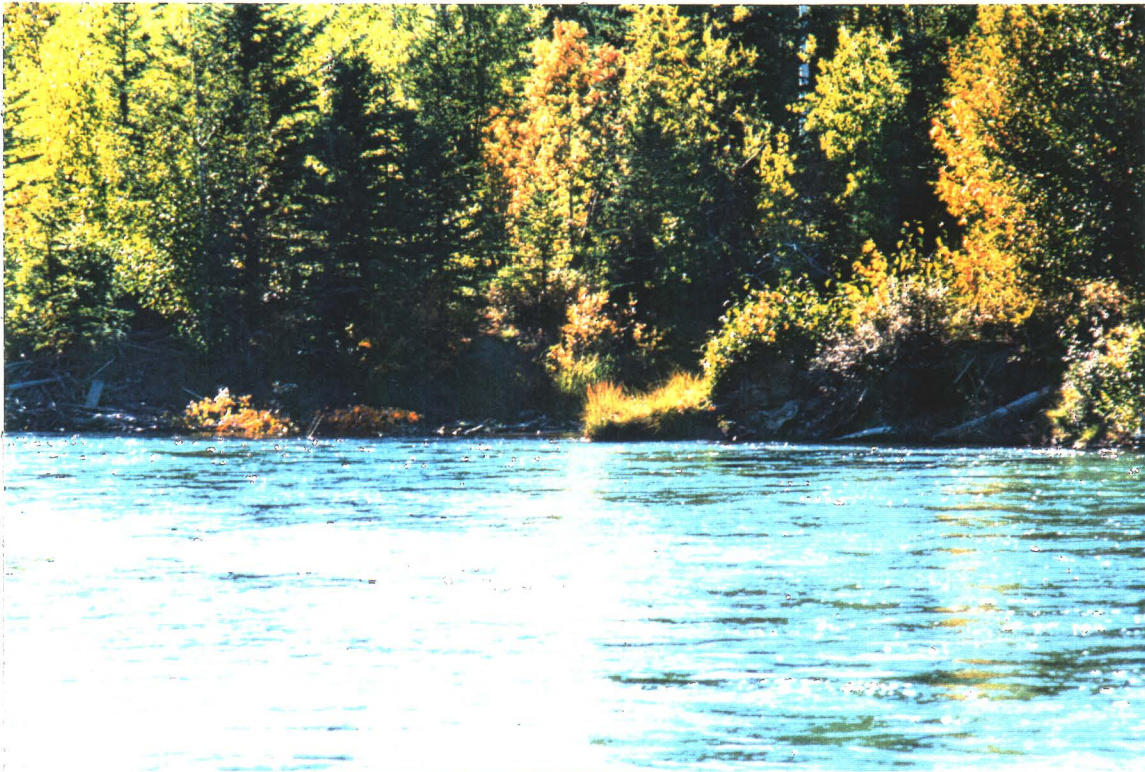
Photograph 44-P1: View of the outlet of the west pond into the Dezadeash River as seen from 44-S11.

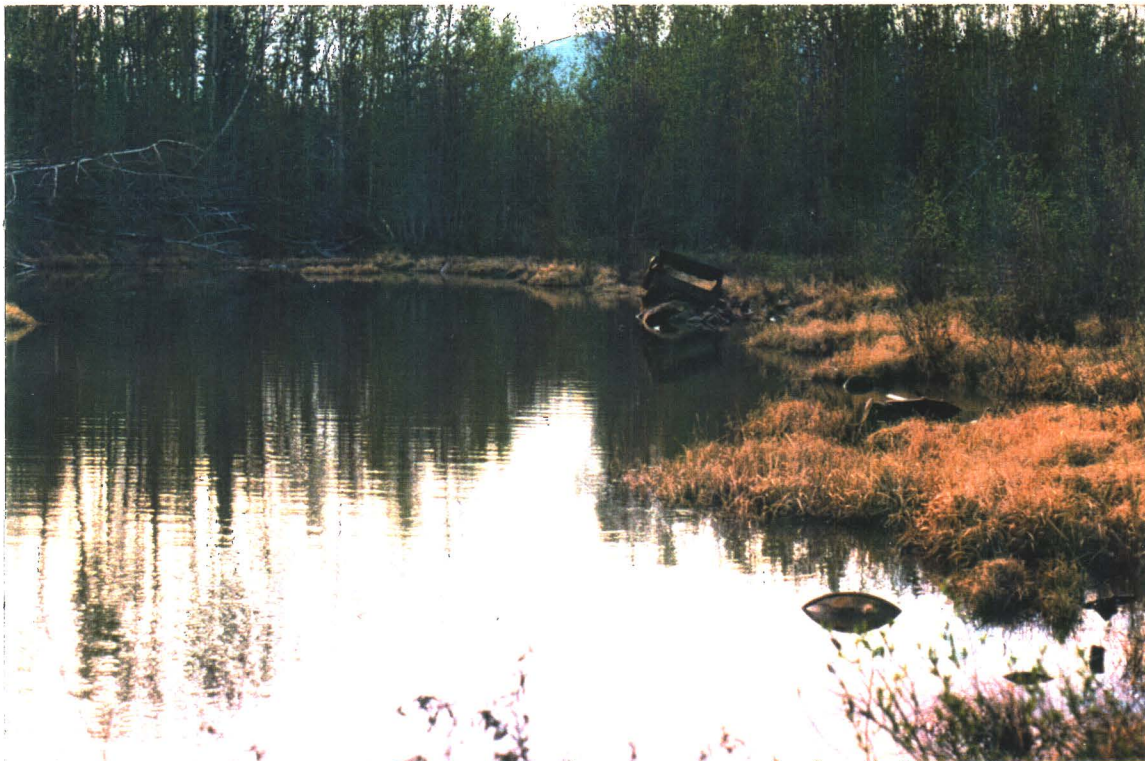
Photograph 44-P2: North facing view of the west pond from its outlet into the Dezadeash River.
