**Phase I & II Environmental
Site Assessment**

**Former Military Site
Donjek River
Mile Post 1130 Alaska Highway
(DIAND Site 31)**

**Arctic Environmental Strategy - Action on Waste
Indian and Northern Affairs Canada
Whitehorse, Yukon**

November 1996

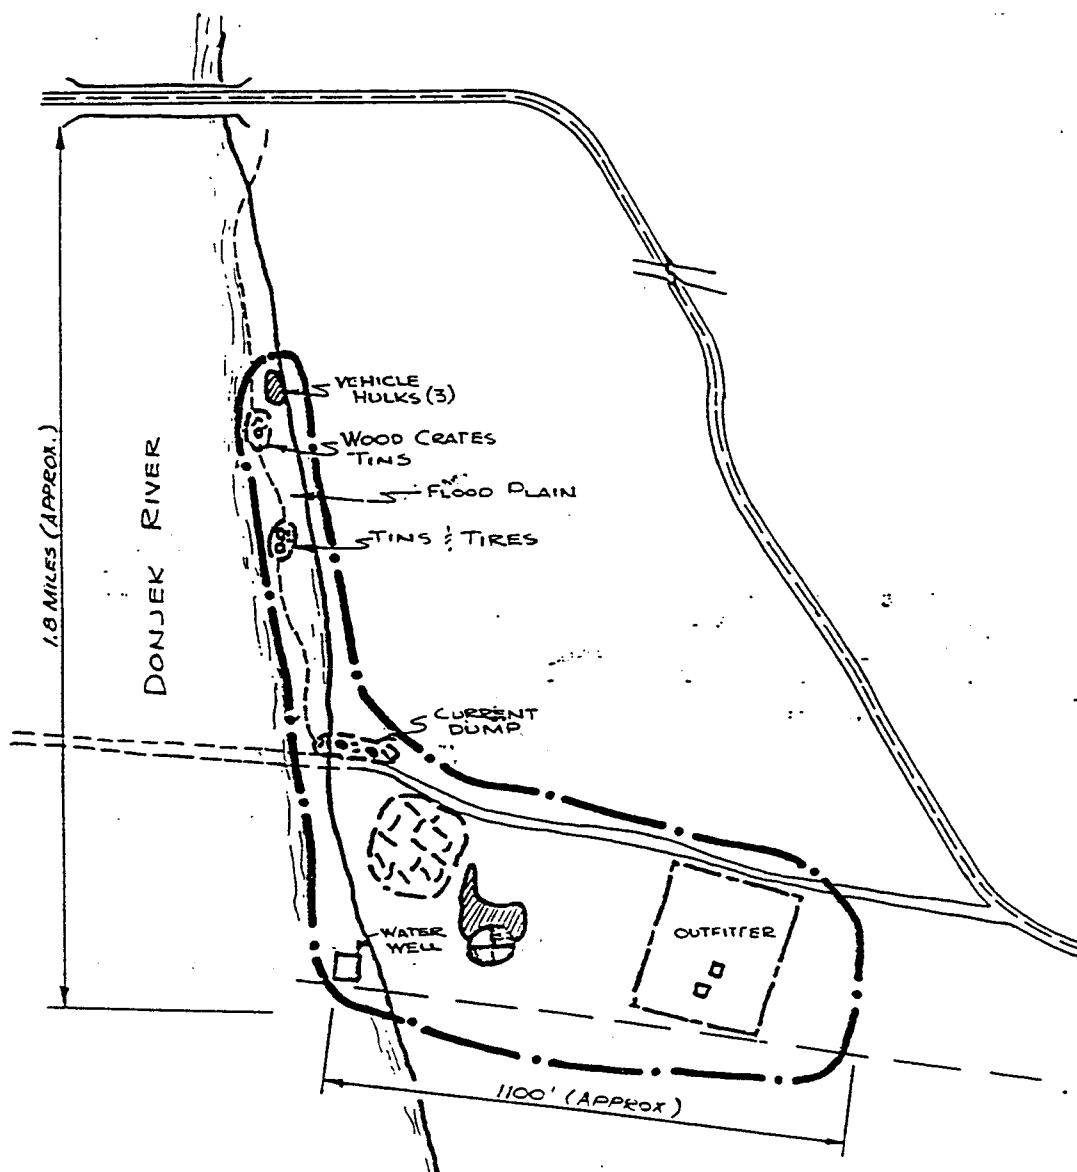
Figure 5. 1976 Mapping of the Subject Site by Edey.

The Alaska Highway Camp and Refuse Locations Preliminary Inventory recorded a dump at this location as did the Operation Clean Up inventory in 1973 (Document 1, Appendix B). Edey (1976) reported that the site contained building debris, old truck bodies, tires, etc. (Figure 5)

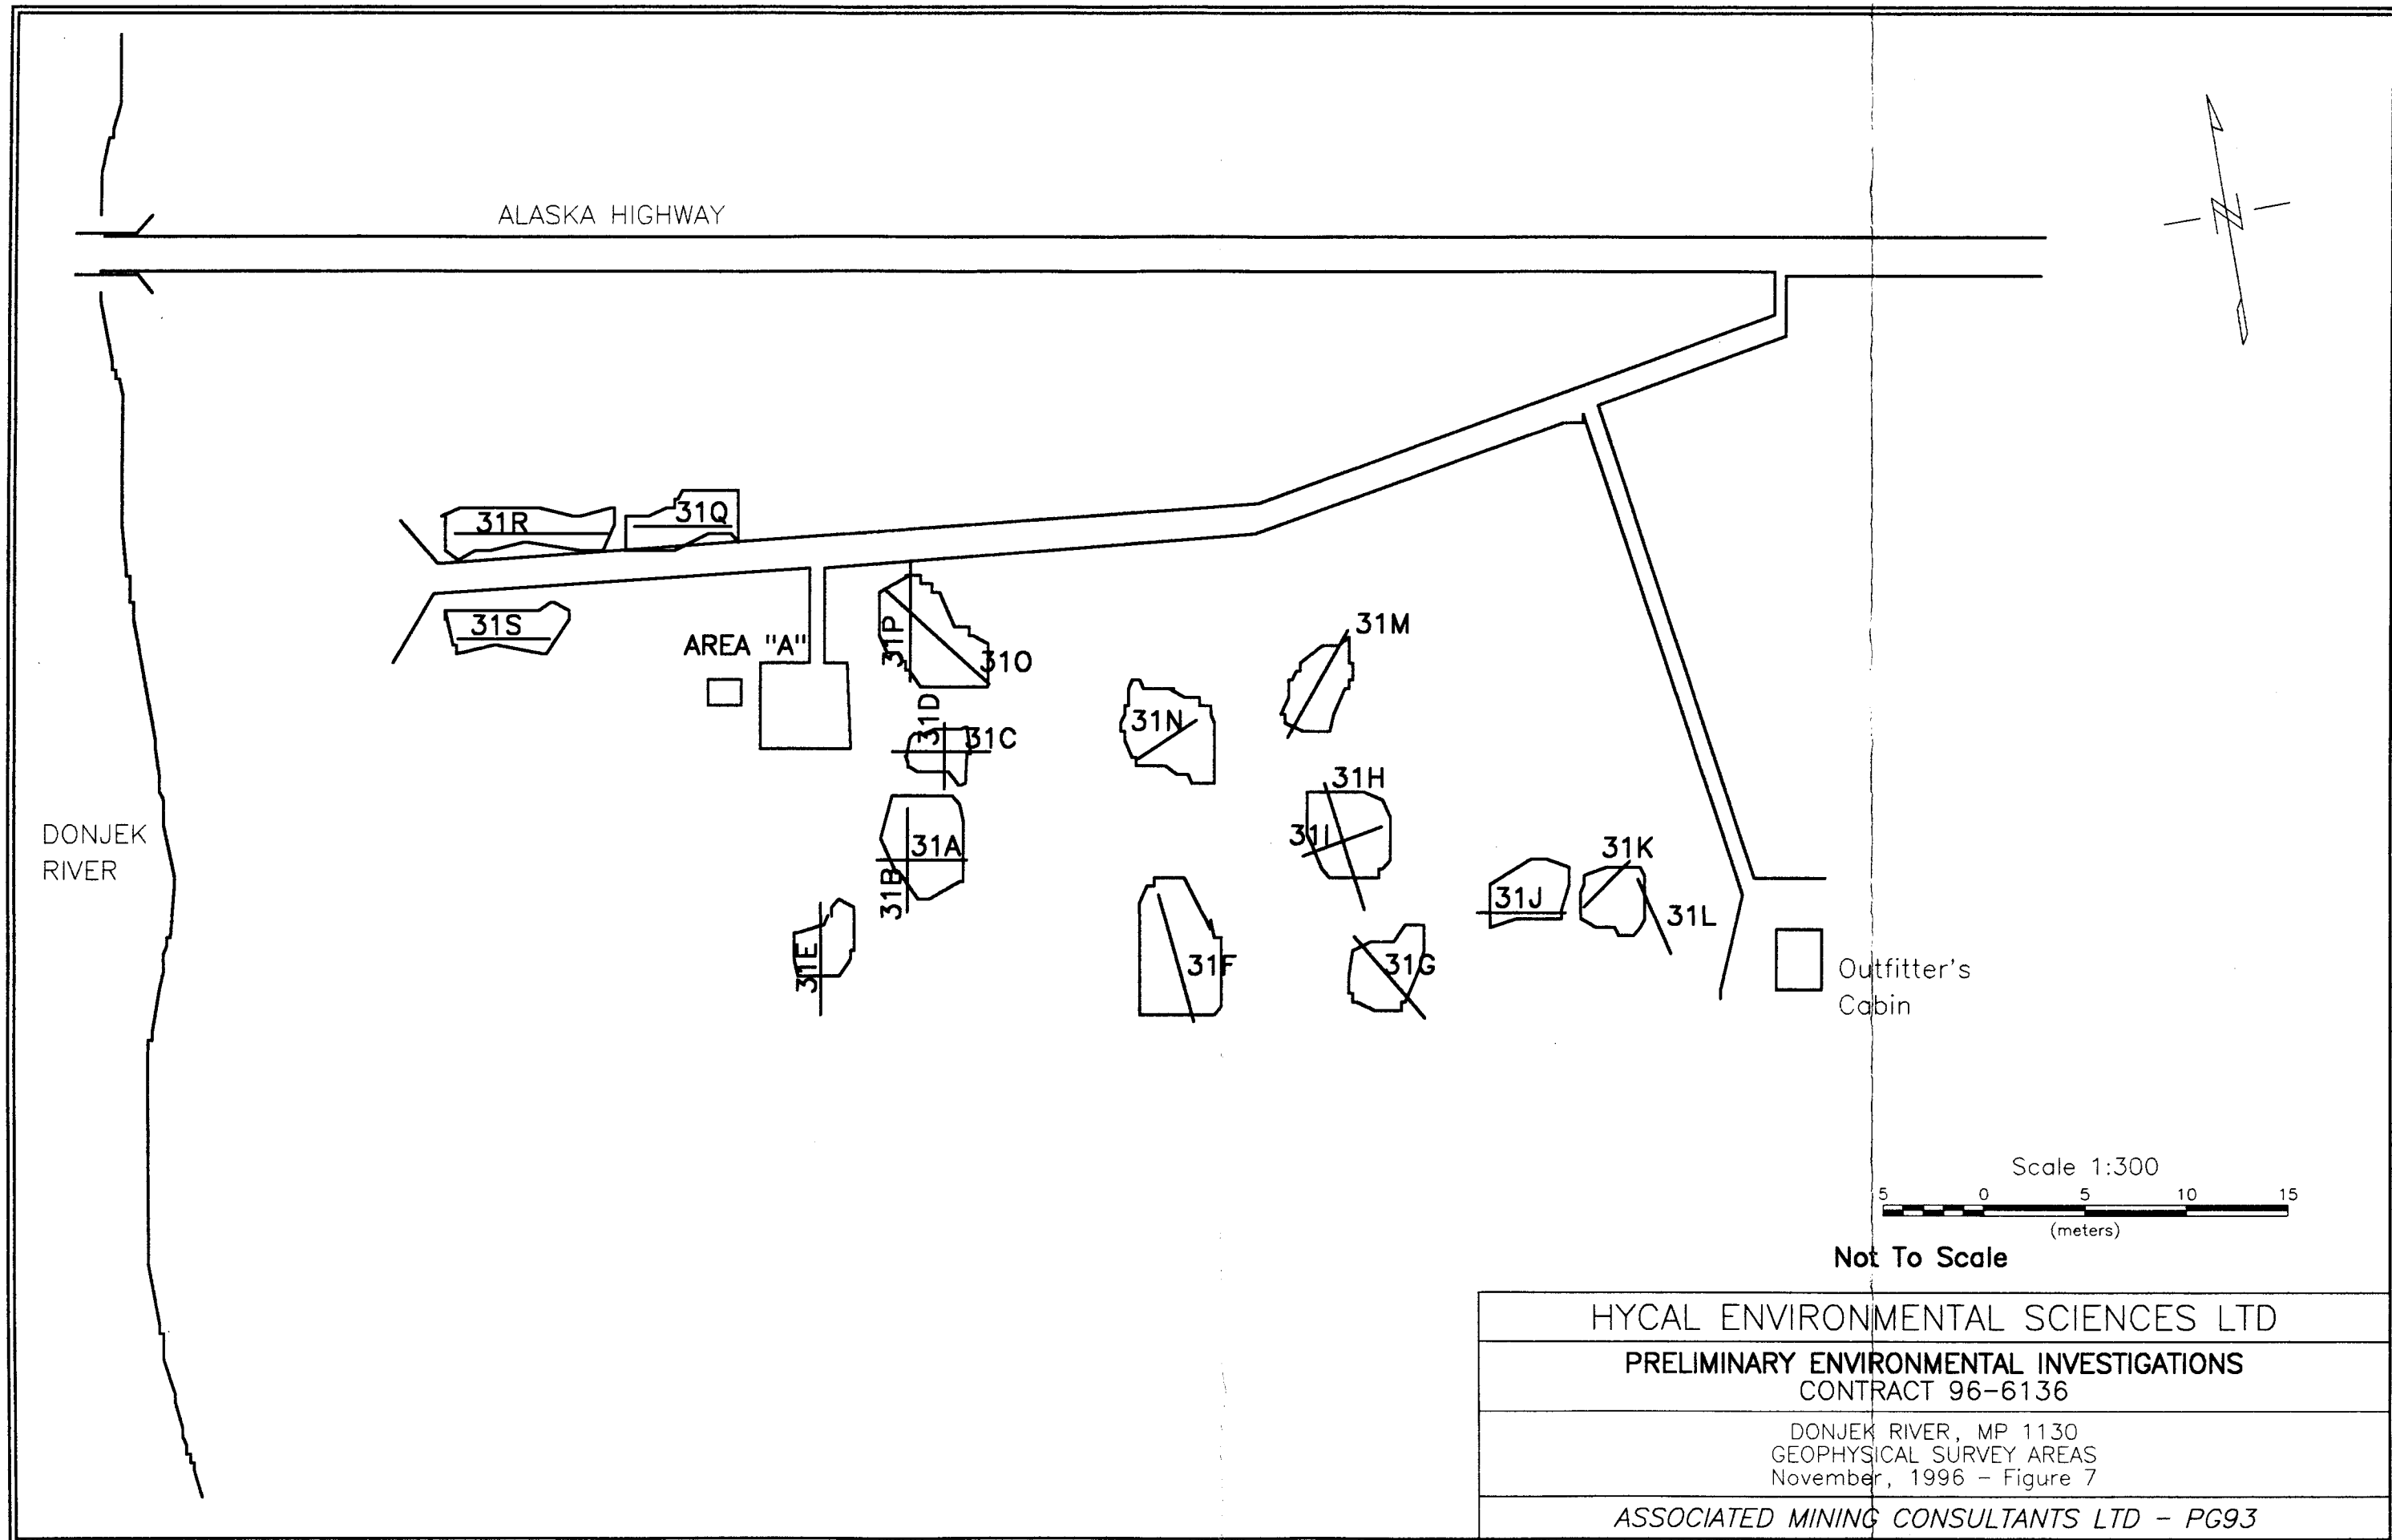
HICAL ENVIRONMENTAL SCIENCES LTD
PRELIMINARY ENVIRONMENTAL INVESTIGATIONS CONTRACT 96-6136
DONJEK RIVER, MP 1130 GEOPHYSICAL SURVEY AREAS November, 1996 - Figure 7
ASSOCIATED MINING CONSULTANTS LTD - PG93

The scope of the project prevented the undertaking of a detailed geophysical study over the full extent of the site. Instead, areas were prioritized for geophysical evaluation based upon site inspection. Areas that were geophysically surveyed are outlined in Figure 7.

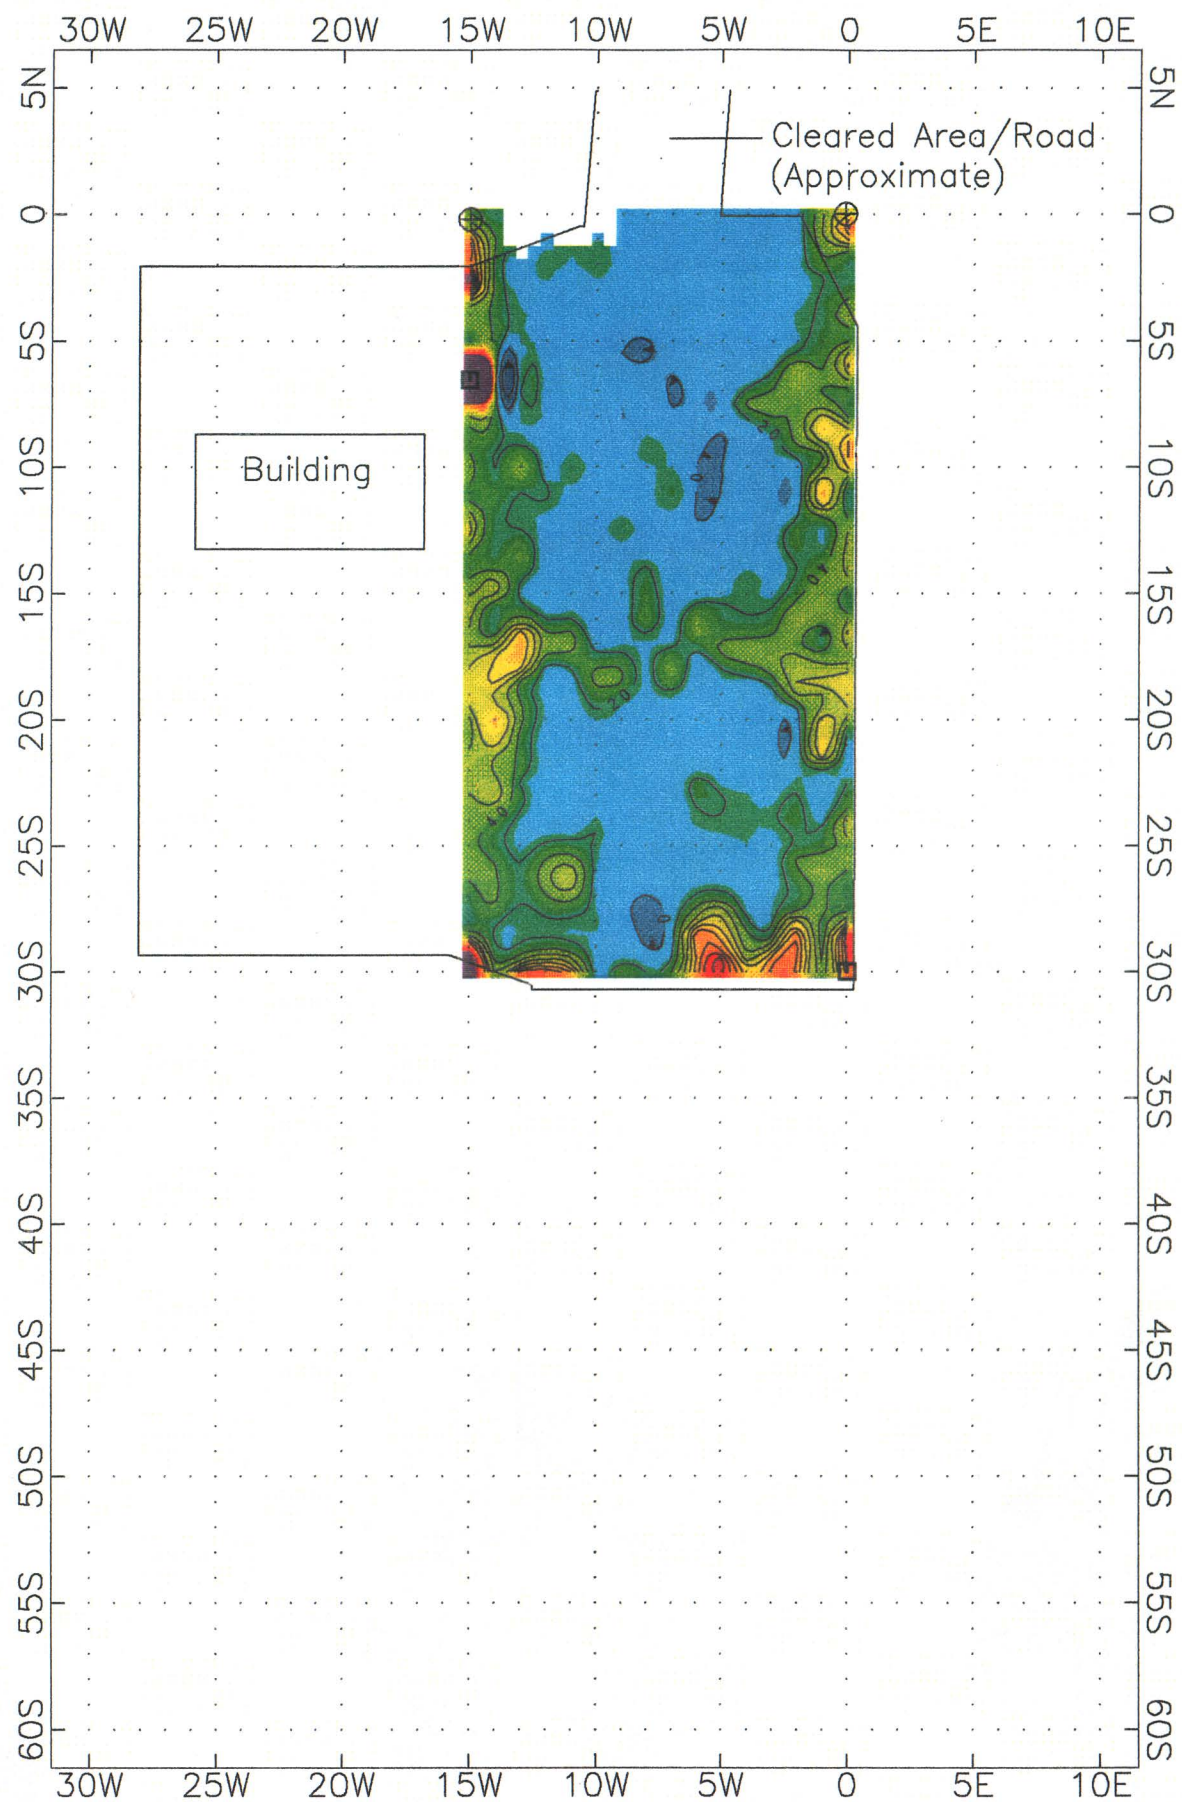
DONJEK RIVER, MP 1130
EM61 SURVEY - Channel 2 - AREA 'A'
November, 1996 - Figure 8

As is apparent in the illustrated results (Figure 8), the EM61 Channel 2 survey indicated regions of anomalous electromagnetic response indicative of buried metal positioned predominantly along the perimeter of the surveyed area. Review of the EM61 Differential Channel survey data (Figure 9) revealed corresponding anomalous response in both position and magnitude, suggesting that the source of the anomalies may extend to a depth of greater than one metre below the surface.
