**Phase I & II Environmental
Site Assessment**

**Former Military Site
Snag - Enger Lakes
Mile Post 1189 Alaska Highway
(DIAND Site 36)**

**Arctic Environmental Strategy - Action on Waste
Indian and Northern Affairs Canada
Whitehorse, Yukon**

November 1996

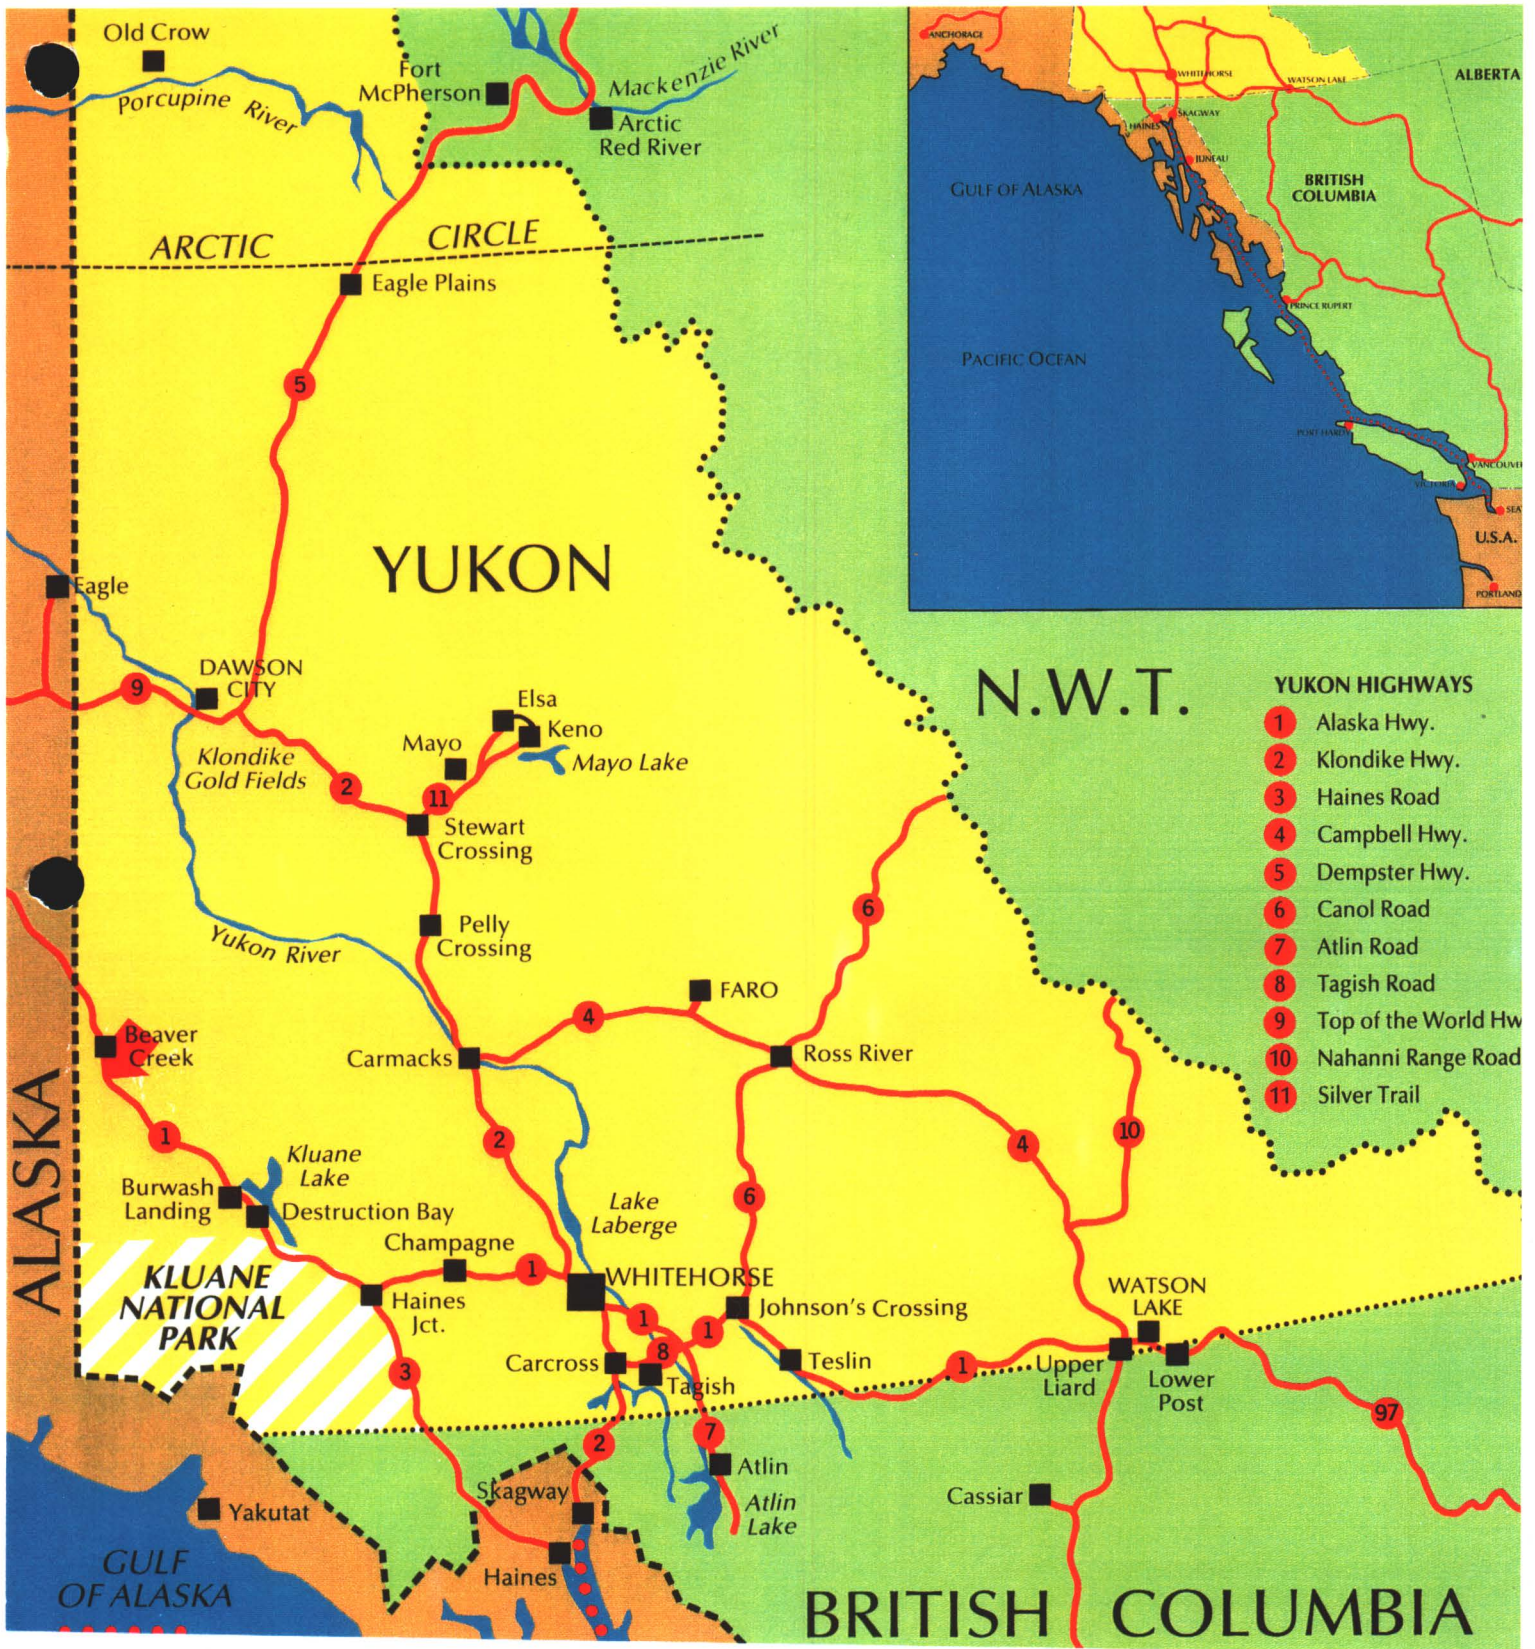
Figure 1. Site Location.

Hycal Environmental Sciences Ltd. (Hycal) was retained by Action on Waste, Arctic Environmental Strategy, Indian and Northern Development, Canada to carry out environmental assessment of four separate sites. This report outlines the investigation of one of these sites, known as "Site 36". Site 36, also known as Snag - Enger Lakes is located in the western Yukon Territory, at Mile Post 1189 of the Alaska Highway (Figure 1).

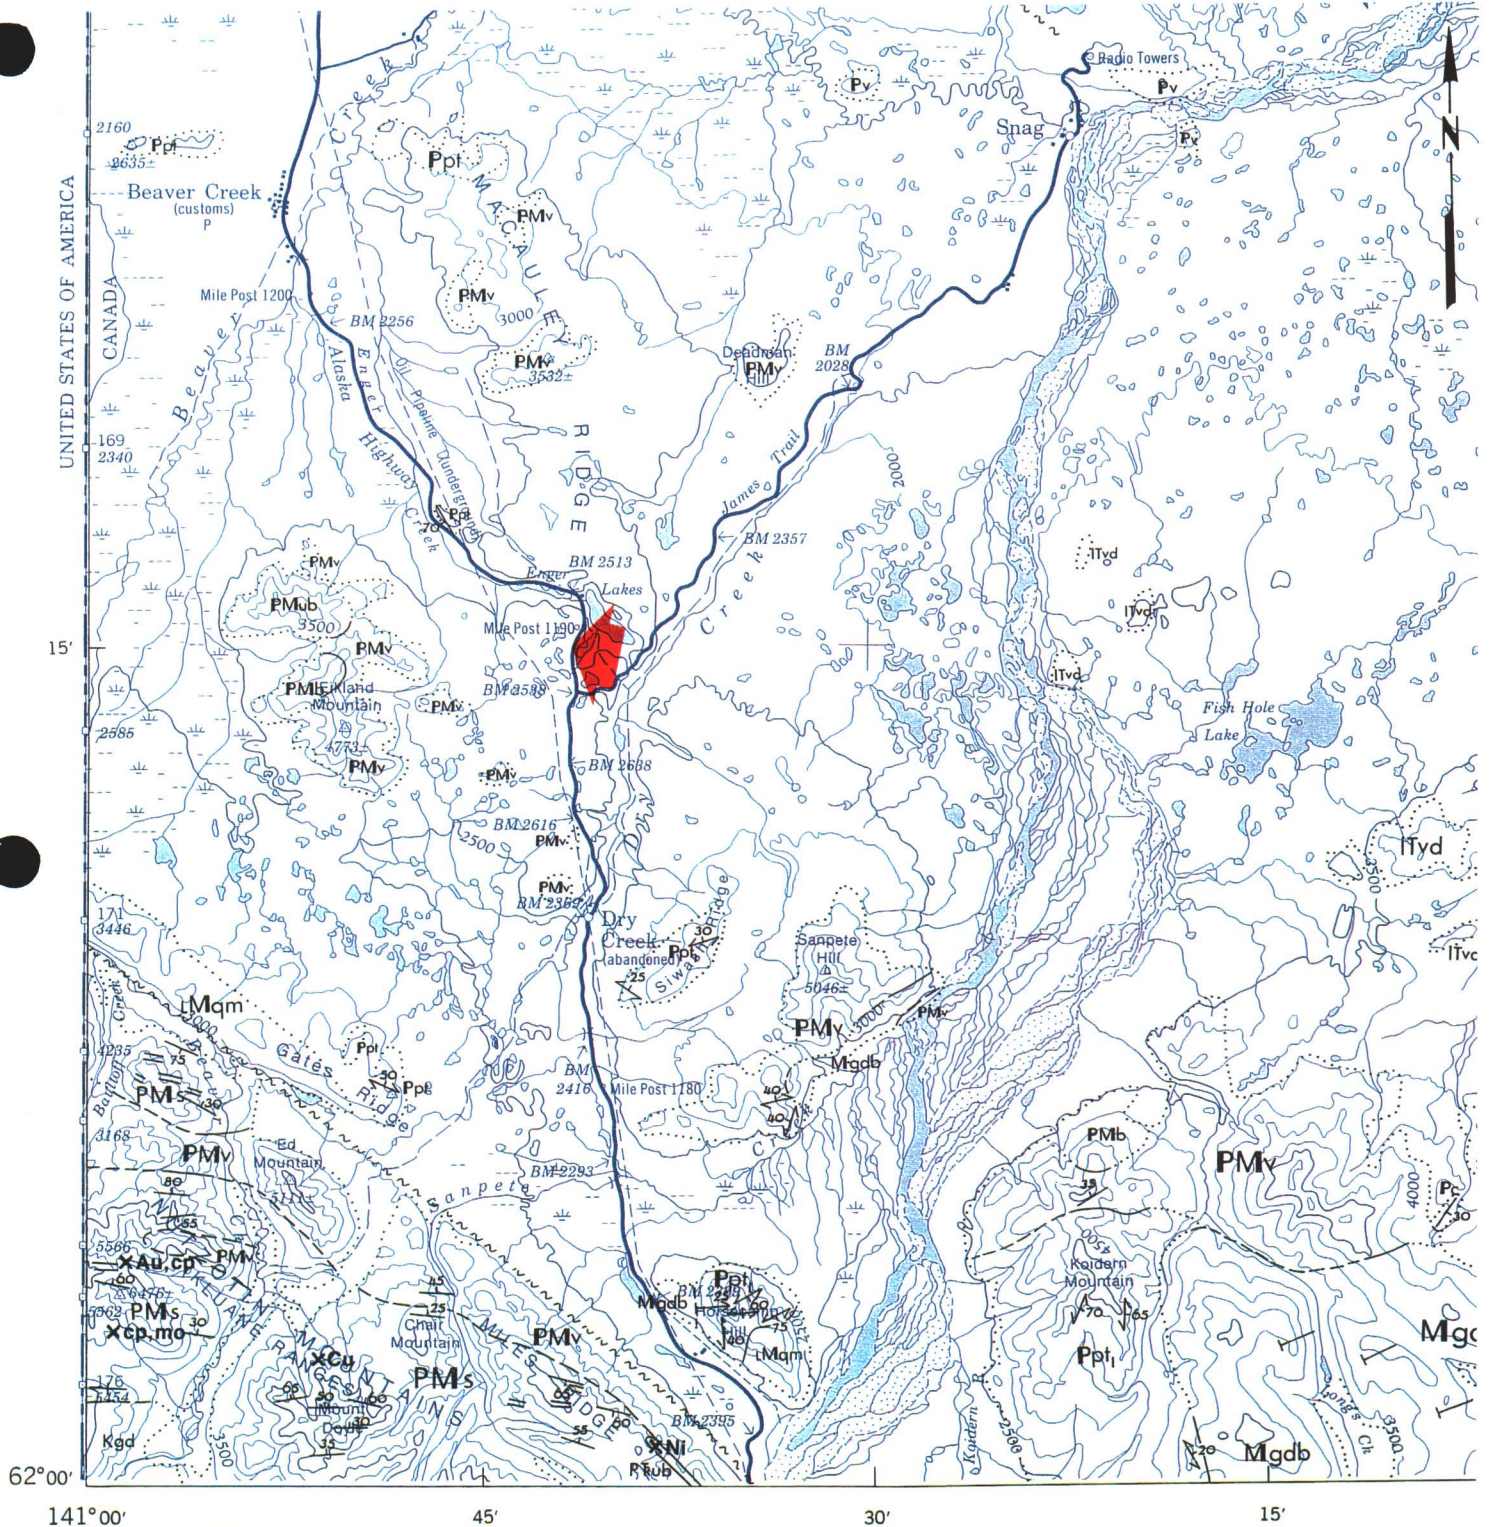
Figure 2. Detailed Site Location.

Mile Post 1189 of the Alaska Highway is located north of the junction of the Alaska Highway and the James Trail, which runs to the old townsite of Snag (Figure 2). The location is approximately 13 miles south of the town of Beaver Creek.
