REPORT NO.: 8054-20

**PRELIMINARY ENVIRONMENTAL
INVESTIGATIONS AT VARIOUS SITES
THROUGHOUT THE YUKON
SITES #3, 4, 5, and 6
Contract 96-6134-1**

Submitted to:
INDIAN and NORTHERN AFFAIRS CANADA
ARCTIC ENVIRONMENTAL STRATEGY
ACTION ON WASTE PROGRAM

NOVEMBER, 1996

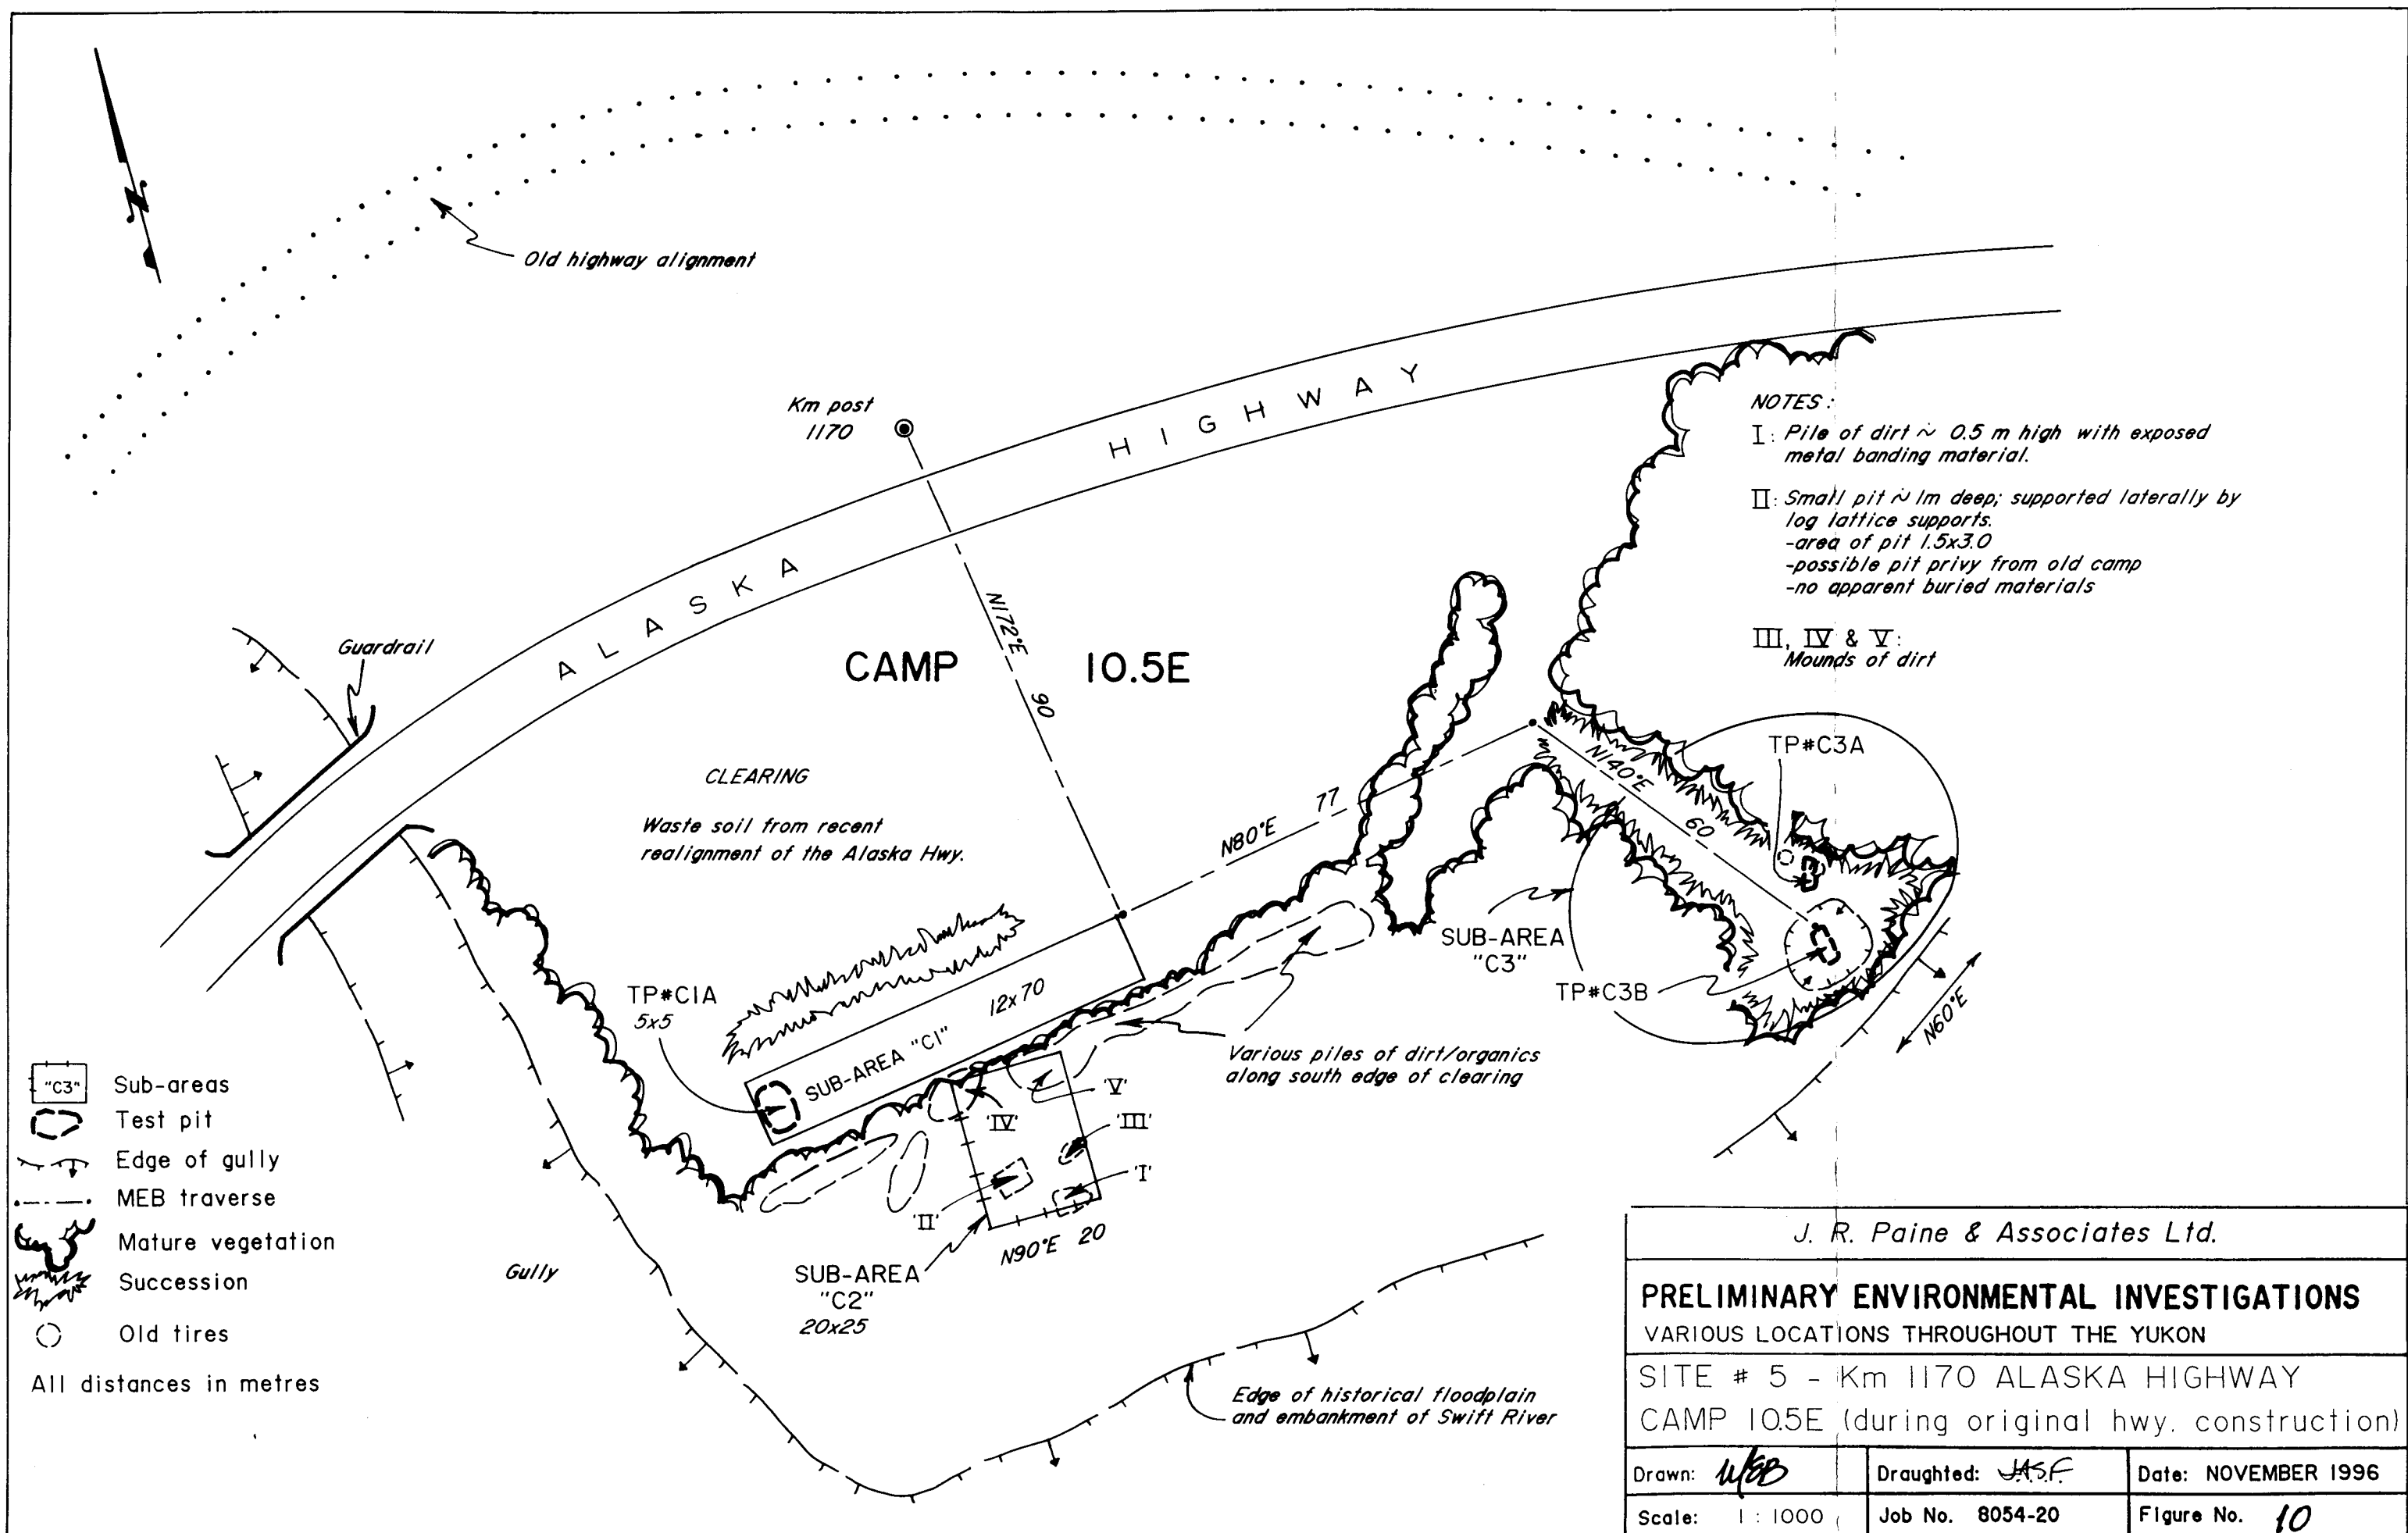
A 48 m by 44 m grid was established in the location depicted on Figure 11 and as illustrated on Photo 16. The area consisted of approximately 0.6 m of fill material placed over the surrounding muskeg. It is not certain as to the origin of the fill material. The only debris item encountered was an old oxidized cable at the south-west portion of the site.

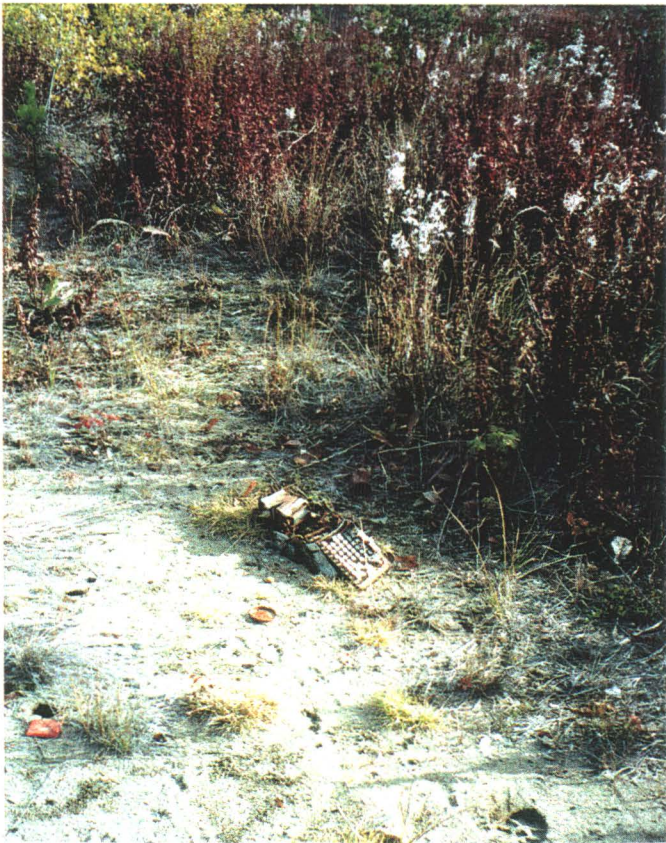
PHOTO 7

7	-Site #3, Rancheria Dump -looking west at dump floor in general area of TP#R-c; note fine grained sand as native soil, cash register most likely deriving from Rancheria Lodge
8	-Site #4, Pine Lake Airstrip, Sub-area P1 -looking at excavation for TP#P1-a located at existing pit structure; note log cribbing at edge of pit wall (top left of photo) and various disposal items
9	-Site #4, Pine Lake Airstrip, Sub-area P4 -looking south-west from top of embankment at north east corner of P4 -note depression due to gravel borrow source activity; note slight regeneration of pine trees
10	-Site #4, Pine Lake Airstrip, Sub-area P2 -looking north west at excavation of TP#P2-d; note various wood and metal debris within pile
11	-Site #4, Pine Lake Airstrip, Sub-area P3 -looking east at area of former generating unit; note metal pipe leading into ground
12	-Site #4, Pine Lake Airstrip, Sub-area P3 -looking south at area of former generating unit; note concrete base for pole or tower

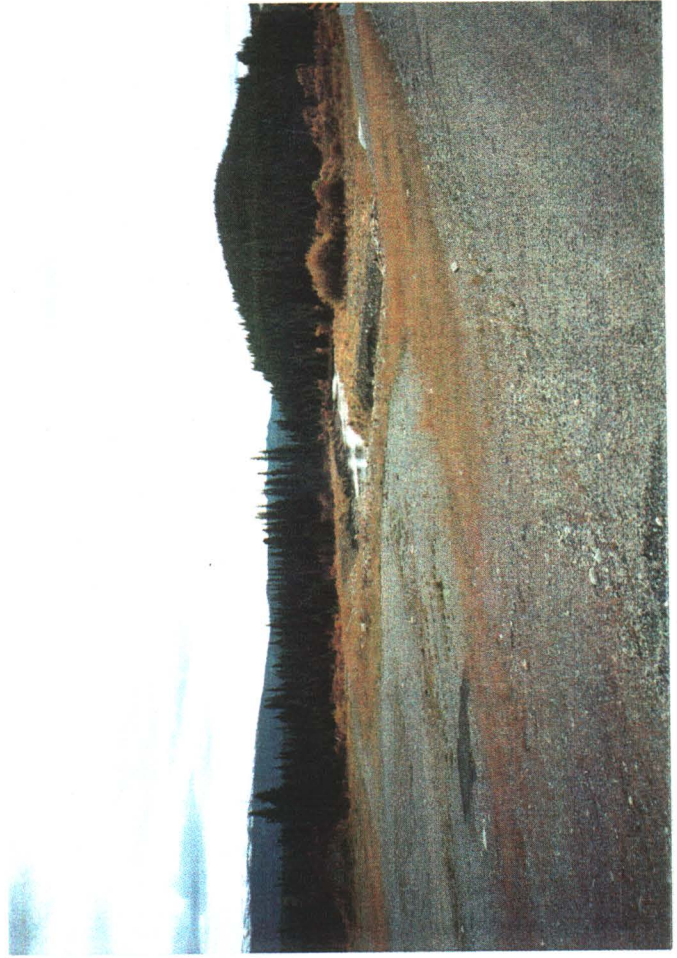
PHOTO 16

13	-Site #5, Camp 10.5 E -looking west from Alaska Hwy at clearing where former Camp 10.5 E was situated; note young grass vegetation recently seeded
14	-Site #5, Camp 10.5E, Sub-area C3 -looking south-east at depression where TP#C3-b was excavated
15	-Site #5, Camp 10.5E, Sub area C3 -looking south-west at small clearing where old tires located
16	-Site #6, Swift River Crossing -looking west at area of clearing adjacent to Swift River and Alaska Hwy

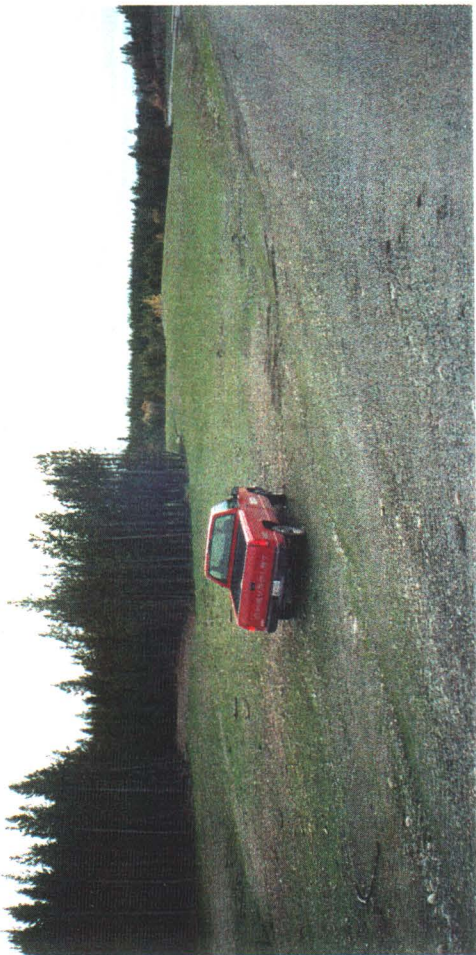
PHOTO 13

Refer to Photo 13 which illustrates the recent construction activity and seeding that has occurred at the former camp area. That the geophysical survey equipment will not detect metals at depths approaching 3.0 to 4.0 metres, the majority of the clearing was not suitable for such a program due to the extensive fill placed here. However, there did not appear to be much fill at the southern perimeter of the clearing and as such, an EM-61 survey was attempted at sub-area C1.

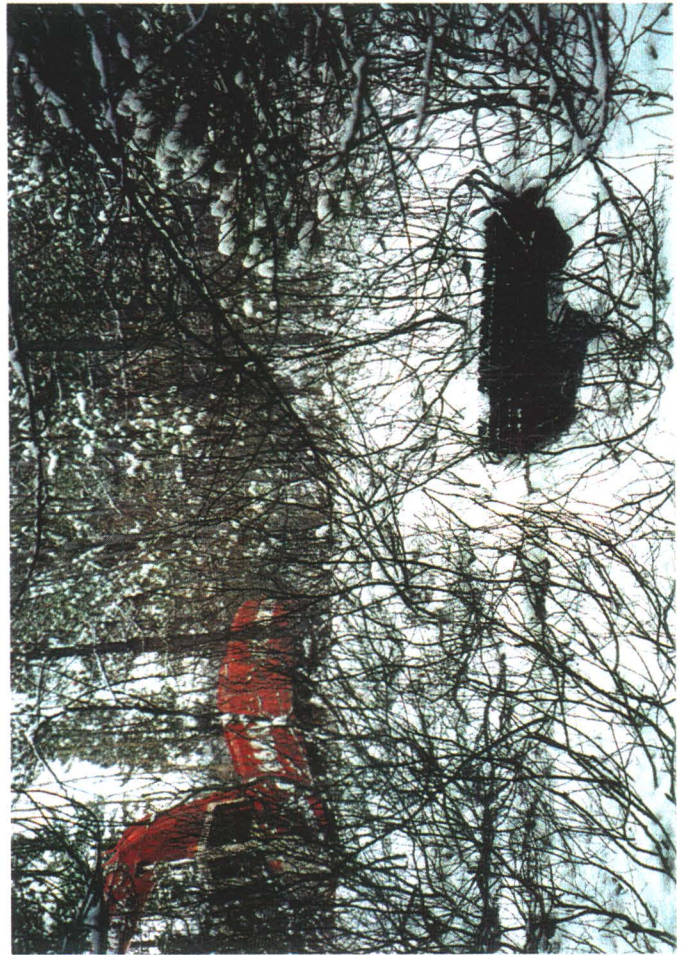
PHOTO 15

- a. A small mound with two old tires of US Army vintage. (refer to Photo 15)
- b. A depression located at the southern edge of the clearing. (refer to Photo 14)

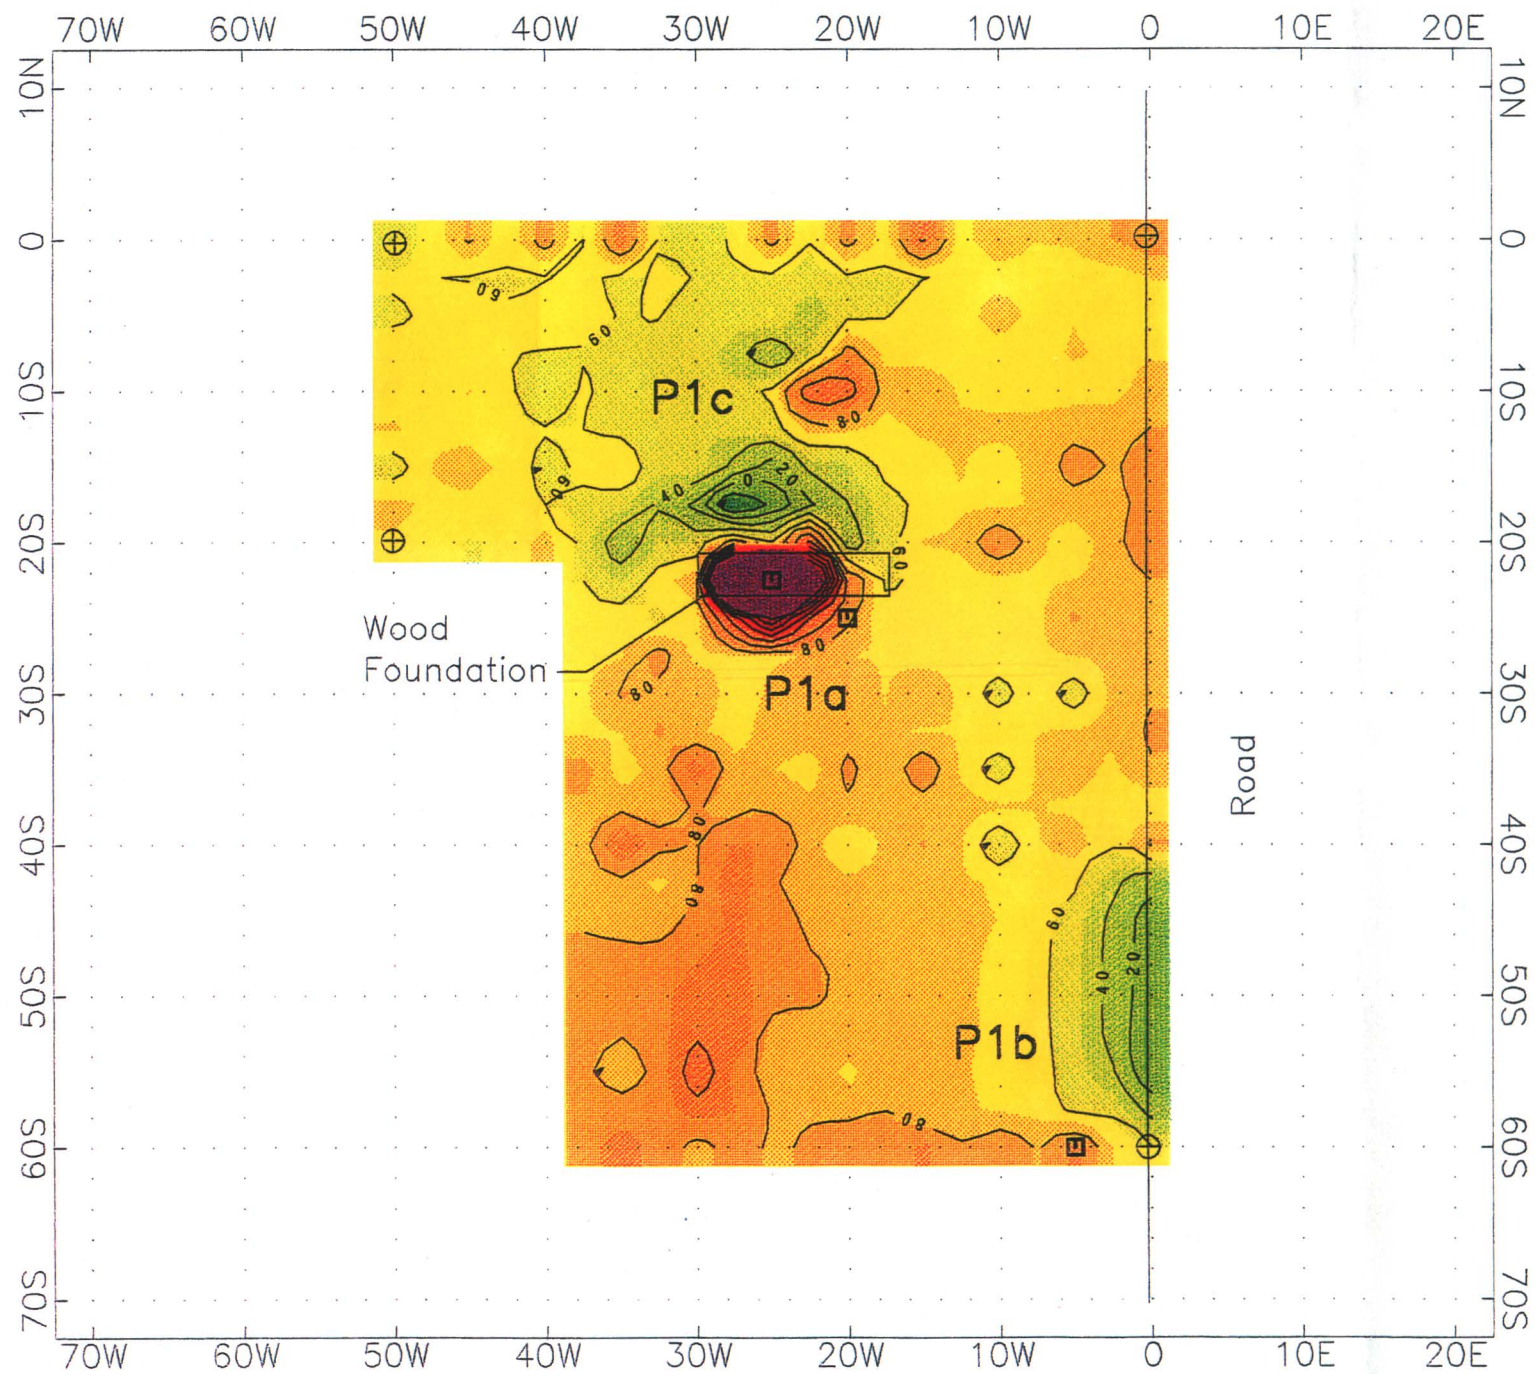
J R PAINE & ASSOCIATES LTD	
PRELIMINARY ENVIRONMENTAL INVESTIGATIONS	
CONTRACT 96-6134	
PINE LAKE SITE P1	
TOTAL FIELD MAGNETOMETER SURVEY	
October 1996 - Figure 2b	
ASSOCIATED MINING	CONSULTANTS LTD. - PG92

- P1a** Occurring within the vicinity of two partially buried metal drums within the perimeter of a wooden building foundation (25W, 22S), the magnitude of the anomalous response suggests that additional buried metal occurs within this vicinity.
- P1b** A relatively broad and weak negative anomaly likely due to buried metal occurring at, or immediately east of 0W, 50S. As the anomalous response was not readily evident during data collection, the survey was not expanded to encompass the full lateral extent of the anomaly.
- P1c** This region depicts a relatively wide extent of slightly depressed magnetic intensity. It is unlikely that this anomalous region is the result of significant, or indeed any, quantities of buried metal.

Snow cover during the time of the geophysical surveys prevented a detailed visual inspection of the ground surface. Therefore, prior to subsequent invasive investigations of the identified anomalies, it is recommended that ground surface be inspected further to ensure that the anomalous responses are not due to surficial metal.

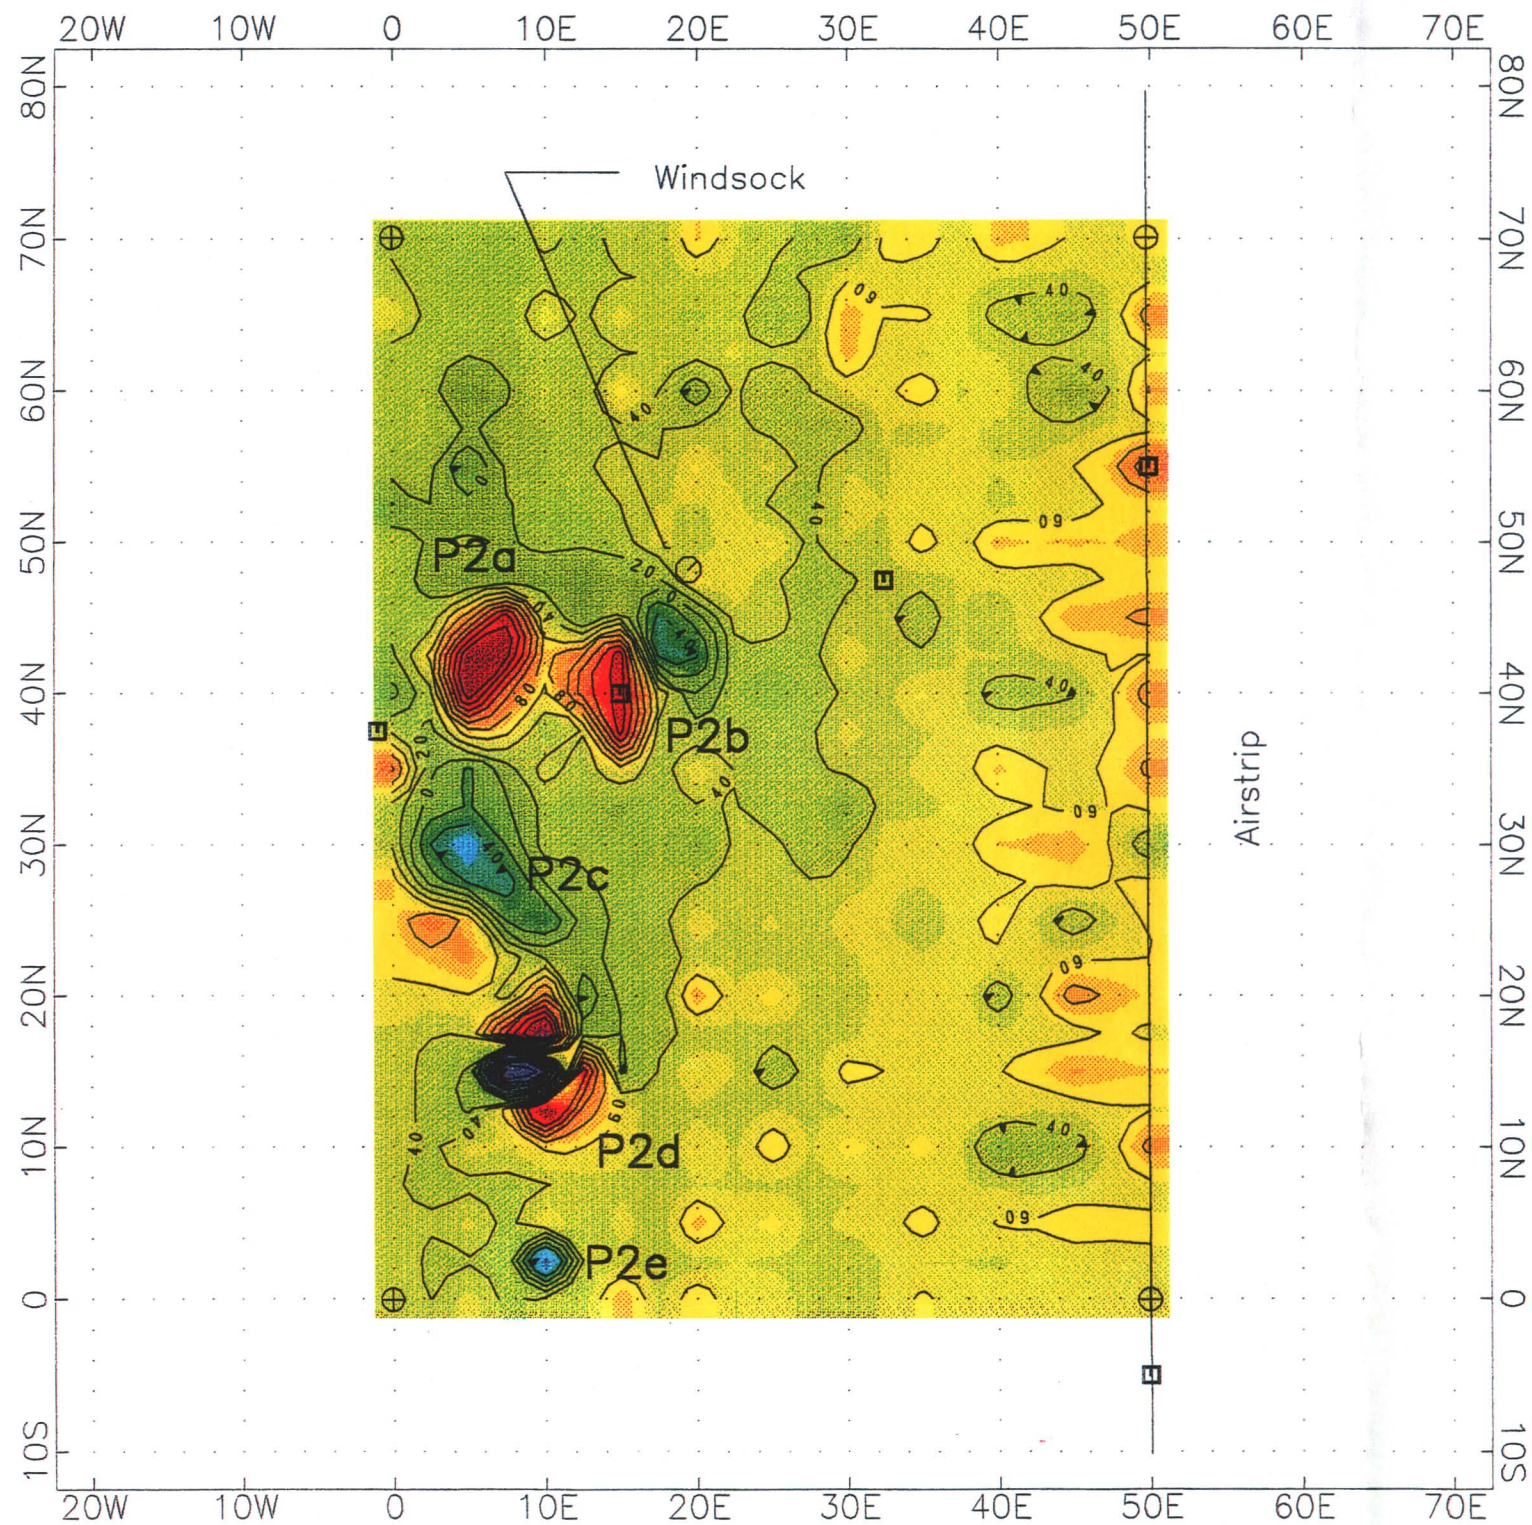
J R PAINE & ASSOCIATES LTD
PRELIMINARY ENVIRONMENTAL INVESTIGATIONS CONTRACT 96-6134 PINE LAKE SITE P2
TOTAL FIELD MAGNETOMETER SURVEY October, 1996 - Figure 2c
ASSOCIATED MINING CONSULTANTS LTD. - PG92

Conditions at Site P2, located immediately adjacent to the existing airstrip (Figure 2a), prevented the use of EM61 survey equipment. Instead, a total field magnetometer survey was conducted, identifying five distinct regions of anomalous response (Figure 2c). Interpretation is as follows:

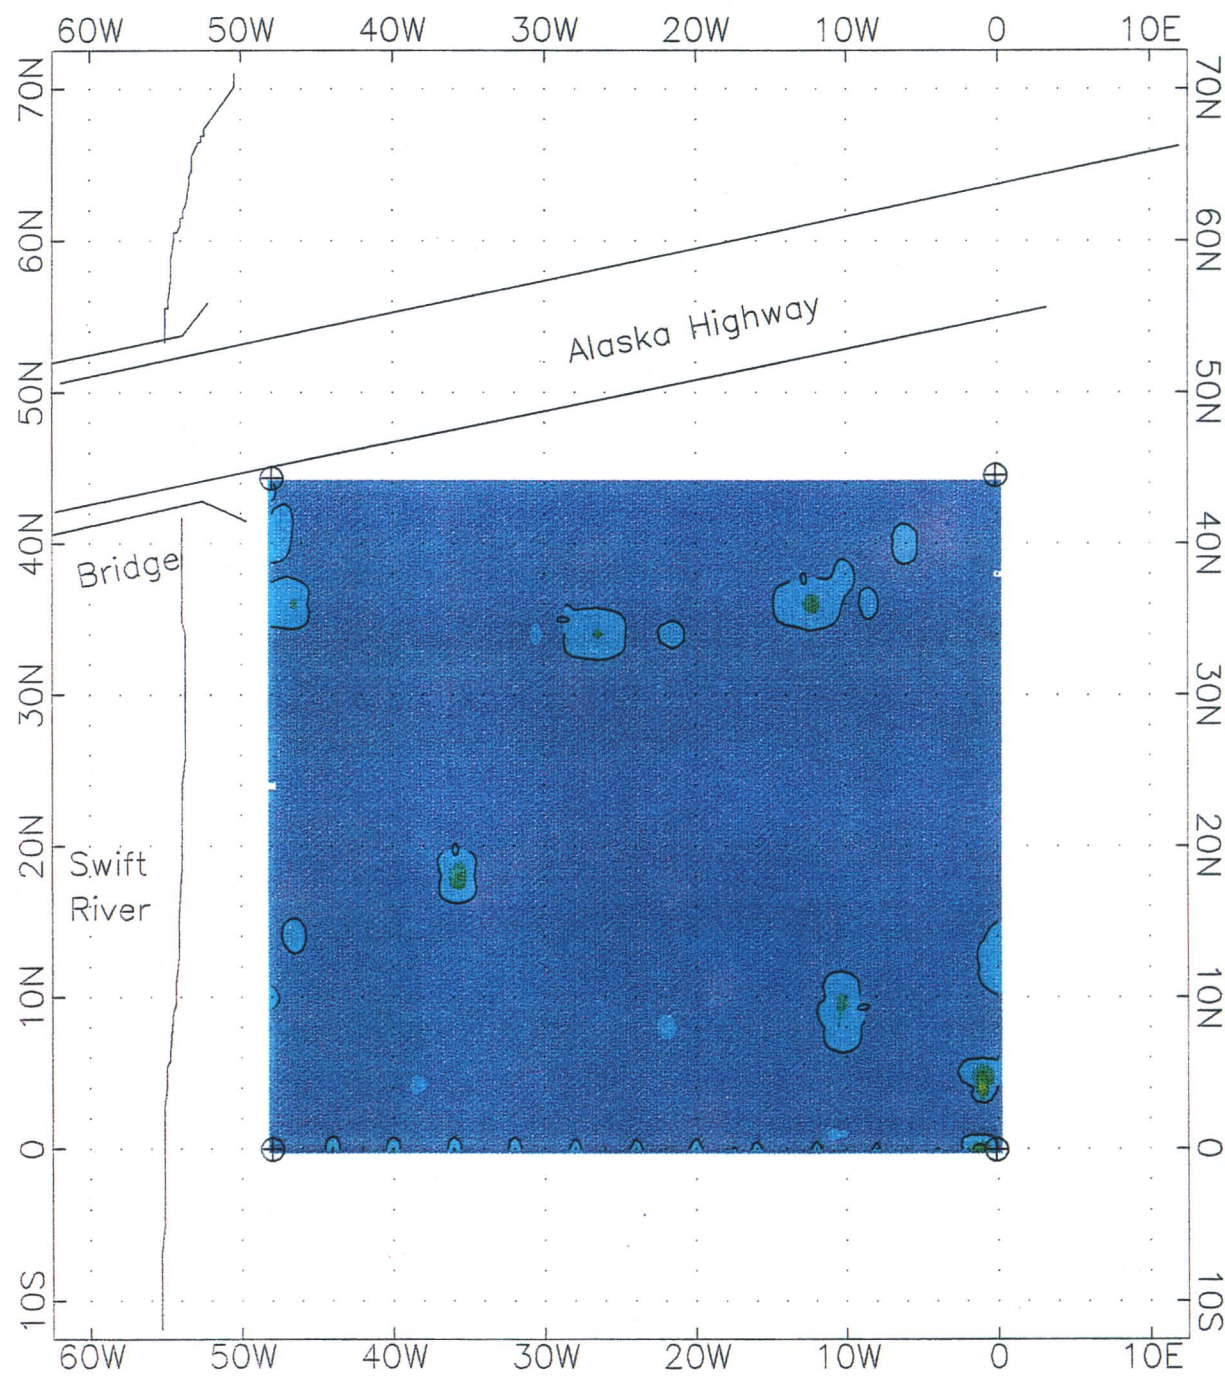
J R PAINE & ASSOCIATES LTD
 PRELIMINARY ENVIRONMENTAL INVESTIGATIONS
 CONTRACT 96-6134
 SWIFT RIVER SITE
 EM61 SURVEY - Channel 2
 October, 1996 - Figure 3b
 ASSOCIATED MINING CONSULTANTS LTD. - PG92

As illustrated by Figure 3b, no evidence of significant buried metal is apparent within the EM61 Channel 2 survey results. Slight increases in electromagnetic response may be attributed to very small metallic articles distributed on surface (ie. small pieces of wire, beverage cans, etc.).

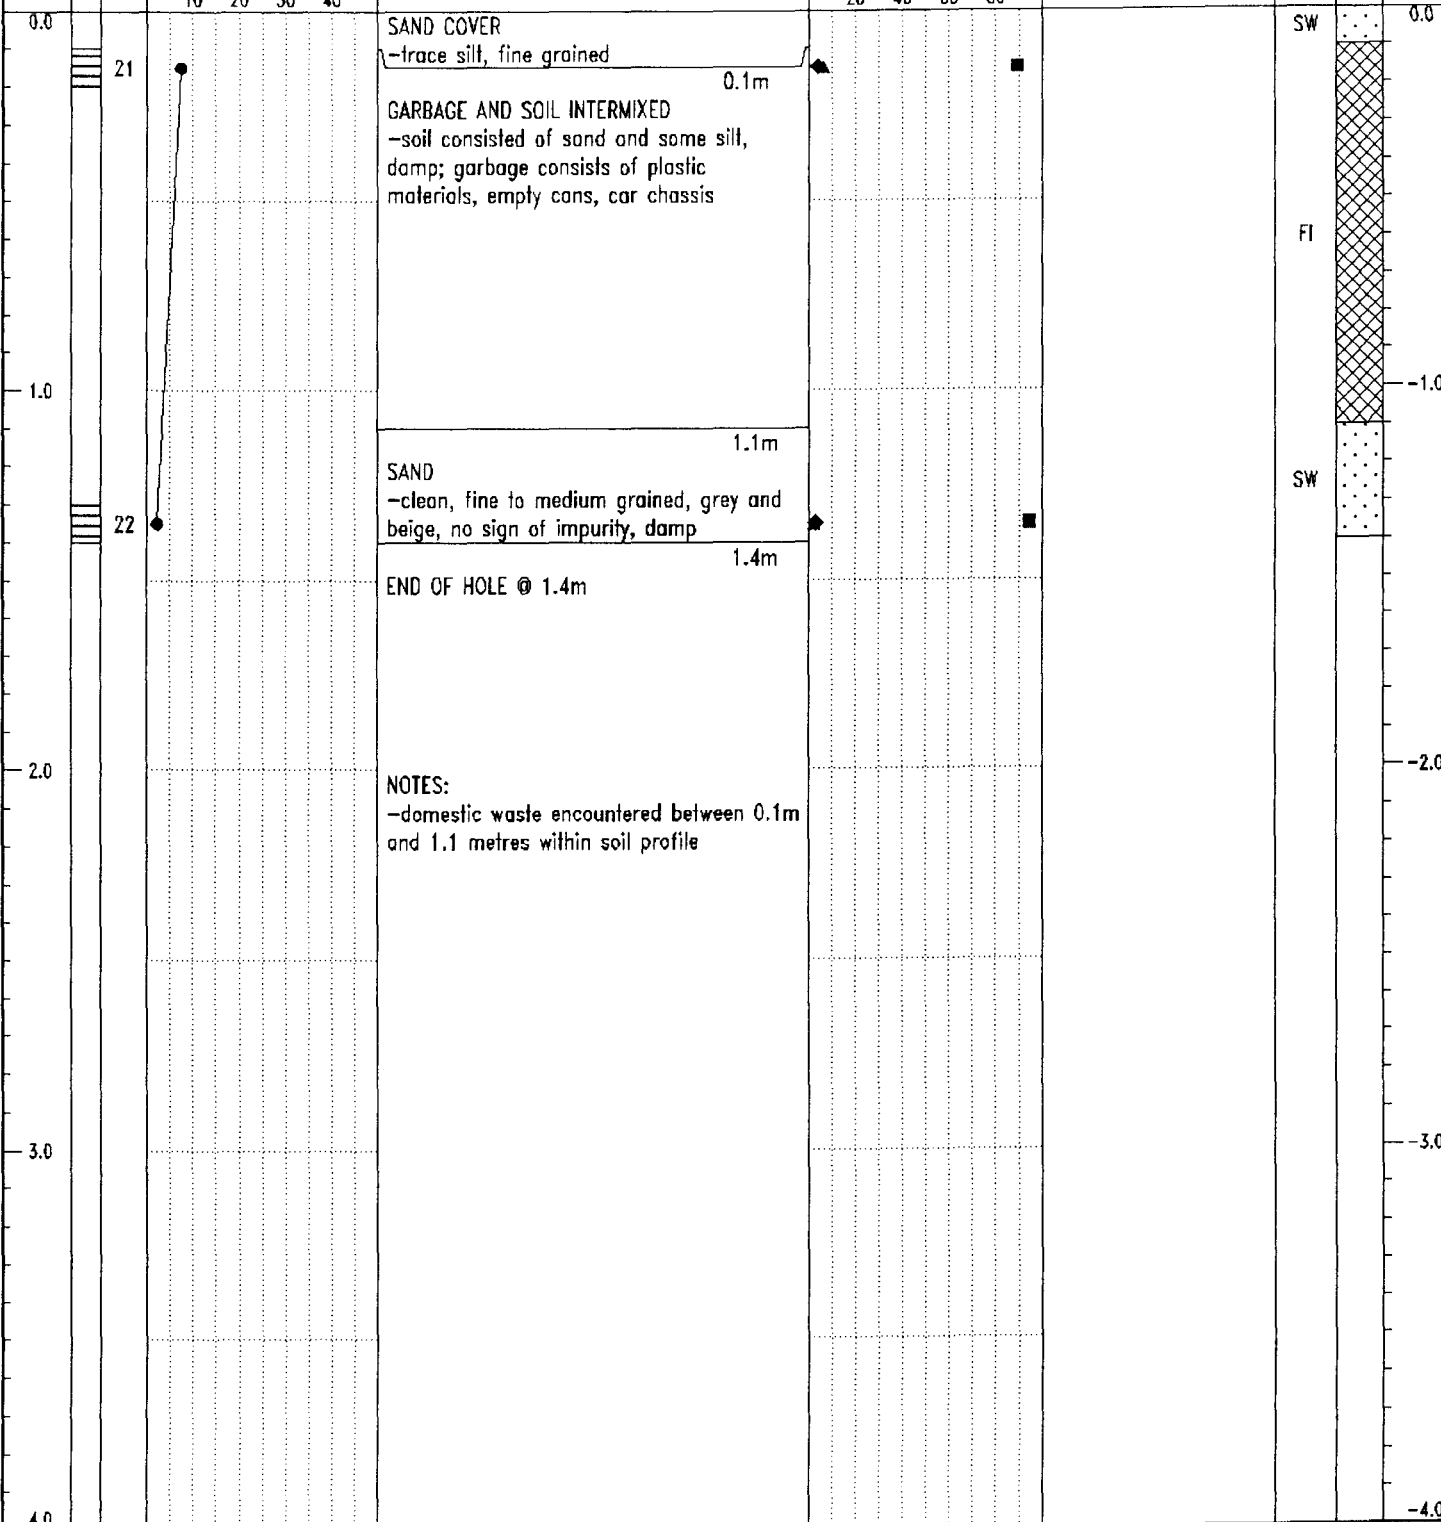
NOTES:
-domestic waste encountered between 0.1m and 1.1 metres within soil profile
