PRELIMINARY ENVIRONMENTAL INVESTIGATIONS
of
EXISTING WASTE SITES
in the
YUKON TERRITORIES

SITE 19 - CRACKER CREEK HJ-33
SITE 20 - CANYON CREEK HJ-34
SITE 42 - HAYES CREEK NORANDA CAMP -CA 35

INDIAN AND NORTHERN AFFAIRS CANADA

FINAL REPORT

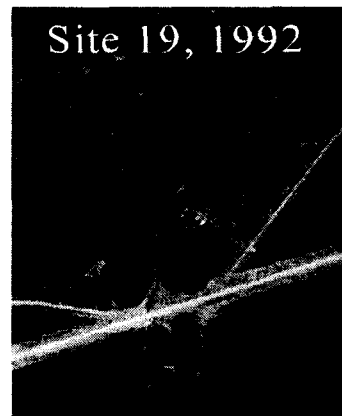
On November 19, 1996, Dr. D. Gregor met with Mr. Jim Coxford, P. Eng., Manager Design and Construction; Mr. Dick Stilwell, P. Eng., Aggregates and Materials Engineer; and Mr. Florian Vedress, Operational Services Manager, all of the Yukon Community and Transportation Services regarding the recent reconstruction of the Alaska Highway at this site. Mr. Stilwell was the engineer in charge of this work. The concern here was with respect to whether or not any waste material was discovered and buried as part of this construction especially as part of the obviously recent filling along the sides of the old right of way. This work was undertaken by a private contractor and Mr. Stilwell indicated that there was no reported excavations of wastes and that the material placed along the old right of way was likely strip material from the new right of way. The old bridge crossing Cracker Creek was collapsed on-site with the steel beams being salvaged as a new culvert was placed just to the west of the old stream crossing resulting in a realignment of the stream channel closer to the natural channel. This is evident in the changes shown in Figures 6a and b.

Figure 6: Airphotos of Site No. 19, Cracker Creek site in 1964 (a) and 1992 (b) showing the general location of the waste sites relative to the Cracker Creek crossing of the Alaska Highway and the Boland property

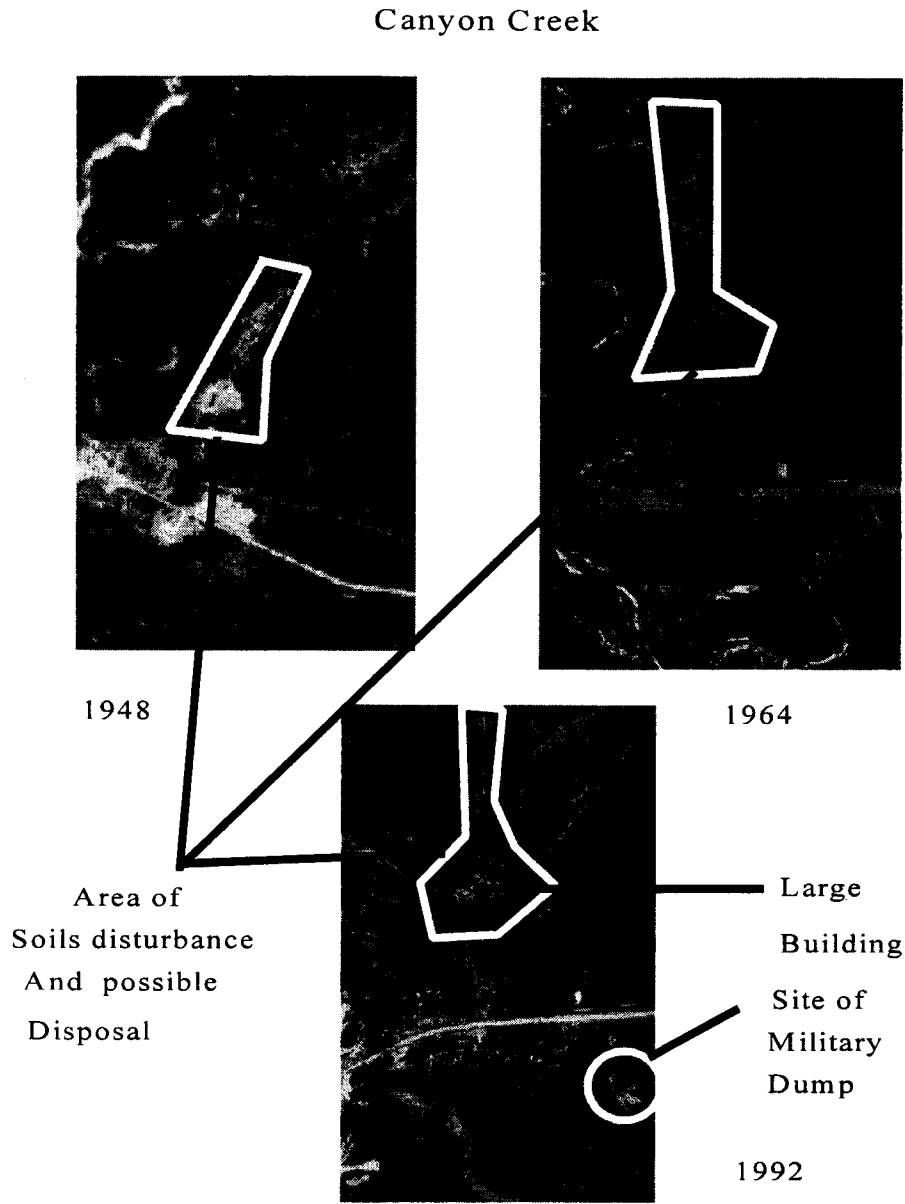
Figure 8: Comparison of airphotos of Site No. 20, Canyon Creek east area showing the area of excavation on the north side of the Highway and adjacent to the east bank of the Aishihik River and the military dump site in 1948, 1964 and 1992.

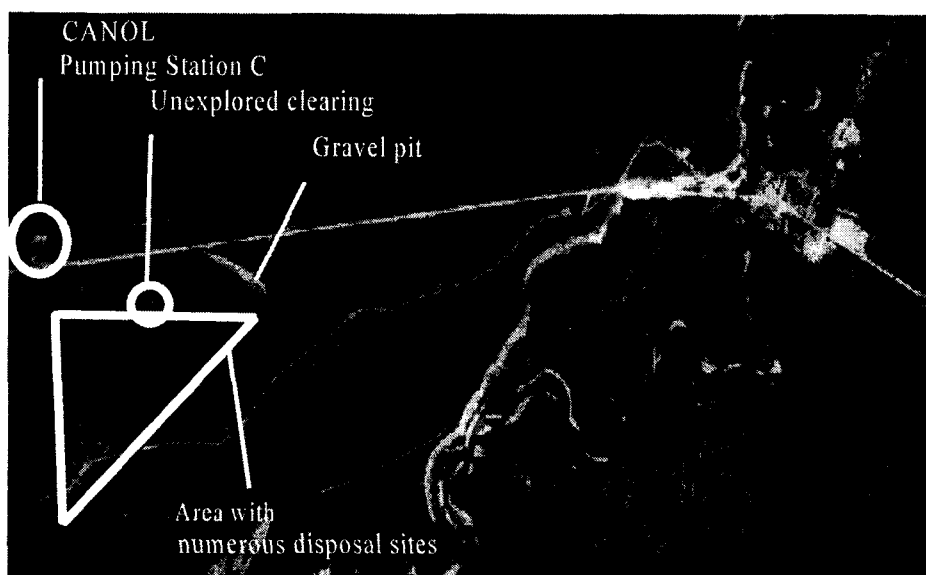
this triangular area we have noted a large cleared area approximately 0.5 km from the present Highway and about equidistant between the two trail access points to the Highway. We did not

inspect this site and we believe that it is a natural clearing as there is no evidence of trails into the site. Nonetheless, we recommend that this be confirmed through a quick visual inspection when the snow is gone.

Figure 9: 1948 airphoto of the Site No. 20, Canyon Creek west area showing the CANOL Pumping Station C site and associated area with numerous waste disposal sites, unexplored clearing and active gravel pit
