**1997 Environmental Investigations along the
Canol Road**

Prepared For:
Ross River Dena Council

Prepared By:
Gartner Lee Limited

May, 1998

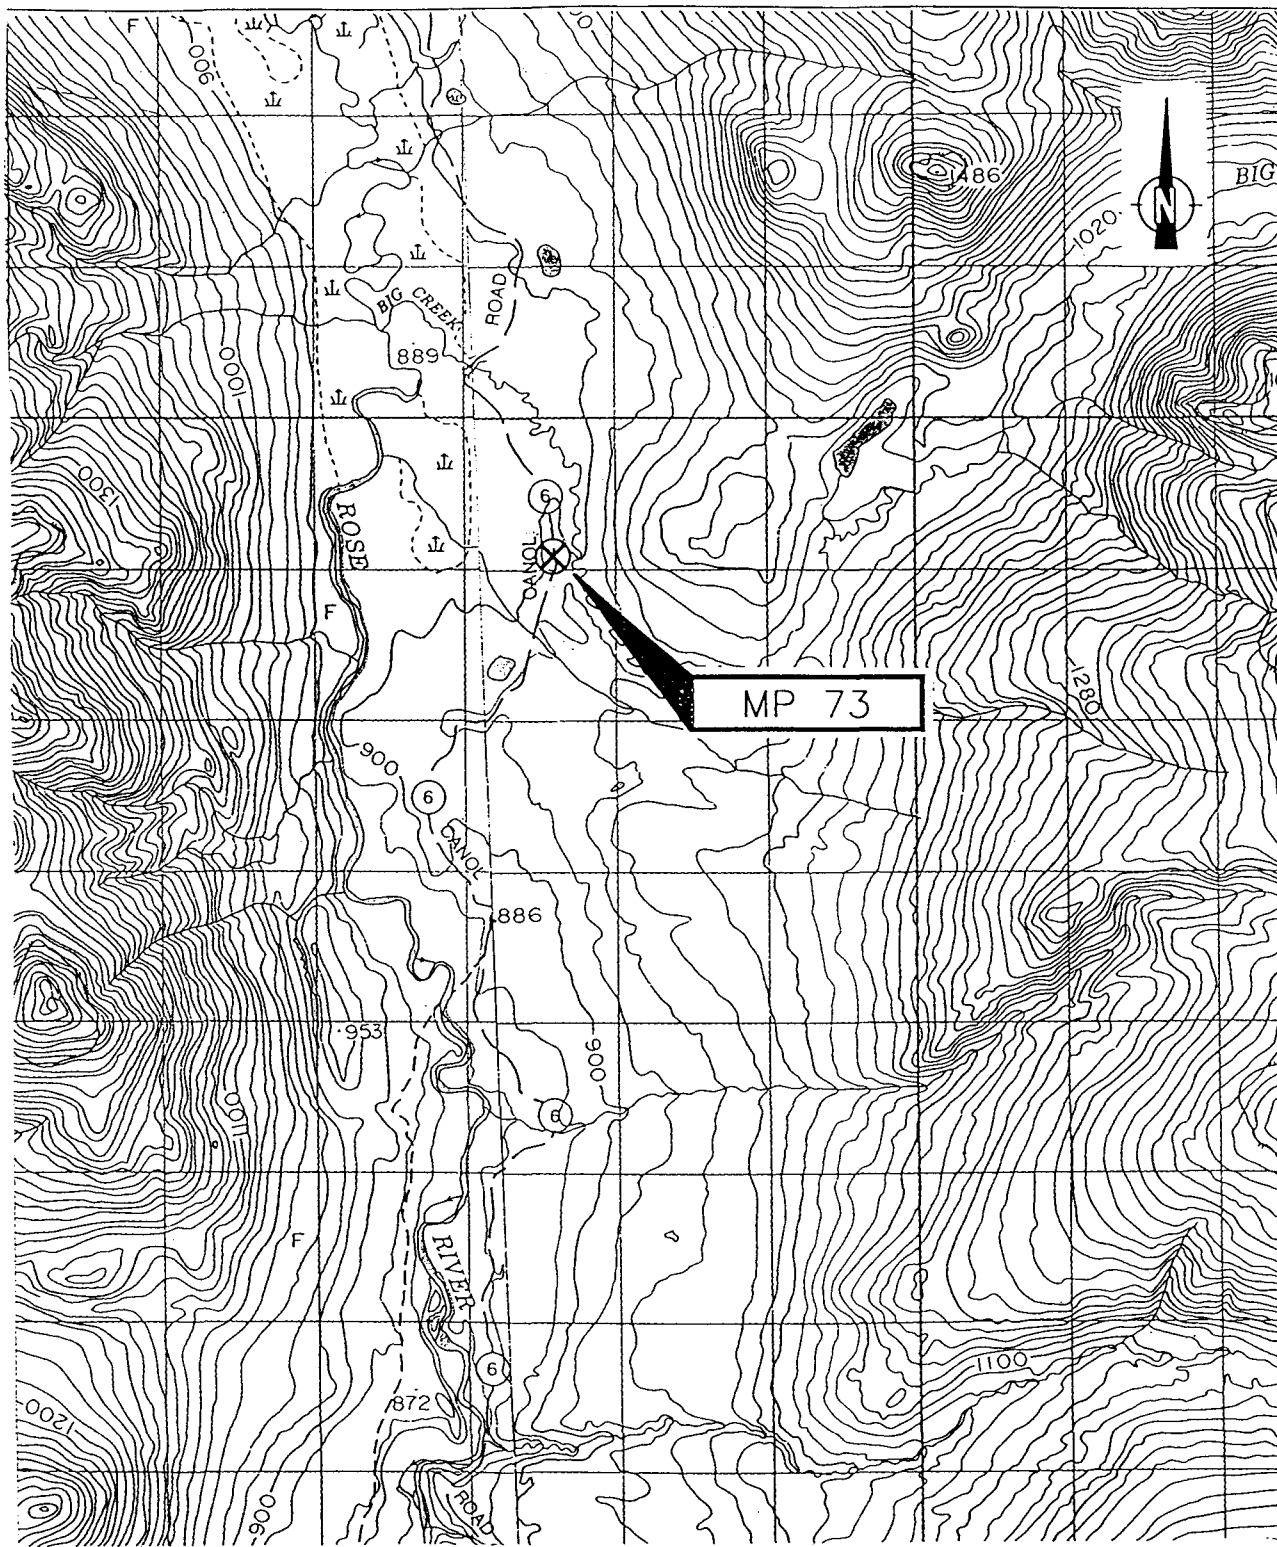
1. soils in excess of 2 m in depth around the POL tank site (Area A in Figure 4) have been impacted by petroleum hydrocarbons at concentrations which exceed the Parkland and Industrial criteria;
2. an Underground Storage Tank (UST) is located adjacent to the pump station foundation (Area B in Figure 4) and the soils beneath the tank have been impacted by petroleum hydrocarbons at concentrations which exceed Special Waste criteria;

3. buried refuse, including full cans of oil and crease, are located on the west side of the road in (Area C in Figure 4) and the underlying soils have been impacted with petroleum hydrocarbons at concentrations which exceed the Parkland criteria.

A program of test pitting was conducted around the dump site located west of Canol Road. A series of five test pits were dug in the dump site area (TP 97-3 to TP 97-7) on August 12th. Based upon the pits dug, the dump site was delineated as shown on Figure 4—an area of approximately 350 m² with a depth of material around 1.5 m. This area is much smaller than originally thought, and seems to be centered around TP 96-6 from the 1996 investigation.

Hydrocarbon contamination was found in the dump site (Area C). Two groundwater monitor wells were installed down-gradient of the dump site. There is wetland area west of the dump site that is a potential receptor of contaminants. The locations of the two wells (MW-1 and MW-2) are shown on Figure 4. Wells were installed by excavating a pit, installing Waterra environmental grade PVC monitoring wells, and backfilling the pit.

The dump site area has been defined as shown in Figure 4 with an extent of approximately 25 x 20 m.
Debris has been encountered in test pitting up to 1.5 m below the surface. The dumps site was found to
contain drums of grease and motor oil (Phillip sample ID 97031496). These drums represent potential
sources of contamination since they contain free hydrocarbon product. Soil samples from the dump site

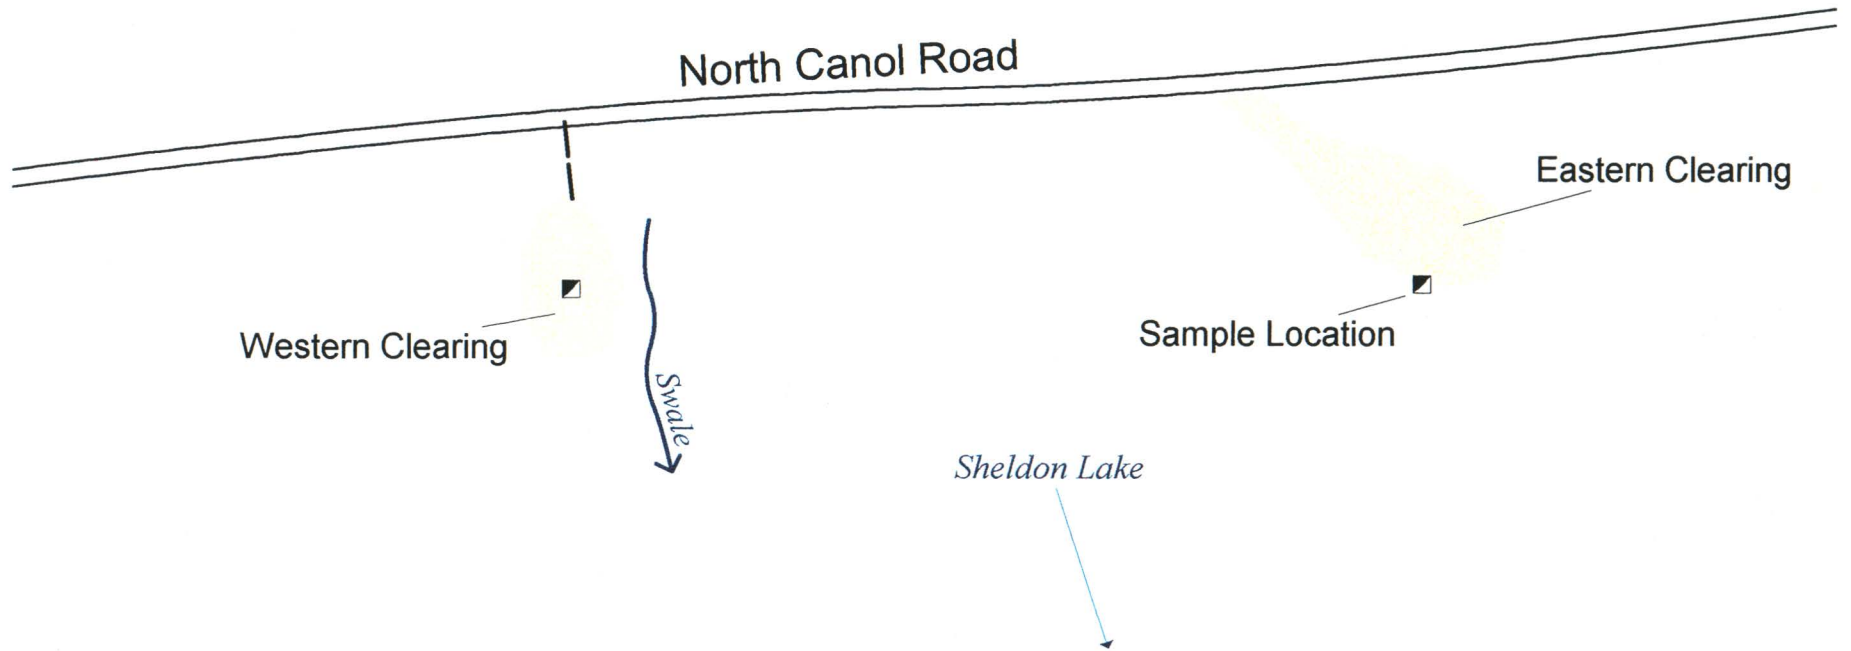
Potential burial sites were reported around MP 220 adjacent the North Canol Road along Sheldon Lake (Figure 17). The site is located on a gentle south facing slope that drains to Sheldon Lake.
