**INDIAN AND NORTHERN AFFAIRS CANADA
ABANDONED CLINTON CREEK
ASBESTOS MINE
1998 SITE RECONNAISSANCE**

APRIL, 1999

**PREPARED BY
UMA ENGINEERING LTD.
ENGINEERS AND PLANNERS
1479 BUFFALO PLACE
WINNIPEG, MANITOBA
R3T 1L7**

Reference: Abandoned Clinton Creek Asbestos Mine – 1998 Site Reconnaissance

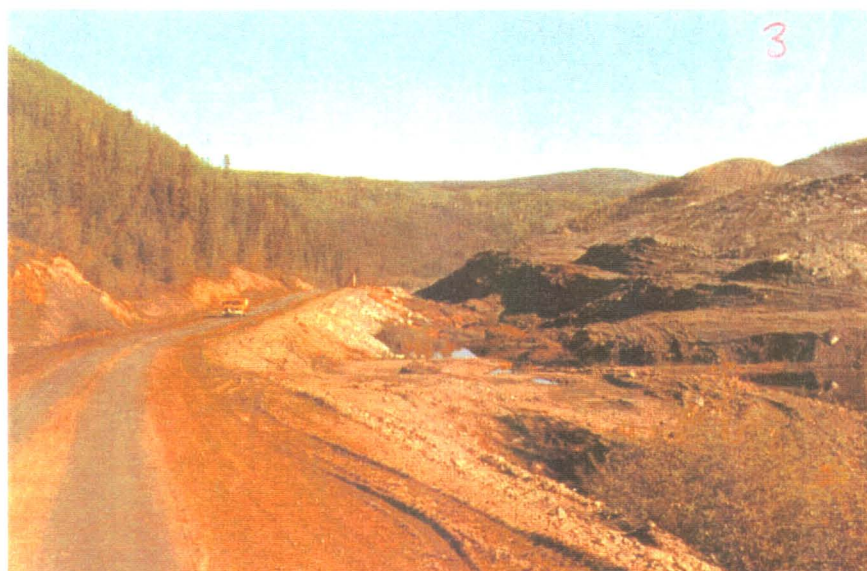
Photo CC-03: Access Road Along North Side of Clinton Creek (about 1974)

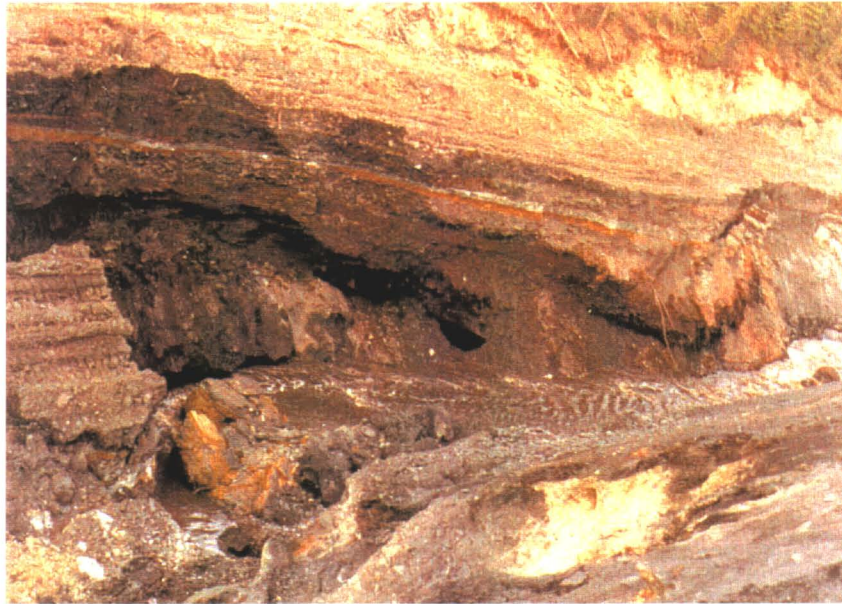
No photographic or written records are available from when the mine first opened until the waste rock dump forced the alignment of Clinton Creek against the north valley slope and ultimately impounded Hudgeon Lake. Photo CC-02 is the earliest available photograph of Hudgeon Lake, looking east at the waste rock dump, lake outlet, and the creek channel. Initially (1974), the creek channel flowed between the waste rock dump and the mill access road located on the north valley slope (Photo CC-03). However, as the water level in Hudgeon Lake increased, the unprotected channel eroded (down-cut) and migrated laterally to the north, eventually washing out the road (Photo CC-09).

Photo CC-09: Erosion of Access Road on North Side of Creek (1975)

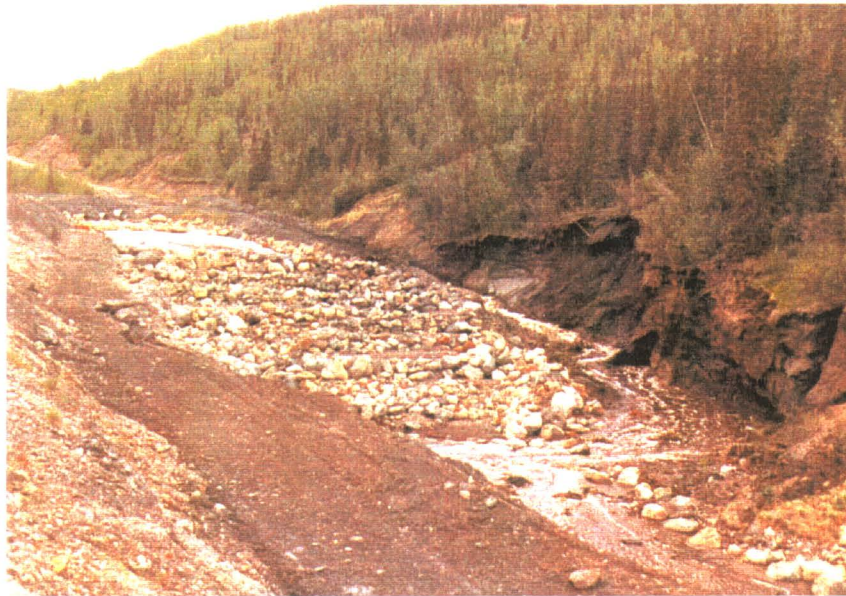
During the summer of 1979, an attempt was made to reduce channel erosion and undercutting by constructing rock weirs and armouring the banks of the channel immediately downstream of the lake outlet. Over the next few years, however, the creek flow bypassed the rock weirs on the north side causing significant erosion (Photo 3 Hardy Associates Ltd, July 1982). By 1983, channel flow had completely bypassed the weirs substantially increasing valley slope erosion as seen in Photo 3 (Klohn Leonoff, August 1983).

Photo 3: Creek Bypassing Weirs (1982)

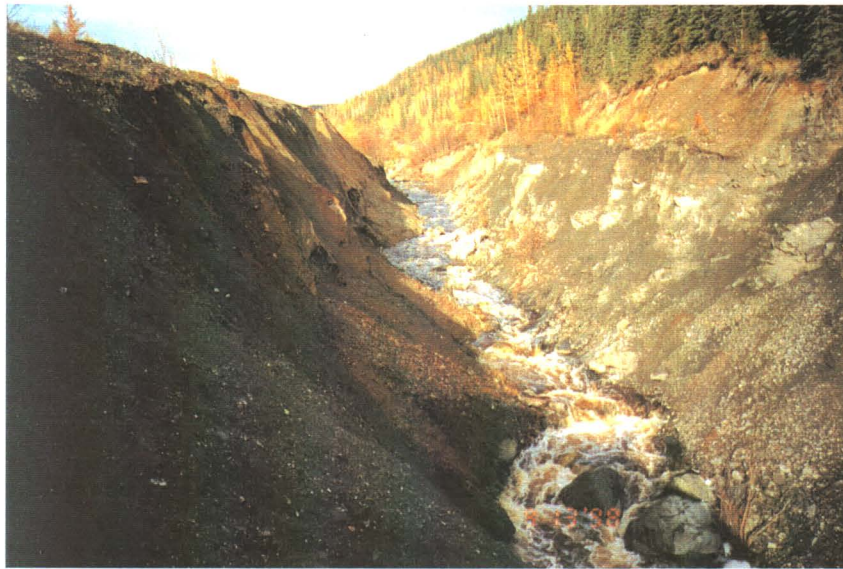
UMA Photo 7-17: Channel Erosion (1998)
