**A Preliminary Environmental Investigation
of Site HJ034 - Canyon Creek**

D. B. Craig, Consulting Engineer
and
W. J. Klassen and Associates Ltd.

February, 1998

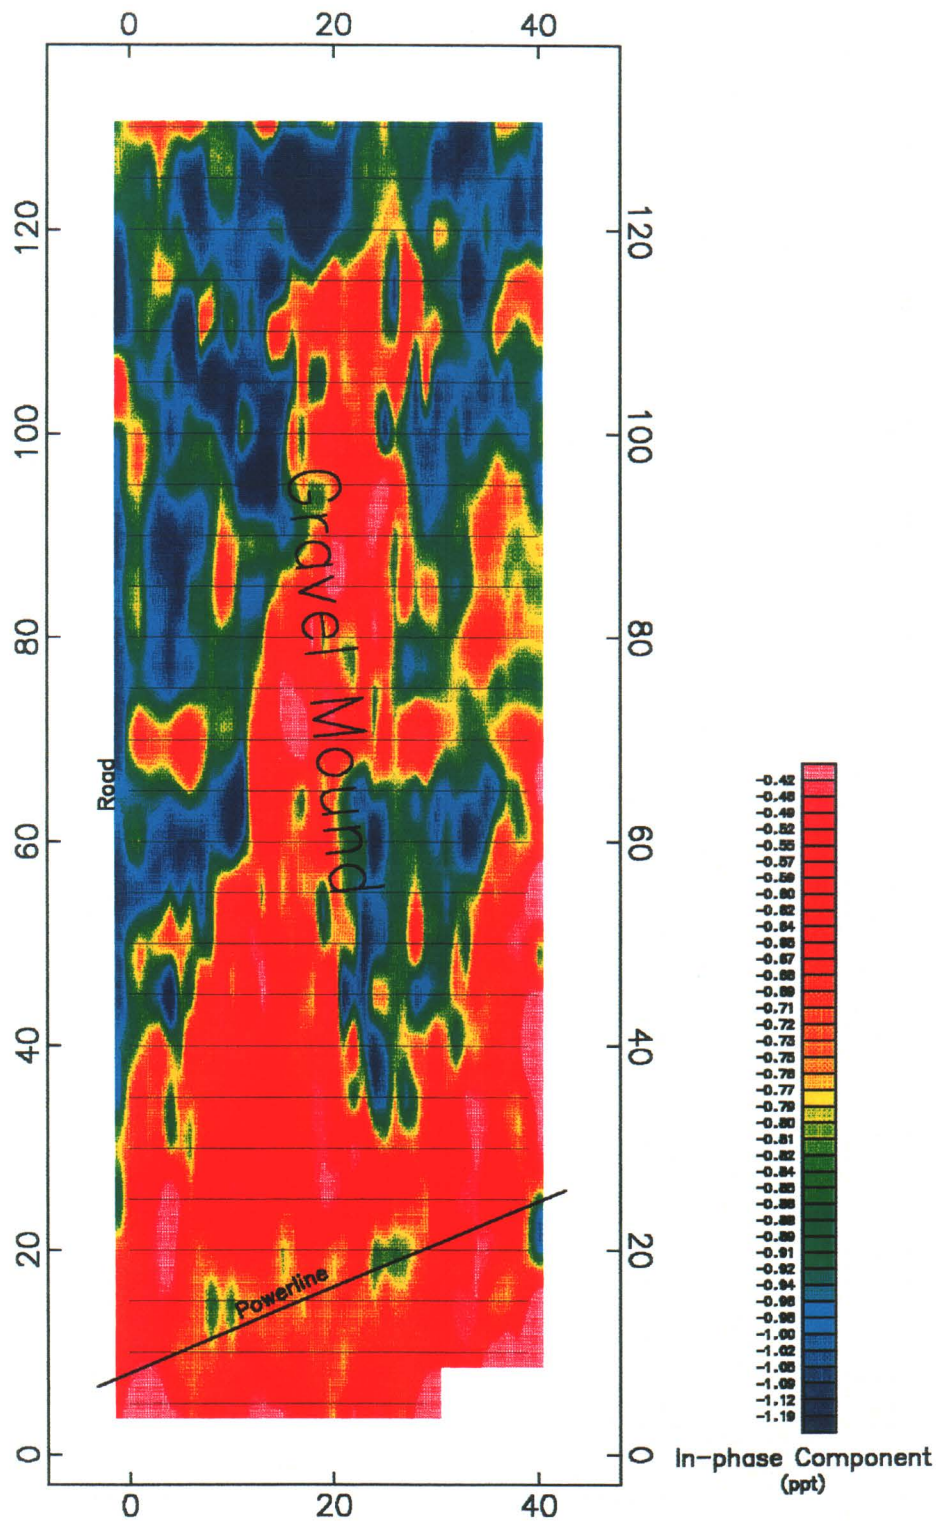
Figure 1b: Canyon Site MDA-1A
In-phase Component

Figure 1b represents the inphase component of the electromagnetic field measured over the site. As stated earlier, this is considered the “metal detecting” mode of the EM31. Similar to Figure 1a, a linear feature which is correlative to the mound is seen in the data, yet no major

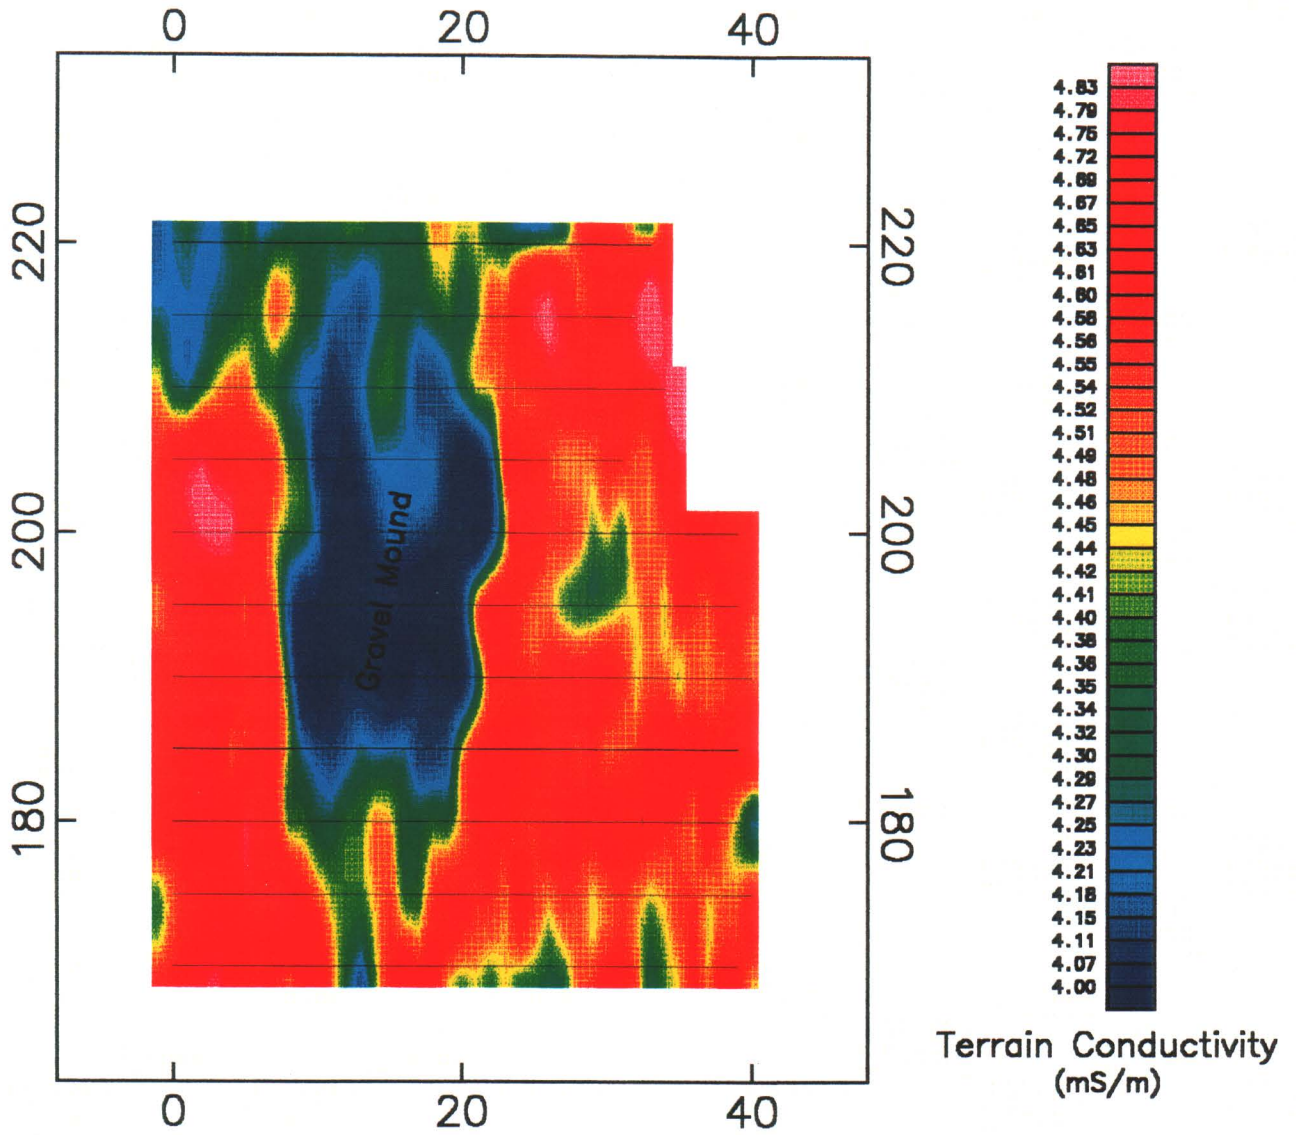
Figure 2a: Canyon Site MDA-1B
Terrain Conductivity

The terrain conductivity of Site MDA – 1B is shown in Figure 2a. In this Figure, the gravel mound which was the target of the survey is clearly visible. The mound shows as a low conductivity feature, with conductivities in the low 4 mS/m range, versus the surrounding alluvial silts and sands in the 4 to 5 mS/m range. This is a very subtle variation in terrain conductivity, and no metallic anomalies were interpreted at this site.

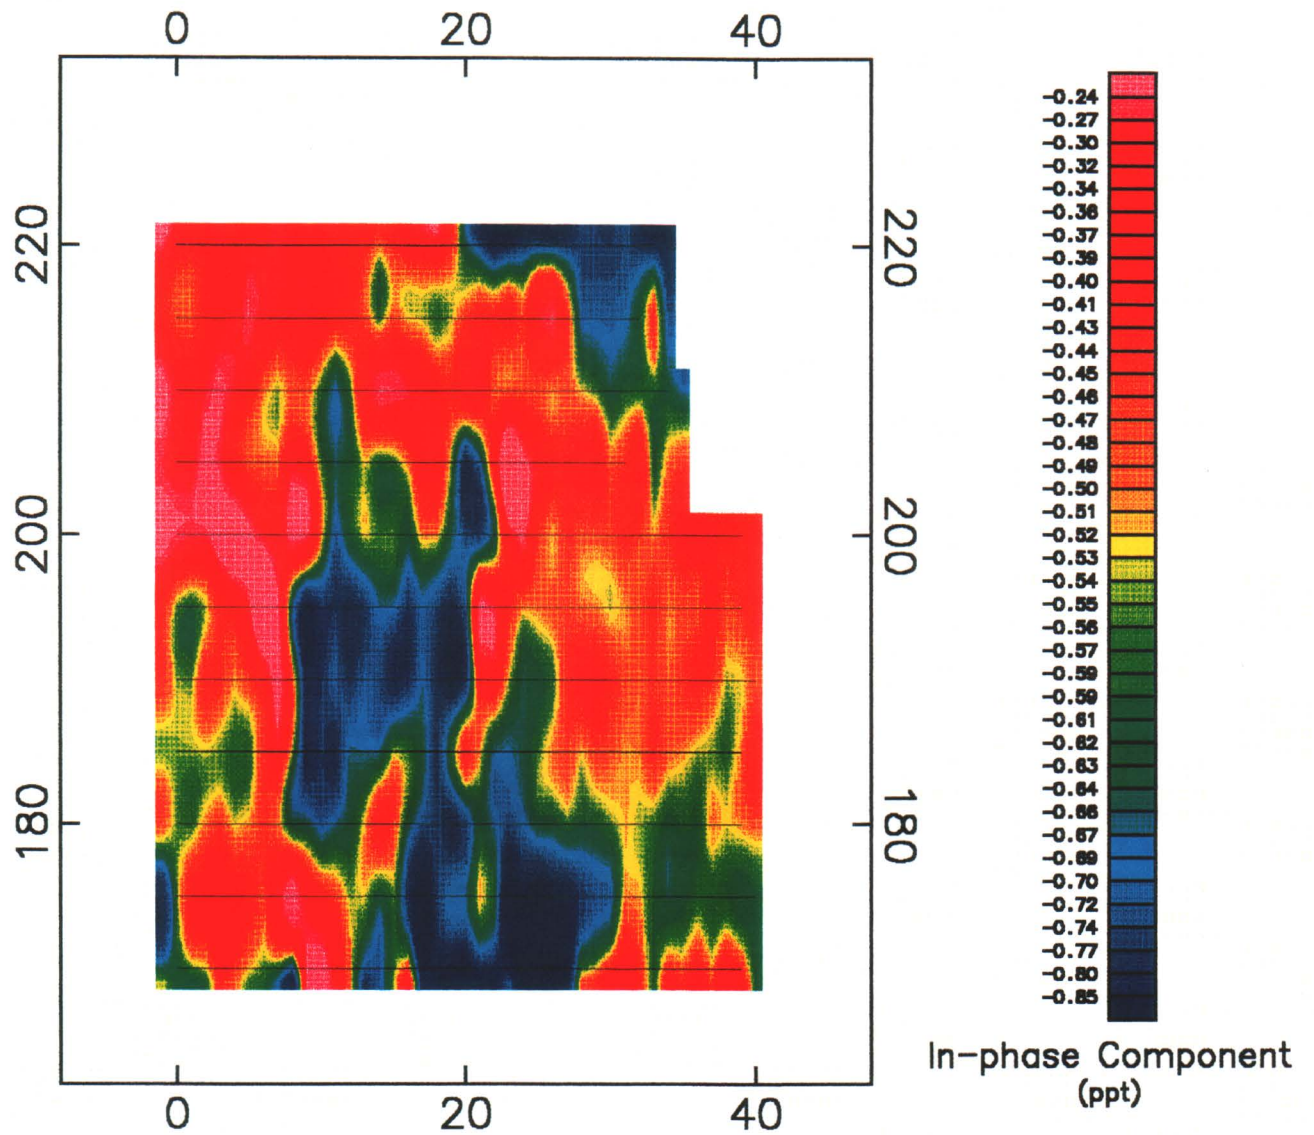
Figure 2b: Canyon Site MDA-1B
In-phase Component

The inphase component for this site is shown in Figure 2b. The data is variable, and shows no major trends, nor significant anomalies that would indicate the presence of buried metal.
