**Inventory of Equipment, Machinery,
Major Fixtures and Hazardous Materials
at the Destruction Bay Pumping Station,
Yukon Territories.**

**Prepared for
Indian and Northern Affairs Canada**

August, 1998

**Prepared by
Arctic Environmental Services Ltd., and KO KEN General Contractors**

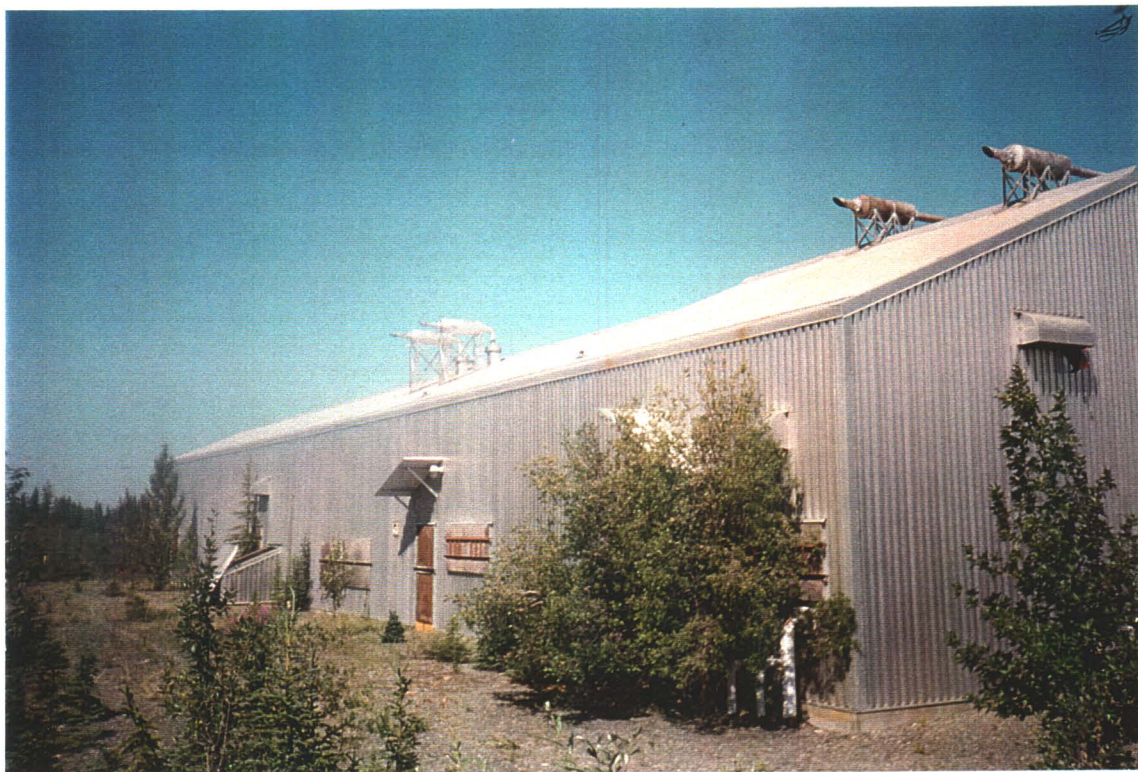
Main Building. Pipeline entry/exit lines.

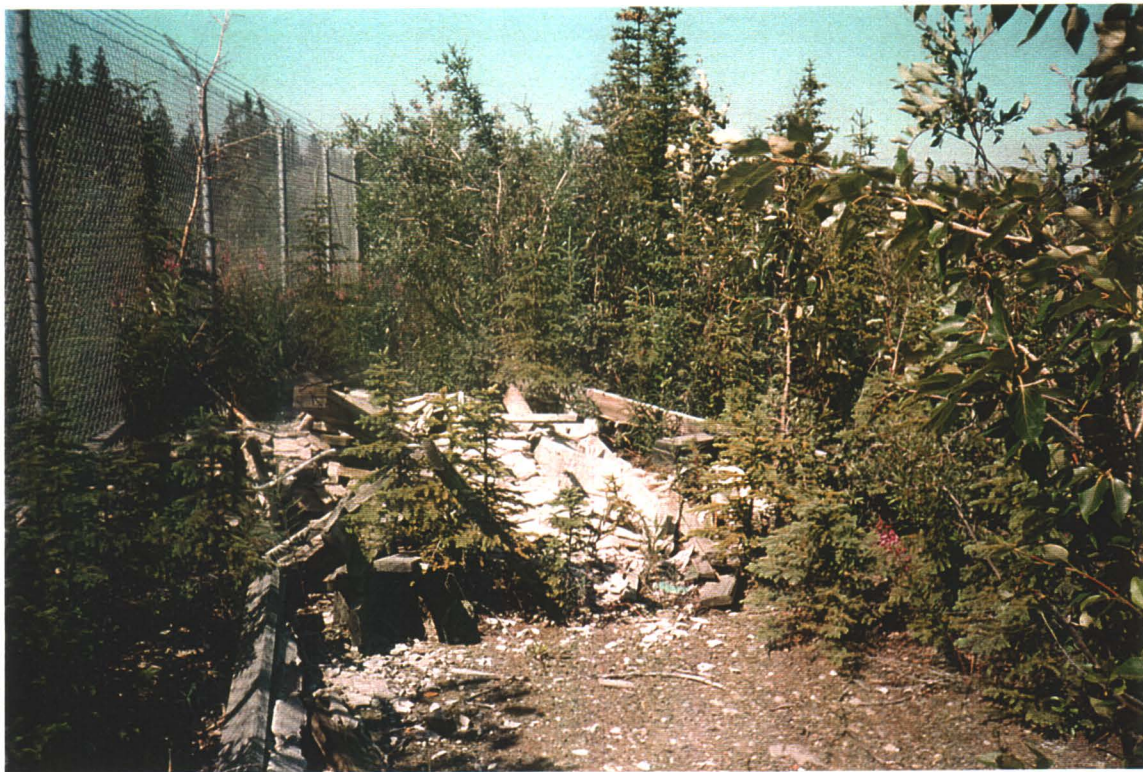
Debris pile back of Main Building

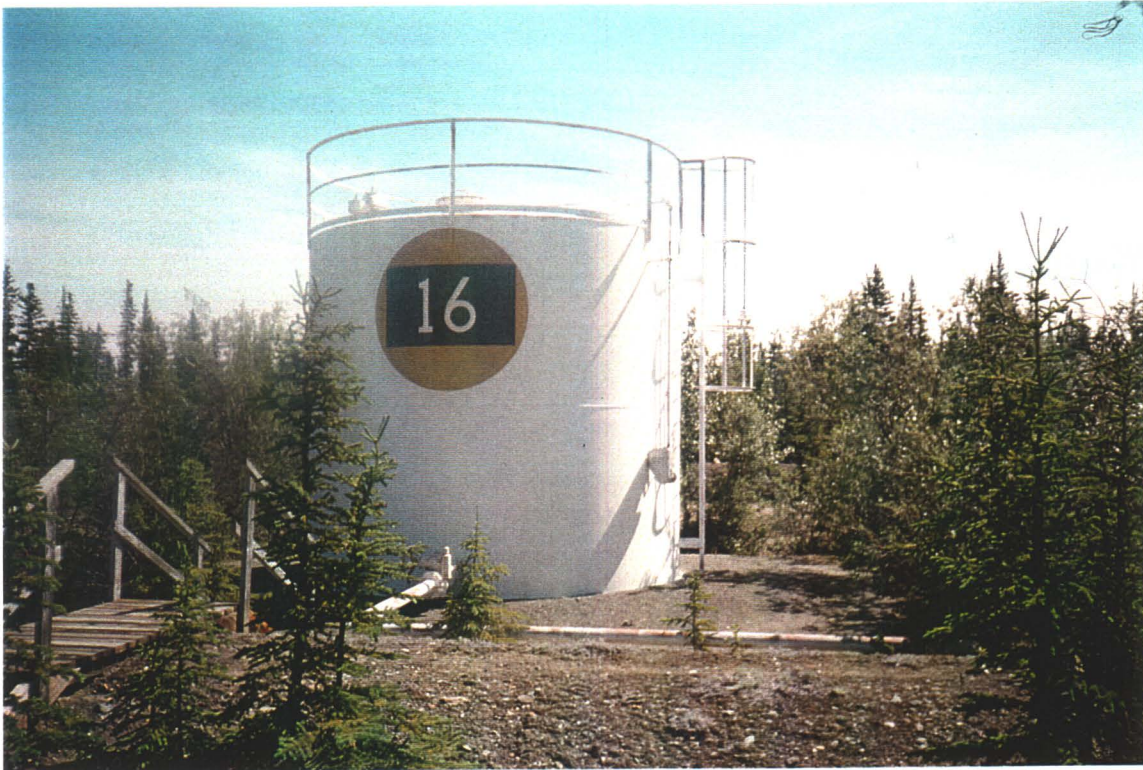
300 barrel tank, cleaned and inspected March 18, 1968

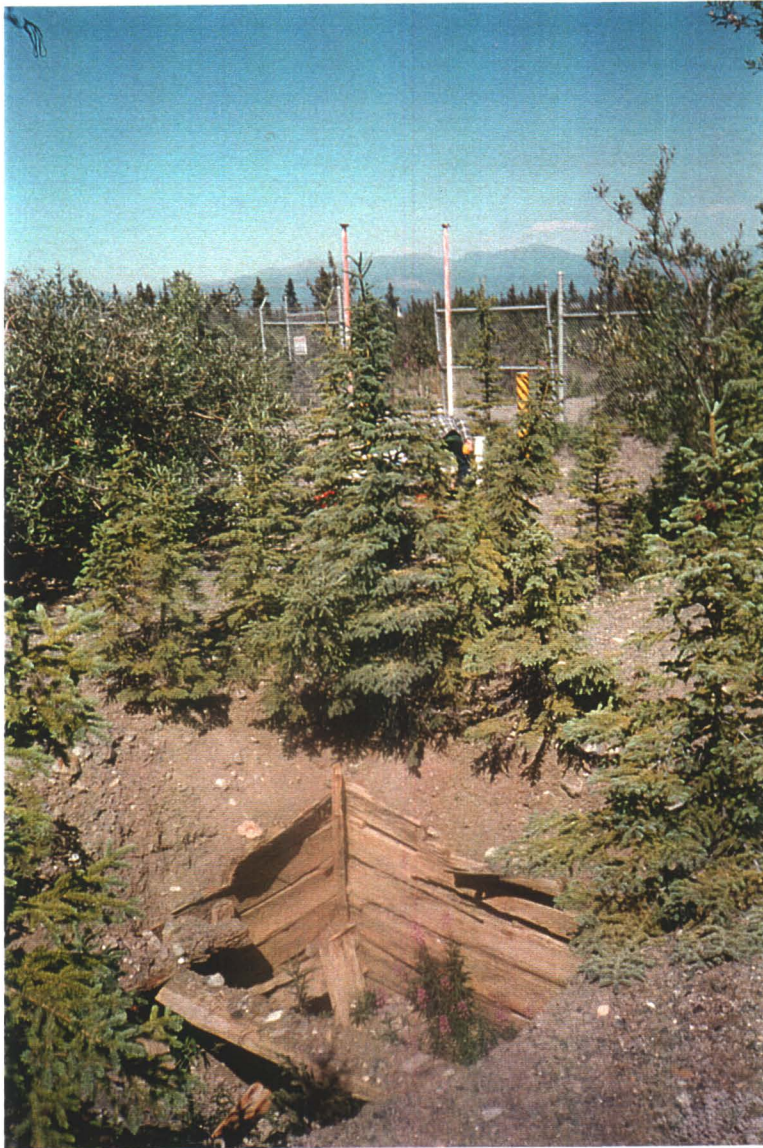
Pit area between bulk product tanks and UST's

- Two underground storage tanks remain on site and should be removed and properly disposed of.
- Old foundations and pumphouse structure should be removed.

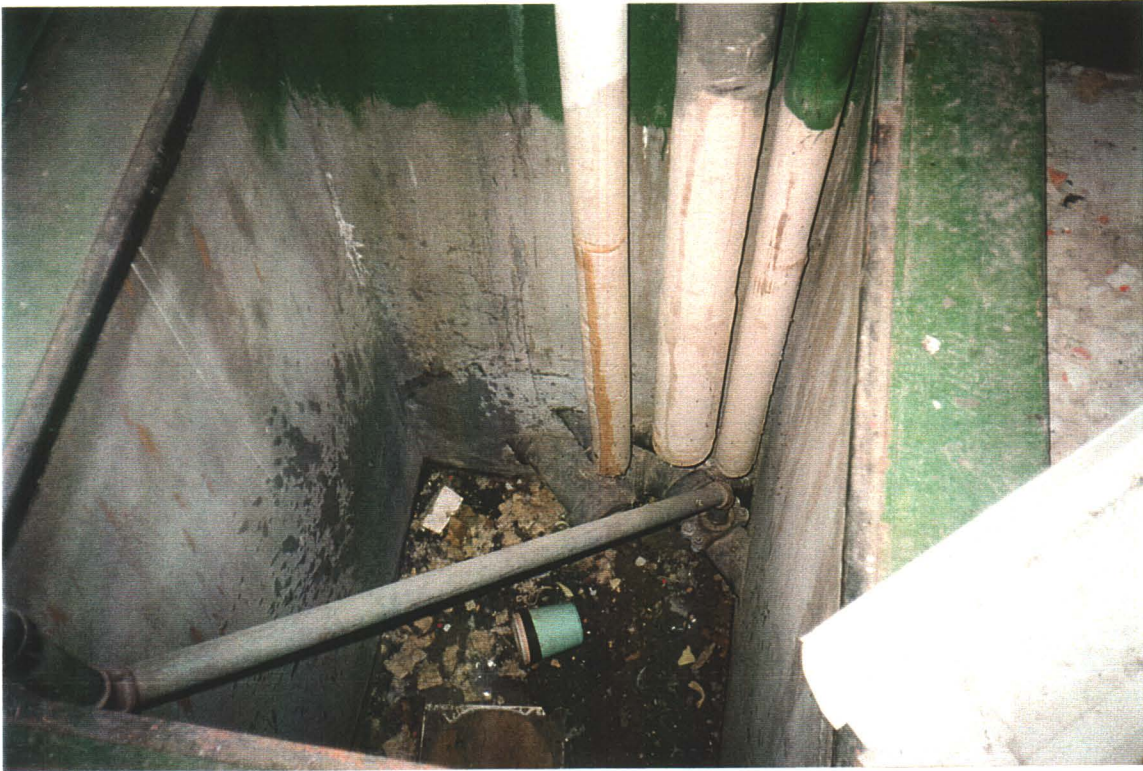
Boiler Room. Steam, sewer, and water lines leading out to former housing area. Condensate return line returns back to boiler room.

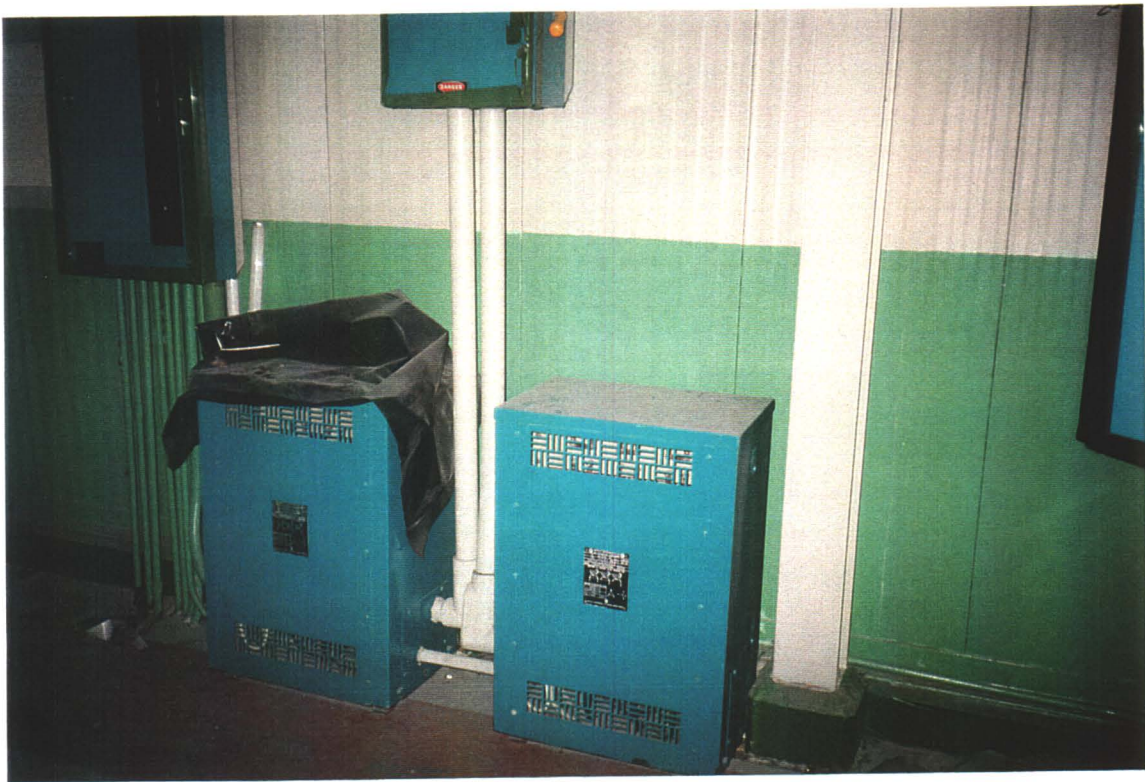
Generator Room. Transformers (dry type)

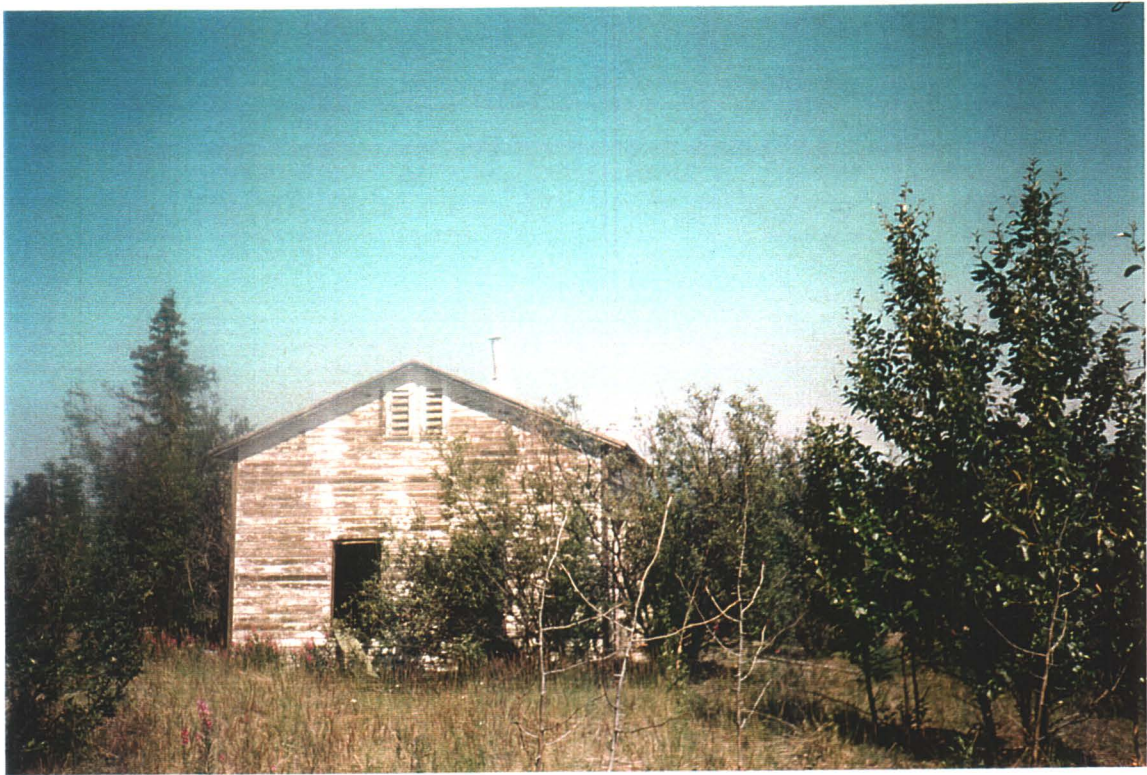
Pump House building. Exterior

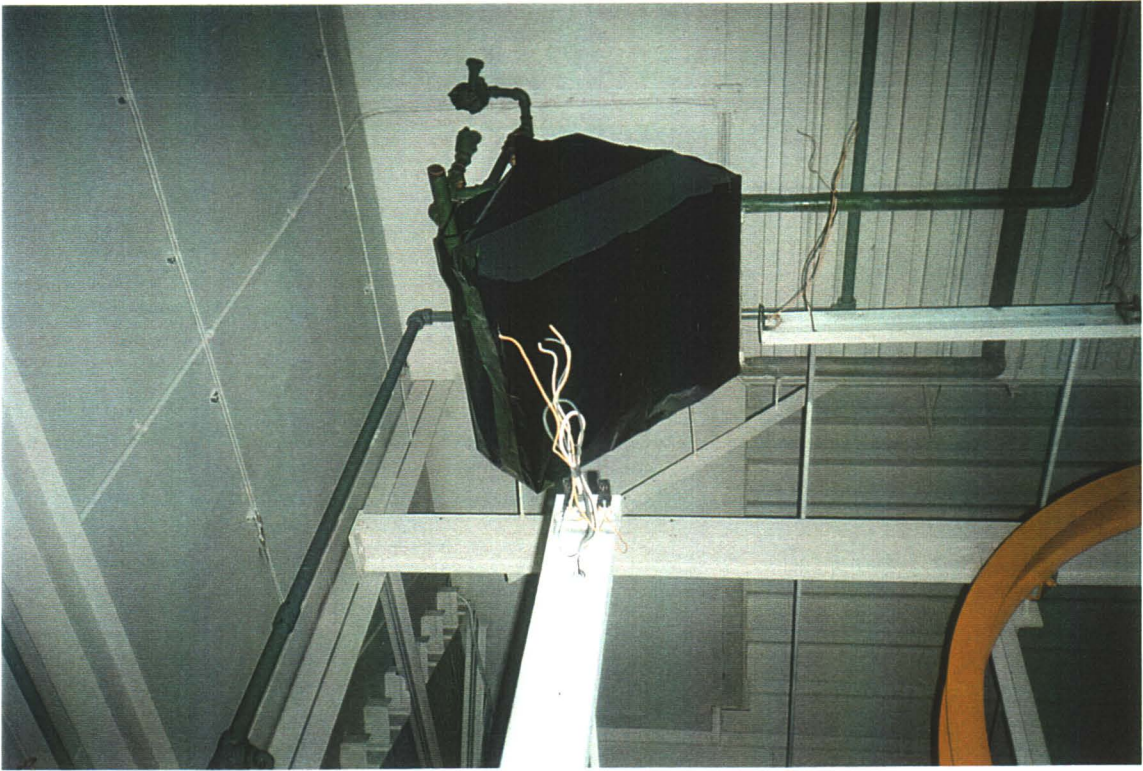
Engine Room. Typical overhead heater device used throughout the building.

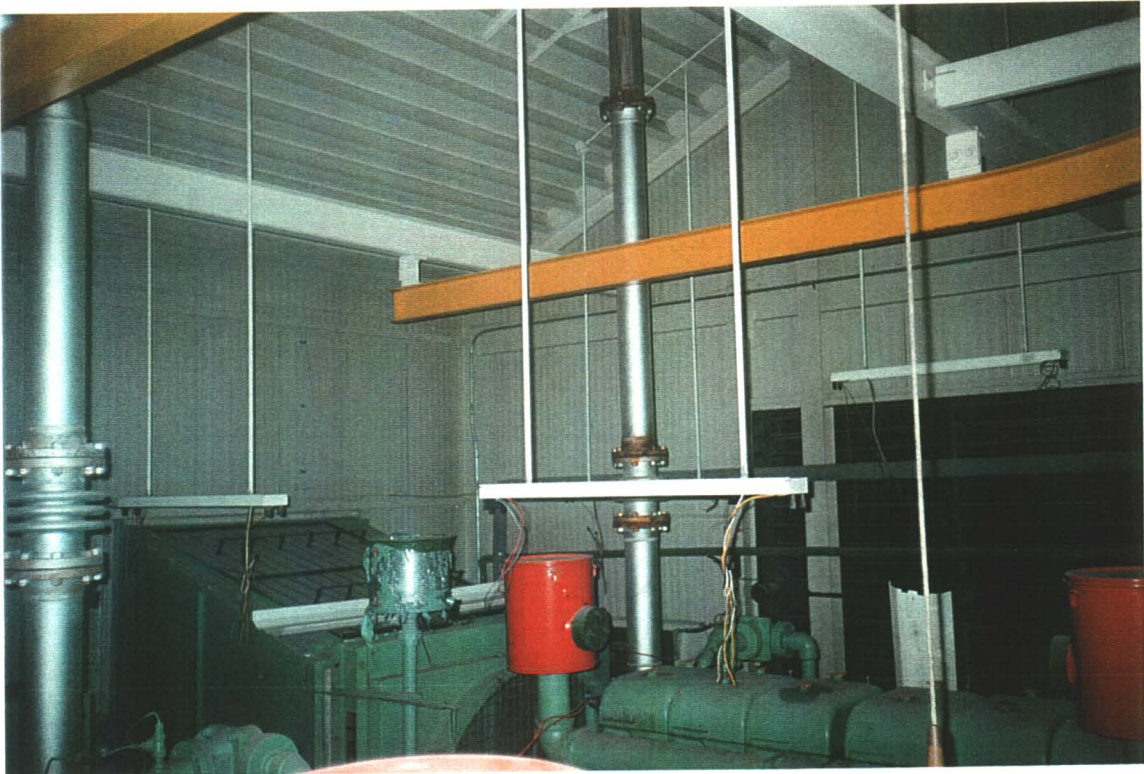
Engine Room. Typical building metal siding/roof structure.

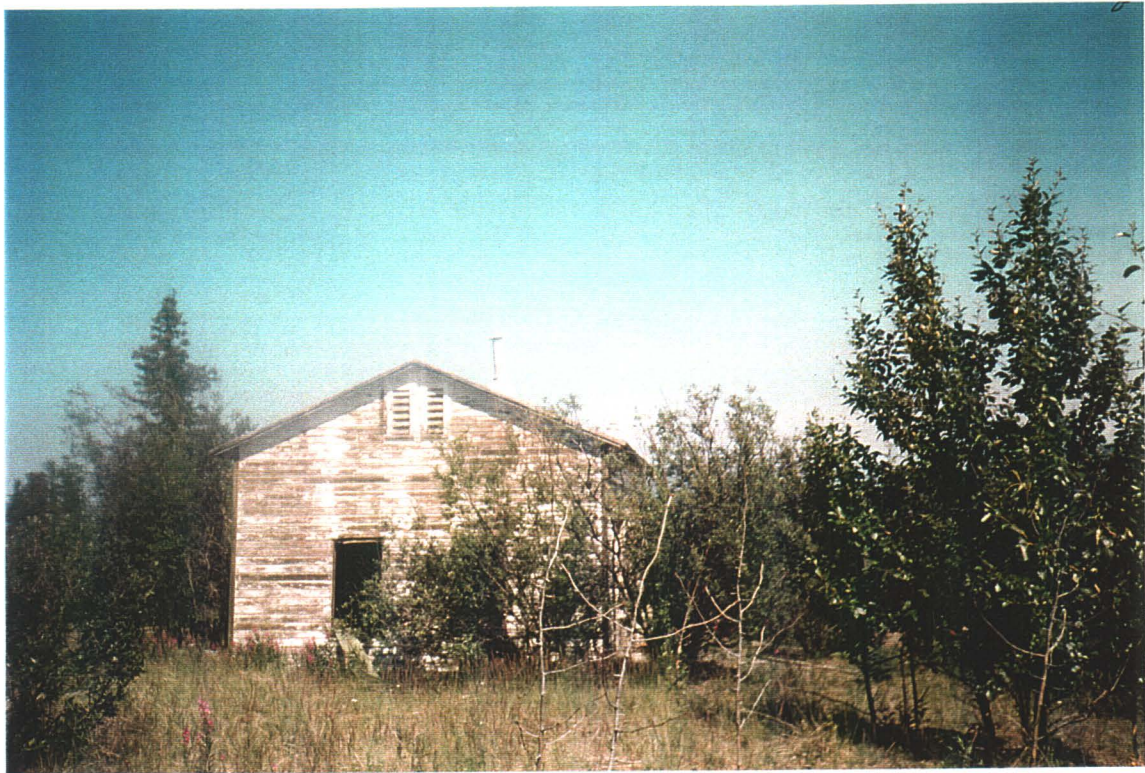
Pump House building. Exterior

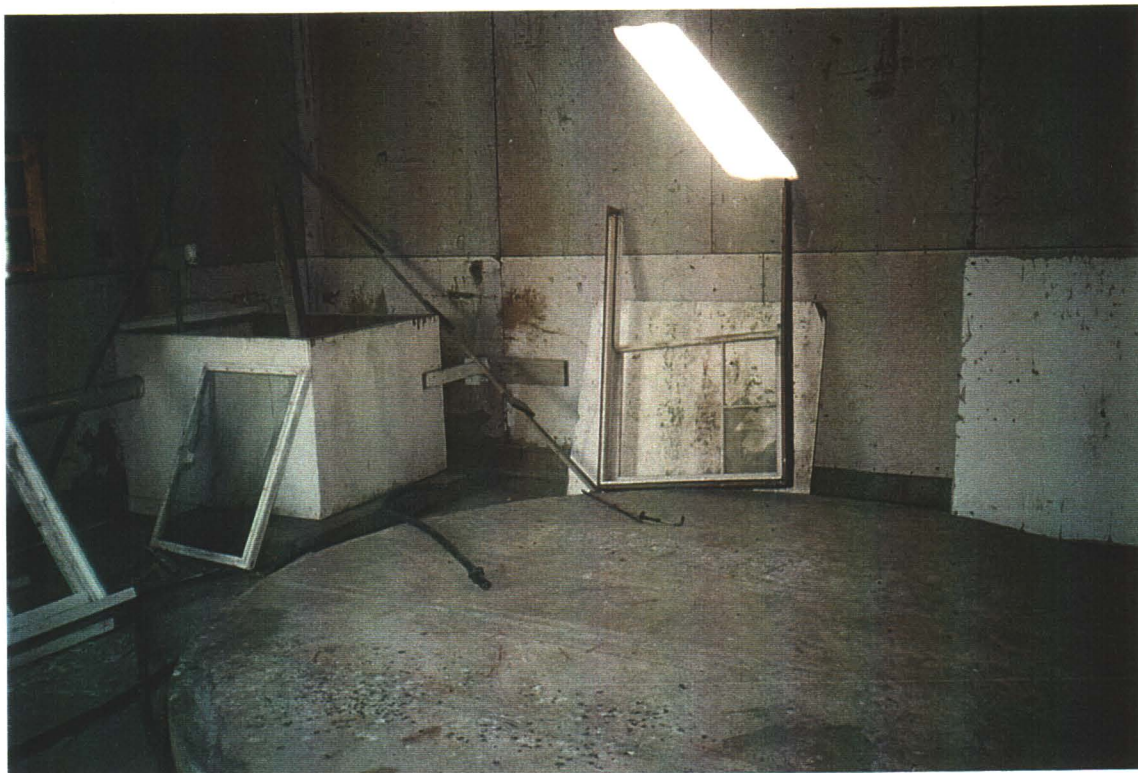
Pumphouse Building interior. Note significant concrete pad structure.

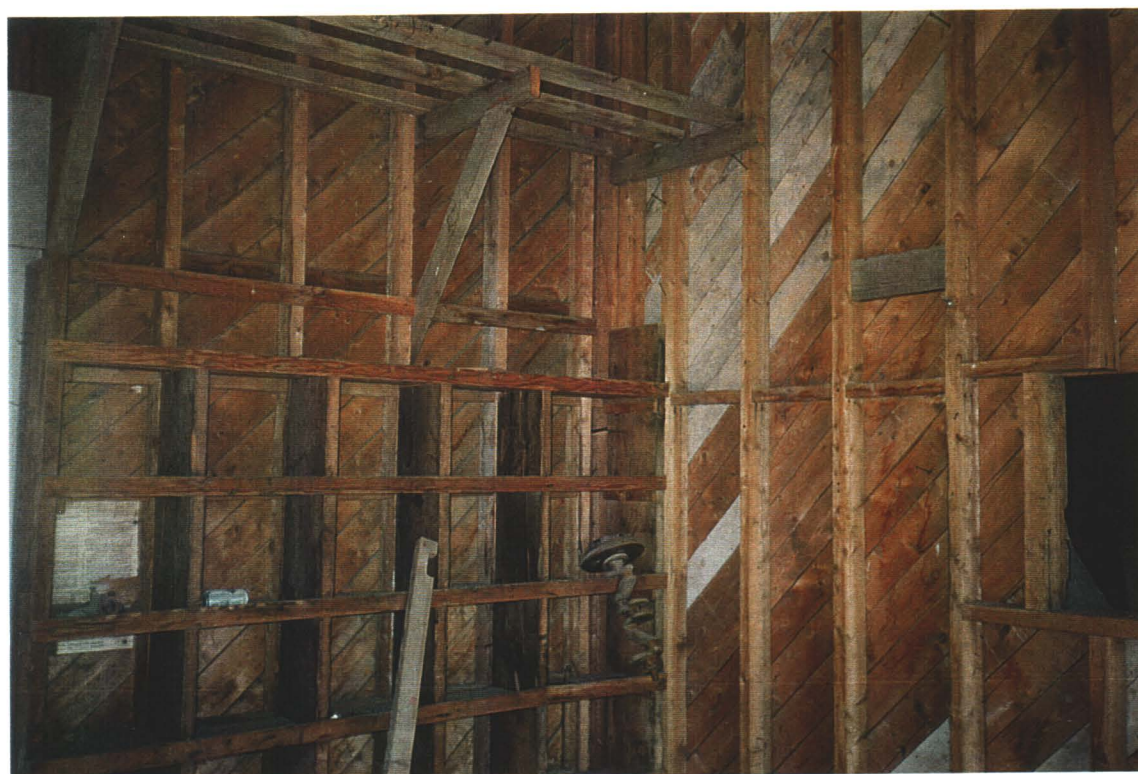
Pump House interior. Detail of wooden siding.
