**DETAILED WORK PLAN FOR
SITE RESTORATION ACTIVITIES**

Blanchard River Station

07 September 1999

Royal Roads University Applied Research Division and
UMA Engineering Ltd.

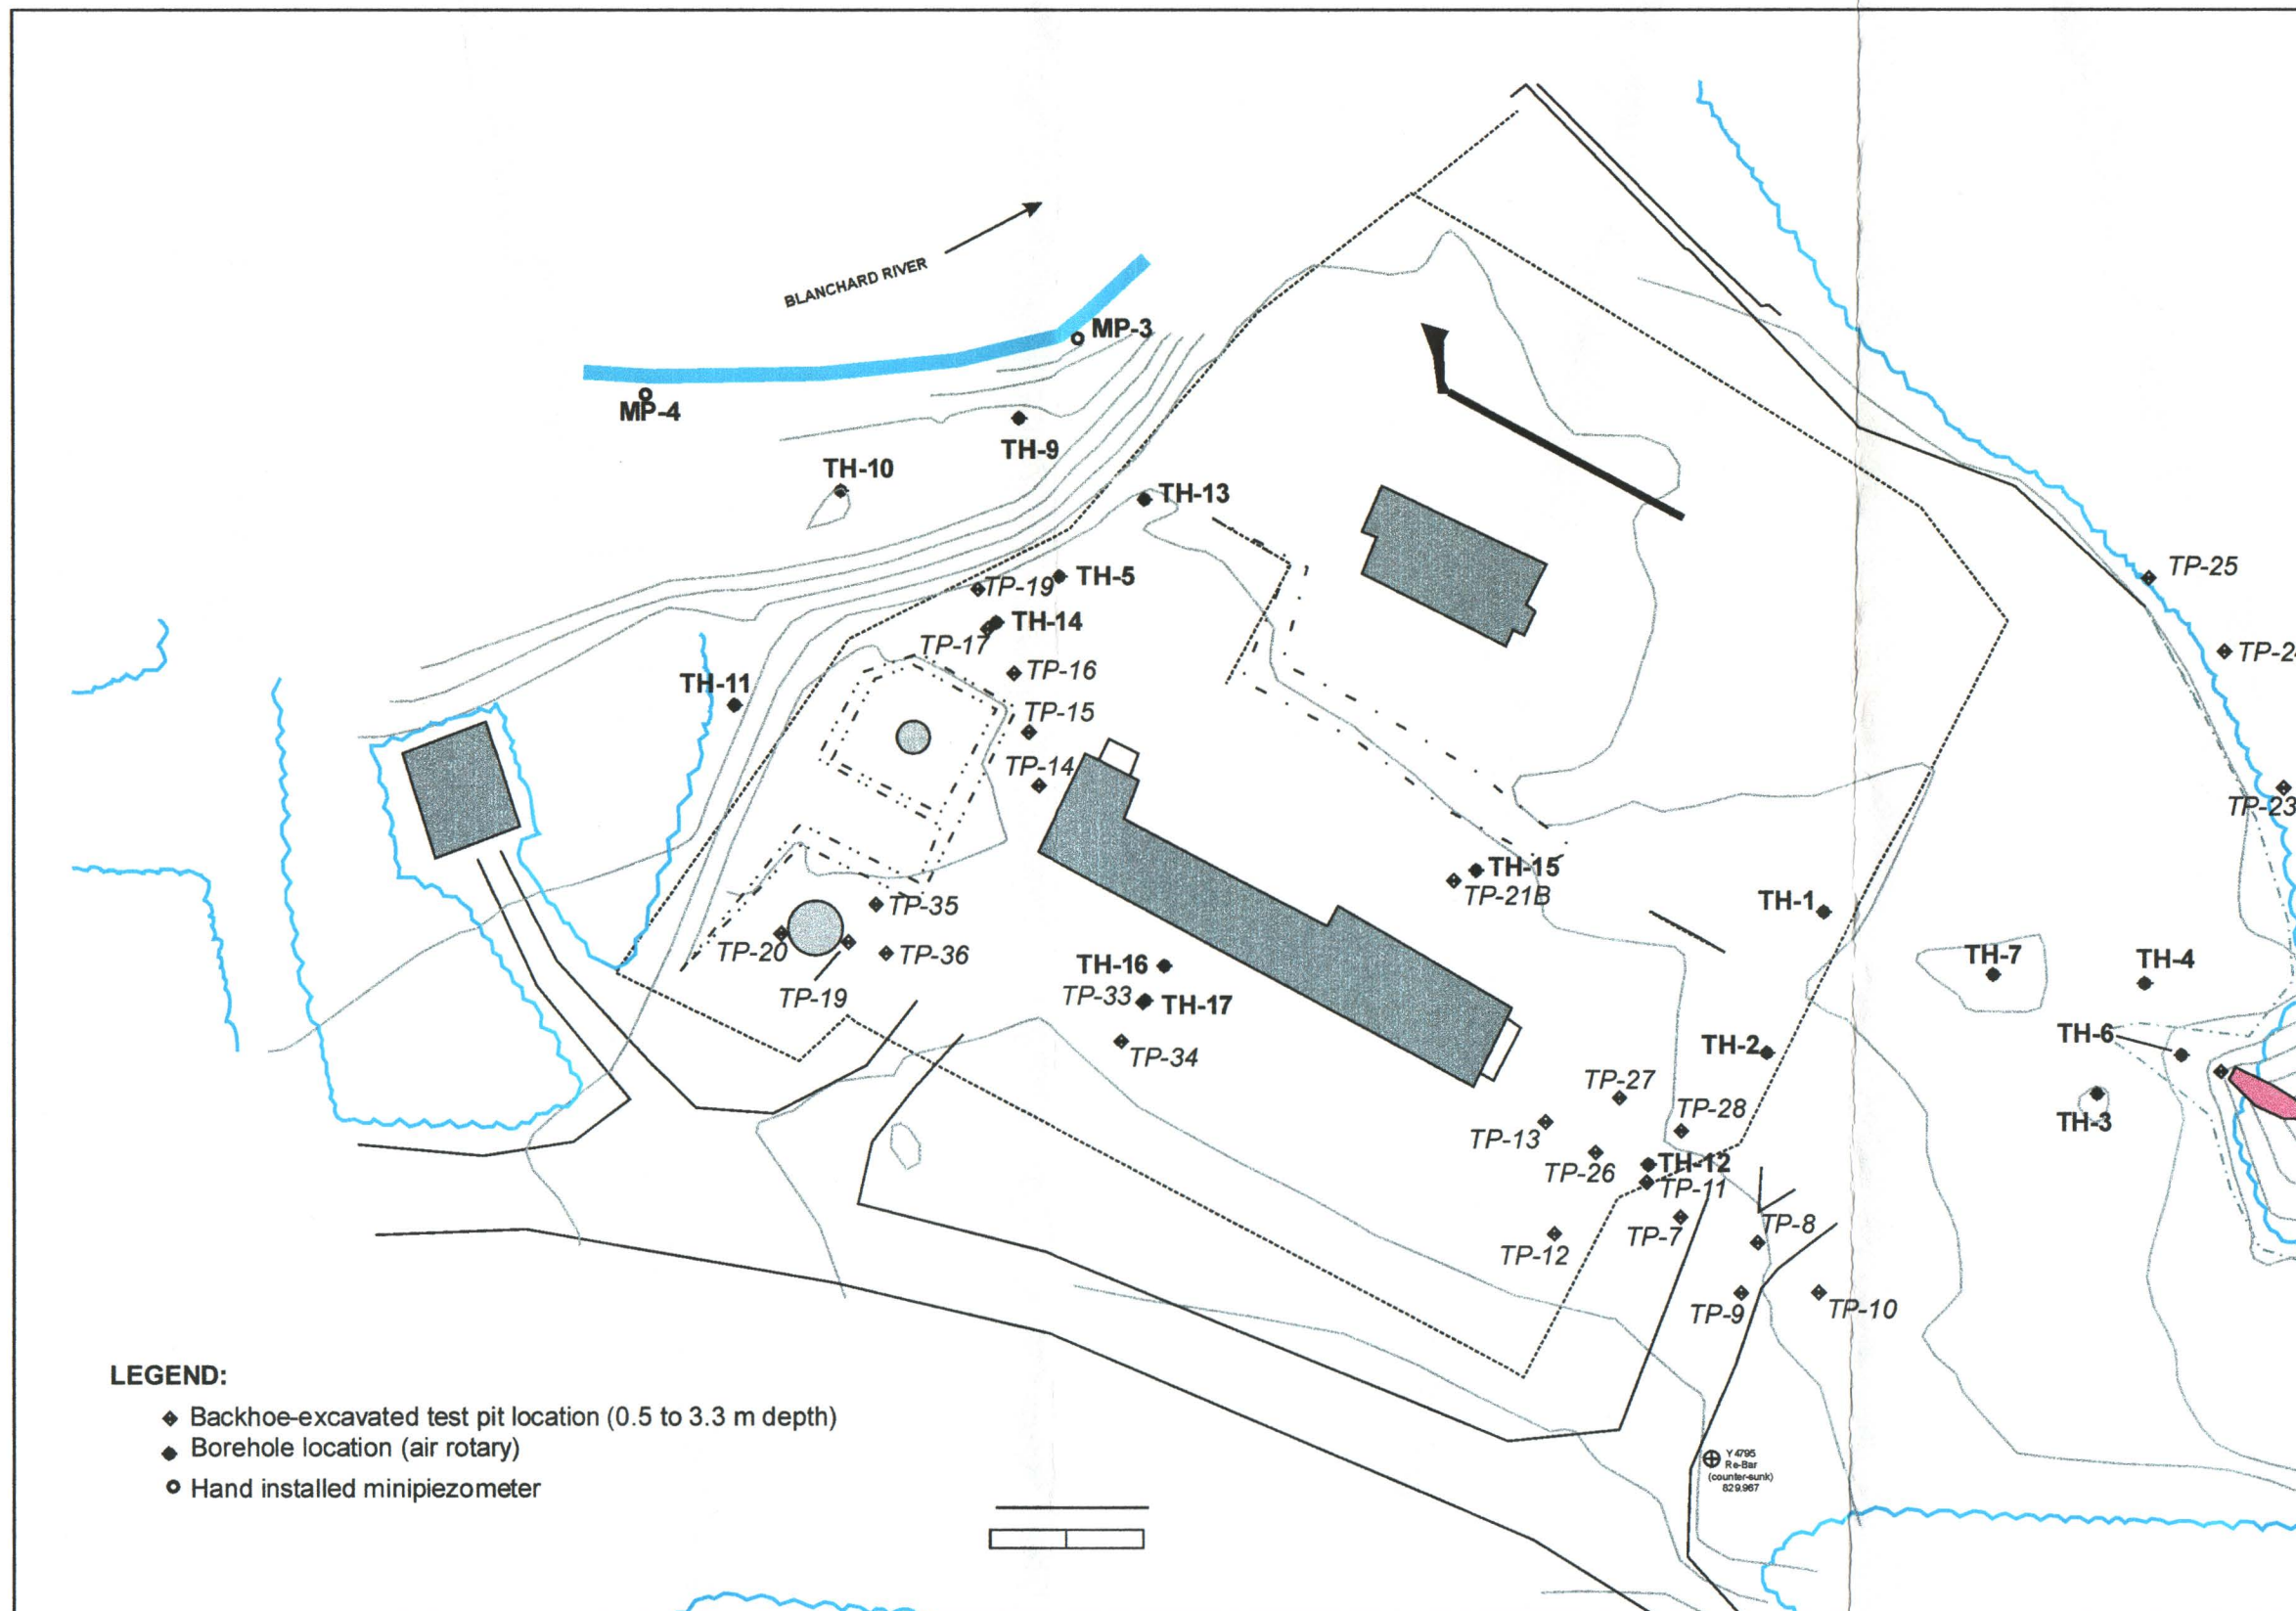
MAP 2.1: BLANCHARD RIVER STATION - SITE LAYOUT
 Including sampling locations, 1995 preliminary site investigation and 1999 detailed site investigation

We identified through historical photographs the past presence of a small above ground storage tank (AST) located to the east of the shop building and across from the well house (Map 2.1: location of TH-17). In addition, a rock pit installed in 1985 to the west of the main shop bay was investigated. This rock pit receives runoff from the main shop floor drains. The rock pit itself and surrounding soils are obviously stained with petroleum hydrocarbons; however, soil and groundwater immediately down gradient from the rock pit do not presently exhibit petroleum hydrocarbon contamination in excess of the Yukon CSR standards. A similar situation exists for subsurface soil adjacent to the largest, now disused AST to the south of the shop, along the north and west sides of the tank. There was strong visual and olfactory evidence of petroleum hydrocarbon contamination; however, the concentrations did not exceed the Yukon CSR standards.

Two areas of the site exhibited subsurface petroleum hydrocarbon contamination which requires mitigative action. The first problem area is located at and down gradient from the site where a burn pit was located during the operation of Blanchard River as a pump station, prior to 1985. The discharge of hydrocarbon waste products to the burn pit from the pump house resulted in petroleum hydrocarbon contamination in the vicinity of test hole TH/MW-12 (Map 2.1) as well as the down-gradient contamination of groundwater and subsurface soils in test hole/monitoring wells TH/MW-1 and -2. The rust coloured stain found in a water course to the north of the site arises from contaminated water emanating from a culvert. It is strongly suspected that the culvert serves as a conduit for contaminated water plume originating from the test pit as well. The culvert, based on an EM survey conducted in 1995, passes through the contaminated area, with its source at the former location of the burn pit.

The second area of petroleum hydrocarbon contamination at the south end of the maintenance building. The subsurface contamination at the south end of the site has on occasion been observed to result in the presence of a hydrocarbon sheen along a limited portion of the Blanchard River shoreline. The area of subsurface contamination includes boreholes TH-5, TH-9, TH-13 and TH-17 as well as mini-piezometer MP-3. The depth of contamination was greatest just above, and limited vertically by a silt-clay layer (at a depth of 6 m at TH-17). The contamination of soils just above a clay layer in test hole TH-9, established on the bench below the site and along the flood plain of the river was dominated by a heavier hydrocarbon component than observed in other borehole or test pit soil samples from the site. The HEPH concentration in sample TH9-7, at a depth below the surface of 4 m, was 29,000 µg/g, possibly indicating the presence of a dense non-aqueous phase liquid (DNAPL) plume migrating toward the river, in addition to the lighter hydrocarbon fraction noted in other boreholes/monitoring wells which is probably moving laterally in concert with, but slower than, groundwater flows.
