**PHASE 1 AND 2
VENUS MINE TAILINGS REHABILITATION PROGRAM
NEAR CARCROSS, YUKON**

**EBA ENGINEERING CONSULTANTS LTD.
Whitehorse, Yukon**

**Public Works and Government Services Canada
Environmental Services**

Project No. 0201-98-13604

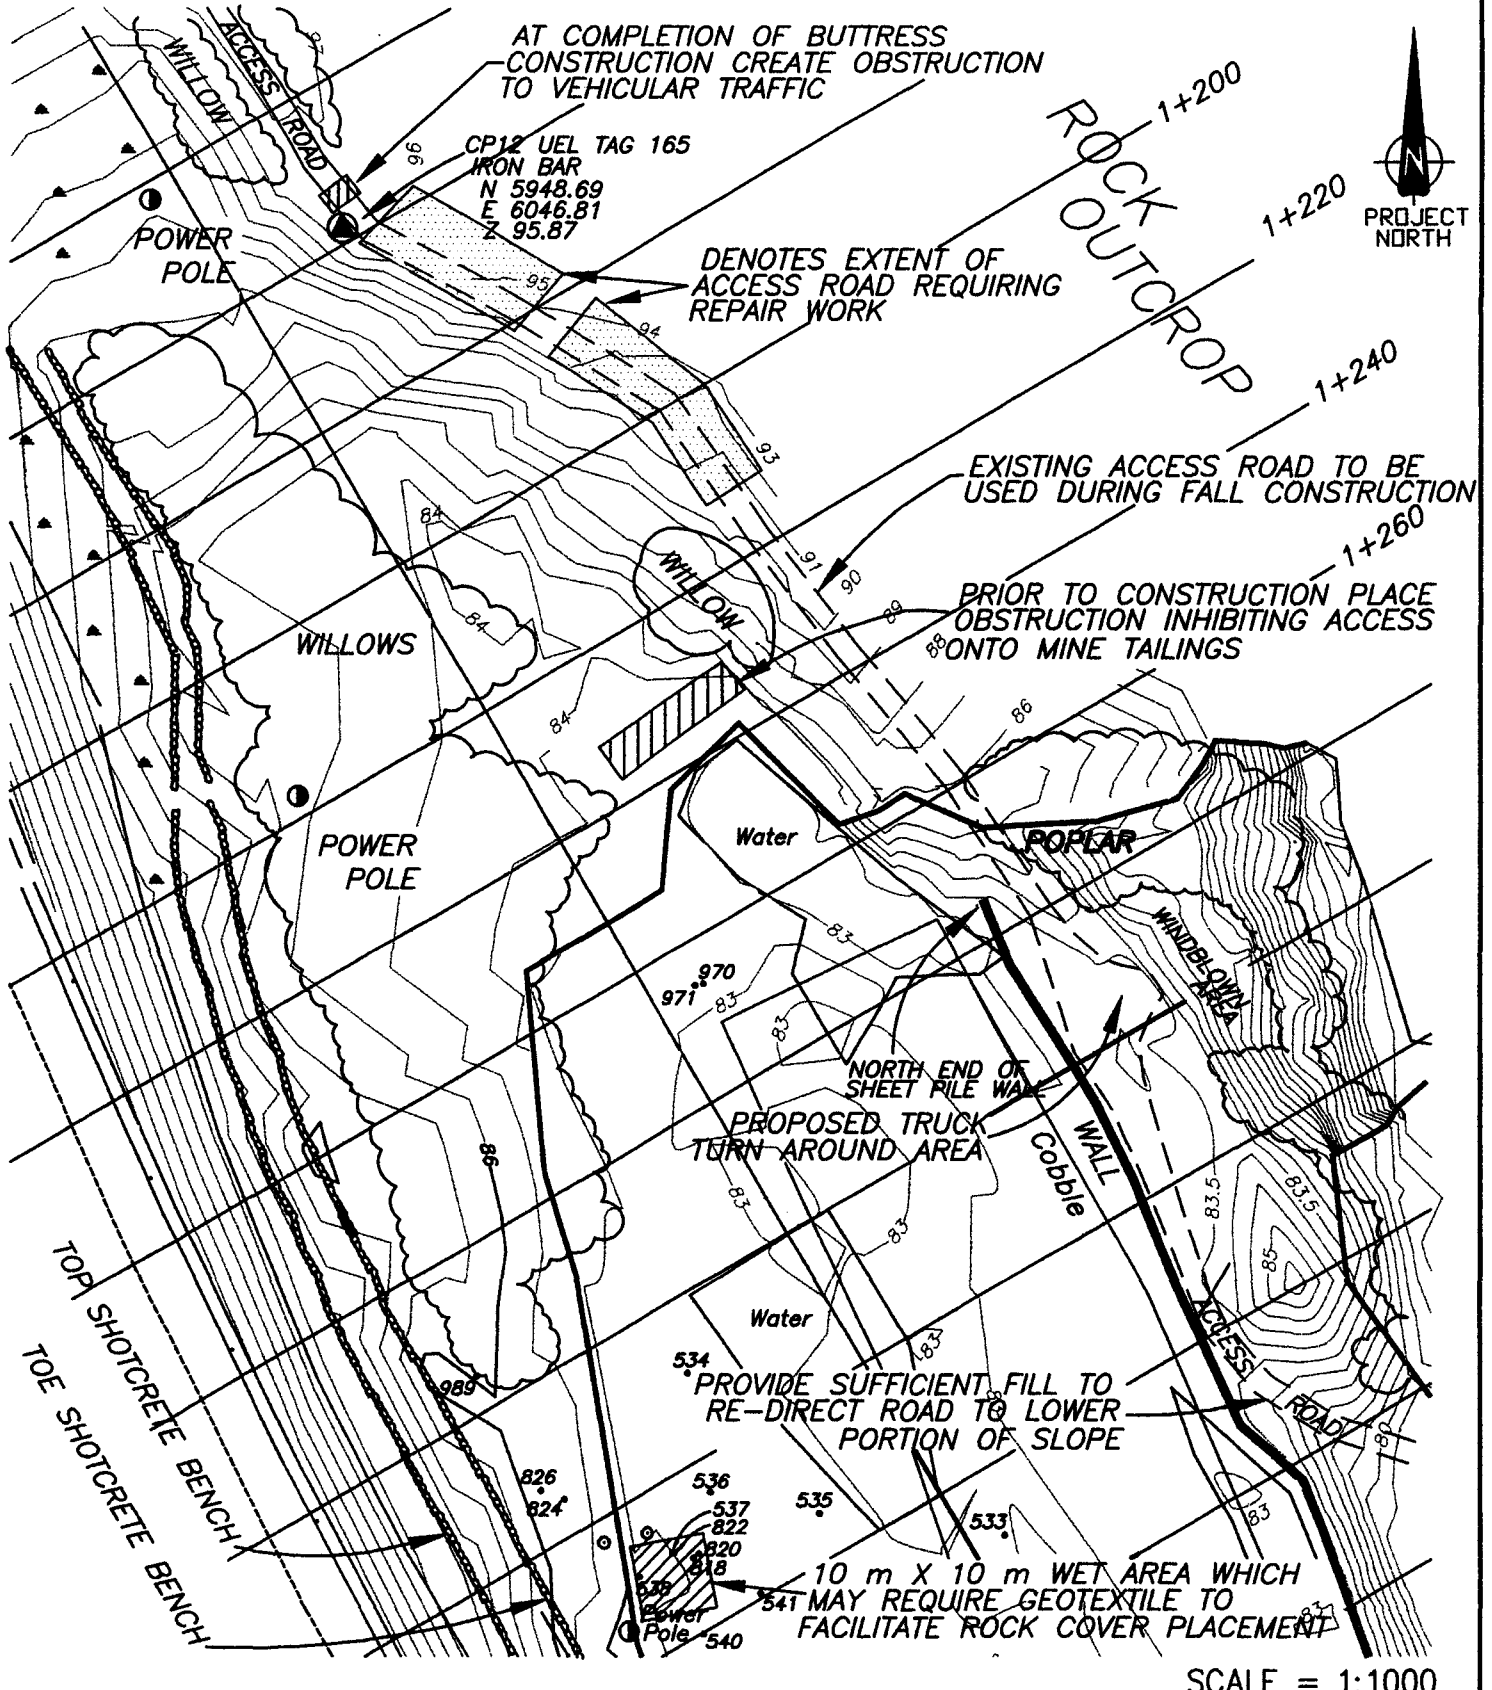
FIGURE 1

- .1 Immediately following the repair of the Old Access Road as described above, the existing access route which leads directly onto the tailings is to be blocked from vehicular traffic by placing boulders and soil along the width of the road as shown on Figure 1. There are currently boulders in this area that simply have to be relocated to restrict access. As well, soil shall be pushed to supplement the barrier created by the boulders.

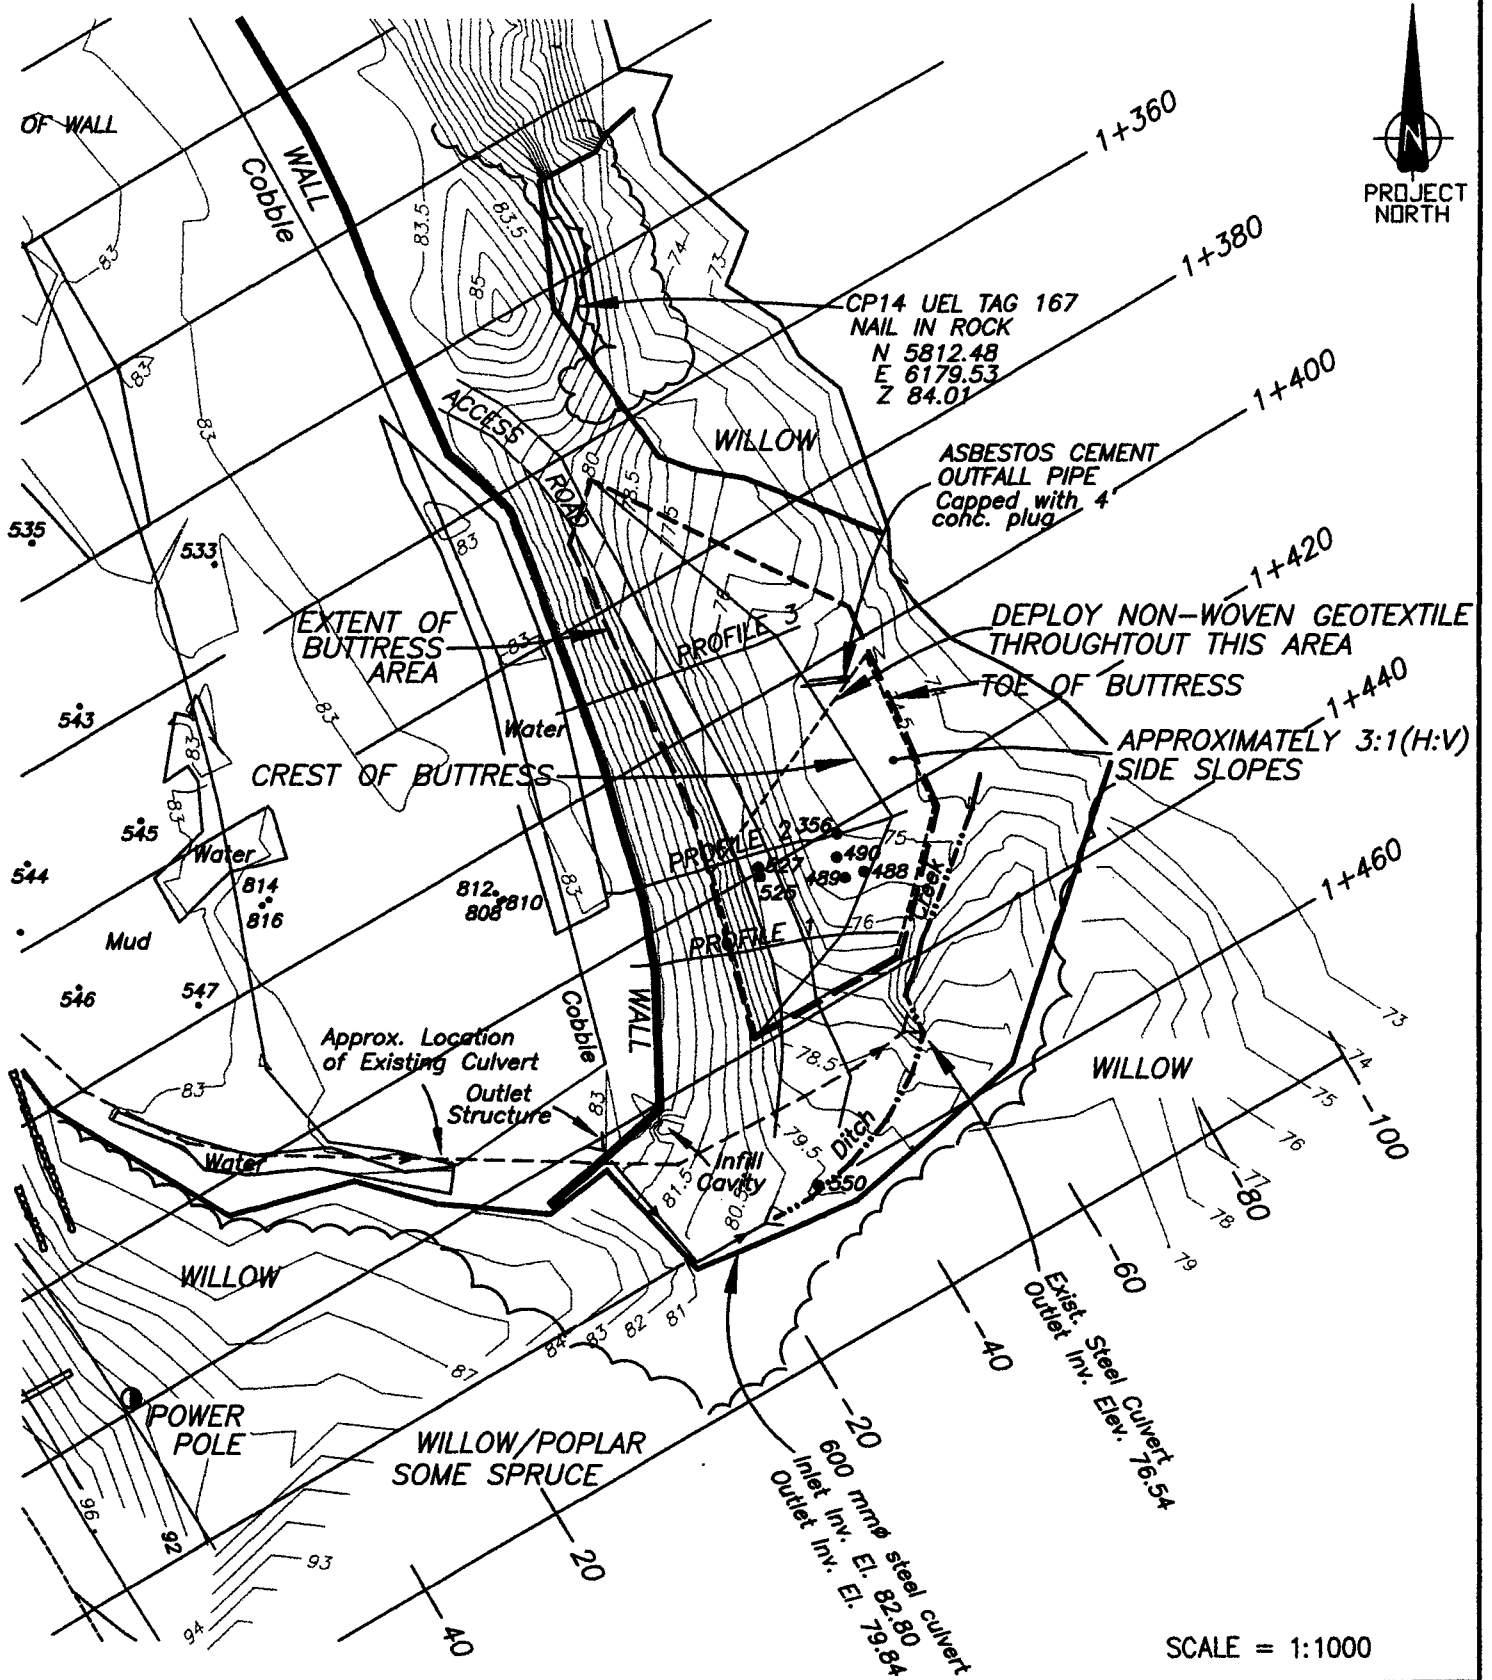
FIGURE 2

- .1 The work necessary for the buttress involves hauling and placing Pit Run material at the south-east portion of the site as shown on Figure 2. The order of execution will involve initially placing a non-woven geotextile in areas where existing saturated, soft soils occur and then placing Pit Run material to the lateral and vertical specifications described herein.

- .3 The geotextile material is to be placed directly on the existing ground surface in the area described in Figure 2. The surface must be free of sharp objects. To achieve an acceptable surface, hand clearing of vegetation or obtuse rocks may be necessary.
- .4 Seams shall have a minimum overlap distance of 600 mm.
- .5 Place Pit Run fill material immediately after laying the geotextile. Pit Run material must be placed so as to avoid damage to the geotextile. This shall include a maximum drop height of 1.0 m for fill directly onto the geotextile and a minimum lift thickness of 0.5 m for the first lift of fill material. Lifts thicker than 0.5 m may be required in wet areas.

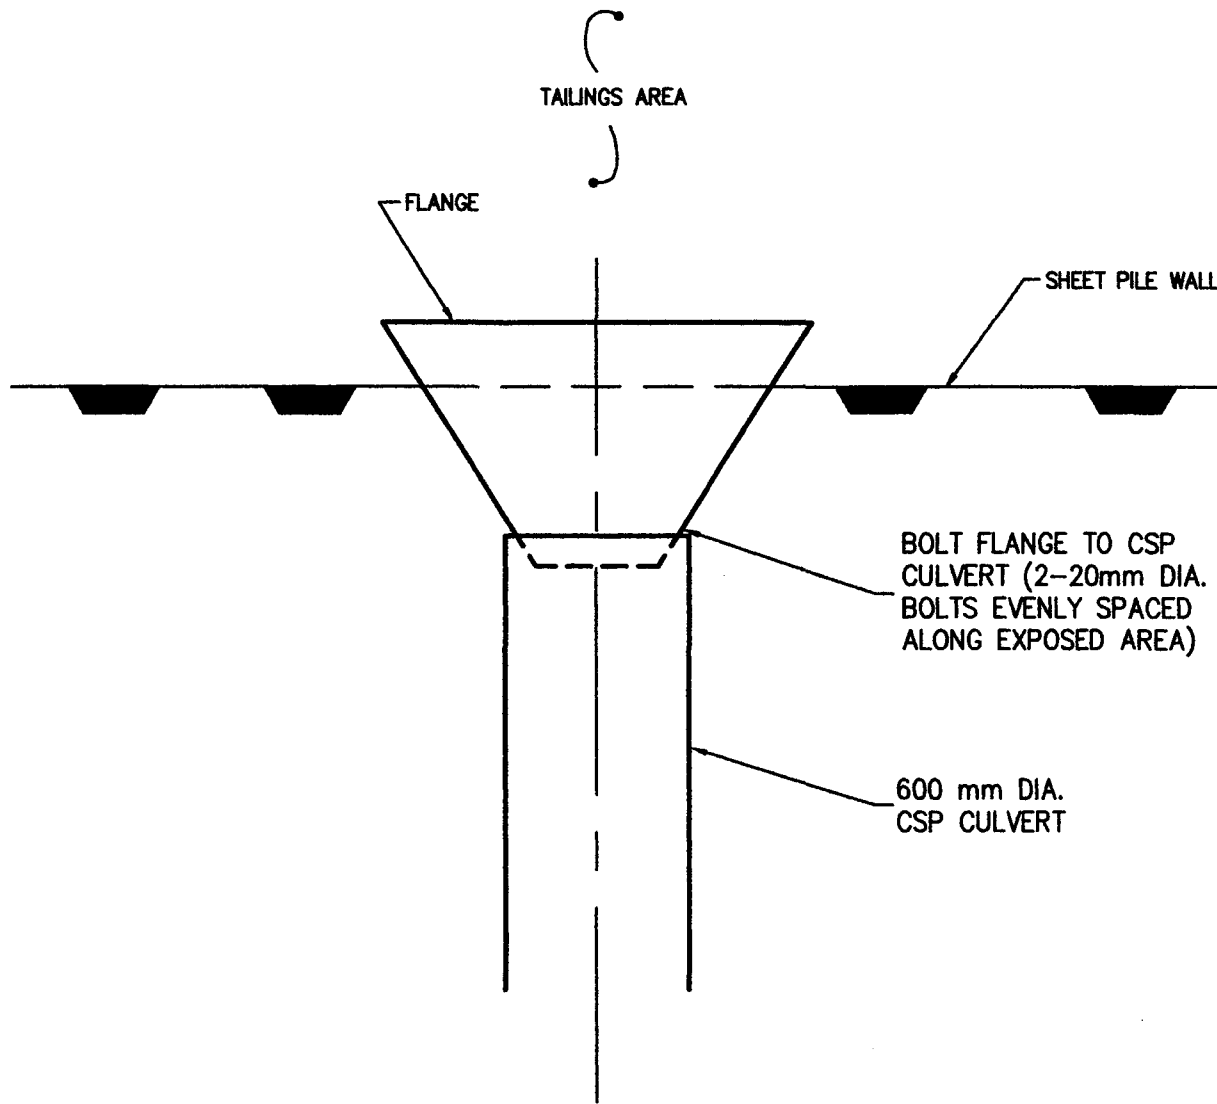
| FILE NO. 0201-98-13604 | | FIGURE 7 |

- .1 The flange connections at the culvert inlet and outlet have not been securely fastened to the culvert. Secure connections shall be made by installing 2 - 20 mm diameter bolts at convenient locations between the culvert and flange, as illustrated in Figure 7. The bolt locations and method of installation are to be approved by the on-site Engineer. Provision shall be made to place a small quantity of 20 mm minus crushed gravel (less than 1 m³) underneath the existing culvert inlet where a small void (less than 200 mm deep) occurs. Minimal compactive effort of this fill material shall be made with hand tools. Damage to the culvert during this exercise shall result in repair at the expense of the Contractor.
