**INDIAN AND NORTHERN AFFAIRS CANADA
ABANDONED CLINTON CREEK
ASBESTOS MINE
1998 SITE RECONNAISSANCE**

APRIL, 1999

PREPARED BY
UMA ENGINEERING LTD.
ENGINEERS AND PLANNERS
1479 BUFFALO PLACE
WINNIPEG, MANITOBA
R3T 1L7

Reference: Abandoned Clinton Creek Asbestos Mine – 1998 Site Reconnaissance

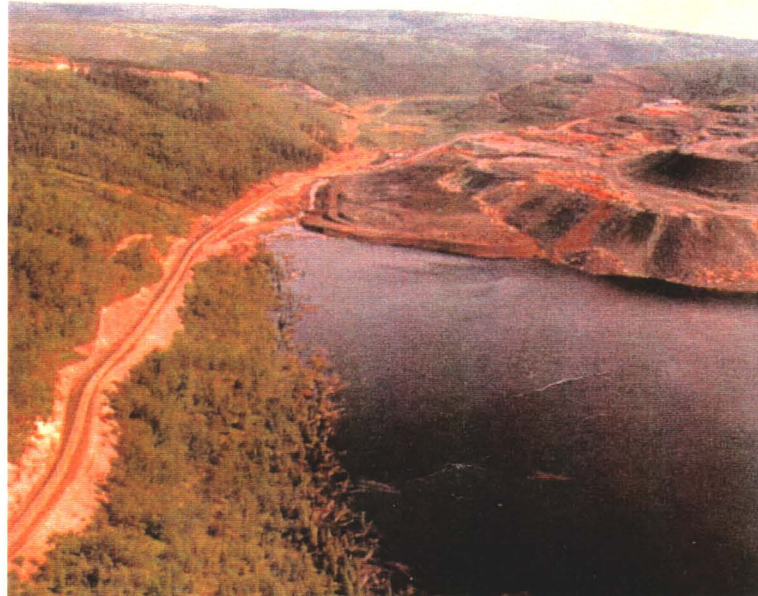
No photographic or written records are available from when the mine first opened until the waste rock dump forced the alignment of Clinton Creek against the north valley slope and ultimately impounded Hudgeon Lake. Photo CC-02 is the earliest available photograph of Hudgeon Lake, looking east at the waste rock dump, lake outlet, and the creek channel. Initially (1974), the creek channel flowed between the waste rock dump and the mill access road located on the north valley slope (Photo CC-03). However, as the water level in Hudgeon Lake increased, the unprotected channel eroded (down-cut) and migrated laterally to the north, eventually washing out the road (Photo CC-09).

Photo CC-02: Access Road and Hudgeon Lake Outlet at Clinton Creek (1974)

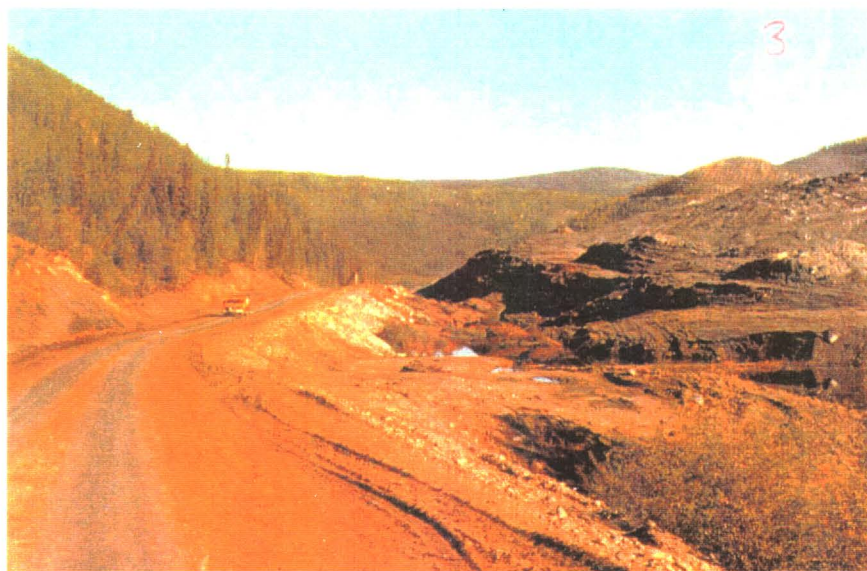
Photo CC-03: Access Road Along North Side of Clinton Creek (about 1974)

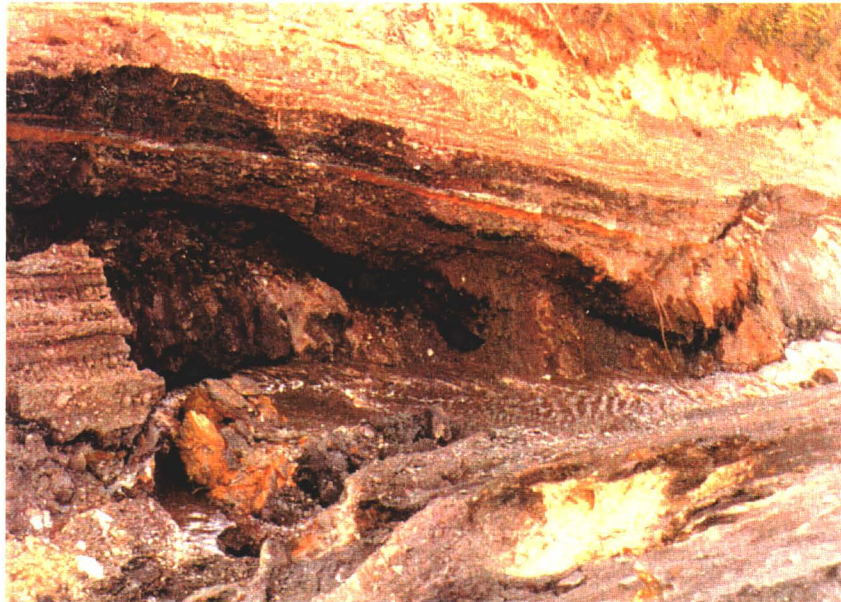
Photo CC-09: Erosion of Access Road on North Side of Creek (1975)

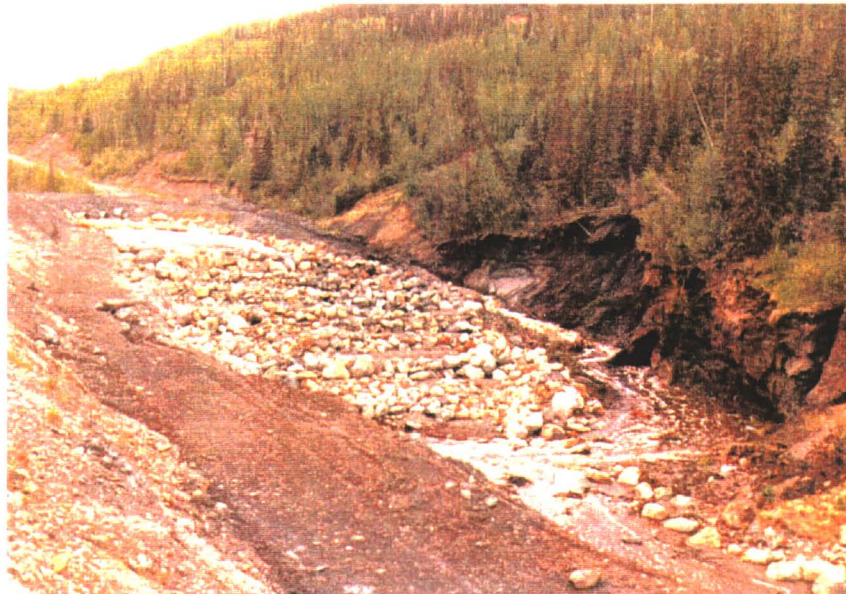
During the summer of 1979, an attempt was made to reduce channel erosion and undercutting by constructing rock weirs and armouring the banks of the channel immediately downstream of the lake outlet. Over the next few years, however, the creek flow bypassed the rock weirs on the north side causing significant erosion (Photo 3 Hardy Associates Ltd, July 1982). By 1983, channel flow had completely bypassed the weirs substantially increasing valley slope erosion as seen in Photo 3 (Klohn Leonoff, August 1983).

Photo 3: Creek Bypassing Weirs (1982)

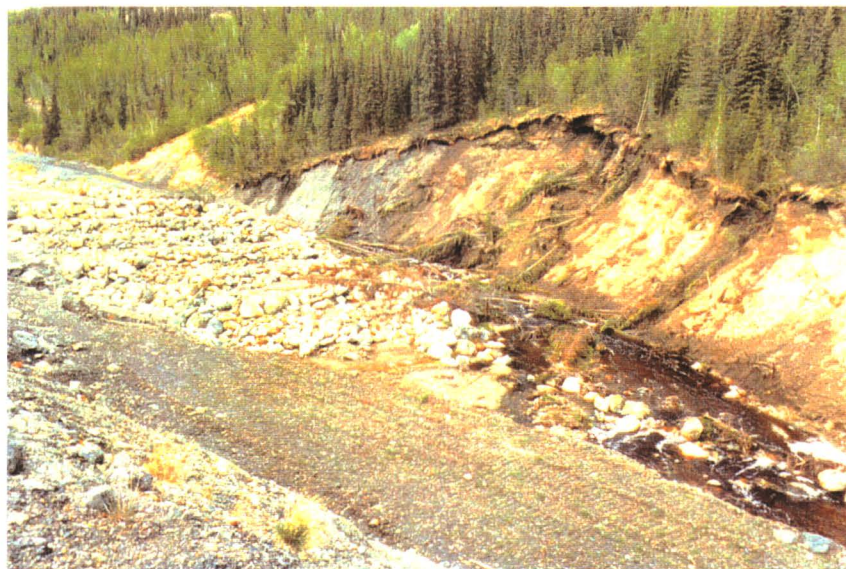
Photo 3: Valley Erosion (1983)

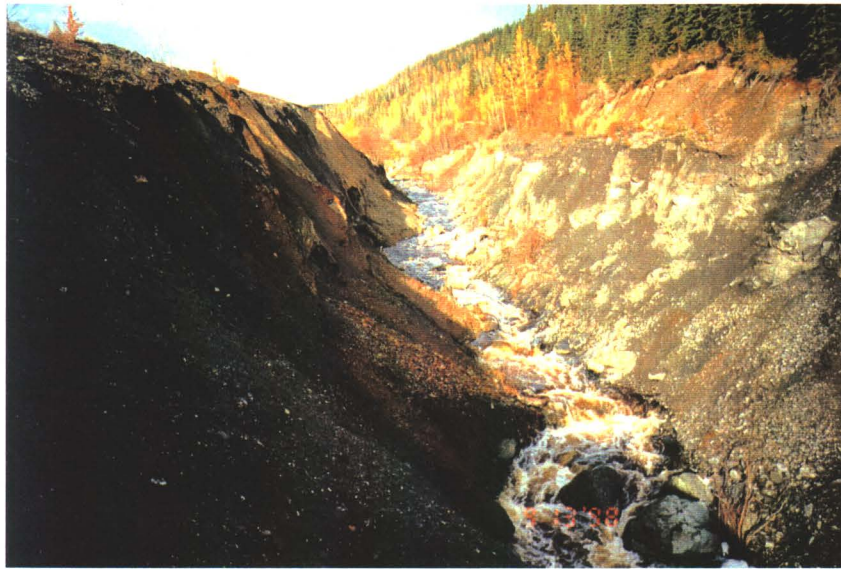
UMA Photo 7-17: Channel Erosion (1998)

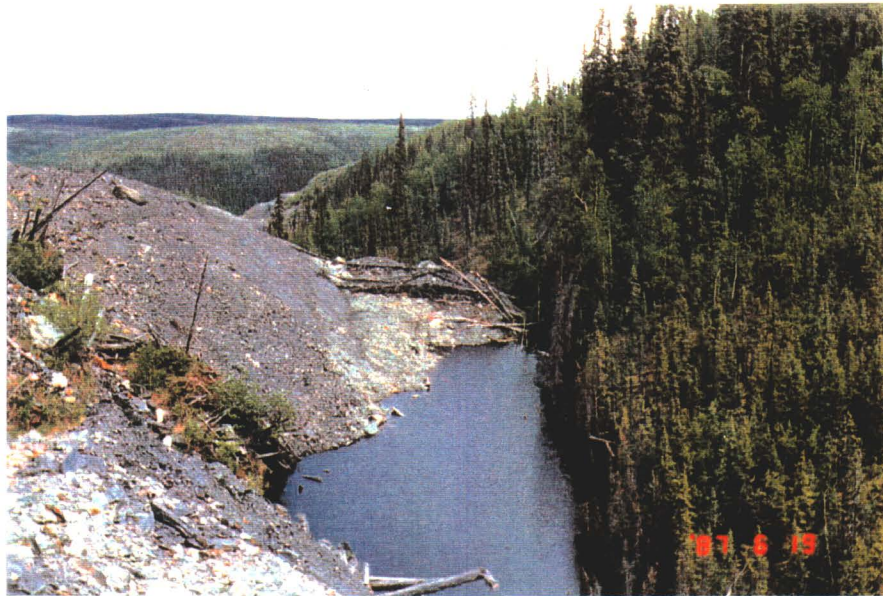
The first blockage (blockage 1) was photographed in 1987 by Geo-Engineering (Photo 8). Subsequent inspections and photos of this blockage and our 1998 site reconnaissance indicate there has been no significant change in the geometry of this is blockage (UMA Photos 10-3 & 10-6 in Appendix A).

Photo 8: View Downstream at Blockage 1 (1987)

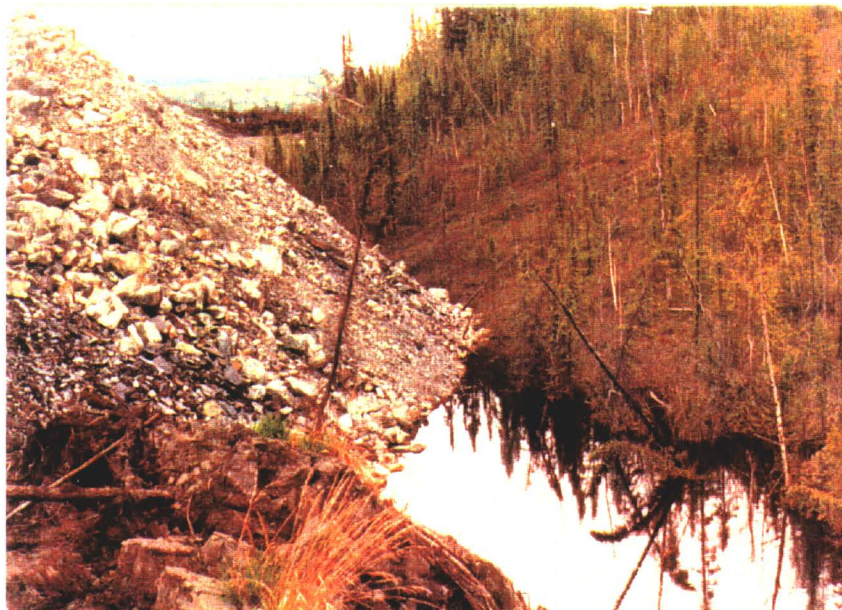
Blockage 2, located upstream of blockage 1, is illustrated in Photo PC-01 taken in 1975. Since 1975, subsequent inspections suggest very little additional movement is occurring (UMA Photo 10-2 in Appendix A). Both blockages probably behave as permeable dams with some water seeping through the waste rock. During high water events however, it is possible the blockages might be overtopped.

Photo PC-01: View Downstream at Blockage 2 (1975)

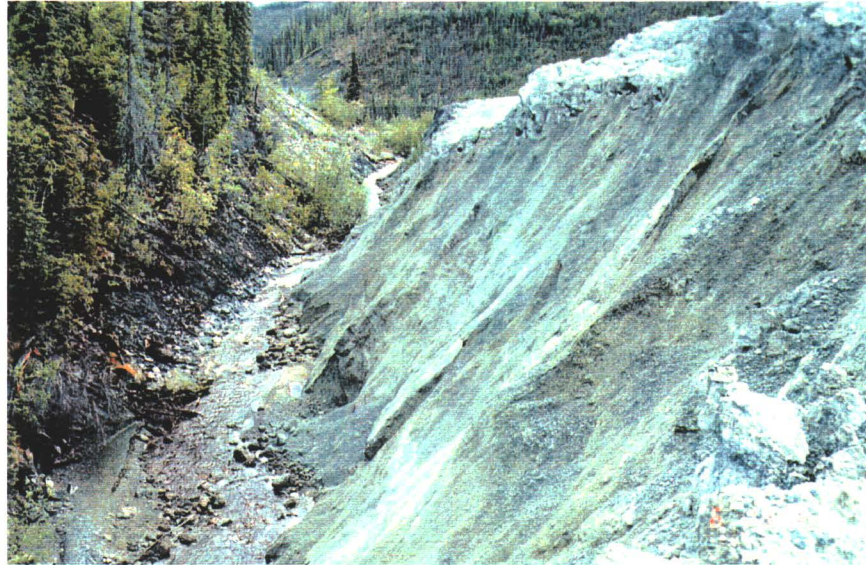
As the tailings continue to move down-slope, they are eroded and transported downstream. A comparison of the position of the leading edge of the tailings in Photo 12 taken in June, 1988 by Geo-Engineering with UMA Photo 5-20 indicates the gradual advancement of tailings into the creek channel.

Photo 12: Toe of South Lobe in June (1998)

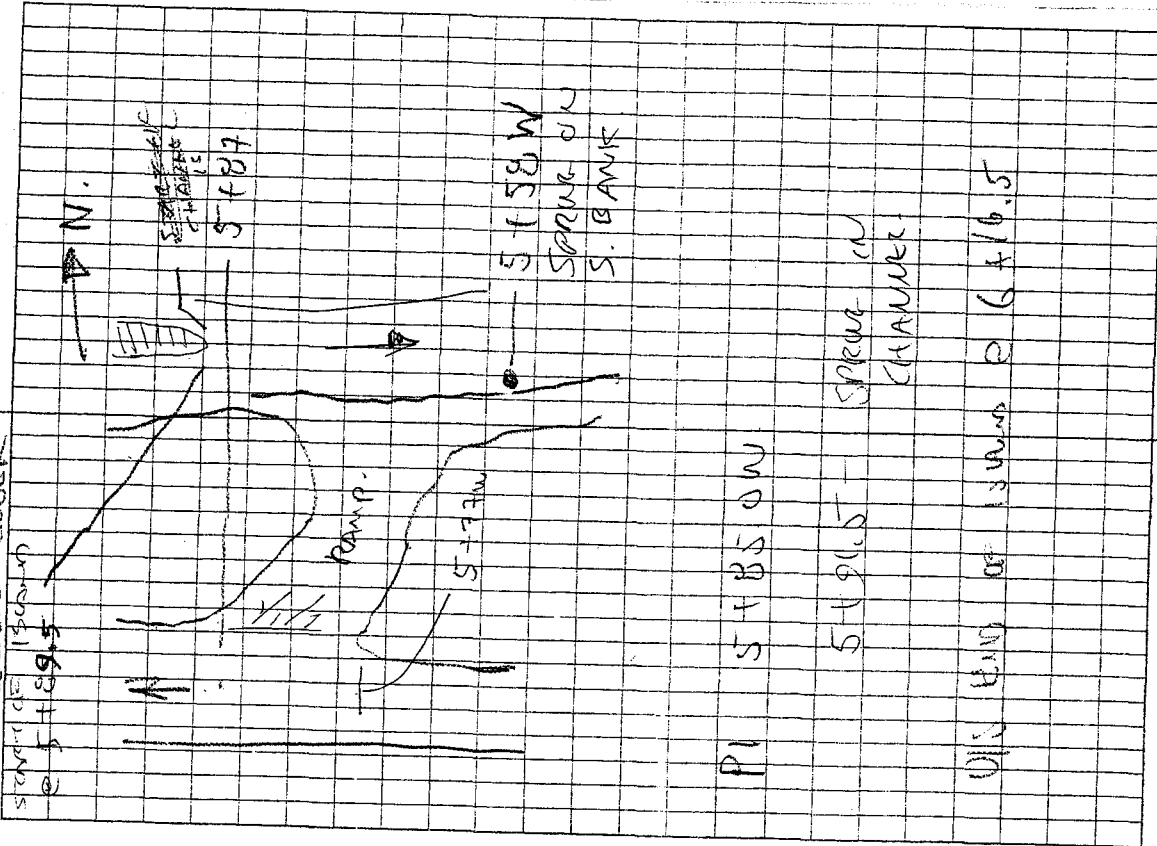
PI 5+85.0 W

5+91.5 - SPRING IN CHANNEL

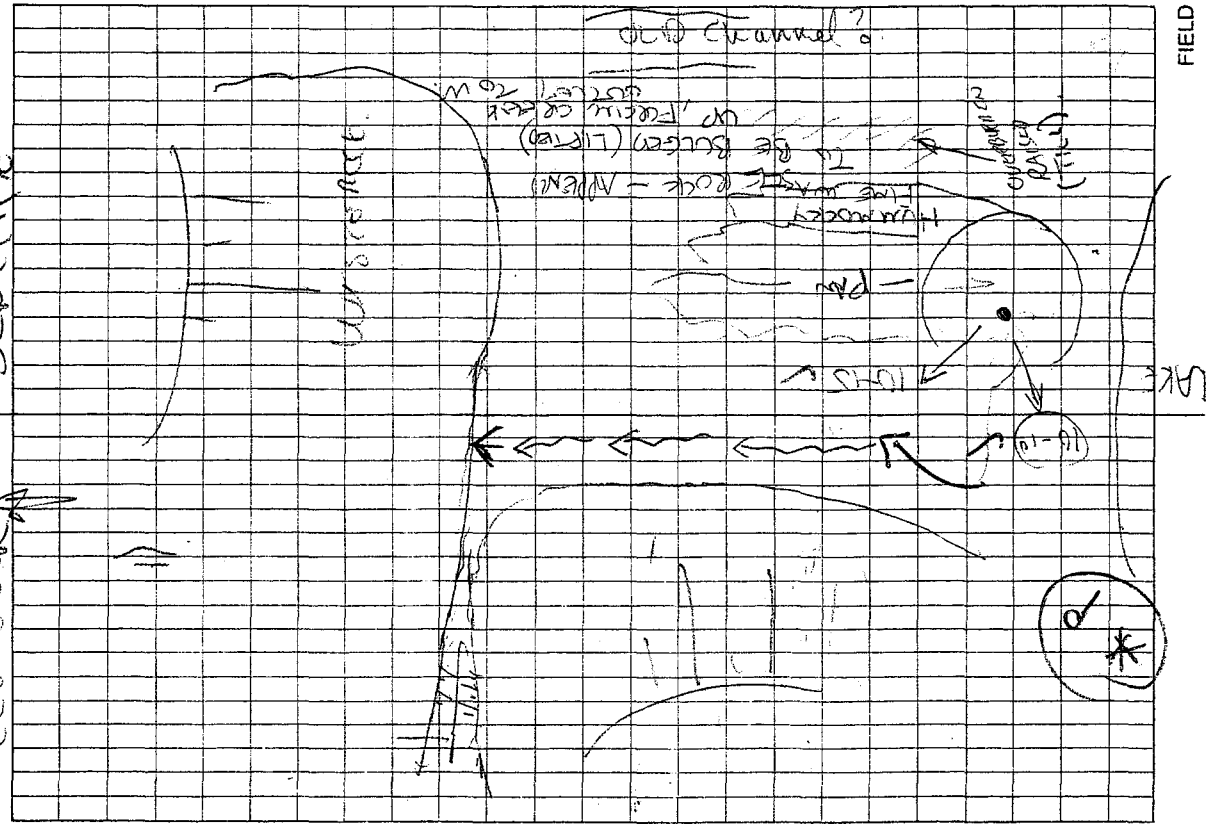
10-1-10-2
 2 CONF (Pond)
 (Photo 223)

Photo 10-3 higher up
 looking @ Pond 2.
