## Environmental Assessment, Casino Mine/Camp, Yukon Region – Final Report

*(Call Up No. 98-6195-04)*

**Environmental Assessment, Casino Mine/Camp –  
Yukon Region**  
**MDA Project no. 99-09-04**

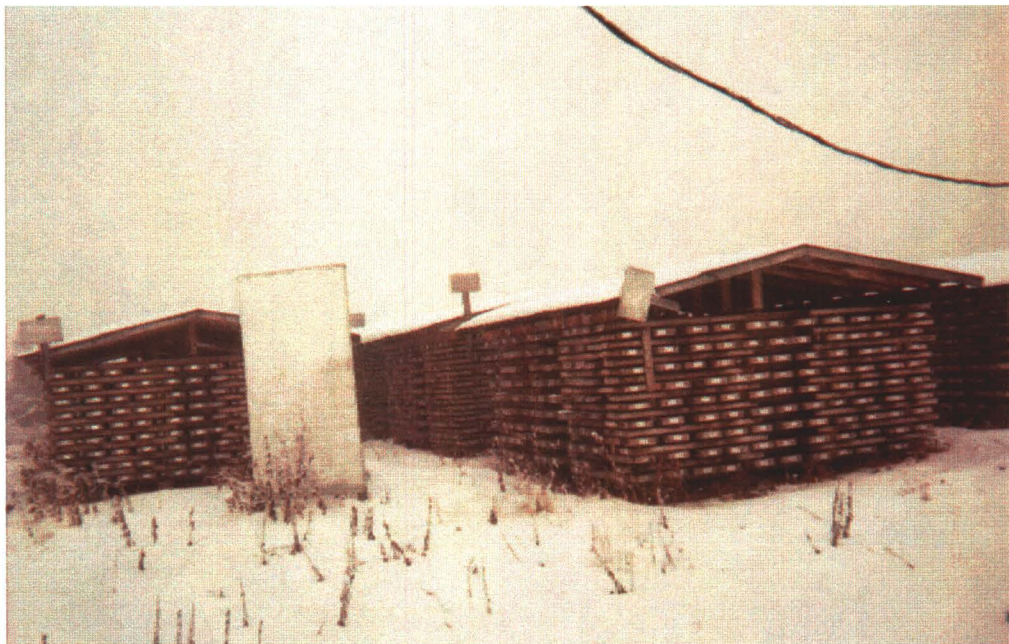
There were over 20 covered core storage structures located at the airstrip. These are well constructed and in good condition as illustrated in Photograph 21. Nearby is a wooden explosives/fuel storage shed with an attached wooden ramp (Photograph 22) and a second small fuel shed near an oval above ground storage tank (Photograph 23) that has partially collapsed. There were no explosives, lubricants or other hazardous items found in the shed.

*Photograph 21:  
View of some of  
the more than  
20 core storage  
sheds located at  
the airstrip*

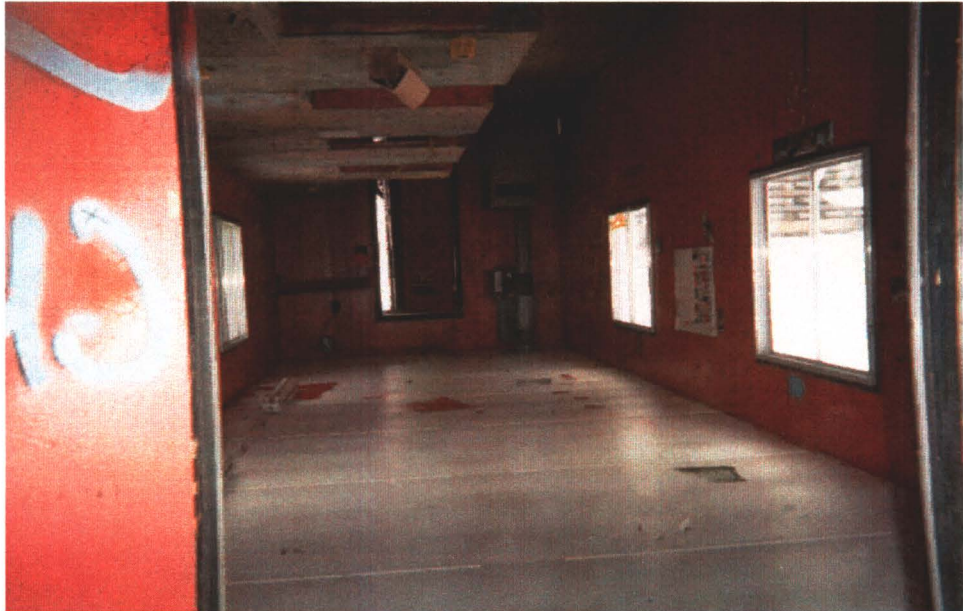
There were two metal clad trailers used for laboratory or office purposes (see Photographs 22 and 24) located adjacent to a series of core examination sheds (Photographs 25 and 26). As evidenced in Photograph 24, the trailers have been cleaned out as have the core examination sheds, except for the built-in benches.

*Photograph 24:  
Interior of  
laboratory or office  
trailer at airstrip*

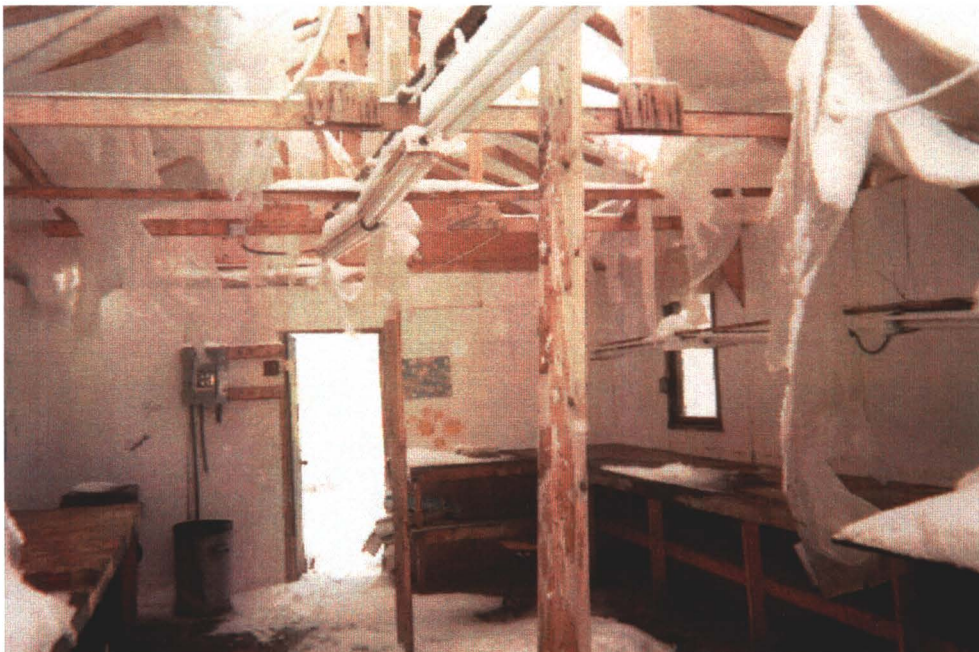
*Photograph  
25: Interior of  
one of the  
core  
examination  
sheds*

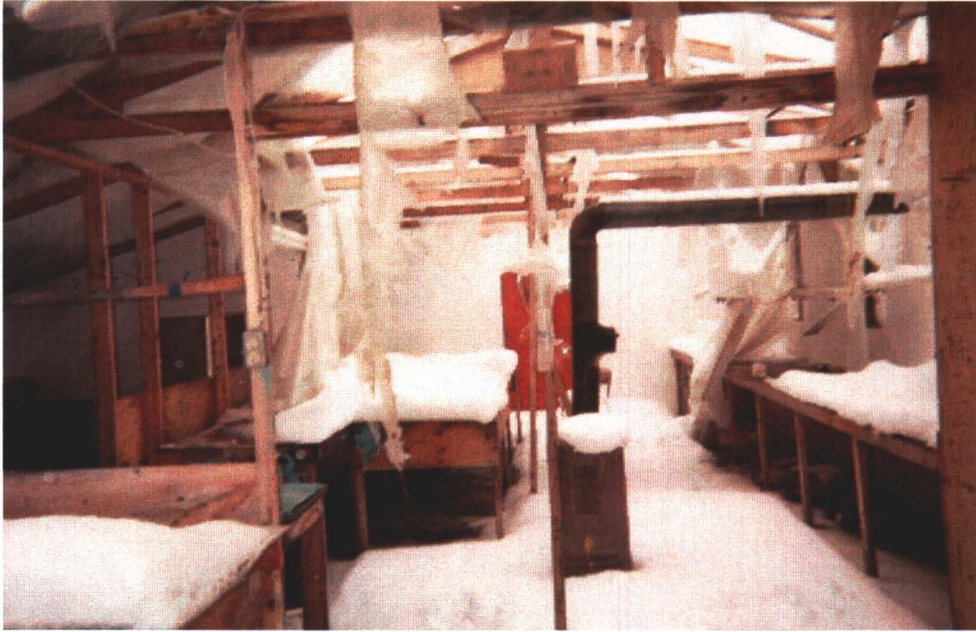
*Photograph  
26: Interior of  
one of the  
core  
examination  
sheds*
