ABANDONED CLINTON CREEK ASBESTOS MINE

RISK ASSESSMENT REPORT

APRIL, 2000

UMA JOB NO. 41 01 4440 038 01 02

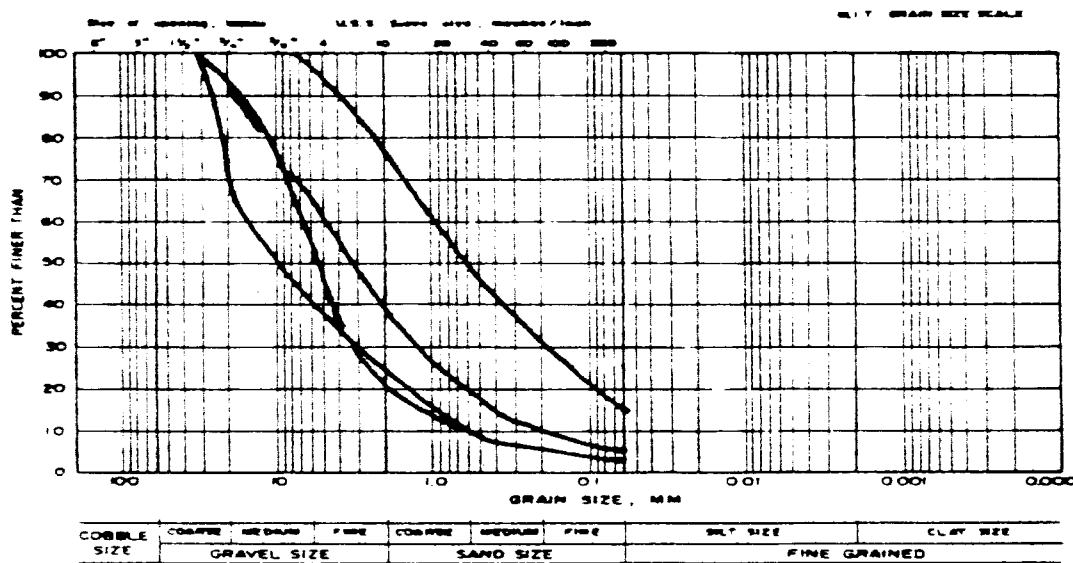
Figure 7-3
 Waste Rock Gradations

The waste rock dump consists of stripped overburden material (likely colluvial soils) and argillite waste rock consisting of sand, gravel and cobble sizes containing occasional boulder size material (Figure 7-3). Given the sequence of open pit development, it is likely that the excavated overburden material is buried deep beneath the waste rock, likely some distance back from (south of) the existing creek channel. The dump material is believed to overlie ice rich alluvial material in the bottom of the original valley (Golder, 1978). Durable boulder size material from the waste rock has accumulated over time along the bottom of the Clinton Creek channel, providing resistance to erosion under normal flow conditions. Boulders from the remnants of the rock weir and channel repairs just downstream of the Hudgeon Lake outlet also help armour the creek channel at this location. Bedrock on the north flank of the downstream portion of the stream also offers resistance to erosion although over the long term, significant incising through the bedrock is evident, in particular through the weathered surface. The freshly exposed waste rock material comprising the south creek bank within the waste dump is considered to be highly susceptible to erosion, even under normal flow conditions.

The impact from waste rock erosion and sediment outwash into the downstream channel is most significant immediately downstream of the toe of the waste rock dump. From Figure 7-3, D_{50} for this material can be taken to be approximately 5 mm placing it within the size range of fine gravel. The D_{100} is shown to be less than 35 mm but the material visible in Photo 14-11A tends to indicate that the largest material size is significantly larger. The critical flow velocities for these sizes of material are approximately 0.6 and 2 m/s during laminar flow conditions. During turbulent flow conditions, such as along Clinton Creek, the direct force of the water will move these materials. Movement of boulder size material is possible under turbulent flow from micro-erosion, which undermines the stability of the boulders causing them to tumble in the direction of the flow.

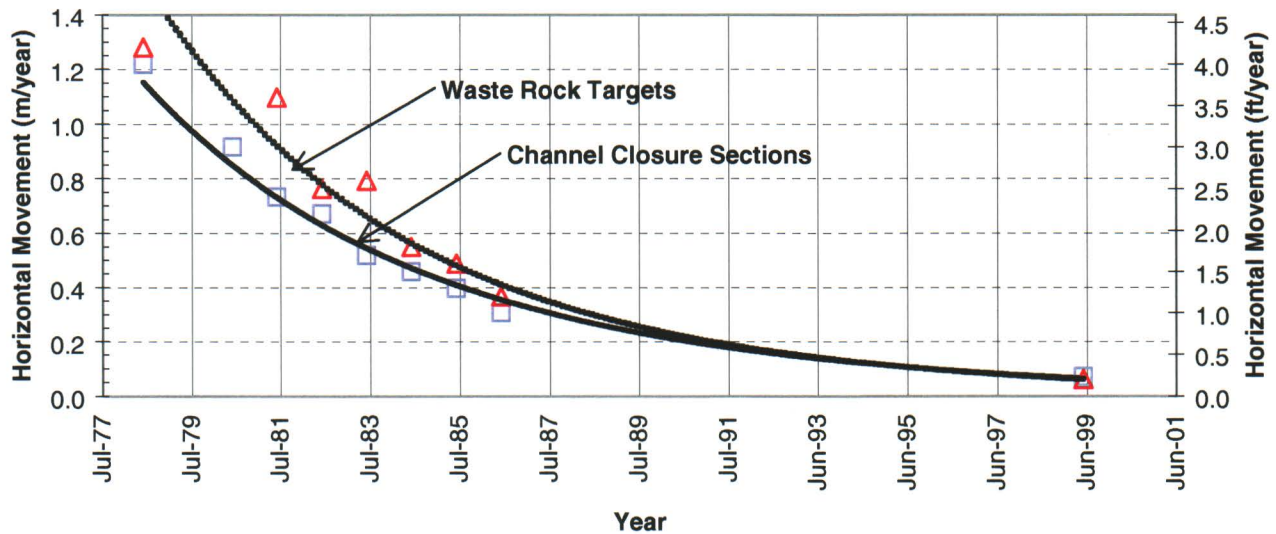
Figure 7-4
 Average Annual Movement Rates

Intact waste rock targets and cross-channel reference lines were surveyed in 1999 (Drawing 06). The monitoring results are illustrated on Drawing 06 where target movements are plotted with arrows to indicate the direction and magnitude of movement since 1986. The current horizontal distances of cross-channel reference lines are also indicated on Drawing 06. Where baseline information was available, the average movement rates over the 13 year period from 1986 to 1999 have been determined and compared with previous data. Over the last 13 years, the average rate of movement for the waste rock targets and channel closure sections is about 0.1m/yr. The trend in movement rates is illustrated on Figure 7-4. It should be noted that the movement indicated at waste rock target 19B (3.57m) was not used in the average for 1999; It is not clear if the monument tied in is consistent with that used for previous surveys i.e. two pins were located close to one another (19 and 19B). Baseline information with respect to cross-channel reference lines was only available for sections J-JJ and K-KK and therefore only these two readings are reflected in the average for 1999. While it is recognized that these 1999 averages do not include data used in previous surveys, they are believed to be a reasonable indication of overall behaviour of the waste rock dump.

The 1999 survey appears to confirm the observations made by Klohn in 1986, that is, the movement rates are decreasing over time. With a reduced rate of waste rock movement, the supply of material from the waste rock dump to feed the creek channel erosion process is diminishing. As down-cutting of the channel continues however, sideslopes on both sides of the channel will become oversteepened resulting in localized instabilities which will deposit material into the stream course. It is likely that intermittent channel blockages at this time are much more likely to occur as a result of these instabilities rather than from larger scale waste dump movements, an observation which is borne out by recent site inspections by Geo Engineering and UMA Engineering. Given the limited volume of water which could be impounded in the confines of the channel upstream of localized failures, the resulting breach would not likely produce a significant downstream flow increase. It should be recognized however, that continued down-cutting of the channel may eventually cause an acceleration in horizontal movement of the waste dump as a result of a reduction in overall slope stability.

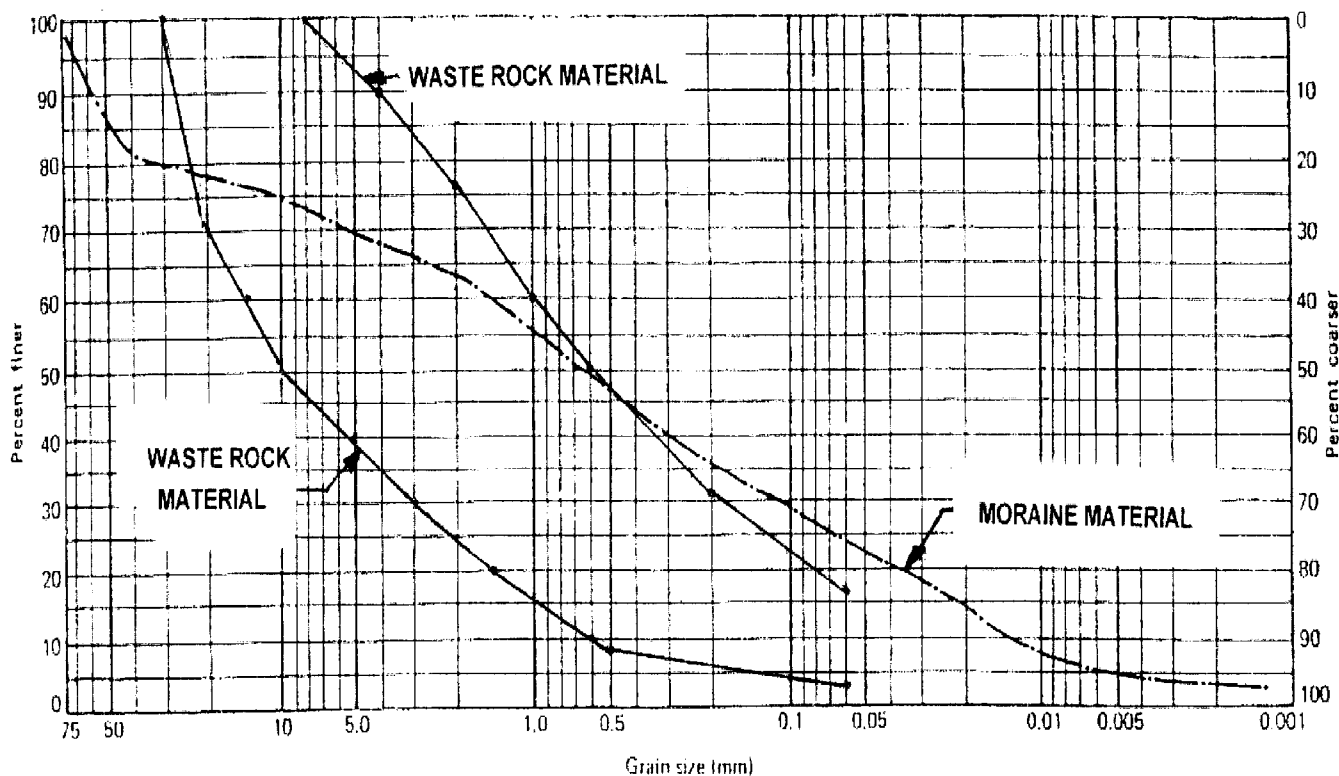
Figure 7-6
Waste Rock and Moraine Gradation Curves

Observed breach failures of natural moraine dammed lakes in British Columbia offer a reasonable indication of potential breach scenarios at the Clinton Creek waste rock dump (Evans, 1986). Similarities between the Nostetuko Lake moraine dam and the Clinton Creek dam (Blown and Church, 1985) were previously reported by Stepanek and McAlpine in 1992, in particular the width of the dams (Figure 7-5). Material properties of the waste rock and moraine are also somewhat similar; both consist of bouldery non plastic sand and gravel size particles. Gradations of the two materials are compared in Figure 7-6. Both materials are relatively stable against internal erosion but would experience rapid surface erosion due to lack of plasticity (cohesion).

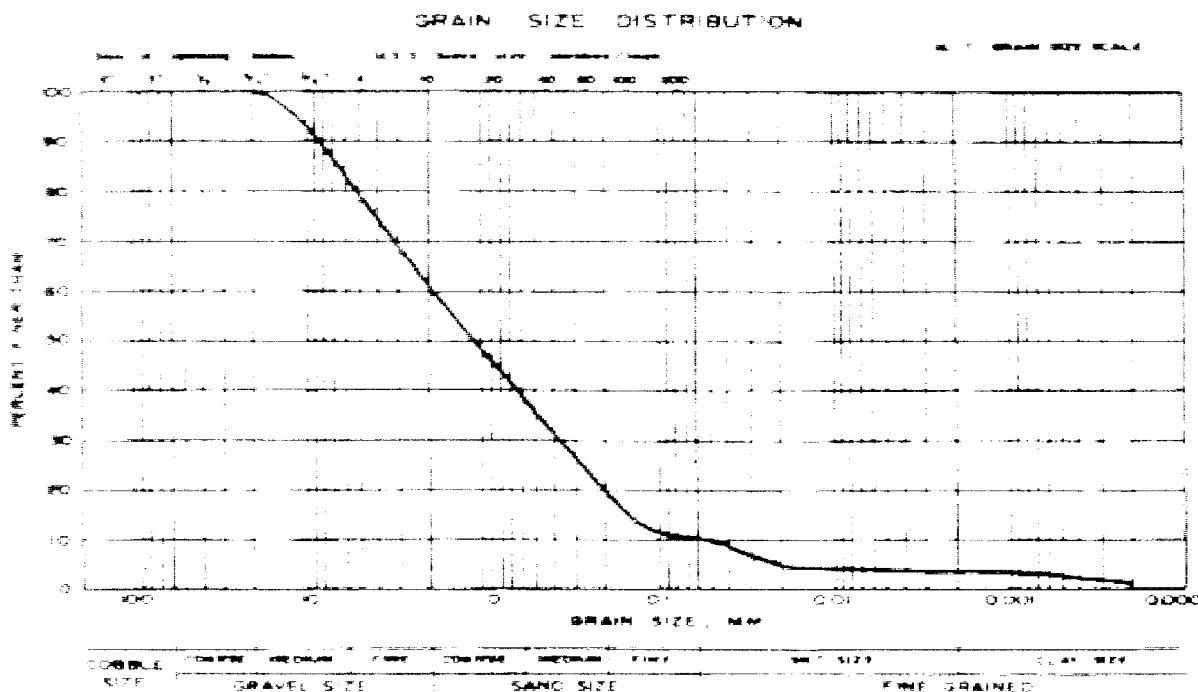
Figure 7-7
 Mill Tailings Gradation

Asbestos tailings from the mill were deposited over the west slope of the Wolverine Creek valley with a stacker conveyor. The original valley slopes at about 17 degrees, dropping in elevation approximately 200 m. The natural soil profile consists of an organic layer overlying silty sandy gravel (colluvial) and weathered argillite bedrock (Golder, 1978). The Colluvium layer tapers from 15m near the top of the valley to almost absent at the bottom of the valley. The mill tailings generally consist of well graded crushed serpentine rock with some asbestos fibre not removed during milling (Figure 7-7).

From Figure 7-7, it can be seen that the mill tailings have a D_{50} of 1 mm and a D_{100} of 20 mm. The D_{50} material has a very low resistance to flowing water with critical flow velocities of approximately 0.3 m/s while the D_{100} material has a critical flow velocity of approximately 1.8 m/s. Based on this
