**INDIAN AND NORTHERN AFFAIRS CANADA**

**ABANDONED CLINTON CREEK ASBESTOS MINE  
ENVIRONMENTAL LIABILITY REPORT**

**UMA Job No. 4440 038 02**

**May 2002**

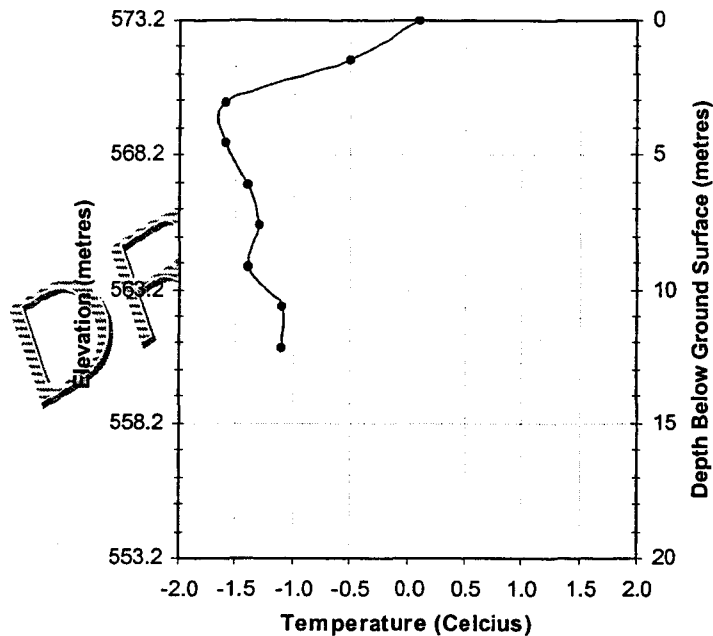
**Figure 4-5**  
**Temperature Profile for T6**

Thermistor string T6 is located about 60 m northwest of the tailings pile. The monitoring results indicate that the overburden soils are frozen to depths of at least 12 m. The relatively warm temperatures 5 feet below ground surface indicate that the active layer could extend to 1.5 m in this area although additional monitoring would have been necessary to measure the active layer thickness. In general, the ground temperatures decrease rapidly with depth to about -1.6 degrees C at 3 m below ground surface and then increase slightly to about -1.3 degrees C below the 3 m depth. This data supports the observation of widespread permafrost.

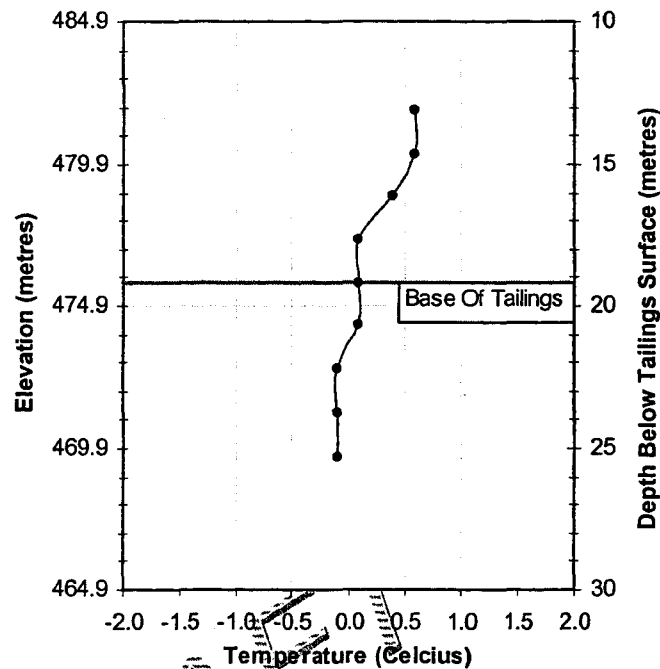
Figure 4-6  
Temperature Profile for T8

Thermistor strings T5 and T8 are located on the south lobe of the tailings pile at the crest and at mid-slope, respectively. The thermistor strings were vertically positioned across the interface between the tailings and overburden soils. Both the tailings and the overburden were observed to be unfrozen. In thermistor T5, the uppermost point was about 0.5 degrees C cooler than the

three points just below, possibly indicating a cool or frost front is advancing from ground surface. The points in the overburden were typically between 0.2 and 0.5 degrees C indicating some degradation of the permafrost had occurred. The temperature profile in T8 decreases gradually from 0.6 to -0.1 degrees C with depth. The temperature of the overburden material appears to be very close to 0 degrees C. The slightly cooler temperatures in the overburden may be due to the thicker depth of tailings at this location (18 m). This is about twice the thickness found at thermistor string T5.

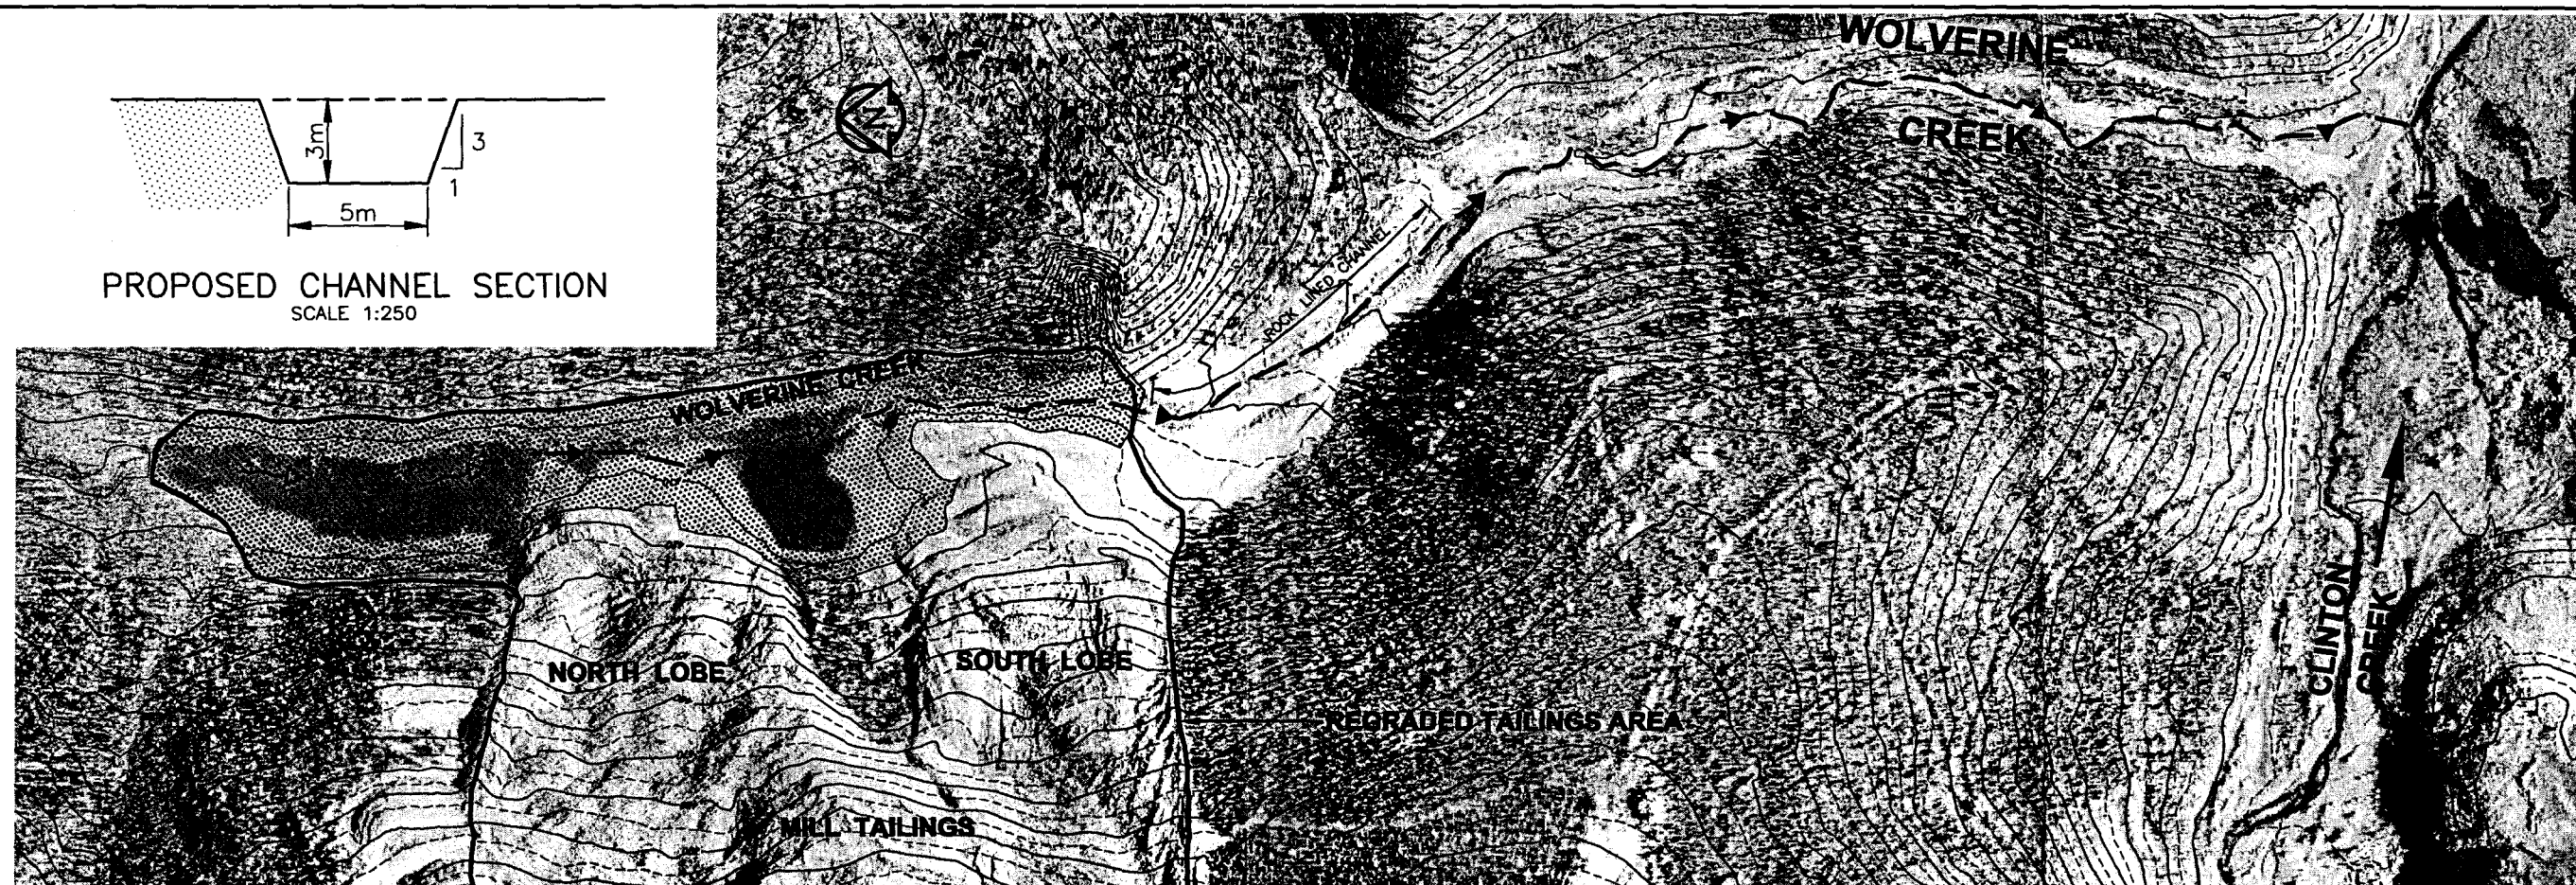
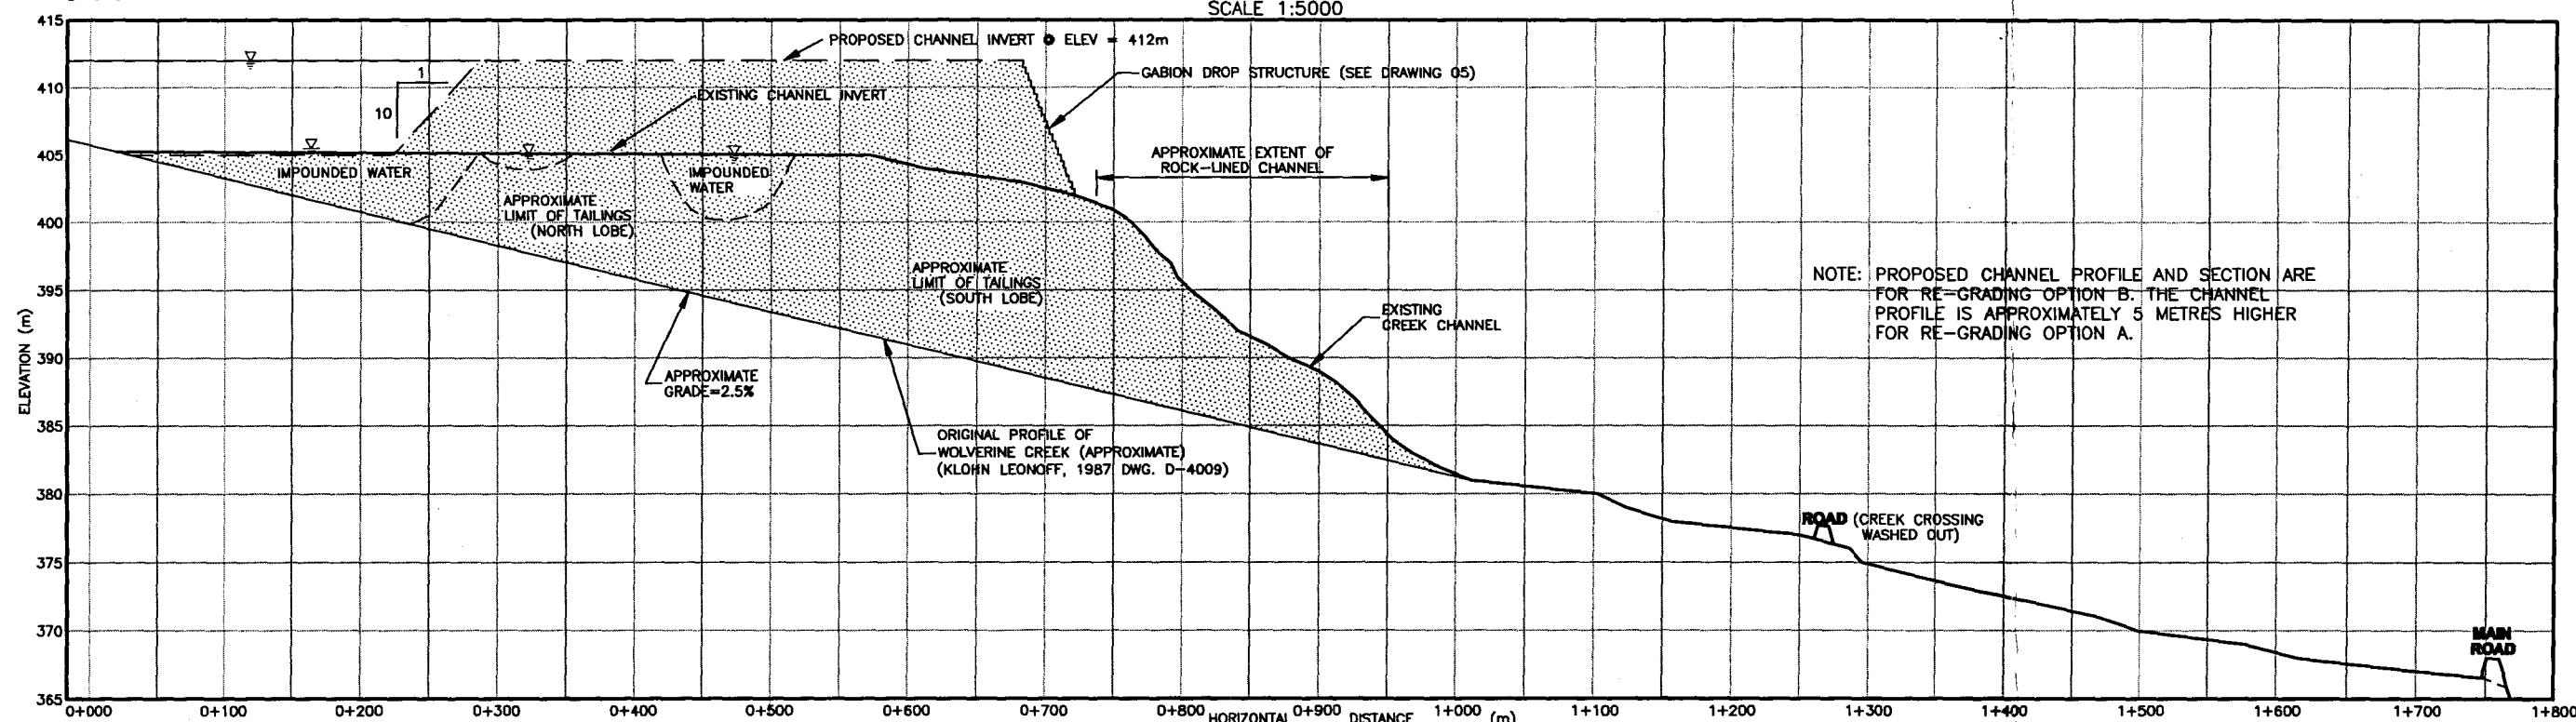
| DWG. No. 17 | REV. - |

granular material large enough to resist erosion. The proposed channel profile for Option B is shown on Drawing 17. Rigid structures such as concrete linings should be avoided due to the risk of cracking and subsequent failure. A transition between the new channel across the tailings and the existing rock-lined channel will be required to ensure the water stays within the stabilized channel. This transition could be accomplished using cobbles and cobble filled gabion drop structures. Final determination of the drop structure profile between the rock-lined channel and the re-graded tailings would be deferred until detailed design.
