**KENO VALLEY/DUBLIN GULCH  
ENVIRONMENTAL BASELINE ASSESSMENT**

**VOLUME IV: Keno Valley Sites #41 to #66, #68 to #70**

Prepared for  
Waste Management Program  
Indian and Northern Affairs Canada

March, 2000

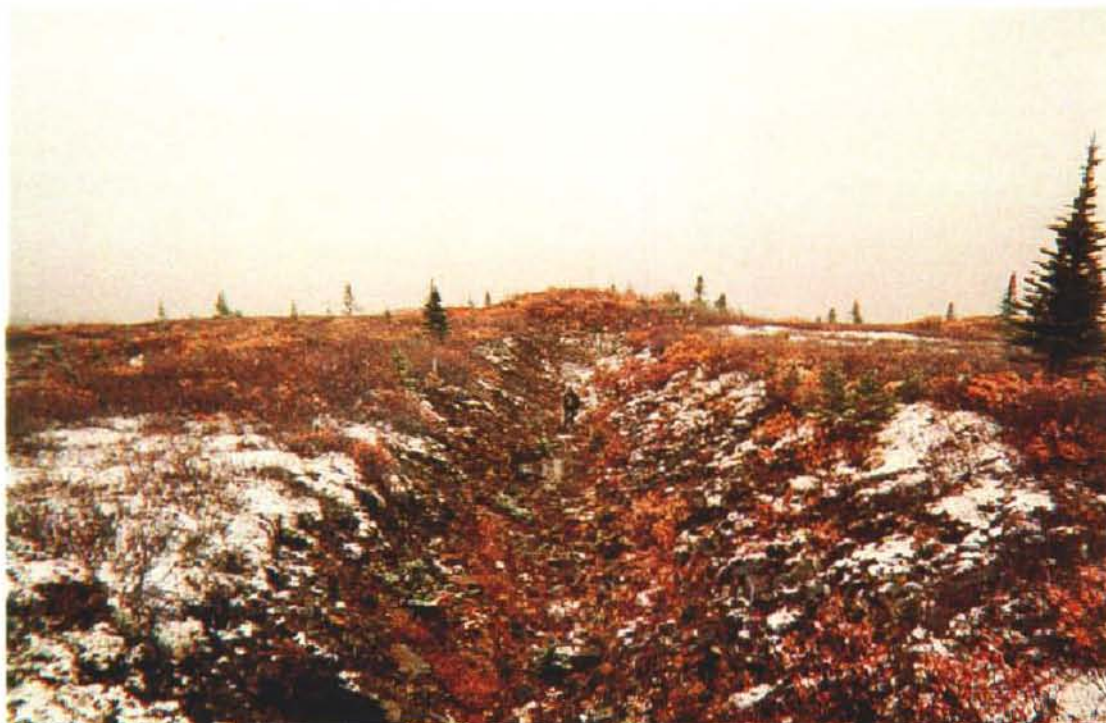
#### Trench 1 (photo 48-1)

Photo 48-1: View of Trench 1 at Apex site. ( AZ 142)

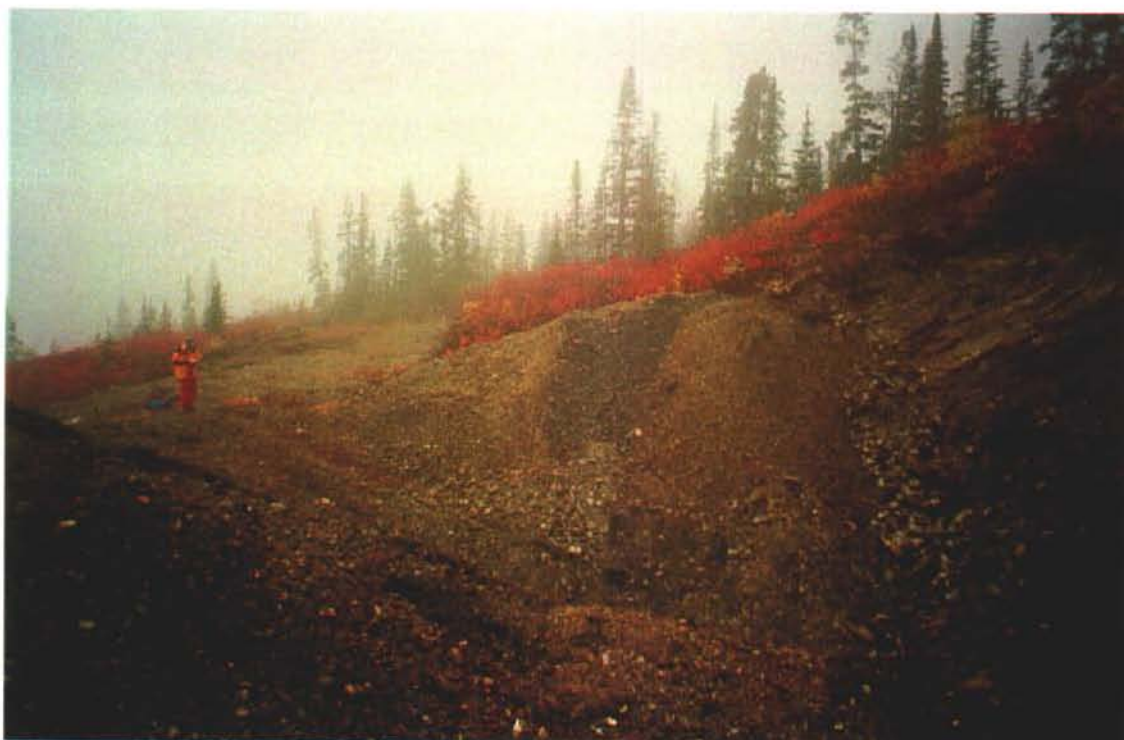
Photo 52-10: Example of waste rock piles surrounding Pit2

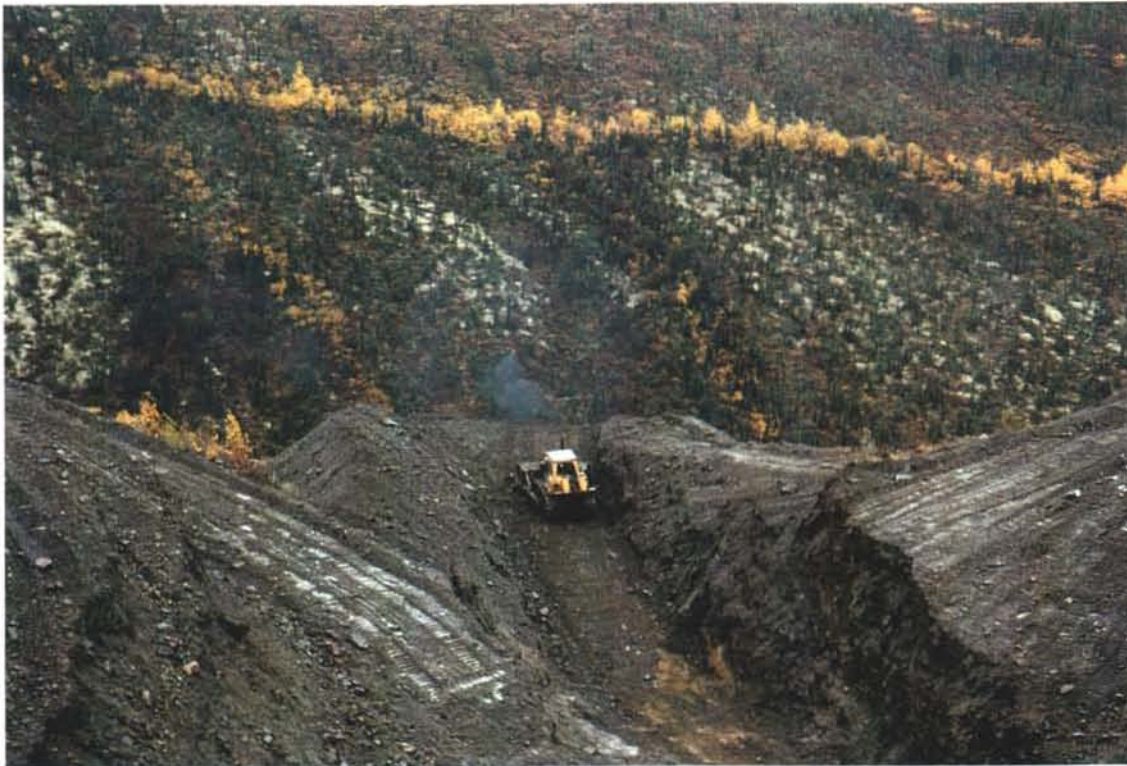
The current claim holder has undertaken further mining of an open cut in the lowest part of Runer. At the time of the site visit, a bulldozer was scraping the bedrock to expose a silver-rich galena vein (photo 55-1). The ore was hand sorted into 2L pails.

Photo 55-1: Bulldozer working at Runer site.

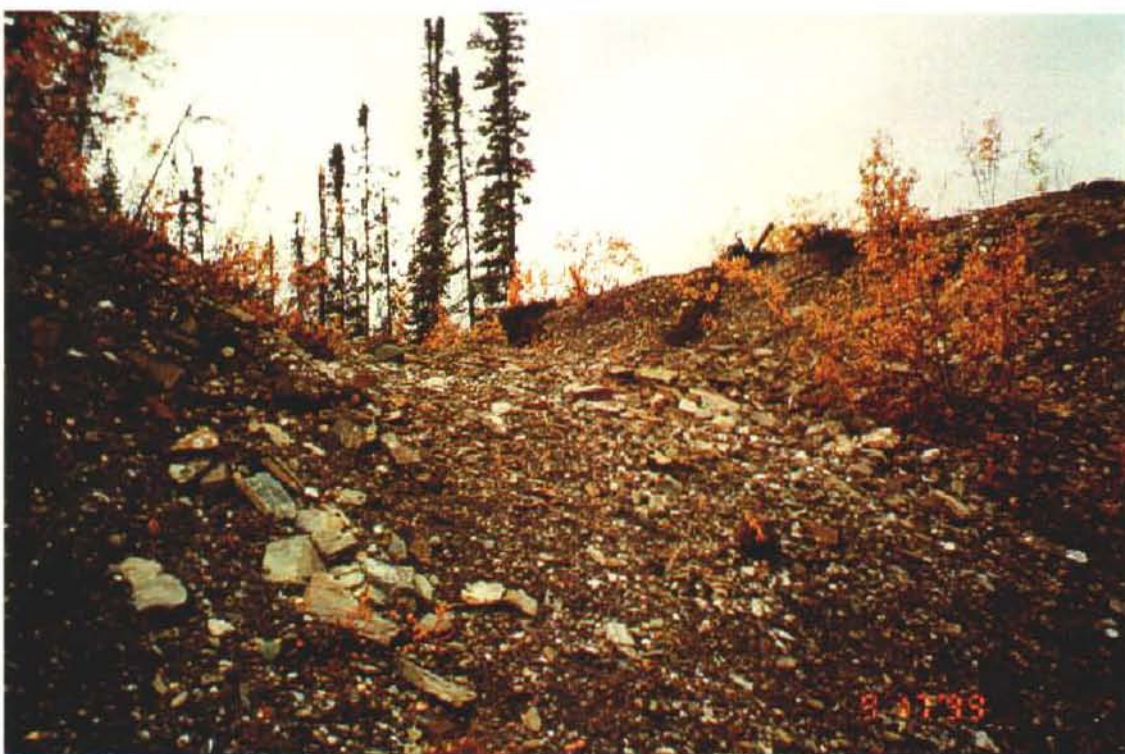
Photo 58-4: Top of knoll at newly trenched area.

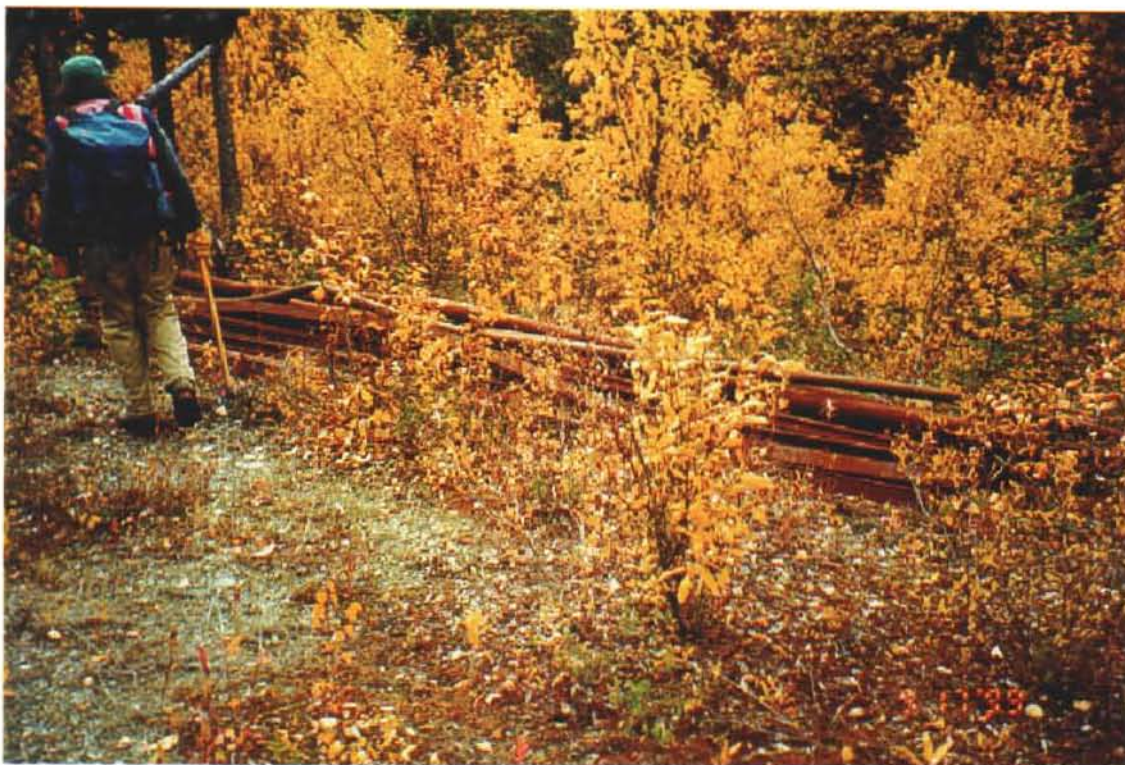
Photo 58-7: Stockpiled rail below adit.

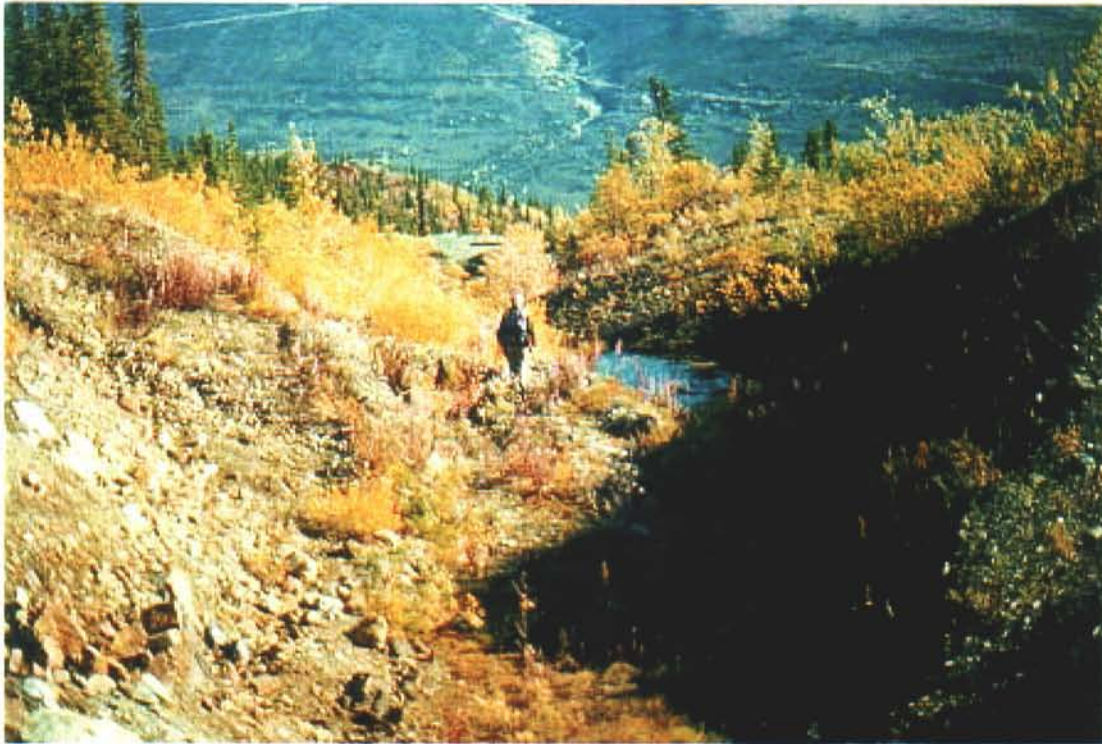
Photo 59-1. Trench, looking eastward from below the shaft.

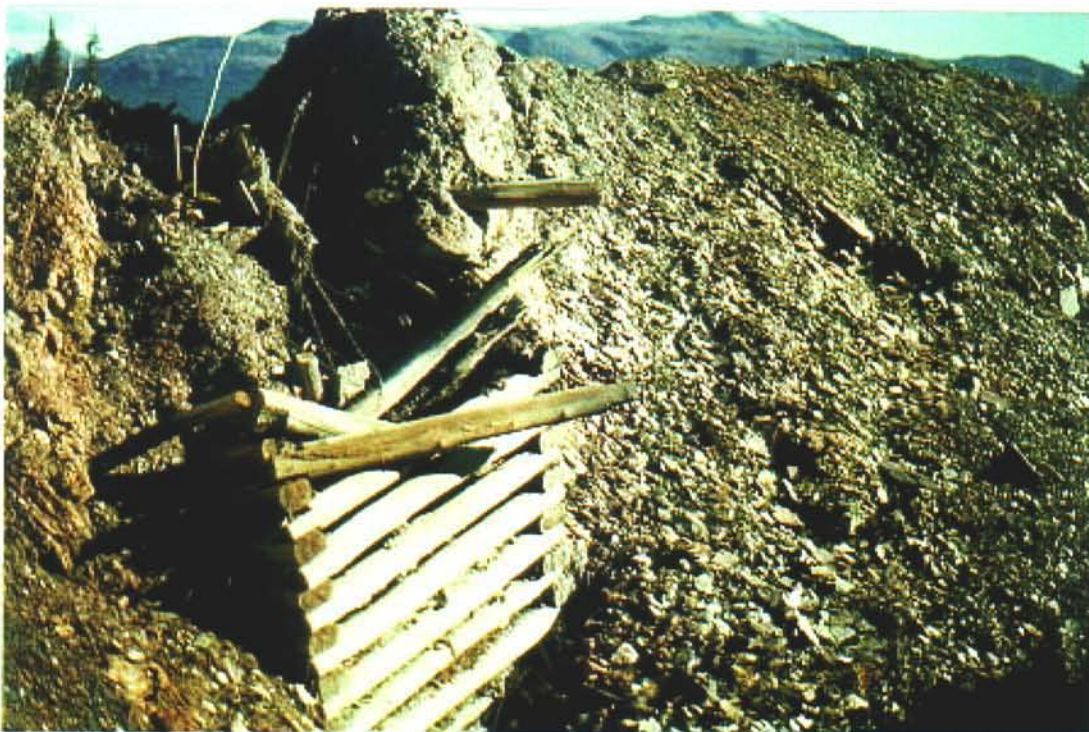
Photo 59-2. Collapsed shaft in center of trench.

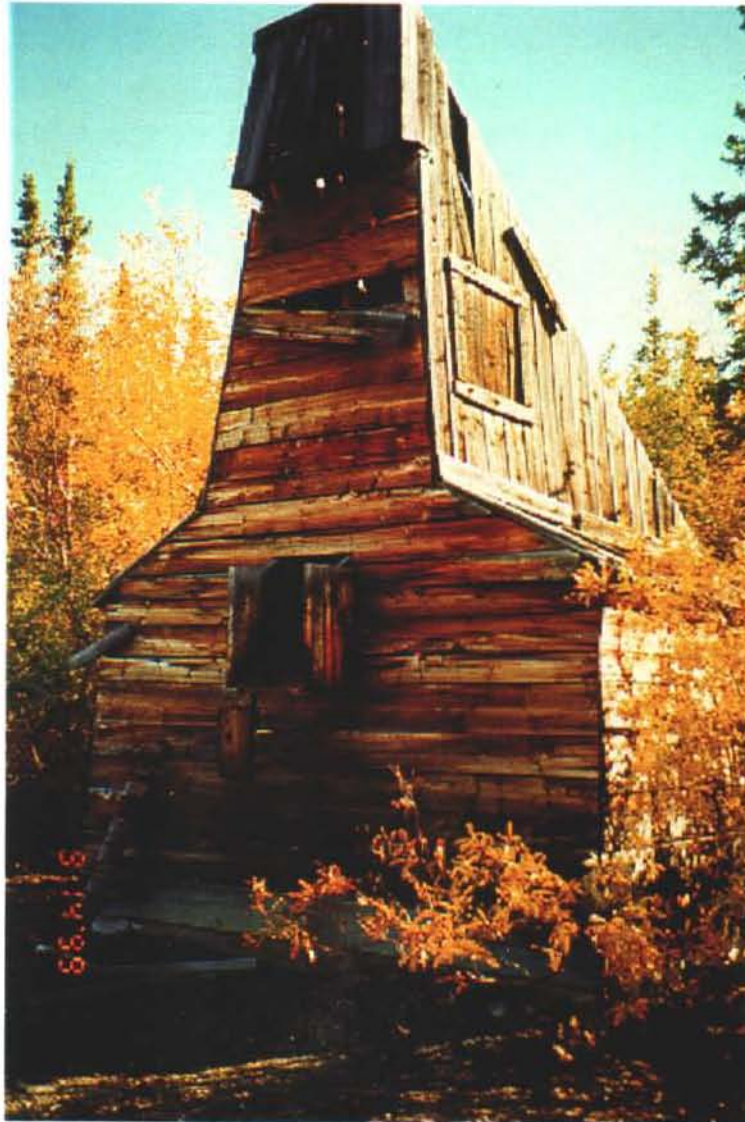
Photo 61-4: Wood framed headframe (61A).

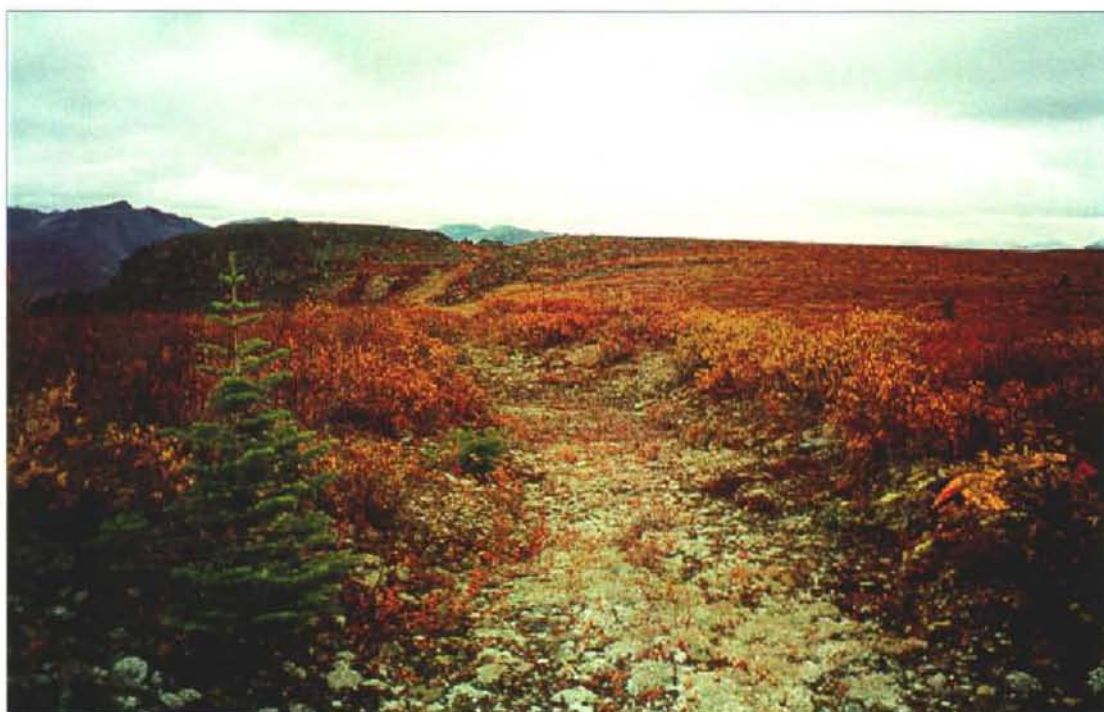
Trench 8 (photo 69-7)

Photo 69-7: View along length of Trench 8. (AZ 033)

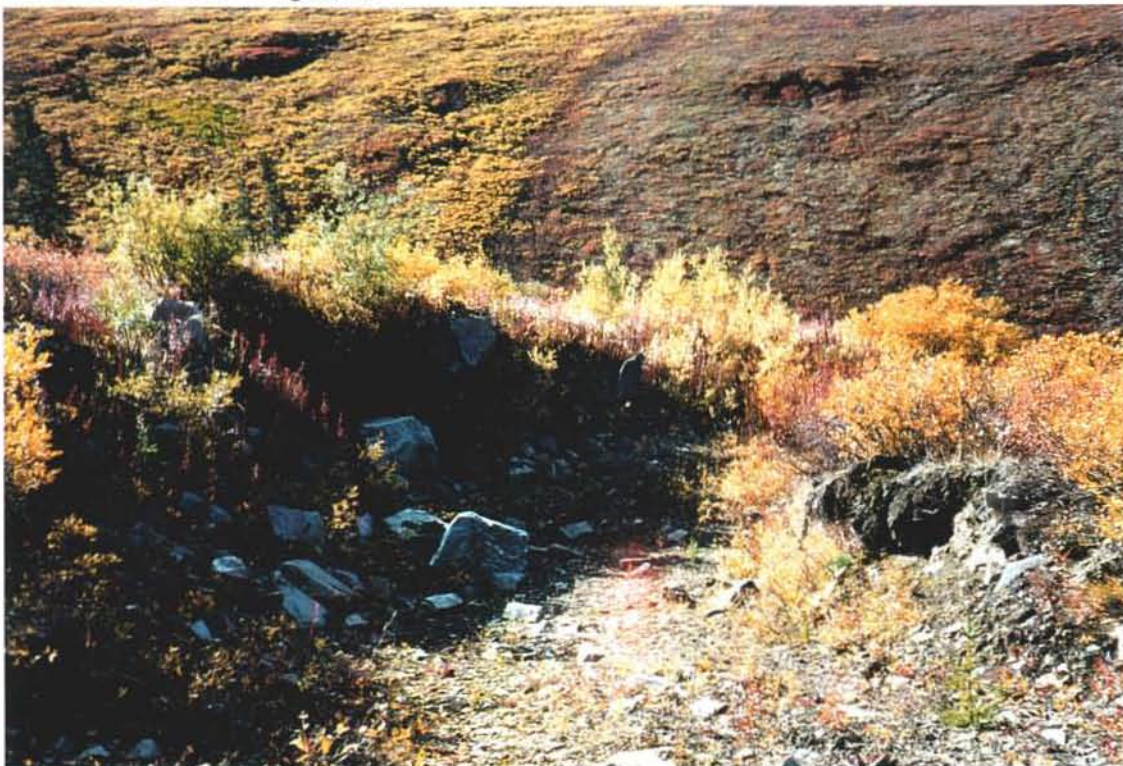
Trench 1 (photo 70-2)

Photo 70-2: View of Trench 1 at Yono site. (AZ 189)

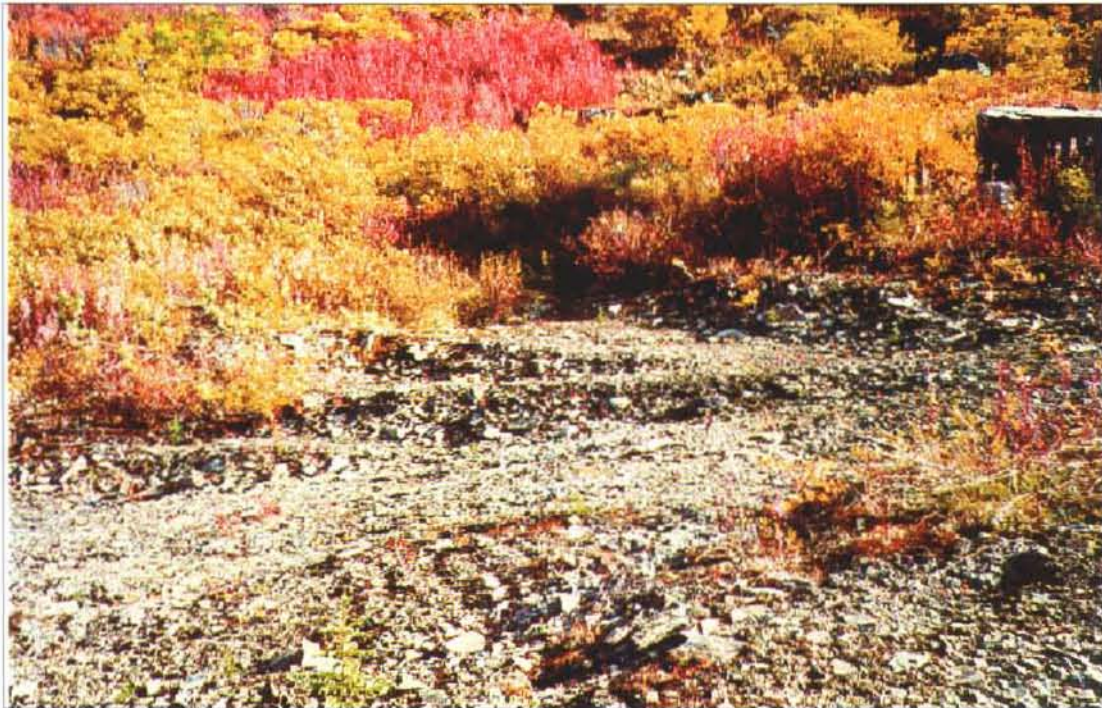
Trench 1 waste rock pile (Photo 70-3)

Photo 70-3: Bulldozed overburden at the mouth of Trench 1.
