**ASSESSMENT REPORT**

**105F-07-1**

**STORMY**

**DIAND TECHNICAL SERVICES**

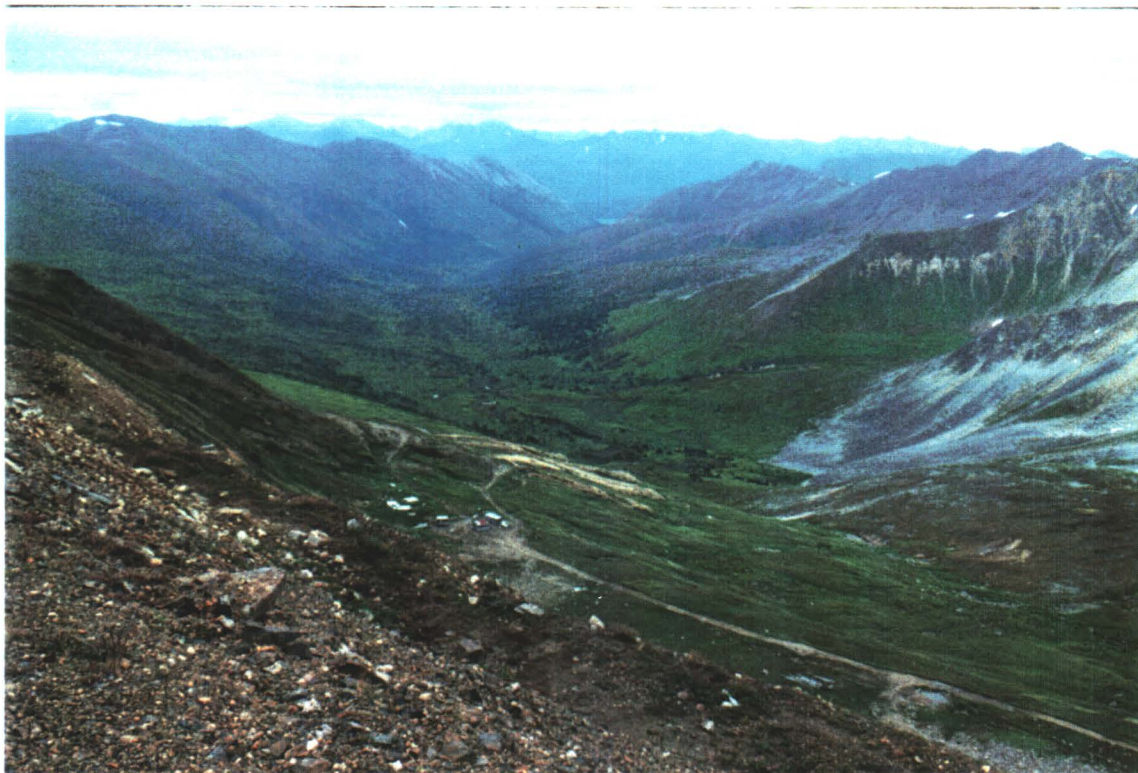
The remaining part of the camp does not provide significant environmental hazard to the area. The wooden buildings will continue to deteriorate and should be demolished and removed or burned, however they pose no real hazard to the surrounding environment. This is considered a **LOW** priority to improve the environment in this area.

CAMP SITE FROM ADIT LOCATION

If a waste clean-up program is implemented in the area, it is recommended that the metal waste be gathered and removed from the site. At the same time, the remaining wood waste should be piled and burned in an acceptable location. This work should be considered a **LOW** priority at this location.
