ASSESSMENT REPORT

115I-06-1

LAFORMA

DIAND TECHNICAL SERVICES

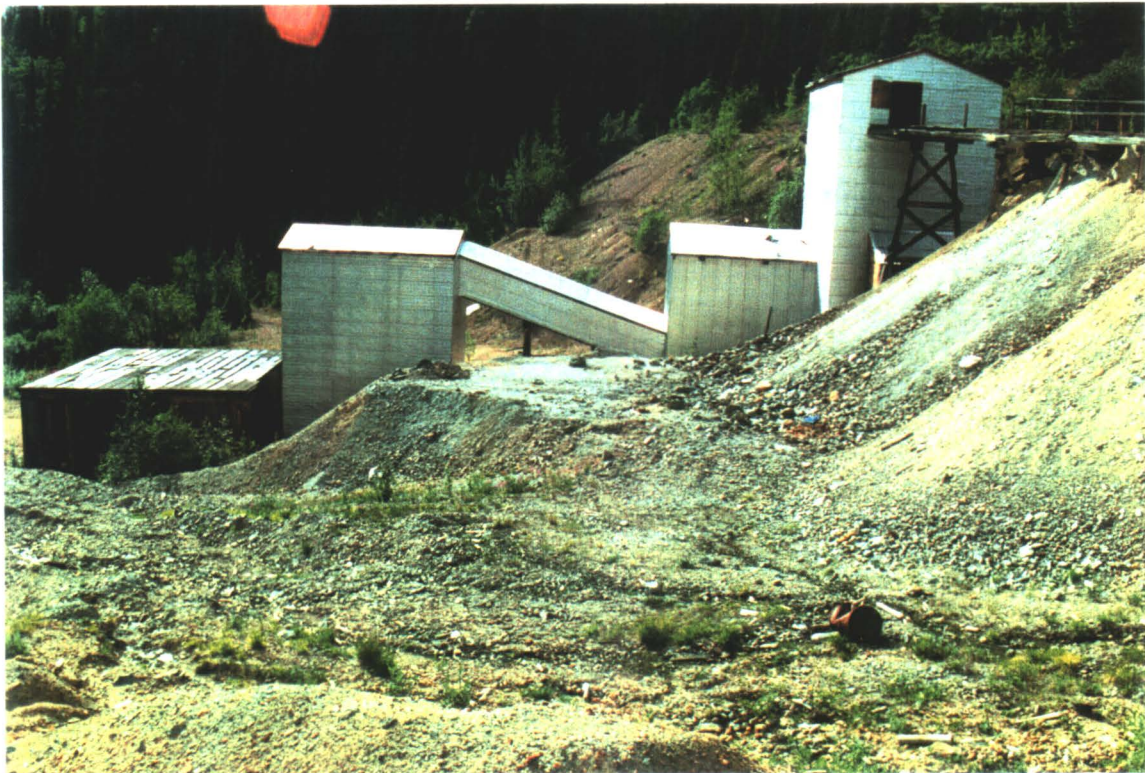
CORE STORAGE SHEDS

The remaining core sheds and storage buildings are deteriorating slowly with time, however they do not appear to pose any ongoing environmental hazard. These buildings should be removed from the site only if a general clean-up program is initiated in the area. This is considered a **LOW** priority. The remaining core should be assessed by a qualified geologist if salvage of the core is to be considered.
