Assessment of Abandoned Yukon Mine Sites

Mount Haldane #37

Prepared for
Public Works and Government
Services Canada

February 1997
GV206.01

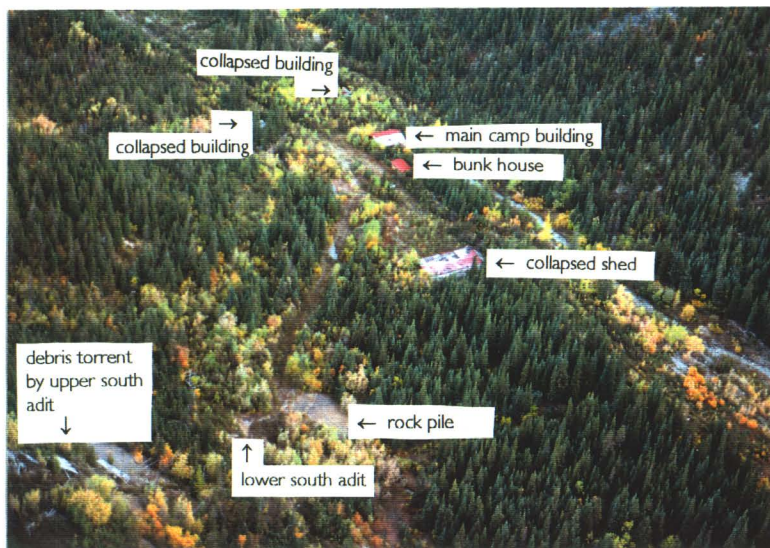
1

The main camp site is located at the base of the gulch. Two adits are present a short distance away from the camp area on the south slope of the gulch and one other adit and several areas of trenching are located along the north slope of the gulch. The main roadways, trails, trenching and excavations are identified on the airphoto (Figure 1.3) and the site layout highlighting significant site workings and structures is provided in Figure 5.1. Photo 1, Appendix A was taken from the air on the day of the site visit and shows several of the structures in the camp area and the mine workings on the south slope.

- Photo 1: View of camp site and south slope from the air.
- Photo 2: Main camp building.
- Photo 3: Bunk house.
- Photo 4: Collapsed wood building west of camp on north side of roadway.
- Photo 5: Collapsed wood building west of camp on south side of roadway
- Photo 6: Collapsed shed building.
- Photo 7: Debris and collapsed wood building near upper south adit.
- Photo 8: Collapsed wood building near north adit.
- Photo 9: Partially full drum at old drill and generator area.
- Photo 10: Old drill and generator.
- Photo 11: Rock pile.
- Photo 12: Lower south adit showing discharge water.
- Photo 13: Upper south adit entrance.
- Photo 14: Upper south adit inside entrance.
- Photo 15: North adit, collapsed.

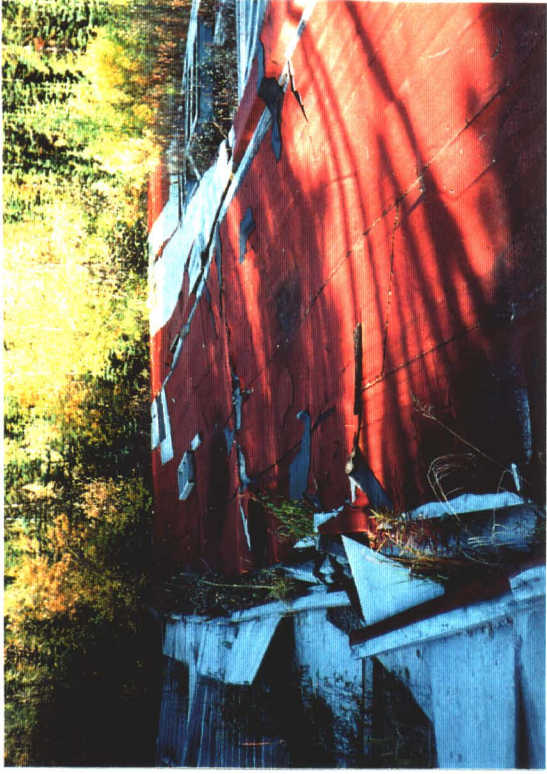
6

This collapsed wooden building (Photos 1 and 6, Appendix A) is located approximately 60 m east of the main building. The dimensions of this former structure are estimated to be 18 x 4.5 m. The remains of the roof contain asphalt shingles. The size of the building suggests that it was formerly a storage building. The presence of debris under the structure could not be verified or assessed.
