Phase III Environmental Assessment

Formo Mine Site

Final Report

Action on Waste Program
Indian and Northern Affairs Canada

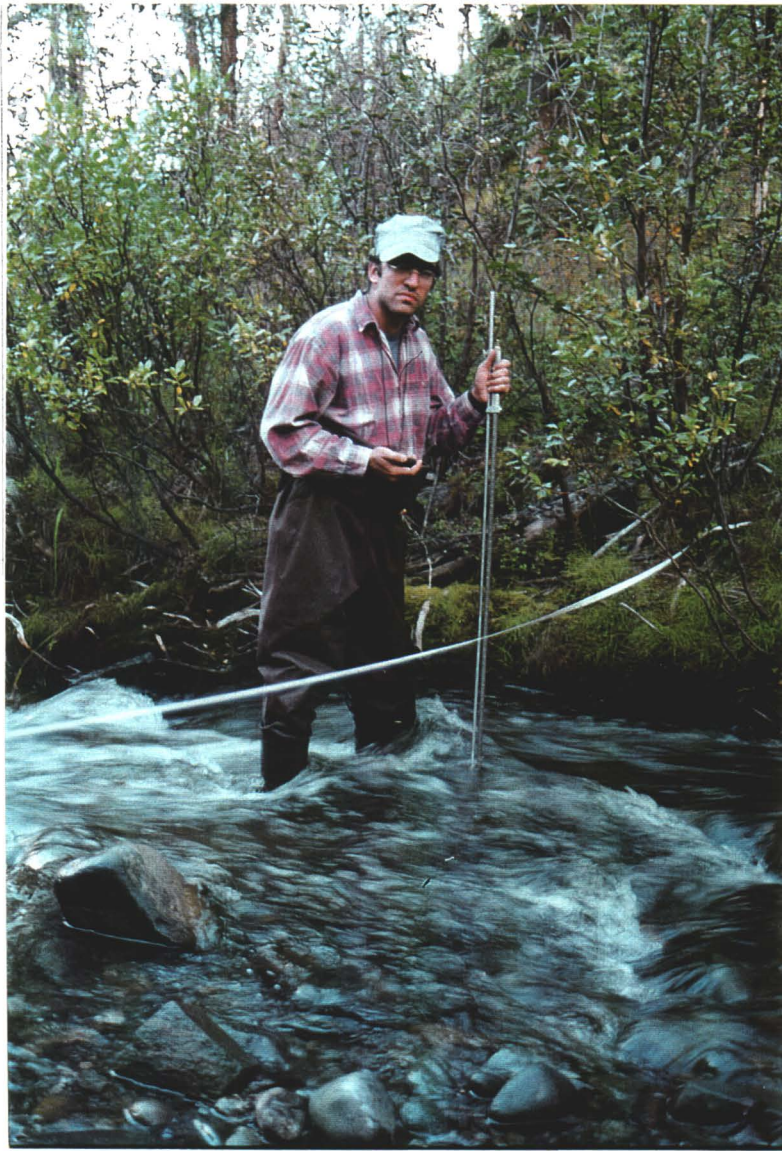
Photo 10. Christal Creek discharge measurement below toe of lower/eastern waste rock slope, 19 August 1997.

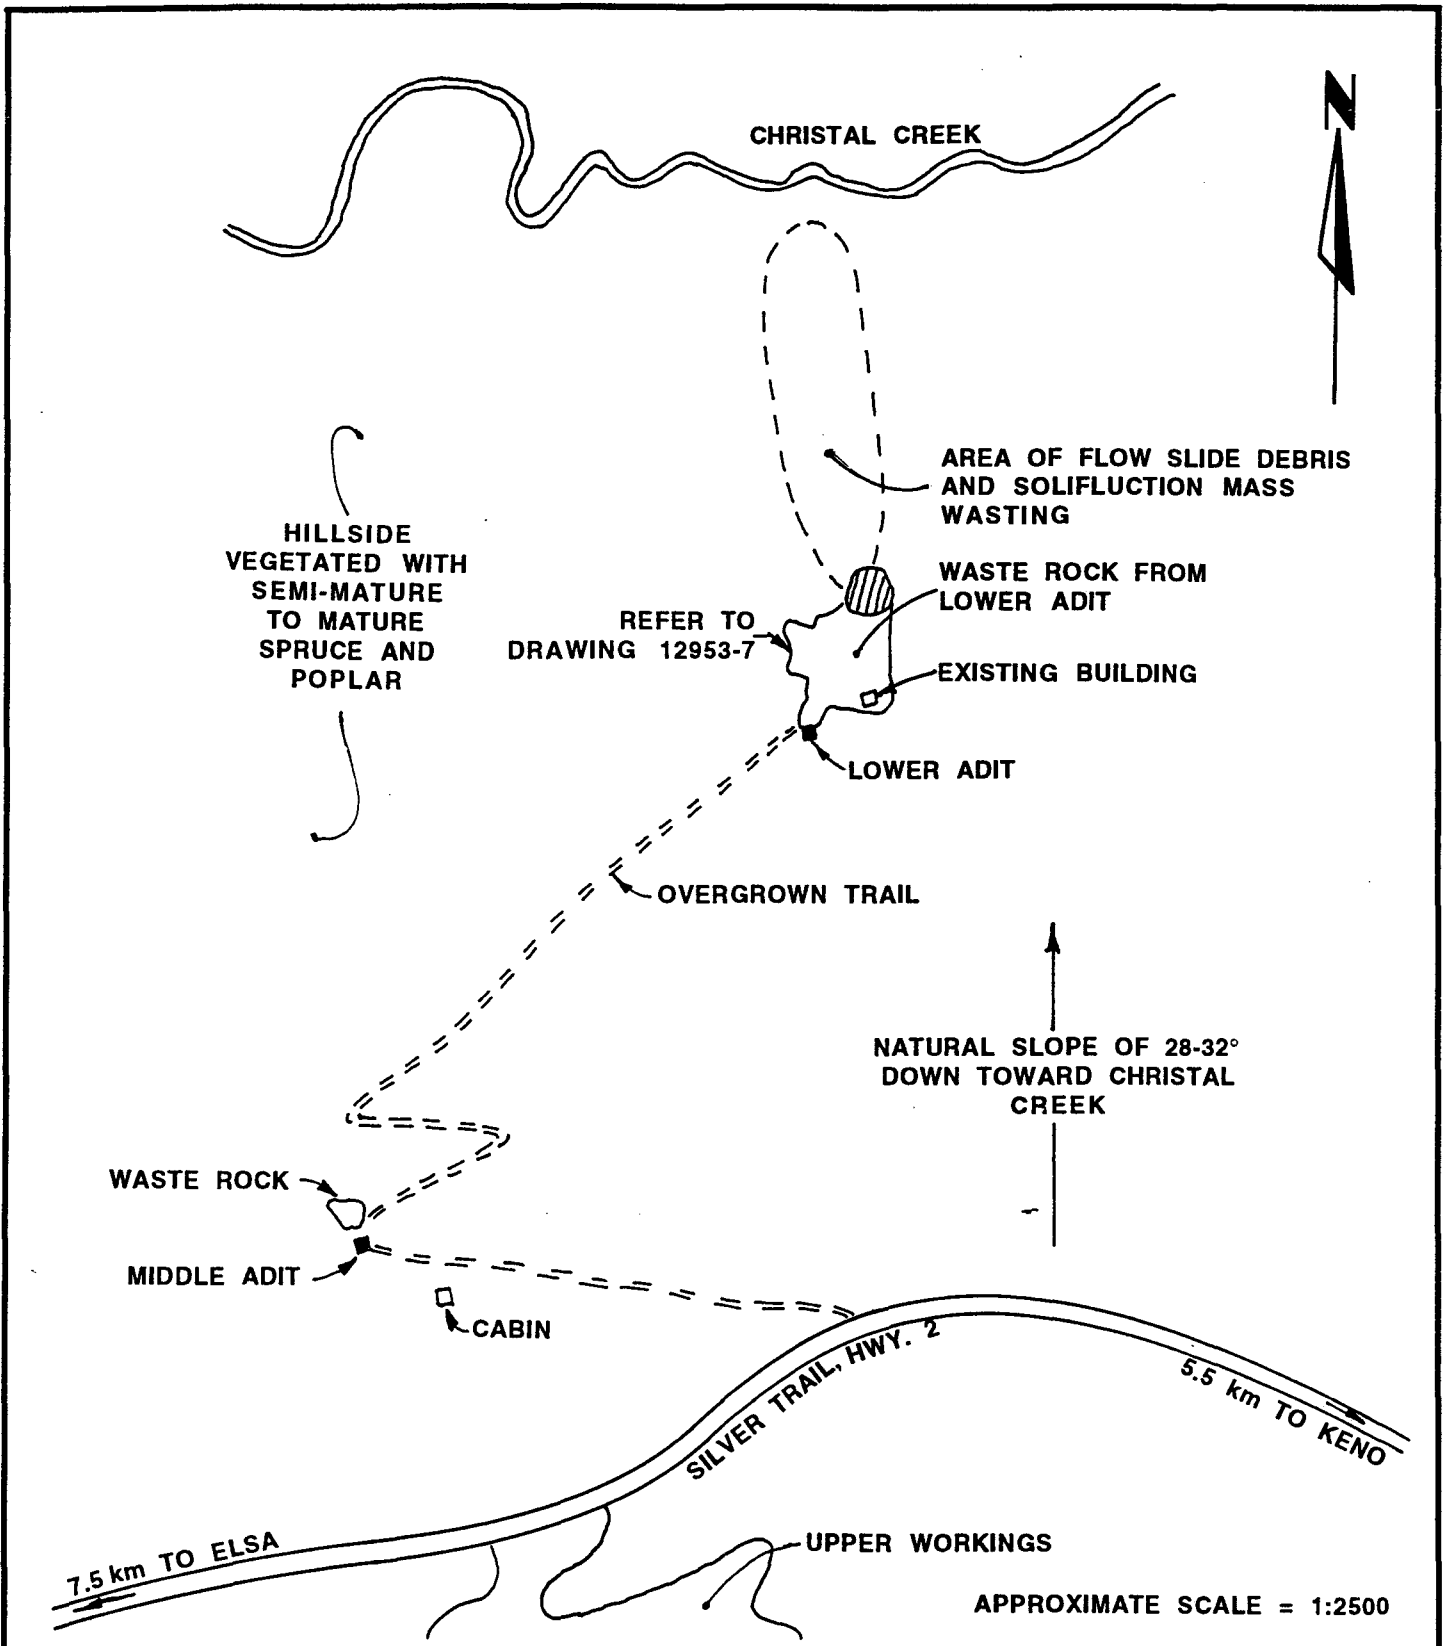
EBA Engineering Consultants Ltd.	PROJECT GEOTECHNICAL SERVICES YUKON ABANDONED MINE SITES			
CLIENT PUBLIC WORKS & GOVERNMENT SERVICES CANADA	TITLE SITE PLAN OF FORMO MINE			
DATE 97/10/08	DWN. MEB	CHKD. MEB	DRWG NO. 12953-6	FILE NO. 0201-97-12953

The lower workings consisted of a waste rock pile covering an area of approximately 80 m by 60 m as described in Drawing 12953-7. The waste rock pile area was slightly vegetated with young poplar and willow and the slope angle ranged from 28° to 34°. The primary area of waste rock material is located immediately below the adit and level pad where the two old structures are located. The most notable feature of this area was the presence of a large slide failure within the waste rock pile at the location shown in Drawing 12953-7 and as depicted in Photo #F3. The slide appeared to be caused by a translational slip which involves a failure surface developing at the interface of an adjacent stratum with significantly different strength. This stratum is typically at a relatively shallow depth and the failure surface tends to be planar and roughly parallel to the slope¹. The failure surface appeared to occur between the native gravel and sand till material and the overlying peat layer. The peat layer, which represented the original ground surface prior to the deposition of the waste rock, was noted as being up to 0.5 m thick as seen in Photo# F4. The instability of this weak layer was compounded by the excessive surcharge load which had accumulated on a slight bench formation along the slope near the bottom of the waste rock area. The natural bench along the slope can be seen on the right hand side of Photo# F3. The peat layer would have virtually no resistance to shear failure induced by surcharge loads from the overlying waste rock. Further, the compression of the peat would decrease its insulating capabilities causing an increase in the active layer and a corresponding decrease in the shear strength of the previously frozen underlying soil. It is believed that the waste rock had accumulated at the bench along the slope until the increase in surcharge load on the unstable peat layer had eventually caused a translational slip failure along the peat and underlying till interface.
