Phase III Environmental Assessment

Venus Mine Site

Interim Report

Environmental Services
Public Works and Government Services Canada
Pacific & Western Regions

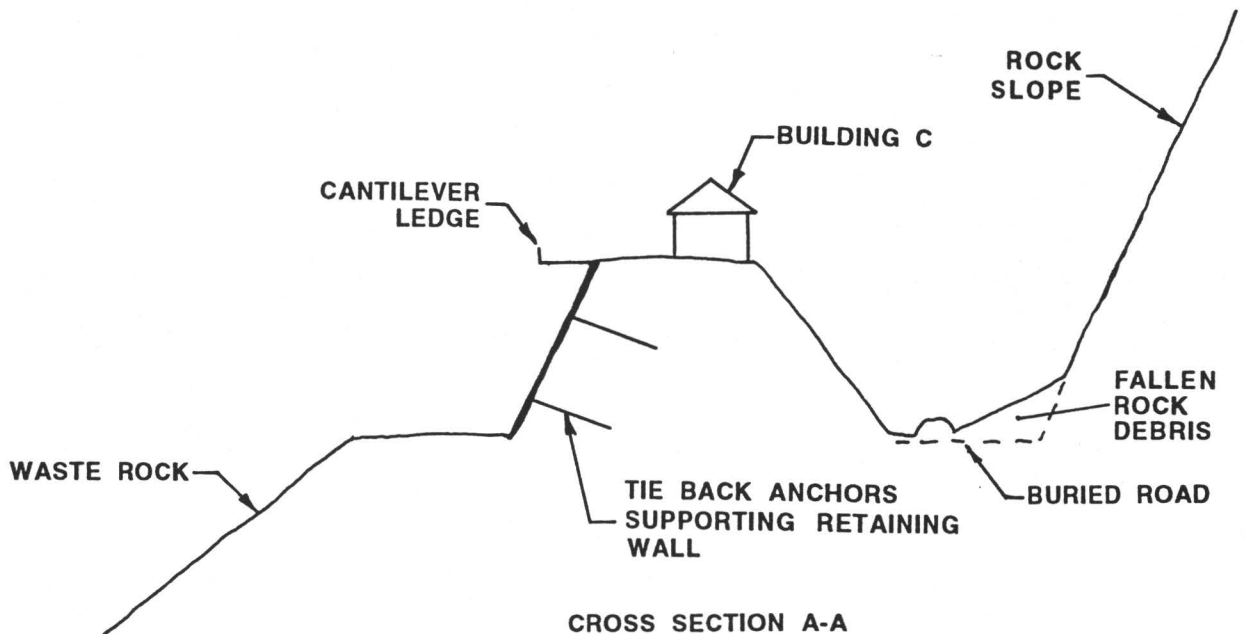
CROSS SECTION A-A

The primary concern with respect to slope stability is the area of the two retaining walls near Adit 2. These retaining walls are constructed of log cribbing and have shown signs of degradation. It is unavoidable that further decay of these retaining walls will occur and that they will eventually fail which may lead to adverse impacts on the South Klondike Highway. It is recommended to intentionally fail these structures to reduce the risk of a future uncontrolled failure. Two options to demolish these retaining walls has been provided. The first option would involve dismantling the retaining walls and mobilizing the waste rock downslope to a catchment area where it could be disposed of off site. The second option would involve relocating the material behind the retaining walls to the level bench area in the vicinity of adit 2 and reshaping the slope to an acceptable grade. Class "D" cost estimates for each of these restoration options have been provided under separate cover.

The site conditions at Adit 2 are essentially as described in the Site Plan enclosed as 12953-12 and in Photos #V2 to V4. In the area of Adit 2, the waste rock piles were considered generally stable and
