**FINAL REPORT  
ASSESSMENT OF REMEDIAL MEASURES FOR  
ARCTIC GOLD & SILVER TAILINGS SITE**

**THE ARTIC GOLD & SILVER WORKING GROUP**

**STEFFEN ROBERTSON AND KIRSTEN (CANADA) INC.**  
Suite 800, 580 Hornby Street  
Vancouver, B.C. V6C 3B6  
Tel: (604) 681-4196 • Fax: (604) 687-5532  
E-mail: [vancouver@srk.com](mailto:vancouver@srk.com) Web site: [www.srk.com](http://www.srk.com)

**FEBRUARY, 1999**

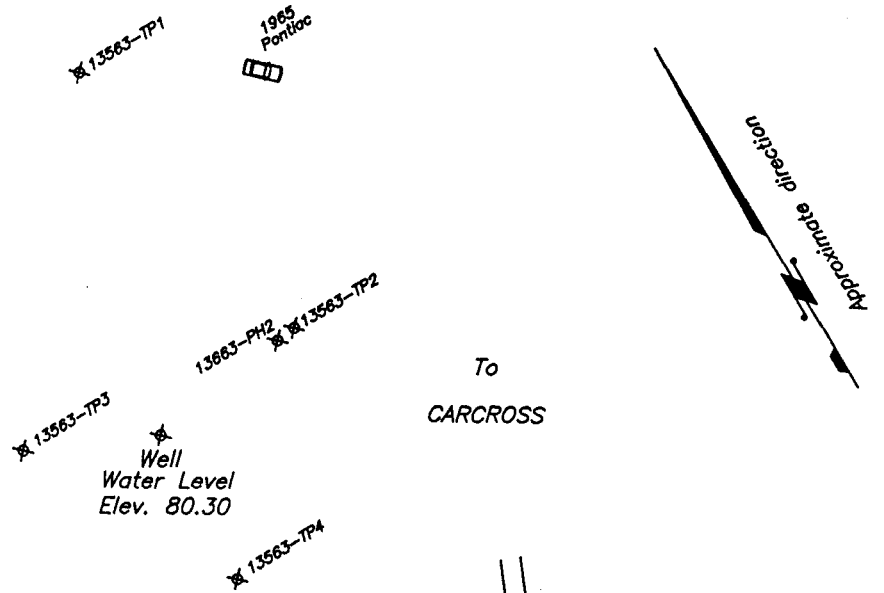
Photo 3. Location of MW6

- To assist in the evaluation of ground water flow and water quality outside of the tailings impoundment area, monitors 13563-MW3 and 13563-MW6 were installed. Based on the topography of the site and on an interpretation of drainage features from aerial photos, the locations were inferred as being hydraulically upgradient of the tailings area. This assumption was validated by on-site calculations using accurate survey data of monitors 13563-MW1 through -MW4 provided by Underhill Geomatics Ltd. on 98/8/31. The horizontal direction of ground water flow was determined to be toward the west, roughly in a direction parallel to monitors 13563-MW1D and -MW2. As seen on the well installation details, monitor 13563-MW6 was constructed for piezometric measurements only. It is noted that the static water level at -MW6 was very close to the existing ground surface, with extensive free water observed while removing the solid stem augers (see Photo 3).
