SÄ DENA HES MINE

ENVIRONMENTAL BASELINE
AND
GEOTECHNICAL EVALUATION REPORT

Prepared by:
**GEO-ENGINEERING (M.S.T.) LTD.
Calgary, Alberta**

April 2000
G1776

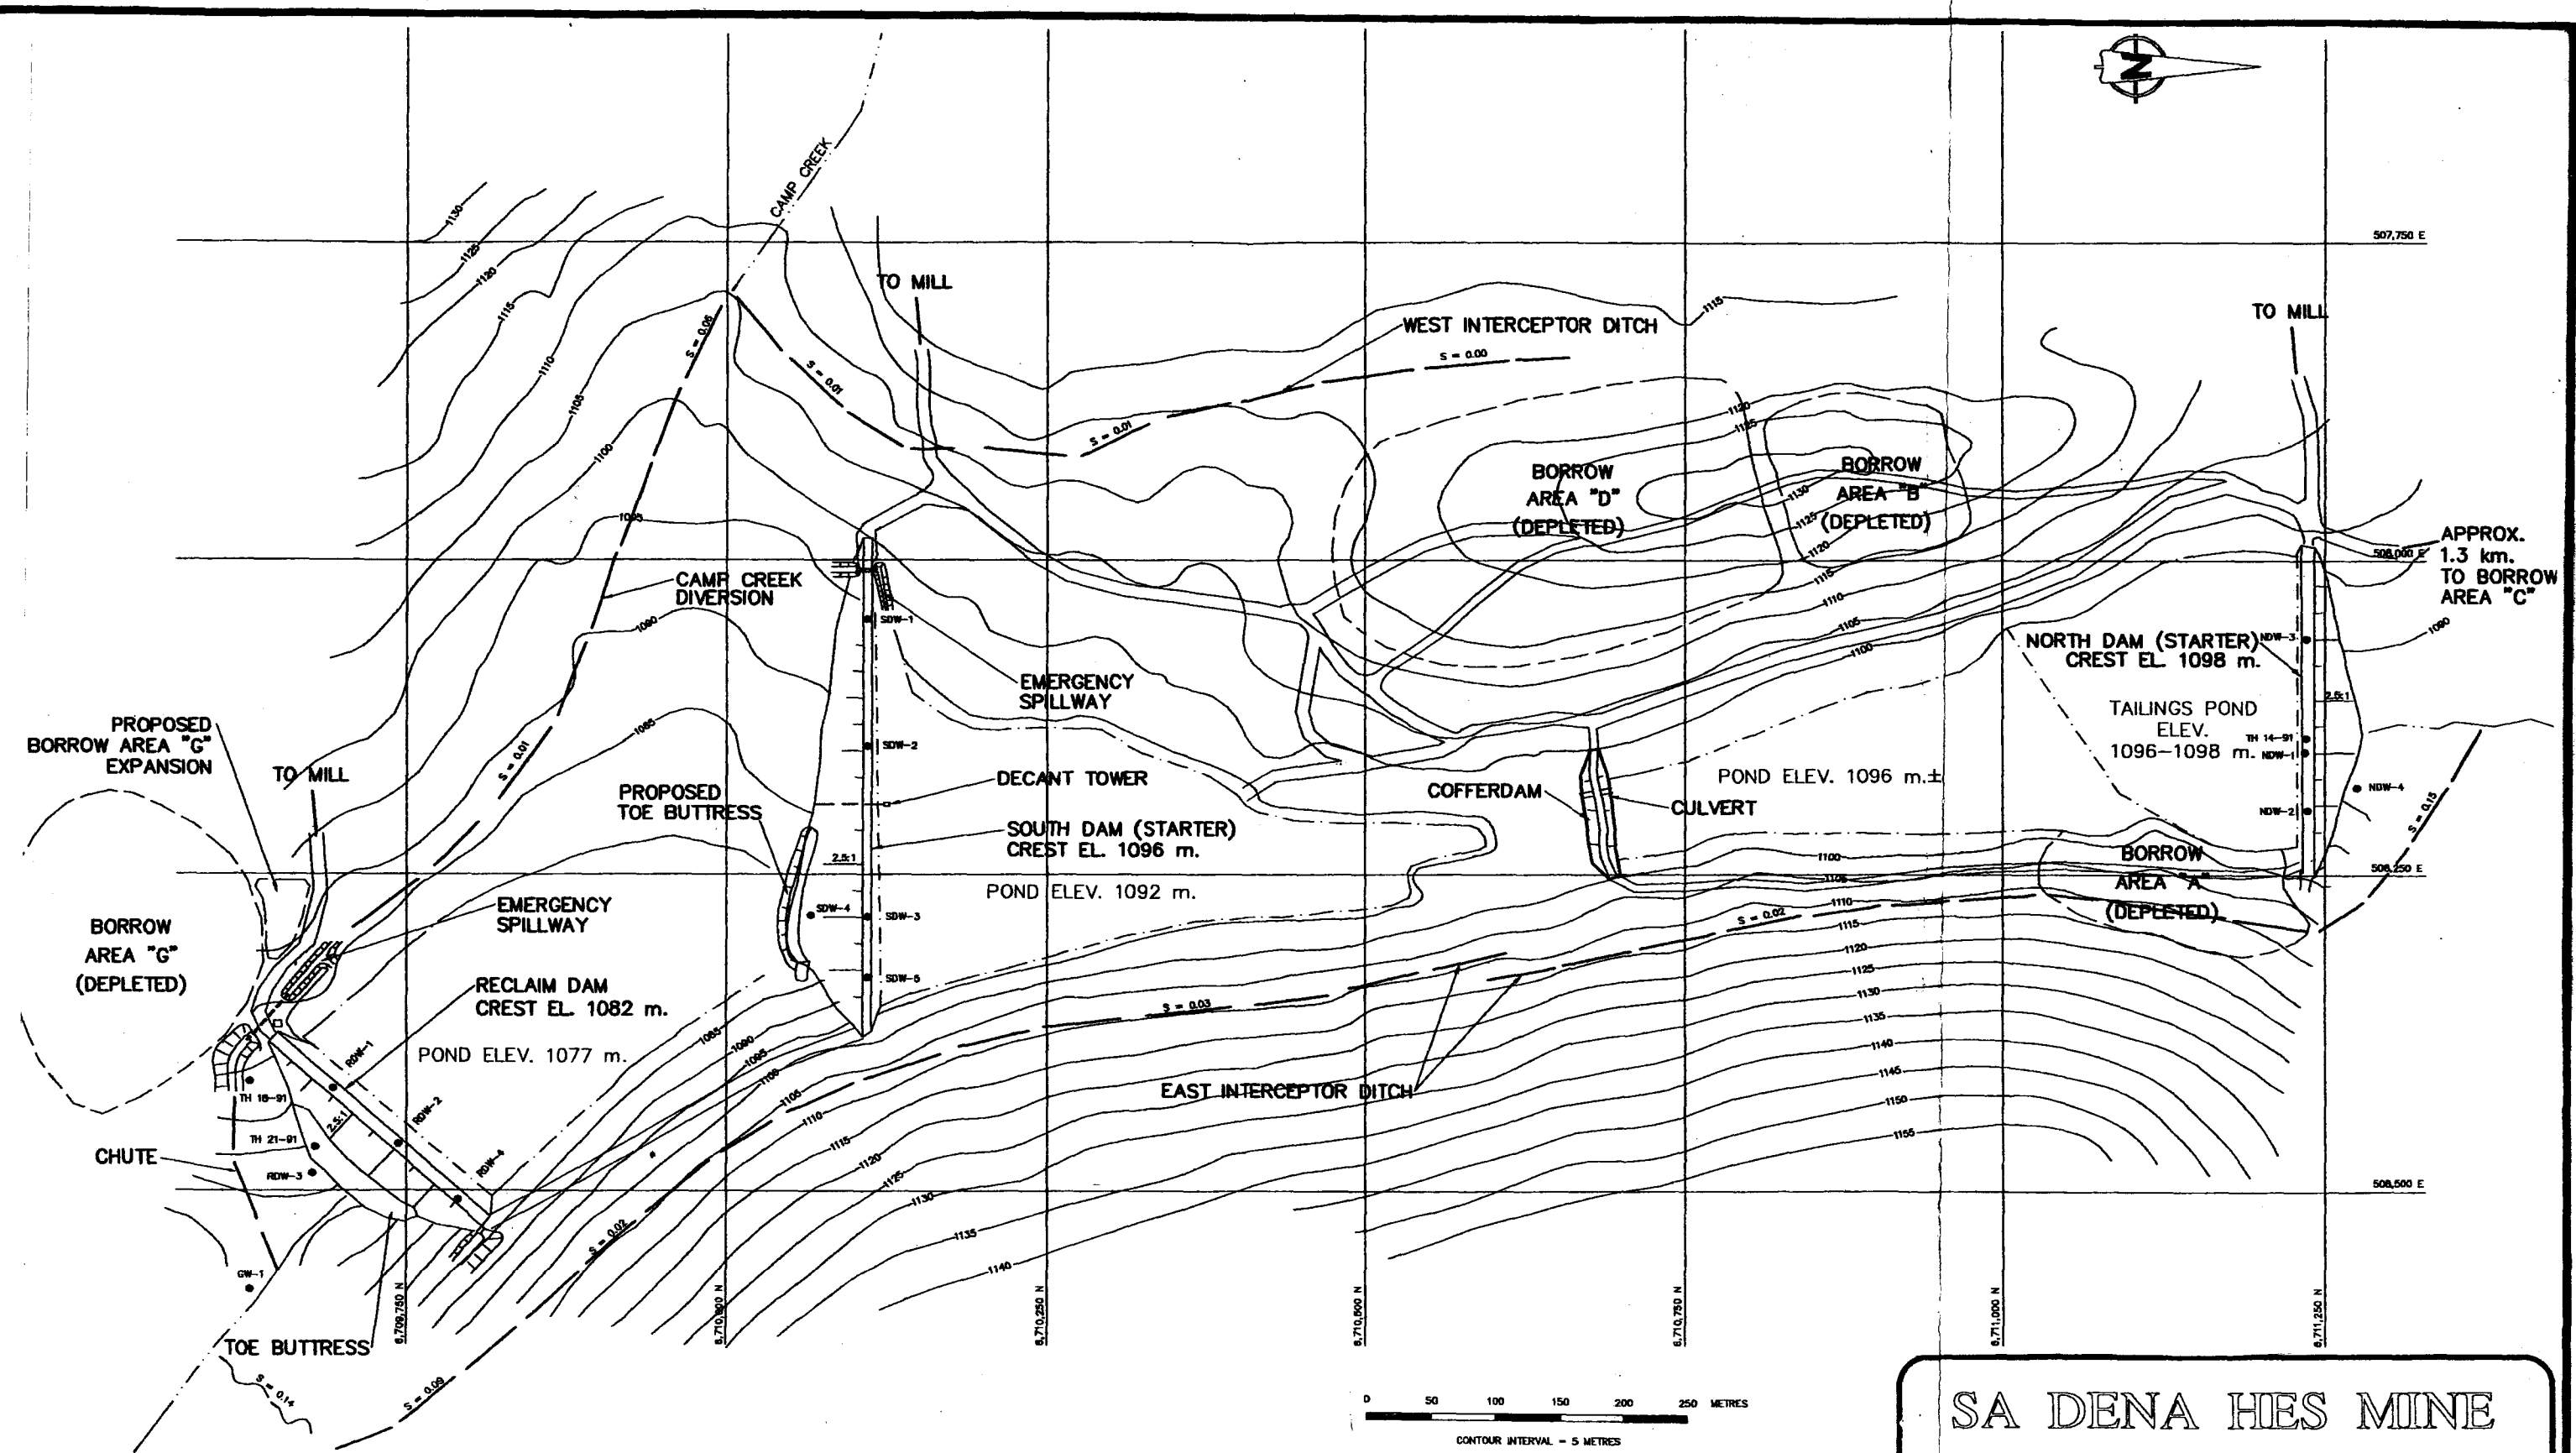
SCALE: As Shown	PROJECT No. G1776	FIGURE 4-4
--------------------	----------------------	------------

The reclaim dam (Figure 4-4) was designed as a zoned structure with a low permeability upstream section, key trench and inverted gravel filter at the downstream toe. The filter was covered, in 1992, with a toe support berm, comprised of blast rock 0.5 to 2.0 m in diameter. In addition, an about 50 m long and up to 1.3 m thick till blanket was placed into the original creek channel.
