BERMINGHAM (# 6)
(MINFILE# 105M 001,d,e)

RUBY 400 #6
(MINFILE # 105M 001 d,e)

Public Works And Government Services Canada Travaux publics et Services gouvernementaux Canada Architectural & Engineering Services Western Region	designed by: conçu par: drawn by: dessiné par:	C.S. Nov. / 99	date:
	approved by: approuvé par:	revisions:	project no. no. du projet:
Drawing title: Birmingham & Ruby (Arctic & Mastiff) Site #6 Site Assessment Yukon Territory	Titre du dessin:	125-12.01	dwg. no. dessin no. 2 of 2

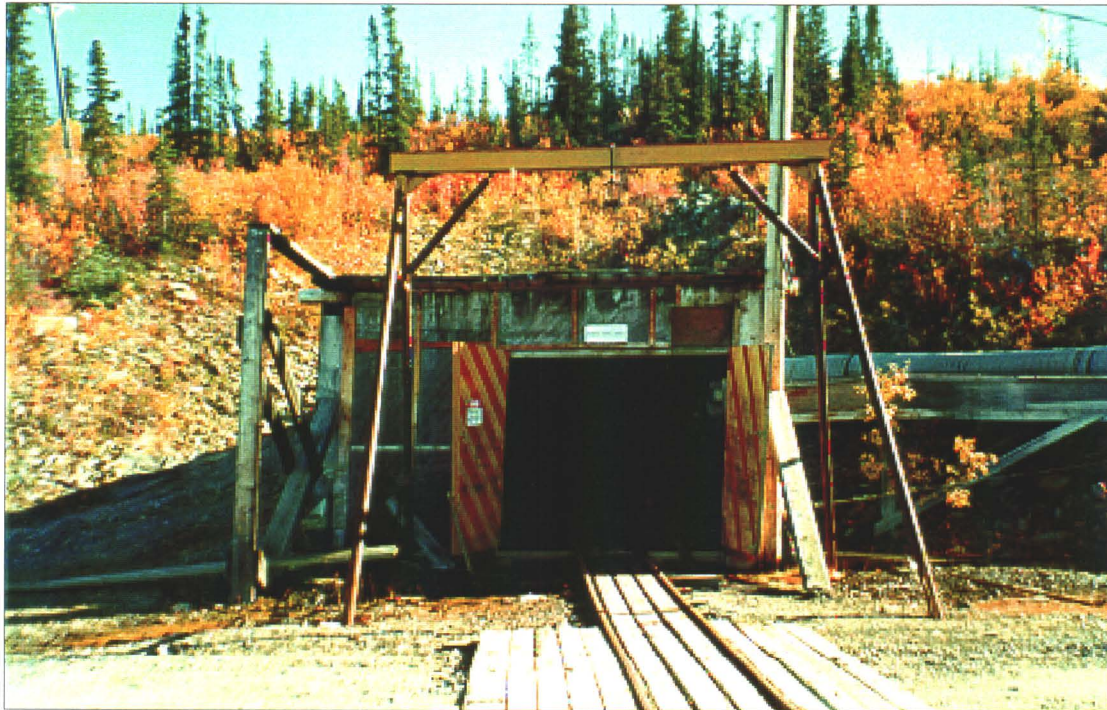
Building 6G – Adit (photo 6-15)

Photo 6-15 : Ruby 400. Adit structure with rail tracks extending from the structure and utilidor on right..

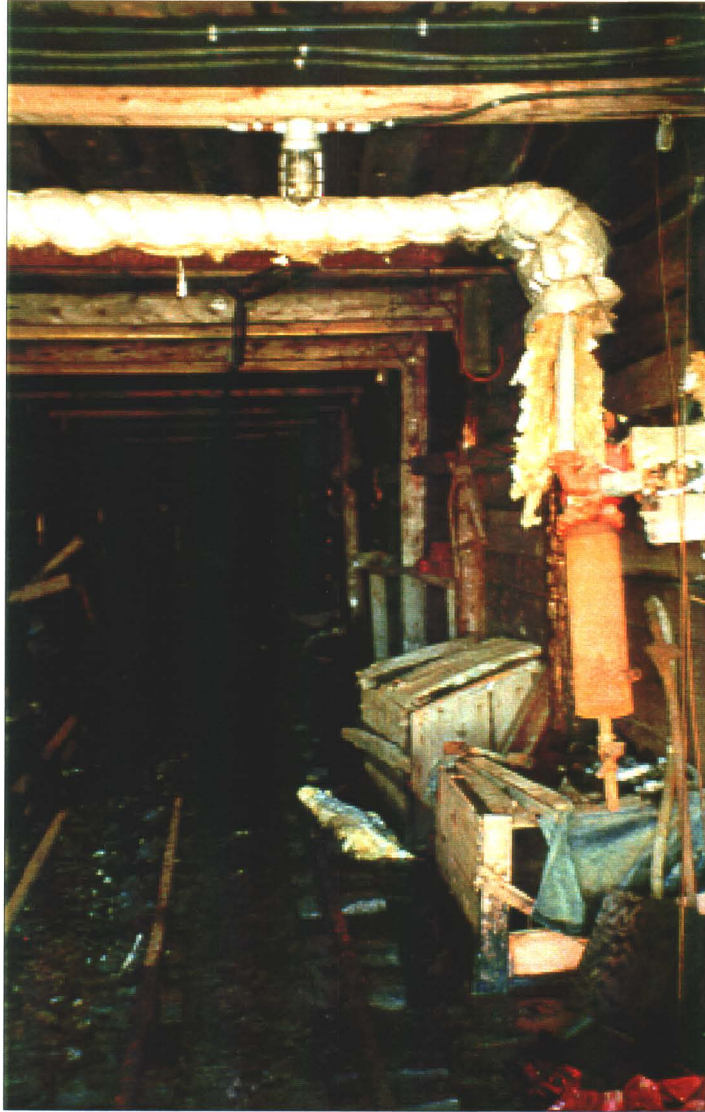
Construction: The structure is constructed of wood frame with tar paper lining the exterior. The interior consists of wood plank sheathing (photo 6-16).

Photo 6-16 : Ruby 400. Interior photo of the adit structure.

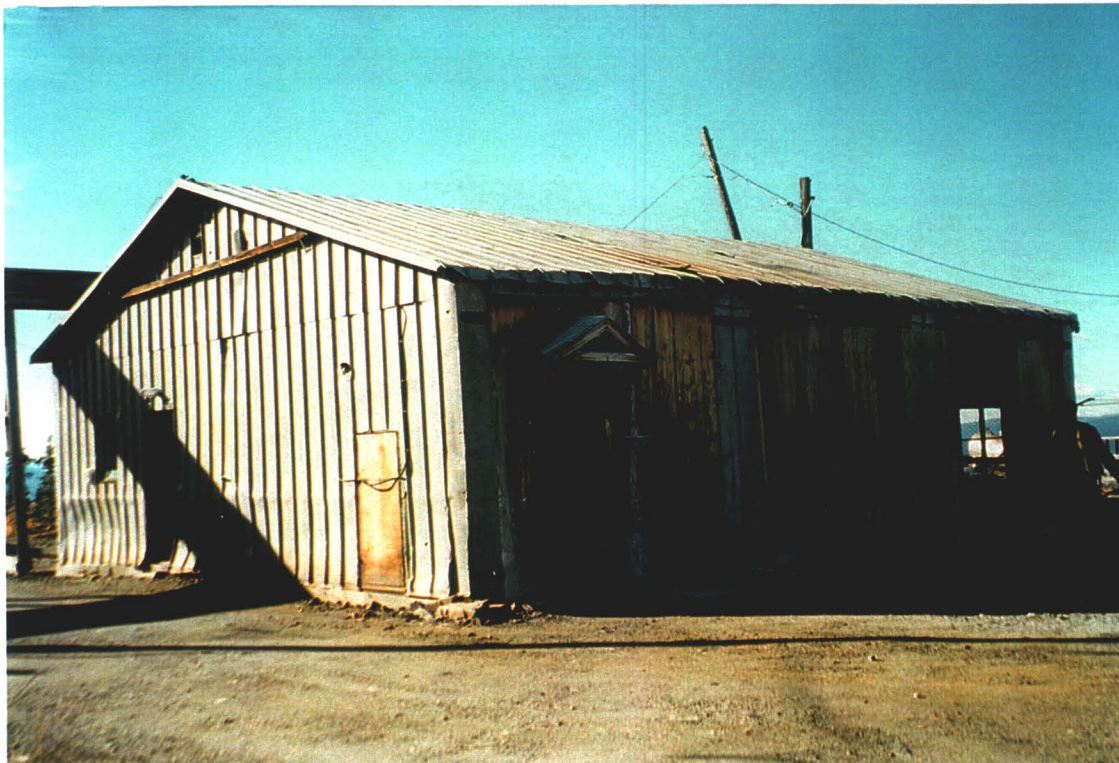
Building 6H - Garage (photo 6-18)

Photo 6-18 : Boiler house and garage structure.

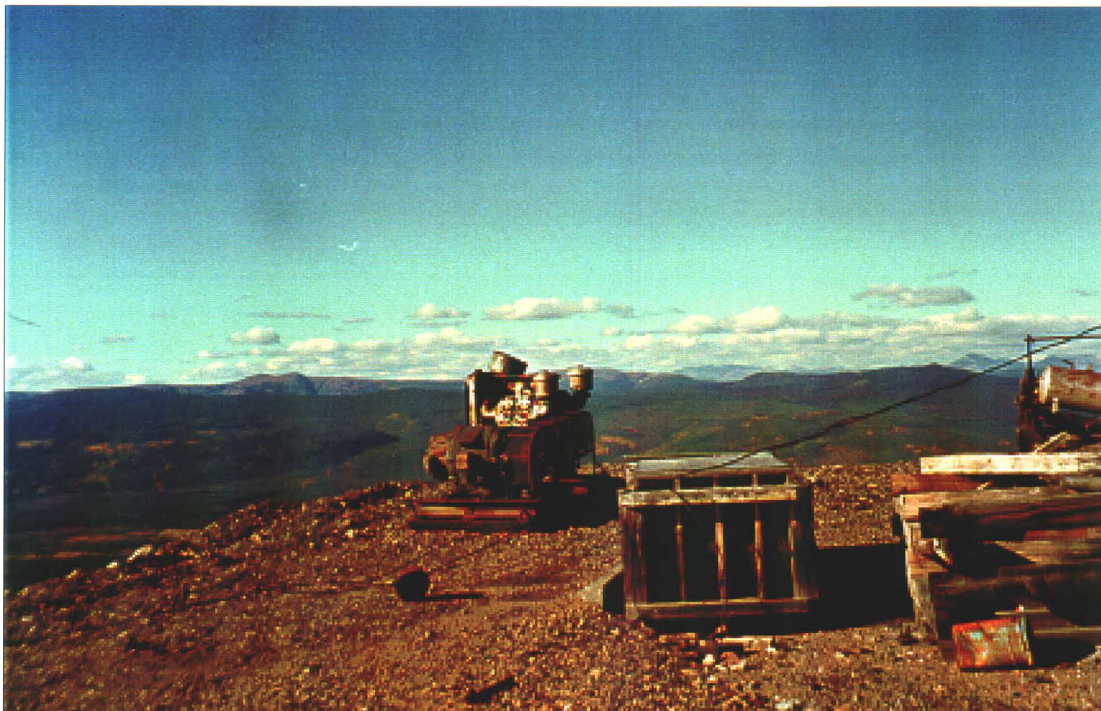
There are intact power lines at the site and it was not know if they were still in service (photo 6- 14). An old electricity-driven compressor was located at the site near the northwest corner of the dump (photo 6- 21). There is some surficial staining under the machine, possibly from remaining product residues left in the engine at the time of abandonment. Information listed on the equipment is as follows.

Photo 6-21 : Ruby 400. Abandoned compressor and some miscellaneous debris.

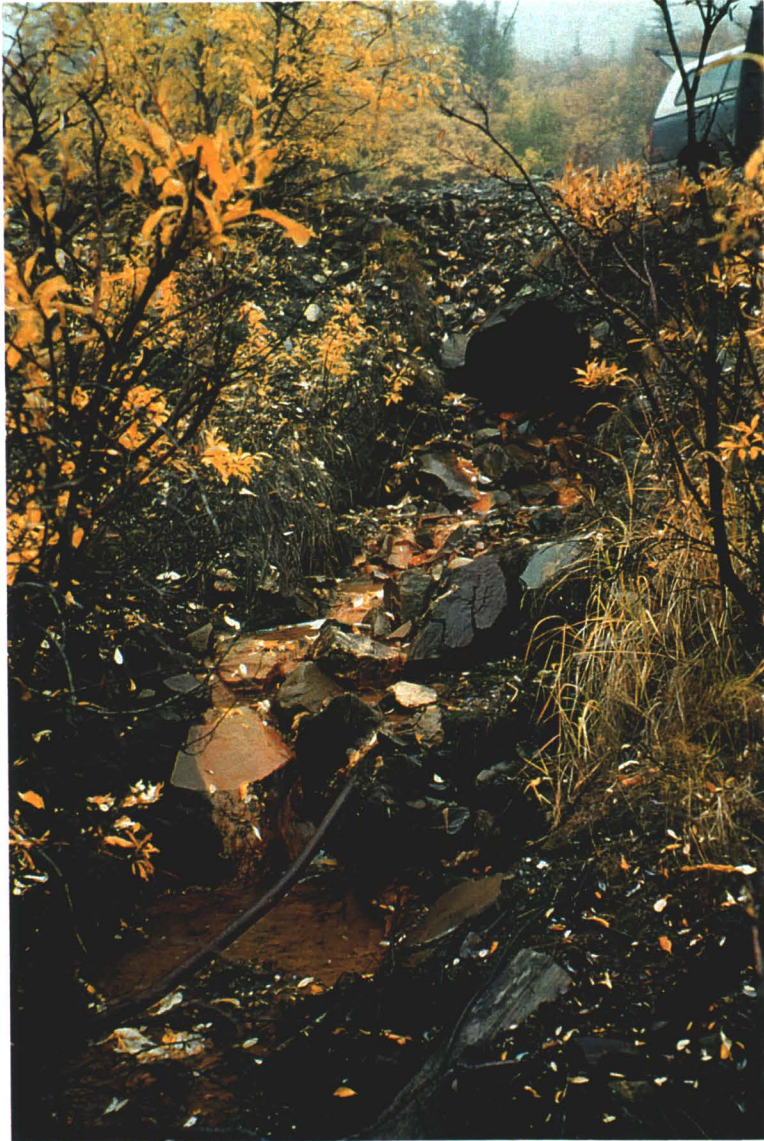
Water sample 06-05-water was collected from a ditch located at the toe of the Ruby 400 on the corner of the south bank (photo 6-23). Drainage is from both groundwater and seepage from the dump. The ditch was dry at the north corner and down gradient for 50m. Field test results for pH levels were 3.3 and conductivity at 228 μ S.

Photo 6-23 : Ruby 400. Sample location 06-05
-water collected below the Ruby 400 dump..
