## DRAGON (UN) & MILLER

### Site No. 10

### MINFILE: 105M 001j

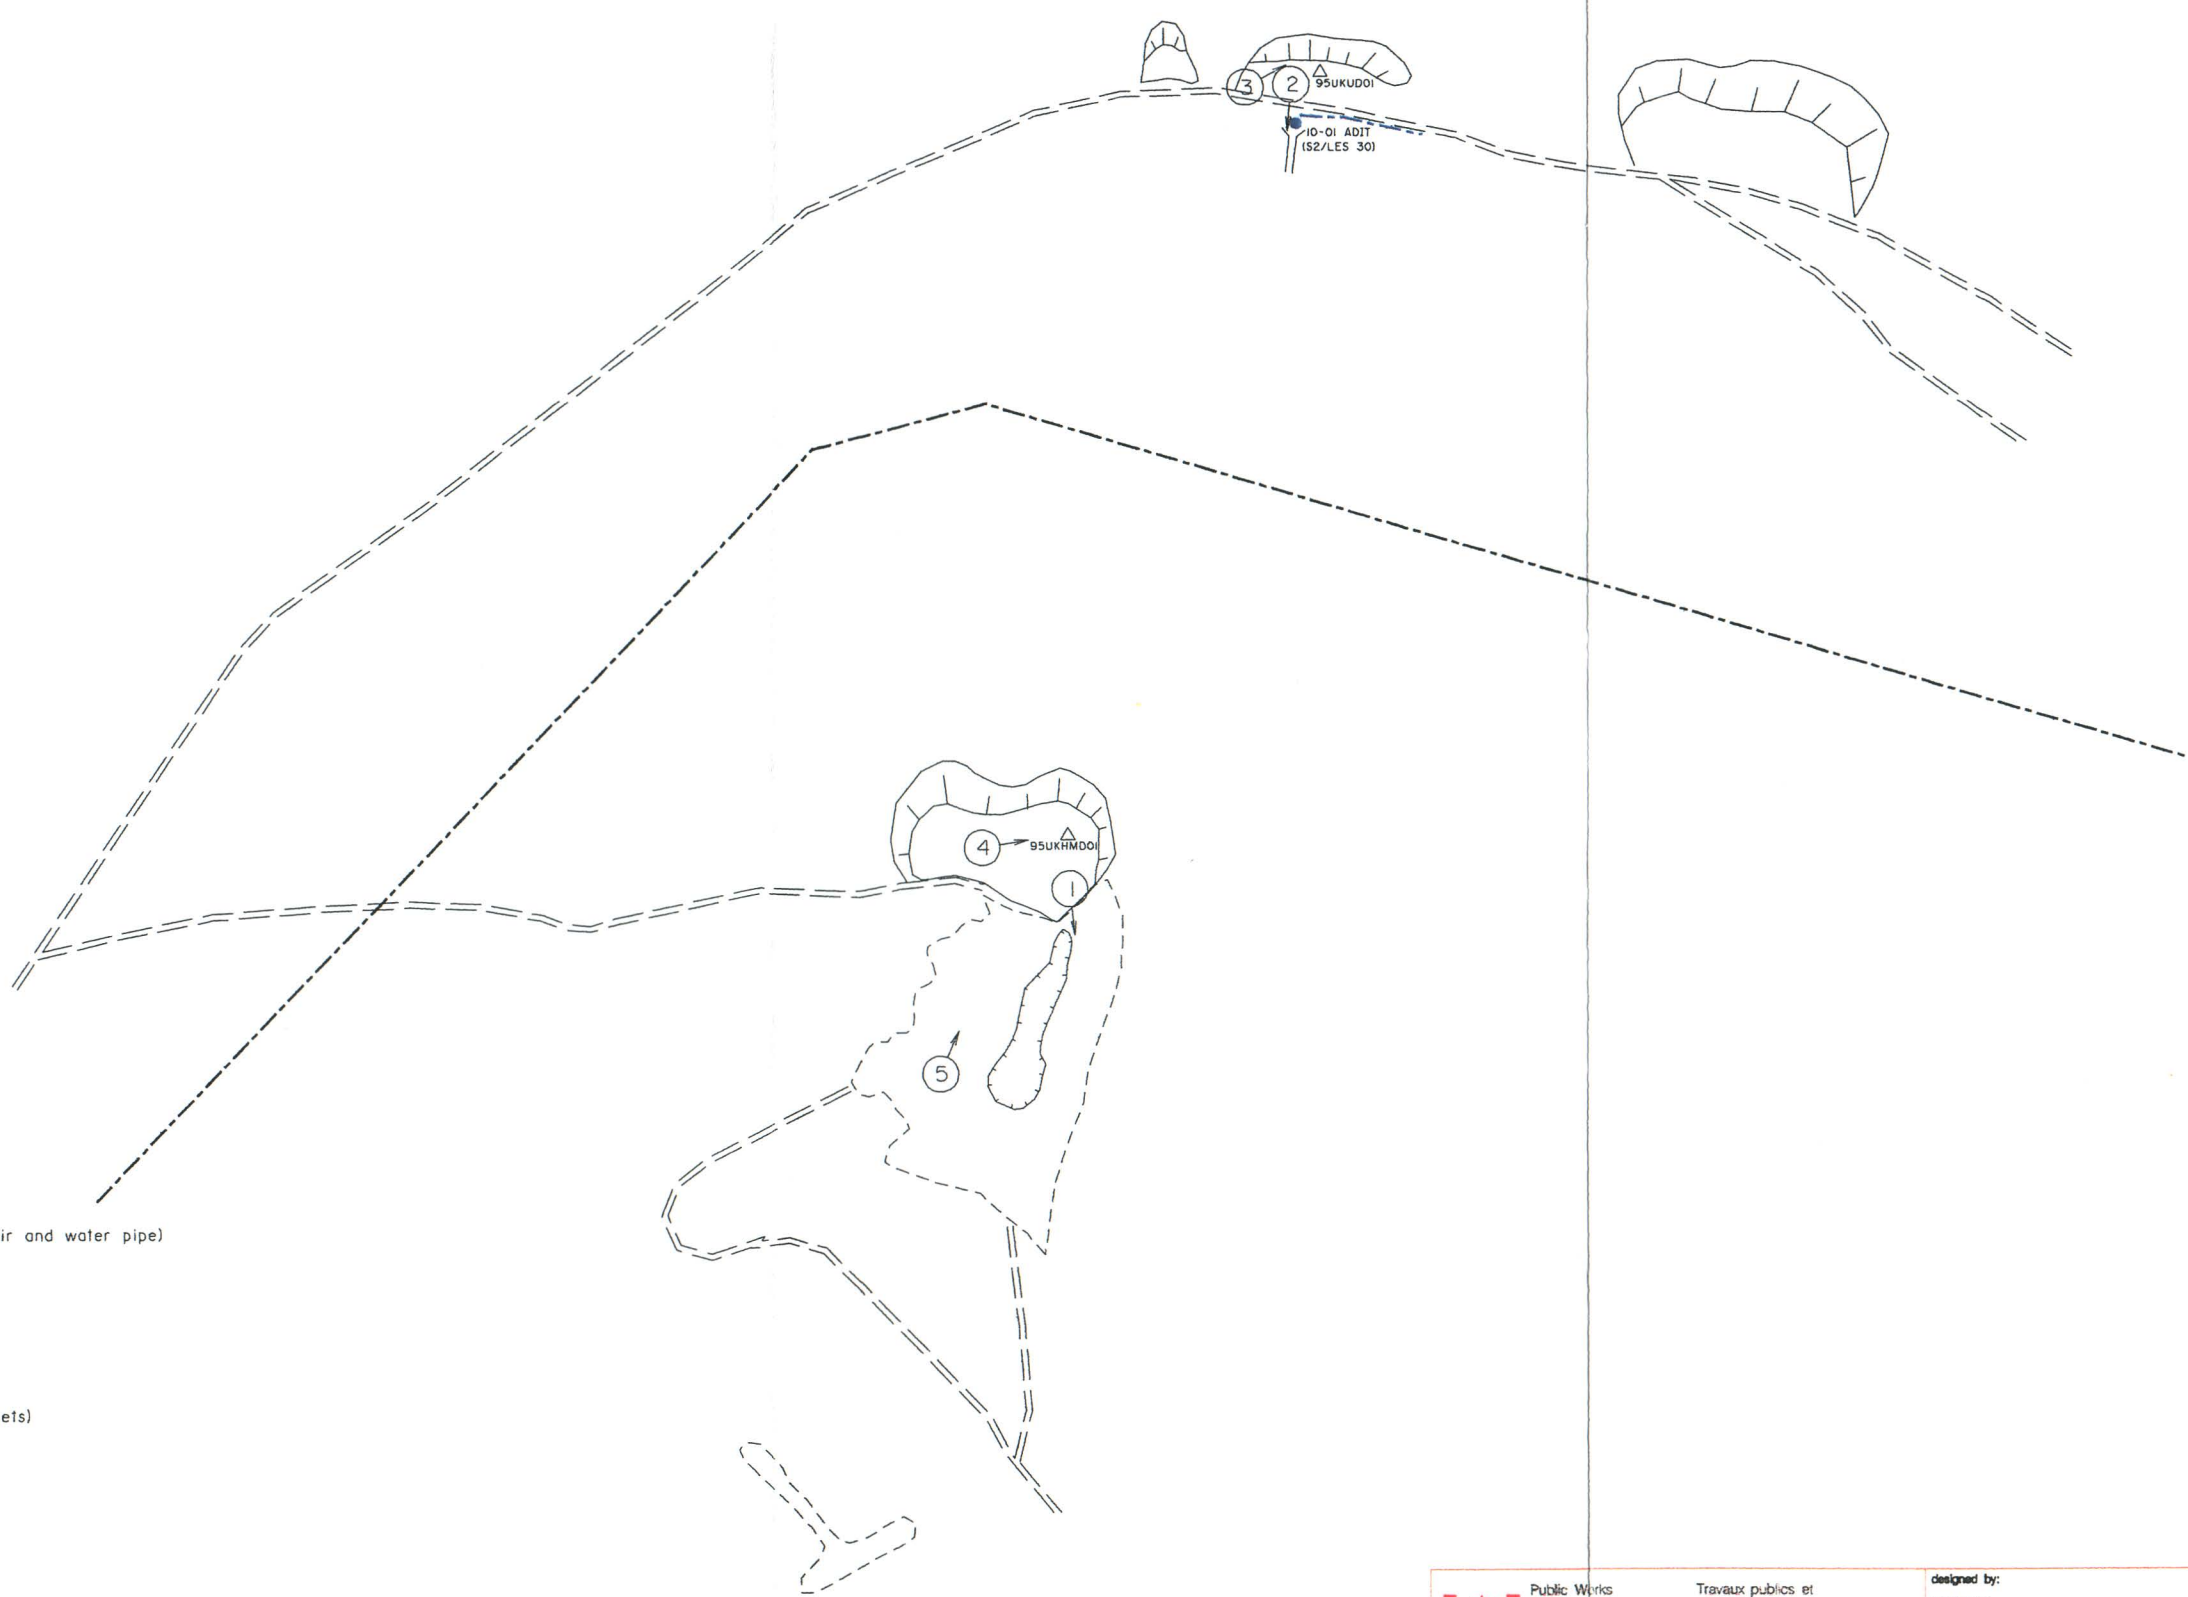
The Dragon (UN) and Miller sites are located on the north slope of Galena Hill (Site 10 Figure 1). The Dragon (UN) adit is on the Calumet Back Road at an elevation of 3900 feet (1189m). The Miller Pit is located south of the Dragon (UN) adit, at an elevation of approximately 4100 feet (1250m). The approximate UTM co-ordinates for this site are 7 088 800m N and 481 500m E.
