BELLEKENO (#22)
(MINFILE# 105M 001y)

1. LOCATION AND ACCESS

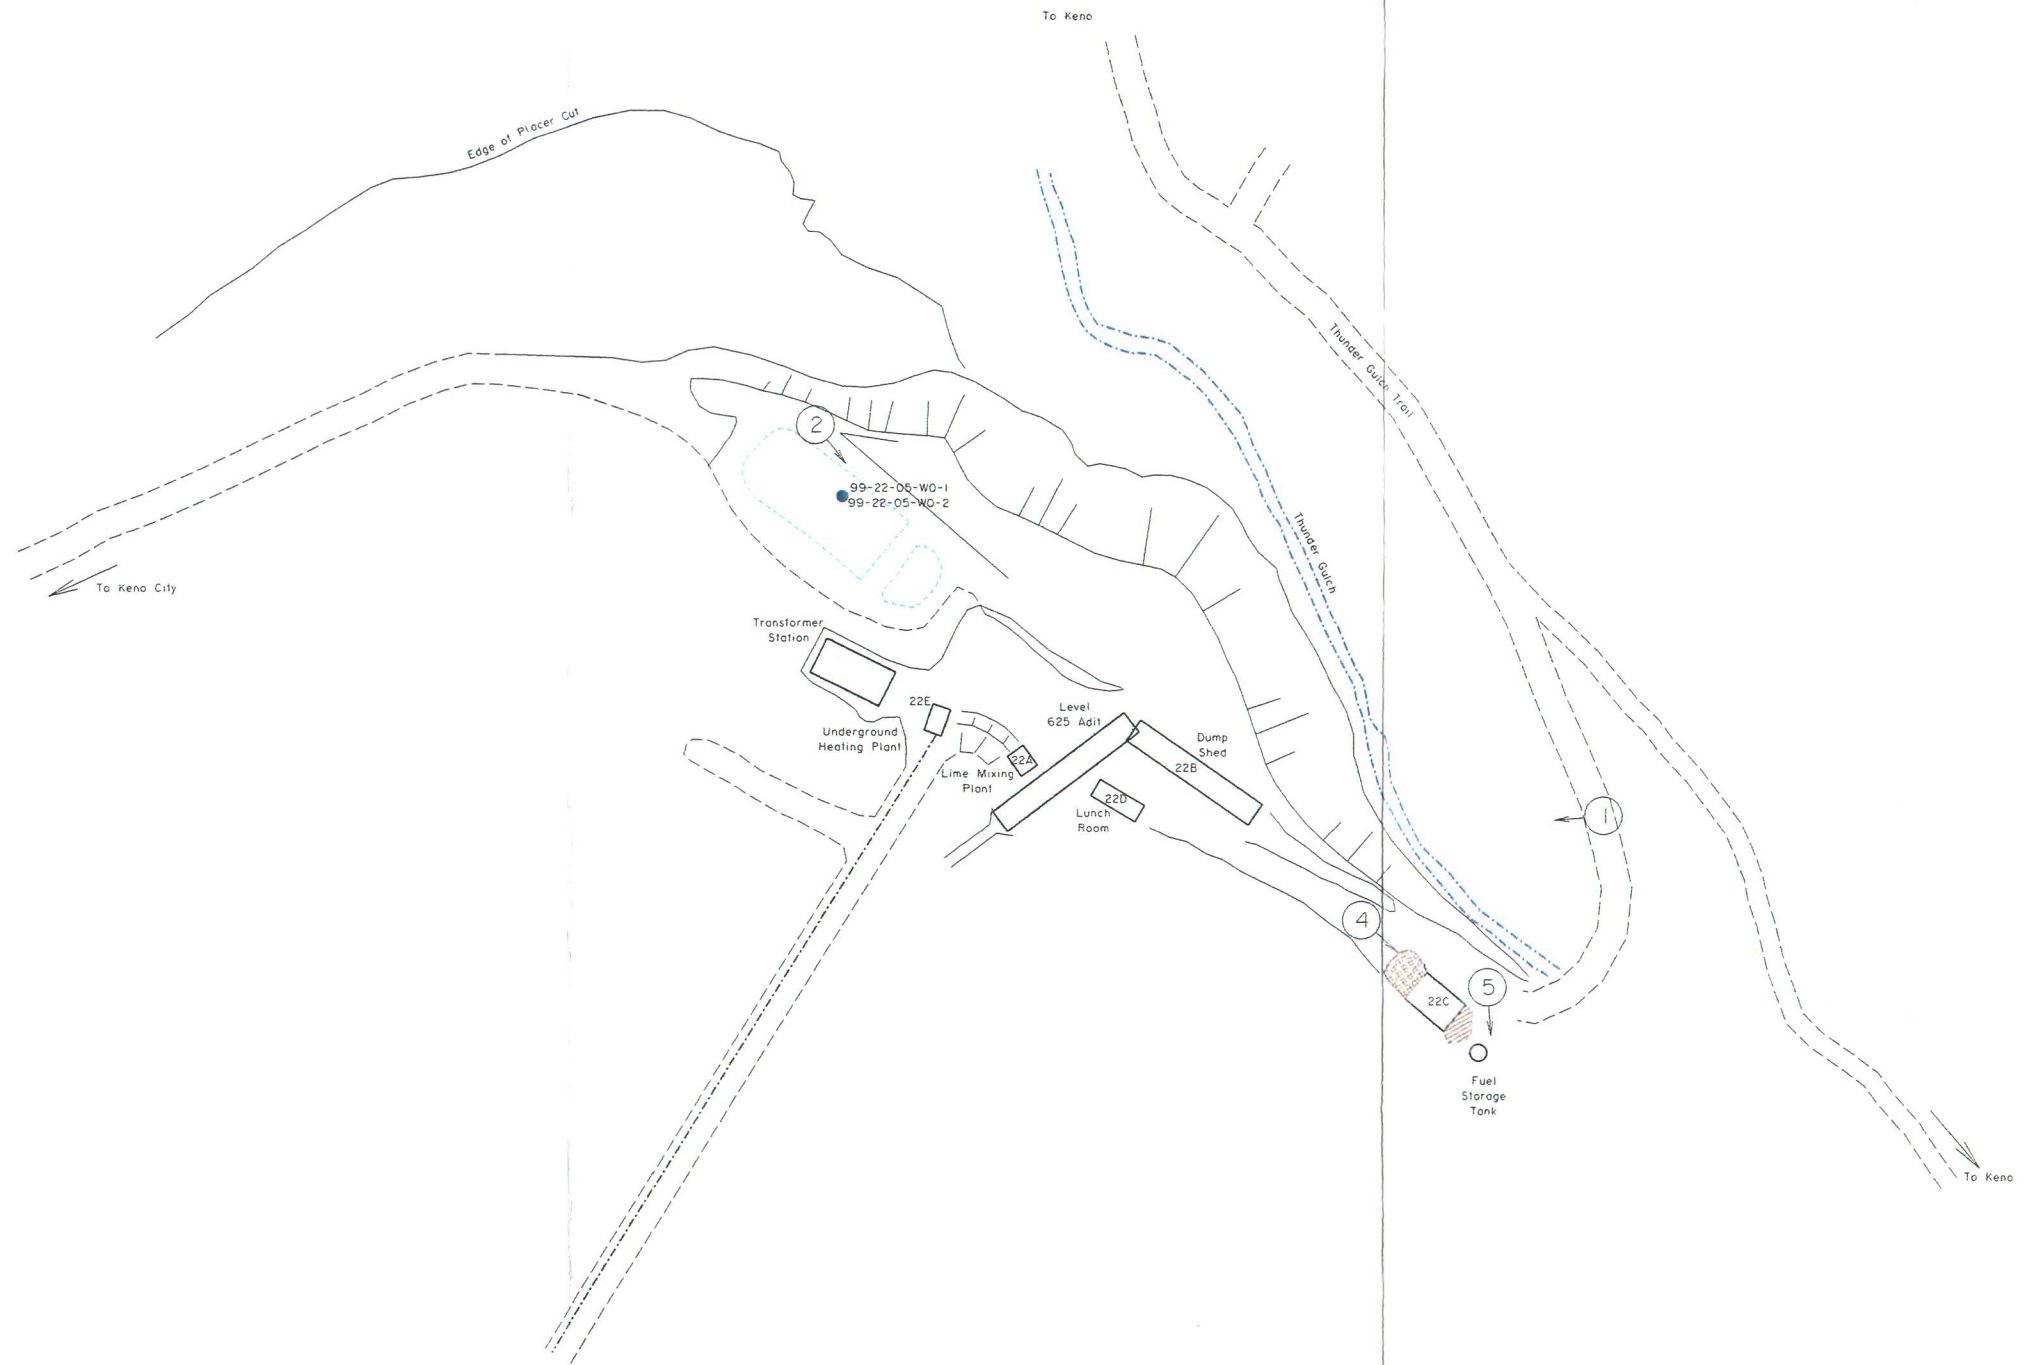
A large area of stained soil was observed in and around the compressor house (Building 22A) at the Bellekeno 625 level adit site (see map). The floor of the compressor house and areas at the entrance and behind the building are black with hydrocarbon contamination. The depth of the contamination is unknown. The estimated dimensions of this area of contamination are 25 m x 5 m. Minor surface soil staining was also observed in several locations in the area between the dump shed (Building 22B), lunchroom (Building 22D) and adit building (Building 22A). No soil samples were taken at this site.

Water quality sample 99-22-05-WQ-1 was taken from the secondary treatment pond (pond 2) at the Bellekeno 625 level adit site. The field pH of pond 2 was 8.0. A field conductivity measurement was not taken. See Attachment B for laboratory analysis data. No surface water was observed at any of the other Bellekeno sub-sites. Surface water from the area drains towards Thunder Gulch and Lightening Creek.

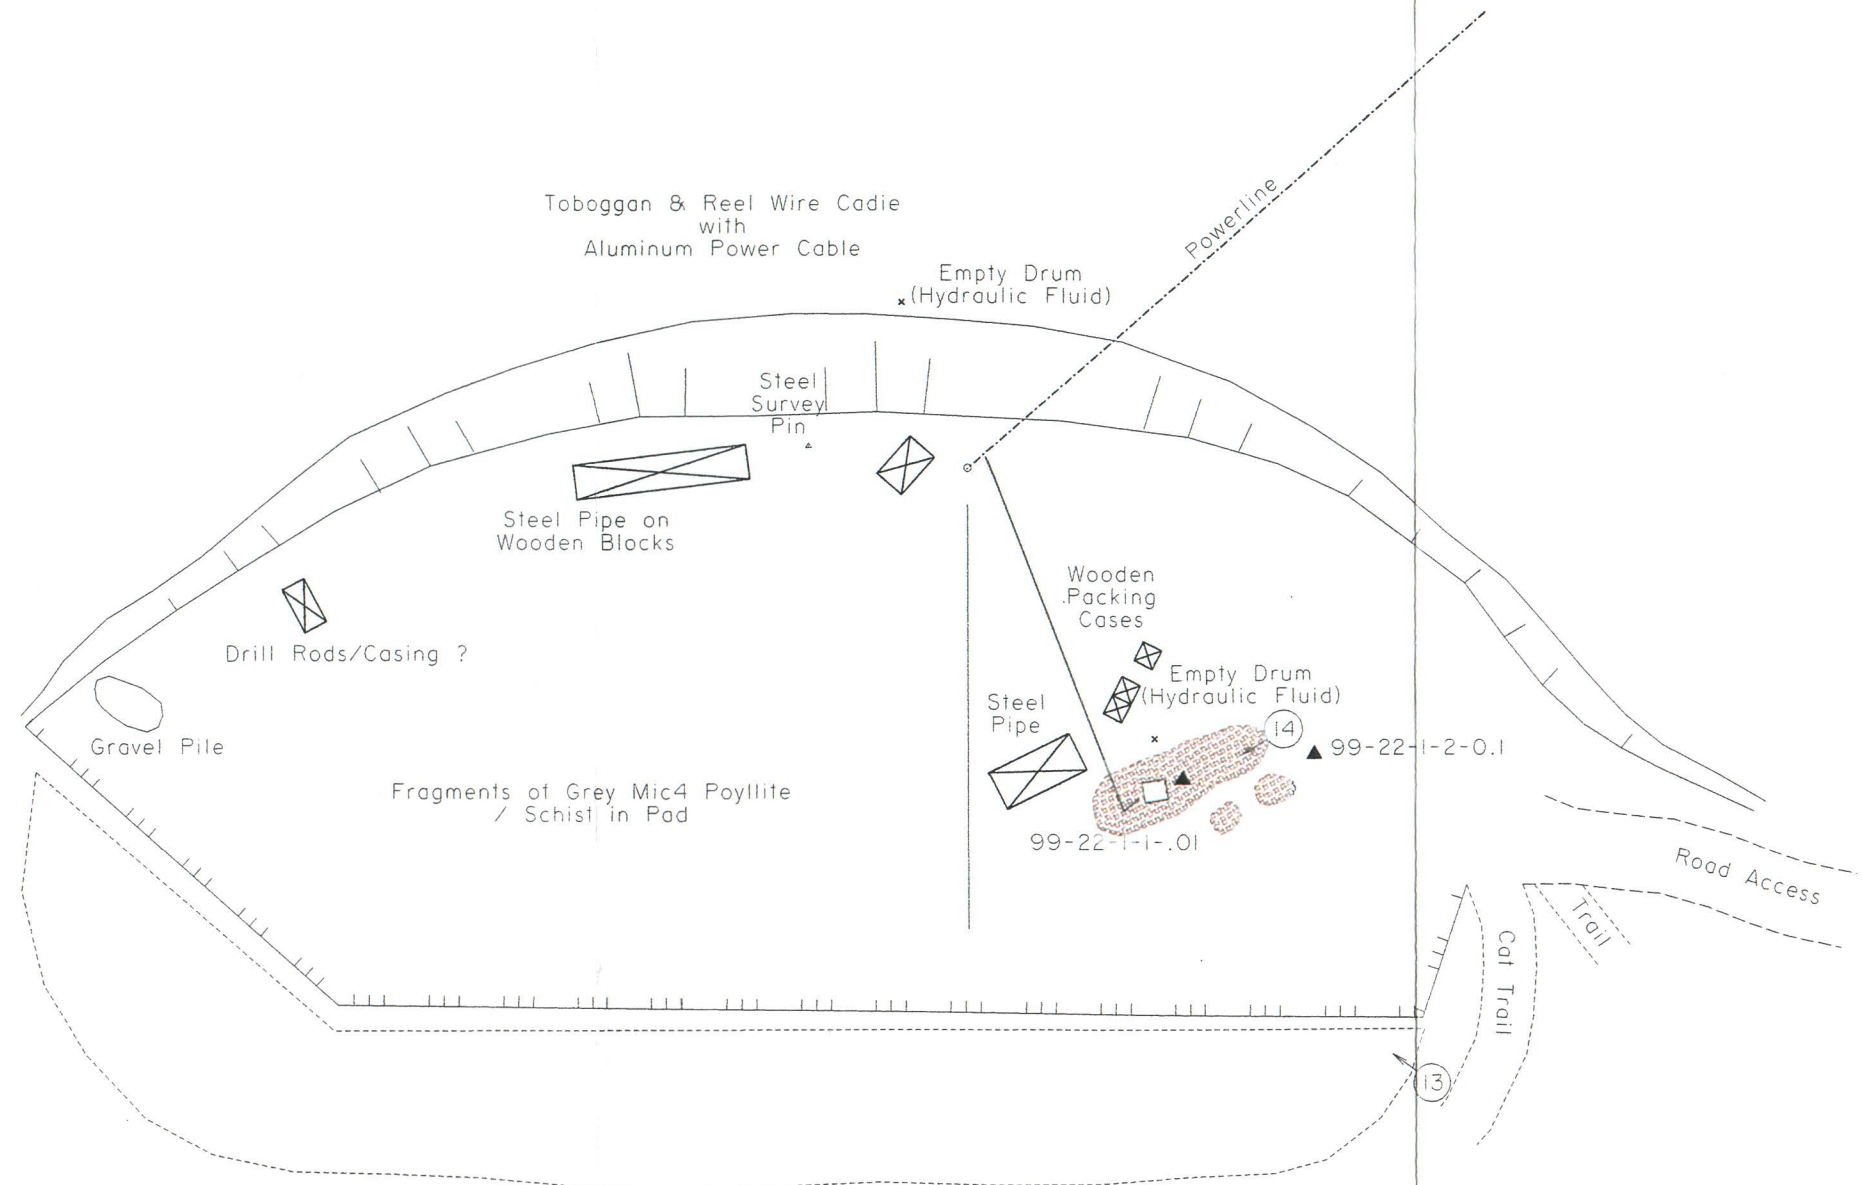
The Bellekeno backfill pad was the site of an attempt to drill a hole from the surface into the Bellekeno mine workings. The hole was to be used to backfill the underground tunnels. The operation was abandoned before the drilling was completed. An area of soil contamination was observed at this site adjacent to the drilling site (see Figure 4; photo 22-14). The source of contamination appears to have been the oily metallic sludge produced during the drilling operation. The estimated depth of the contaminated soil is 0.15 m. The estimated dimensions of the area of contamination are 12 m x 4 m. Two more small areas of surface staining were observed adjacent to the larger area. Soil sample 99-22-1-1-.01 was taken from the contaminated area at a depth of 10 cm. A background sample was taken of the soil at the Bellekeno Backfill site at a depth of 10 cm (sample 99-22-1-2-.01). Laboratory analysis data are contained in Attachment B.
