**DIVIDE**  
**SITE #40**  
**MINFILE# 105m 001ay**

Public Works And Government Services Canada	Travaux publics et Services gouvernementaux Canada	designed by:	
		conçu par:	
Architecture & Engineering Services Western Region		drawn by:	C.S.
		dessiné par:	Nov. / 99
Drawing title: <b>Divide Site #40 Site Assessment</b> Yukon Territory	Titre du dessin: 	approved by:	
		approuvé par:	
		revisions:	
		project no. no. du projet:	125-12.01
		dwg. no. dessin no.:	1 of 1

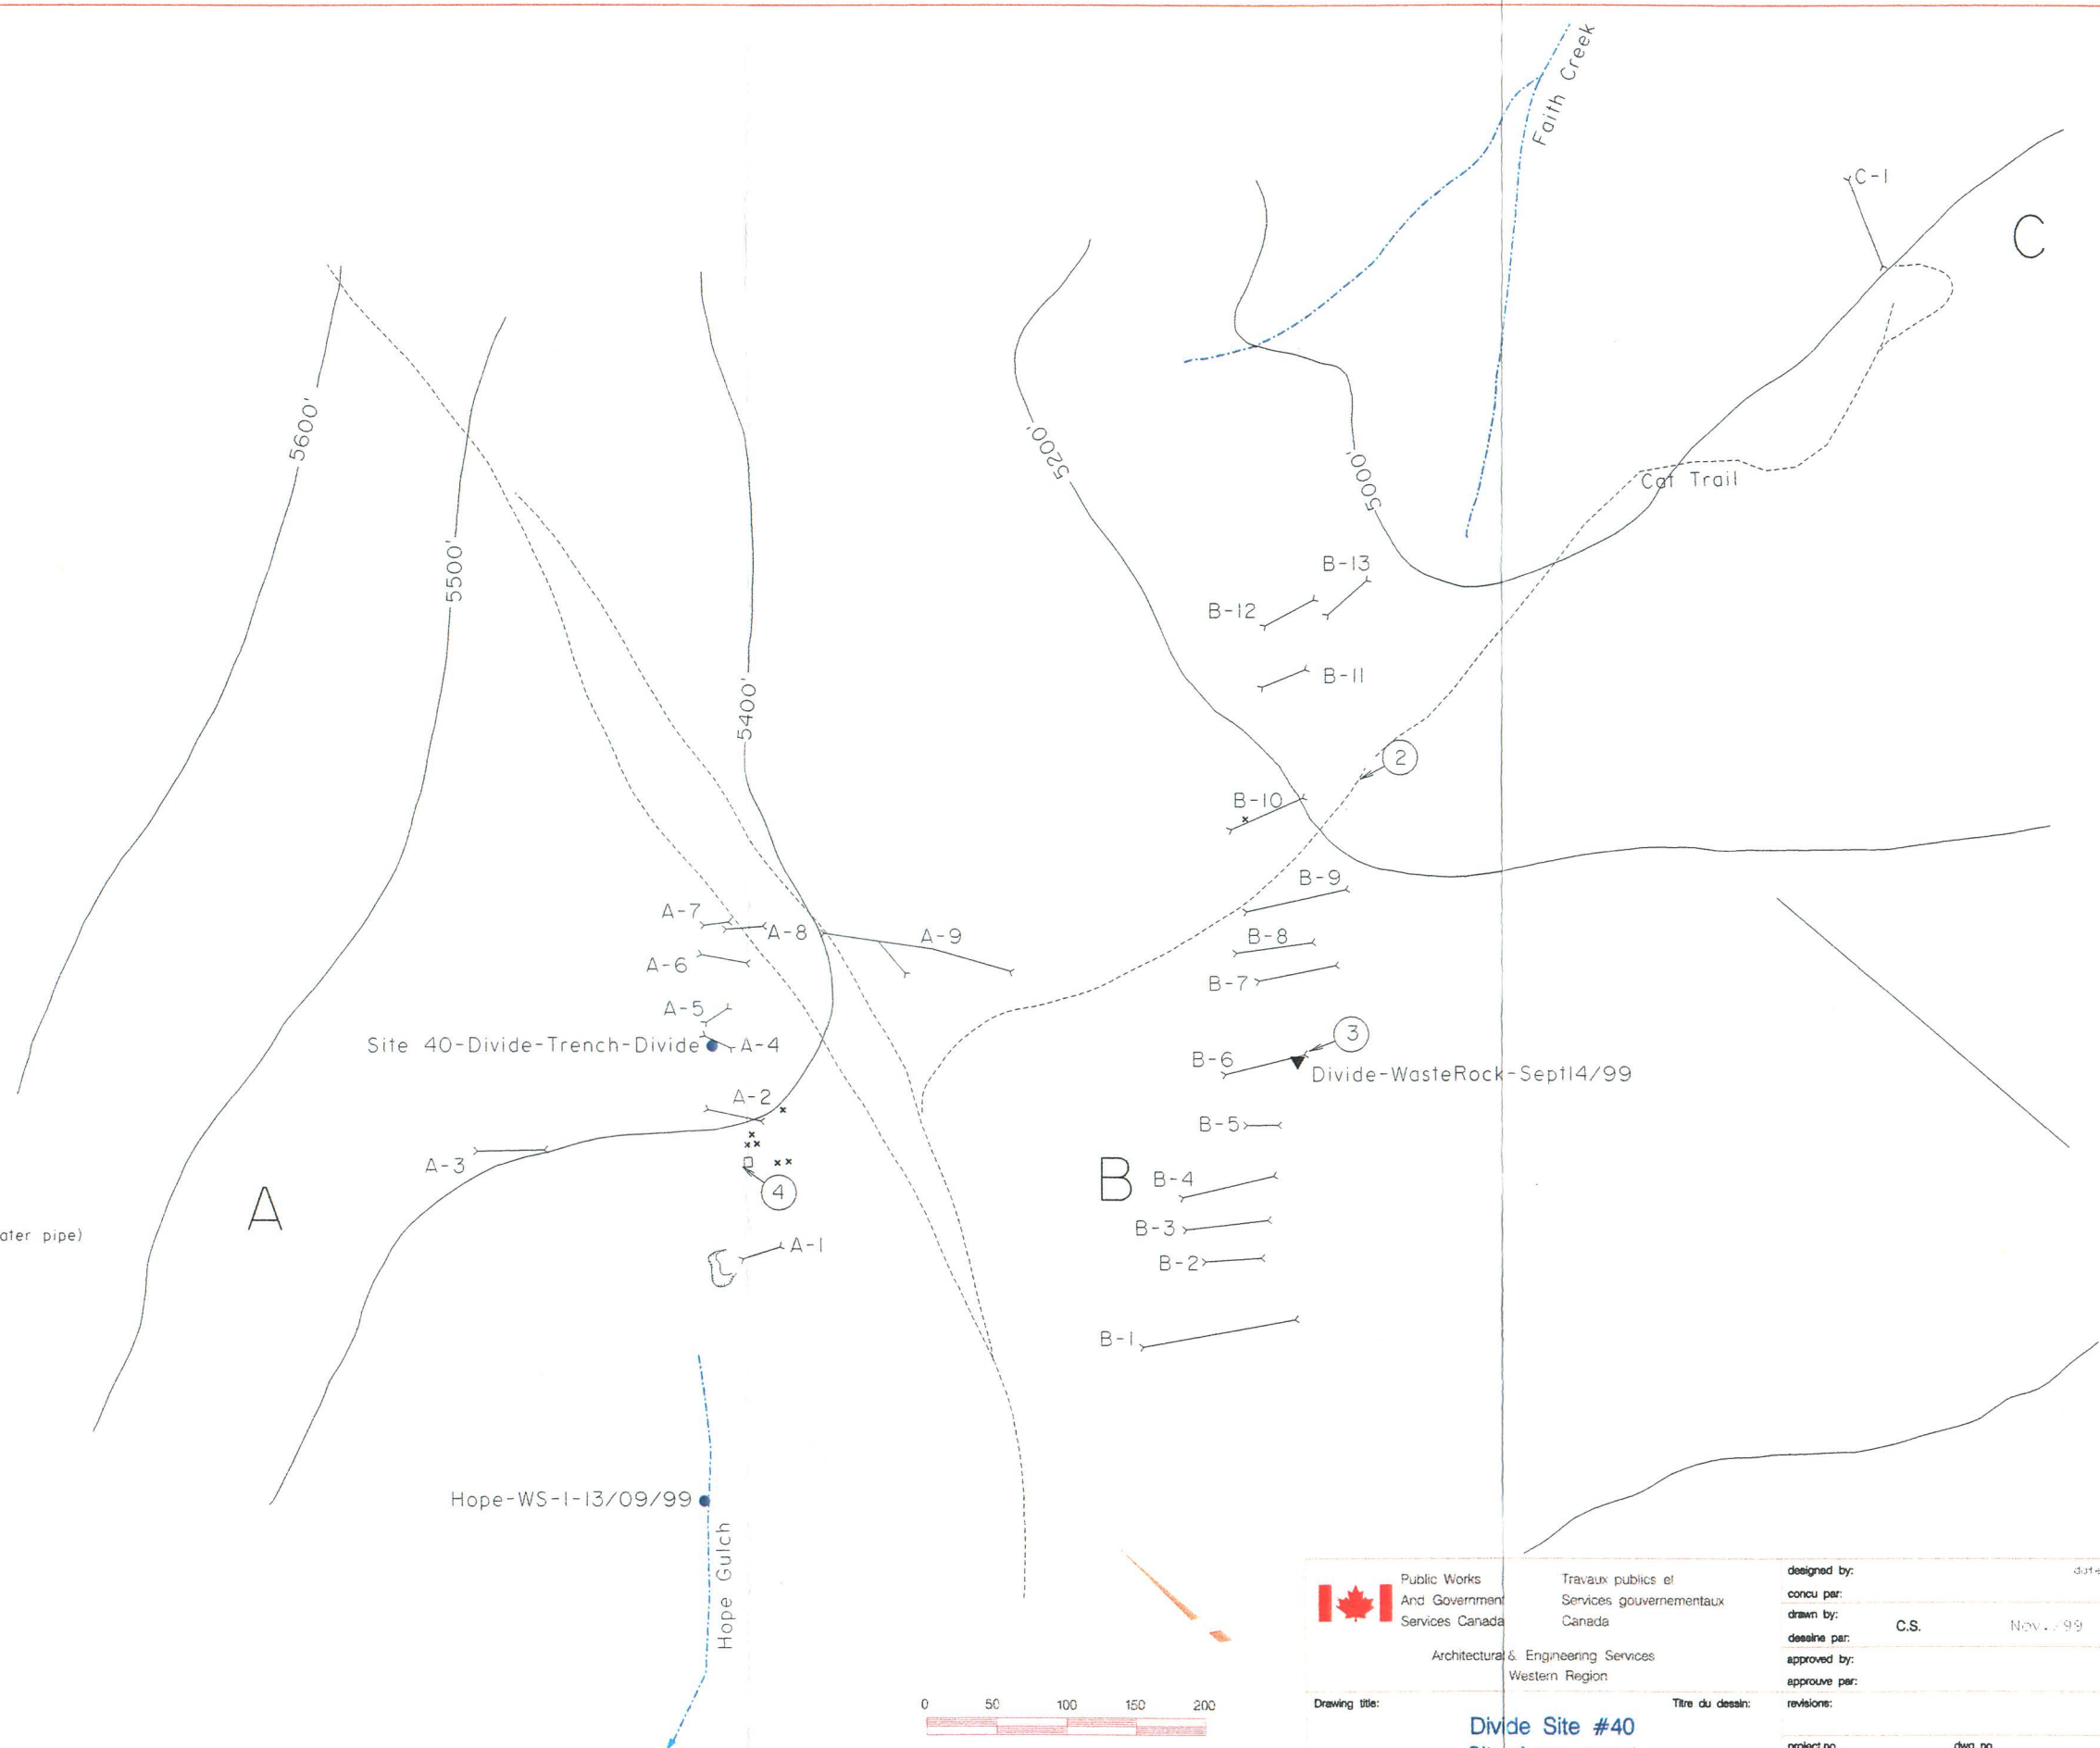
Bulldozer trenches were examined in three areas, which for this report are referred to as Zones 'A', 'B' and 'C'. Zone 'B' is sub-parallel and approximately 300m south of Zone 'A'. Zone 'C', consisting of a single trench, is located approximately 600m east of Zone 'B'. A total of 17 trenches were observed.

There are 9 trenches in zone 'A' all aligned roughly northwest-southeast. The westernmost trench is roughly 100m east of the headwaters to Hope Gulch. The trenches are about 2m in width, 1 to 2.5m in depth and range from 8m to 53m in length. The wallrock in most of the trenches in this zone is phyllite with quartz veining and localized siderite. Minor oxidation staining was observed in the exposed veins. One trench was in overburden. A water sample (Site 40-Divide-trench) was collected from ponded water in trench A3.

There is one building and some scattered fuel drums in the area. No mine site infrastructure such as electrical equipment, rail or trestle was observed.
