DEVON
SITE #41
MINFILE# 105M 001az

Public Works And Government Services Canada	Traux publics et Services gouvernementaux Canada	designed by:	date:
	Architectural & Engineering Services Western Region		conçu par:	
Drawing title:		Titré du dessin:		drawn by:
Devon Site #41 Site Assessment Yukon Territory				C.S. NOV. /99
project no. no. du projet:		125-12.01		approved by:
				approve par:
				revisions:
				dwg. no. dessin no.
				1 of 1

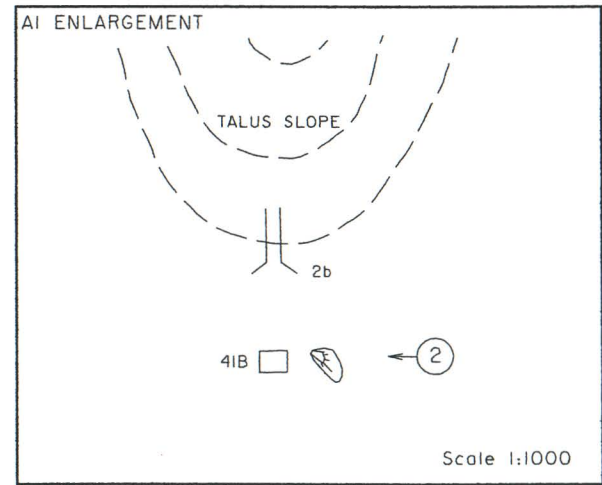
The adit is located at the base of a talus slope. Broken timbers indicate where the entrance was, however, the adit has collapsed and can no longer be accessed. The small waste rock pile a few meters south of the adit suggests that the adit was not developed very far. The ground around the adit appeared stable at the time of the site visit.
