EAGLE
Site No. 59
MINEFILE: 105M 021

Public Works And Government Services Canada	Travaux publics et Services gouvernementaux Canada	designed by: _____ date: _____ conçu par: _____
		drawn by: C.S. Nov. /99 dessiné par: _____
Architectural & Engineering Services Western Region		approved by: _____ approuvé par: _____
Drawing title:	Titre du dessin:	revisions: _____
Eagle Site #59 Site Assessment Yukon Territory		project no. no. du projet: 125-12.01
		dwg. no. dessin no.: 1 of 1

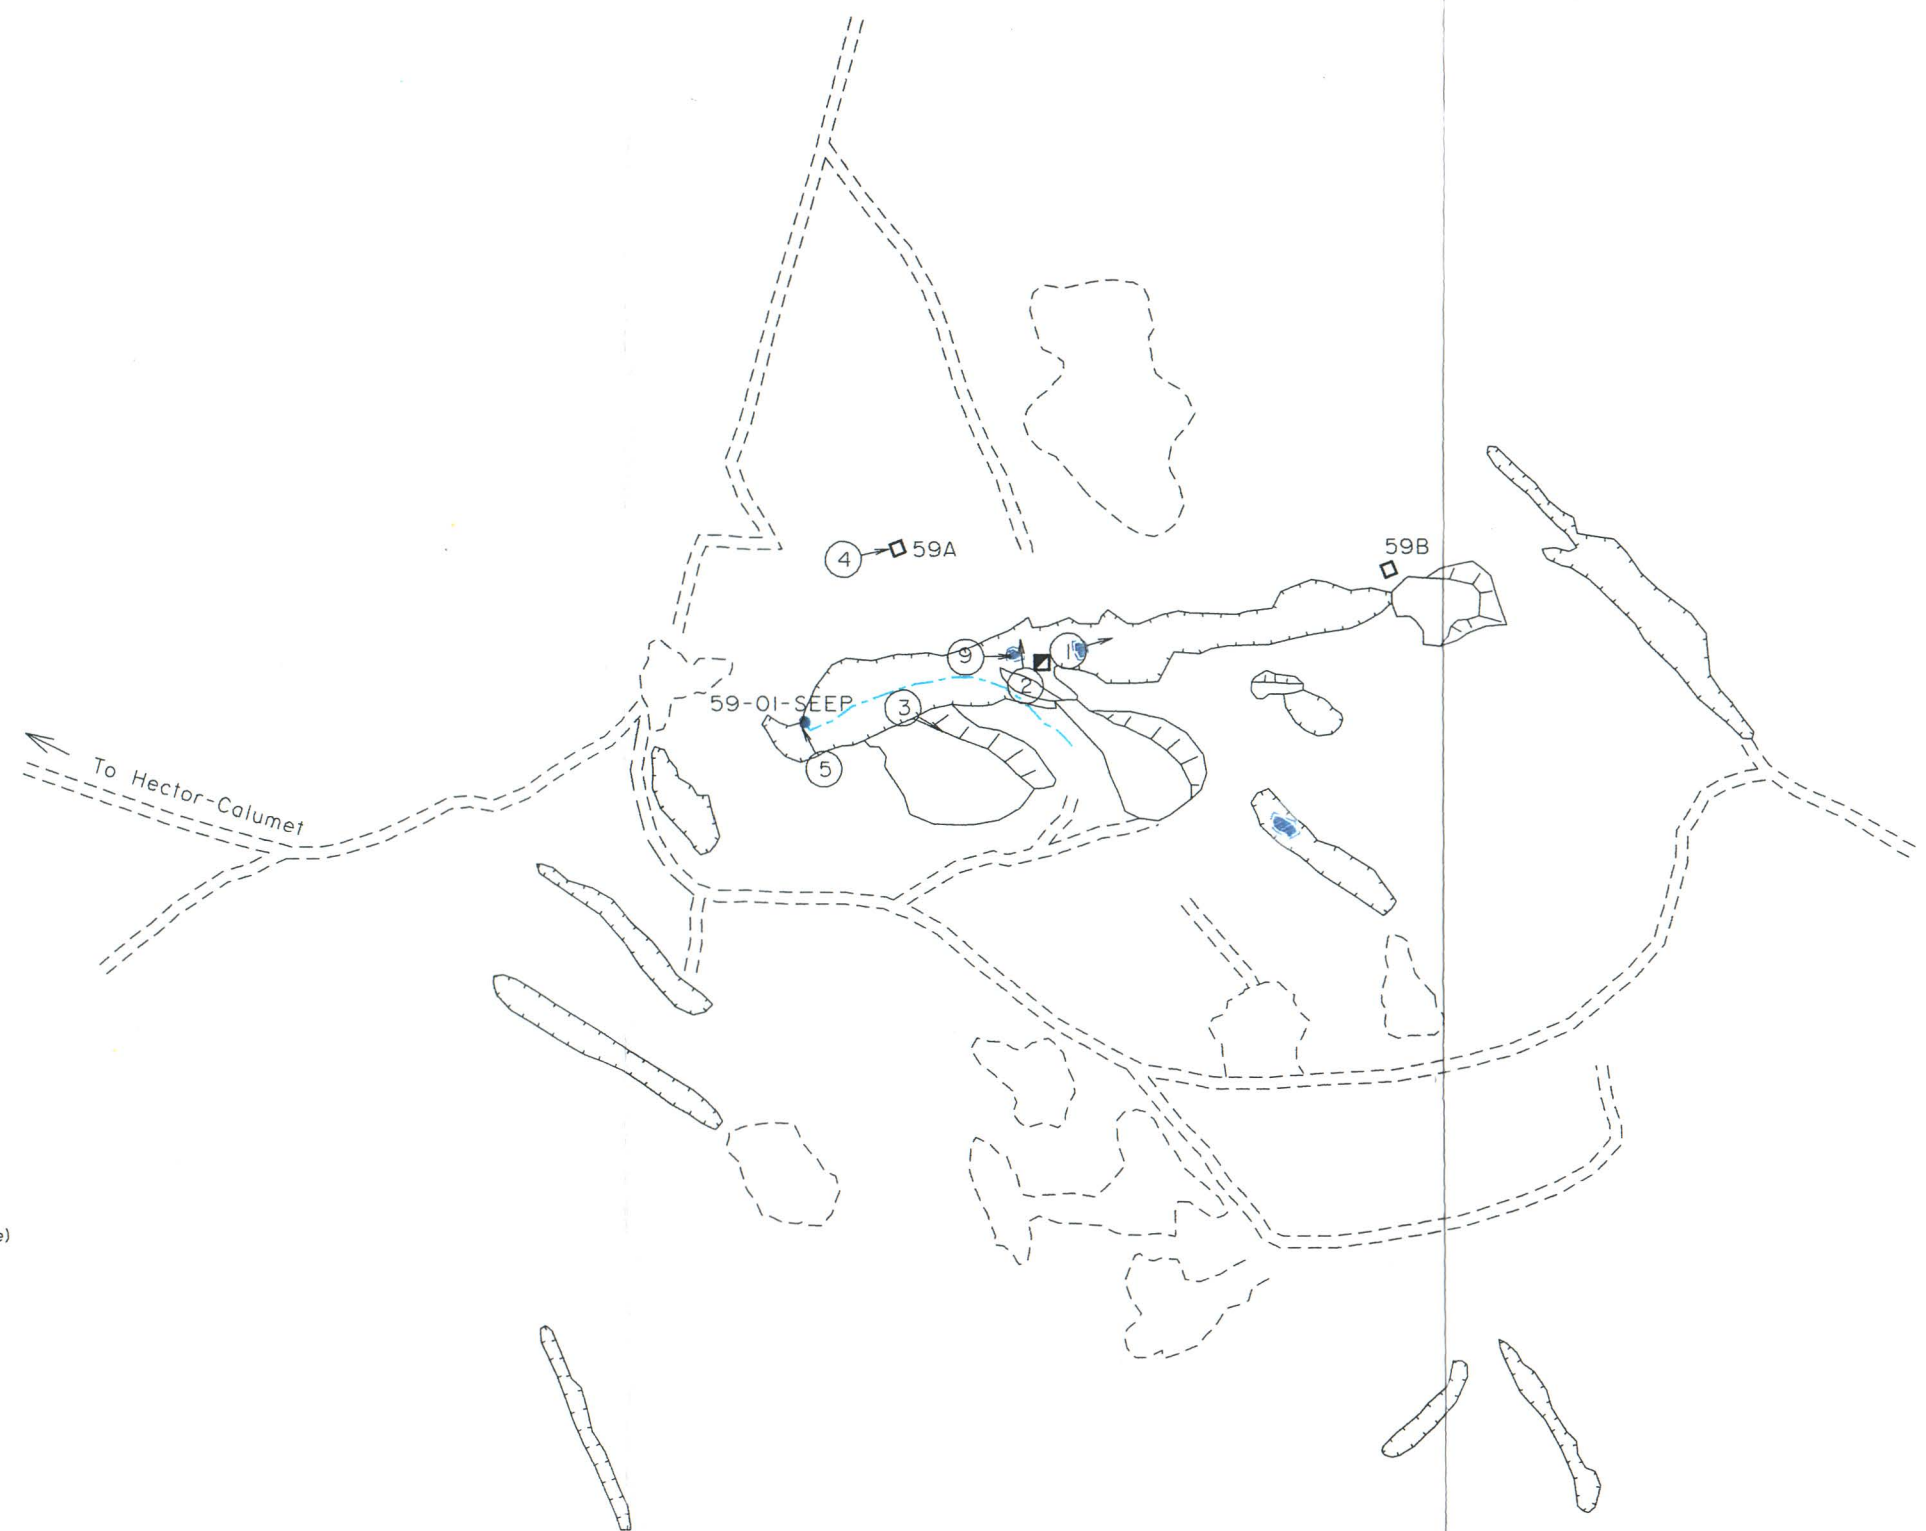
Workings at the Eagle site consist of a single, large trench, a collapsed shaft, and several shallow, older trenches. These are shown on Figure 2.

Condition: The trench walls are stable.

Condition: The shaft has completely collapsed. The trench was excavated around the shaft.

Few sulfides and little iron staining was seen on the surface of the waste dumps. There was no evidence of seeps from the dump, and no apparent impact on the vegetation growing around it. No waste rock samples were collected from the dump.
