TOWNSITE MINE # 76
(MINFILE # omitted from minfile)

Public Works And Government Services Canada	Travaux publics et Services gouvernementaux Canada	designed by: conçu par:	date:
		drawn by: dessiné par:	C.S. Nov. /99
Architectural & Engineering Services Western Region		approved by: approuvé par:	revisions:
Drawing title: Townsite Mine Site #76 Site Assessment Yukon Territory	Titre du dessin:	project no. no. du projet:	sheet no. feuille no.:
		125-12.01	1 of 1

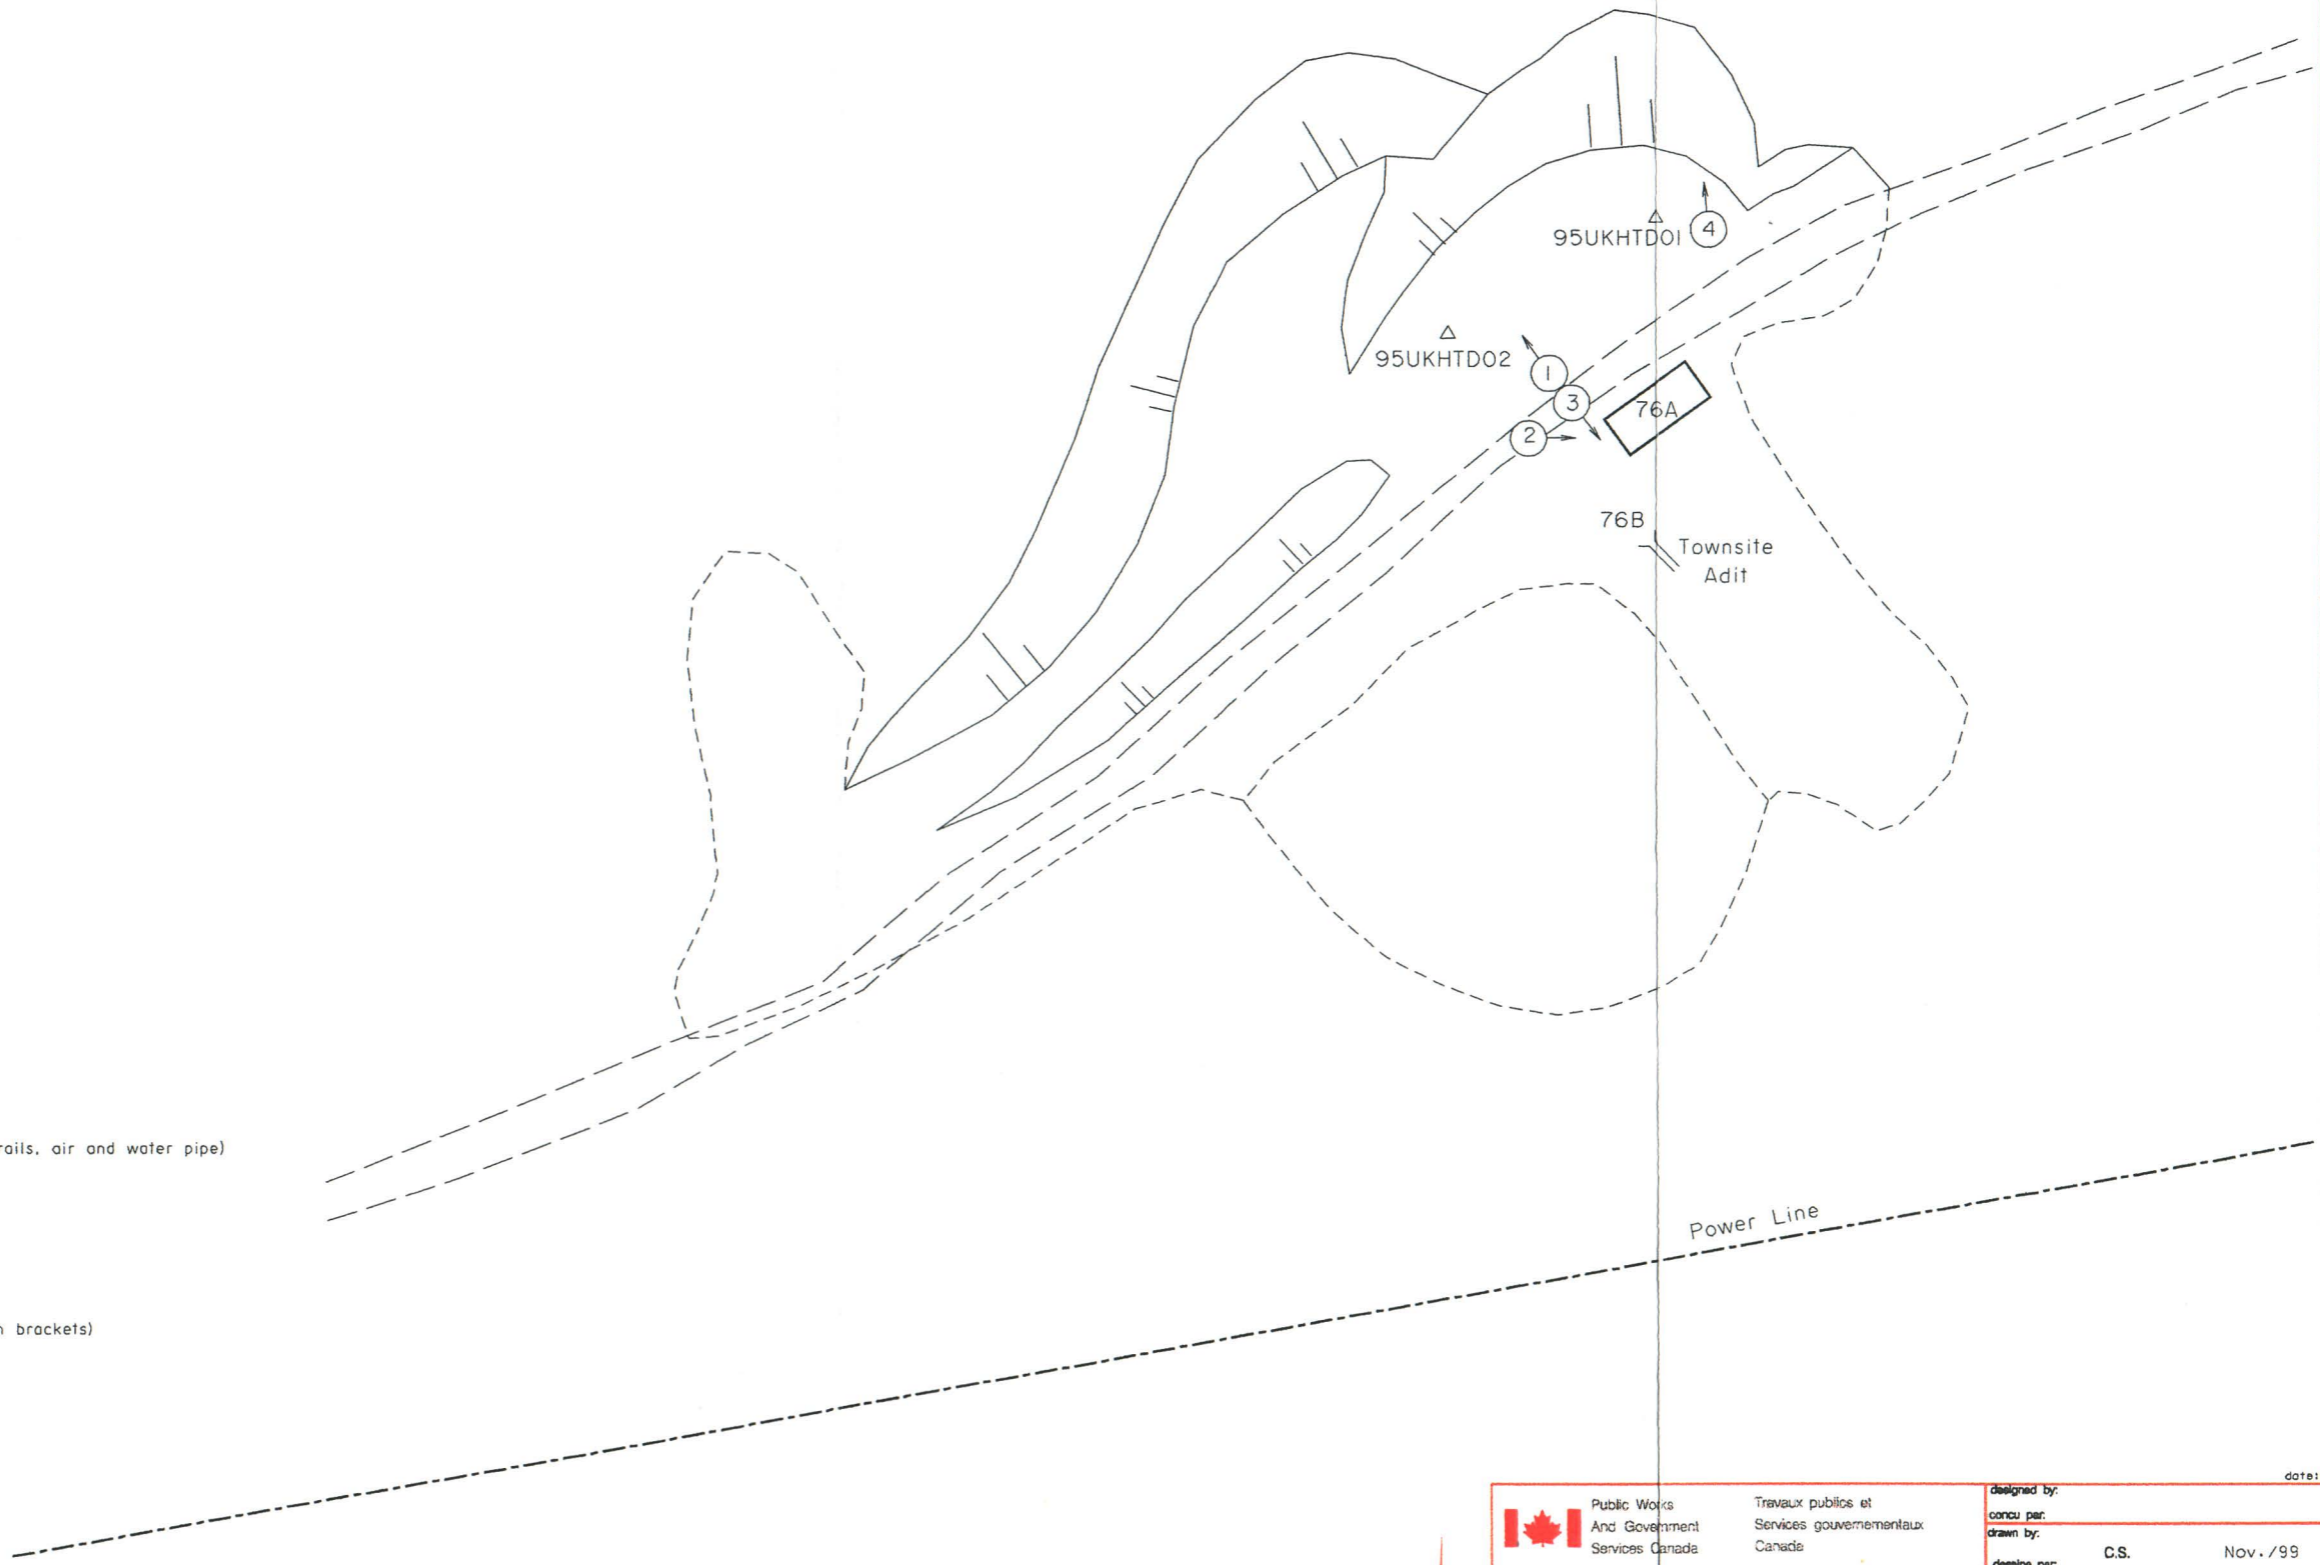
Comprised of development waste rock, vein material and the quartzite excavated to collar the portal. (~ 13,000 tonnes). The dump consists of barren quartzite, schist and quartz veining. It exhibits moderate limonite staining (Oct. 1 F05-P09). There is a small kill zone directly below the dump (~30 m down slope x ~10 m Wide), which does not appear to be regenerating vegetation. There is no sign of any appreciable surface drainage through the dump. Two samples were reported in the literature. These samples consisted of ABA testing conducted in 1995 on two samples, one indicating that it had the potential to produce acid.

There are two buildings at the site. Building 76A serves as a workshop and office accommodations on two separate levels. Building 76B is the portal entranceway. There was building debris scattered around the site, however, there was no visual sign of staining on the surrounding soils. Wood cribbing and some wood sheathing (photo 76-1) is located to the west of the road to reinforce a waste rock dump that was used as a loading area (photo 76-2).

The portal structure was collapsed, there is timber cribbing visible, however, the rock overhang has caved in and the structure is considered a safety hazard. No services were noted at the portal. There was no drainage evident from the structure. No samples were taken at building 76B.
