ELSA VILLAGE

SITE #78

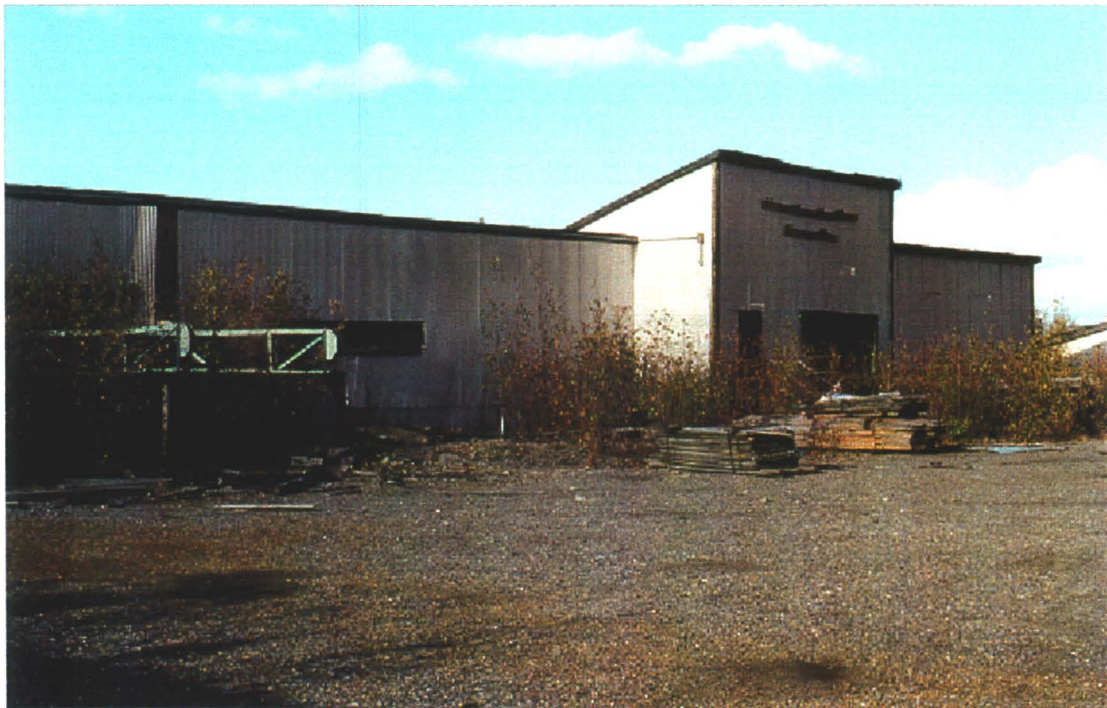
Building # 4: Sawmill (photo 78-3)

Photo 78-3 : Elsa. View of Building #4, the sawmill. (Azimuth 030°)

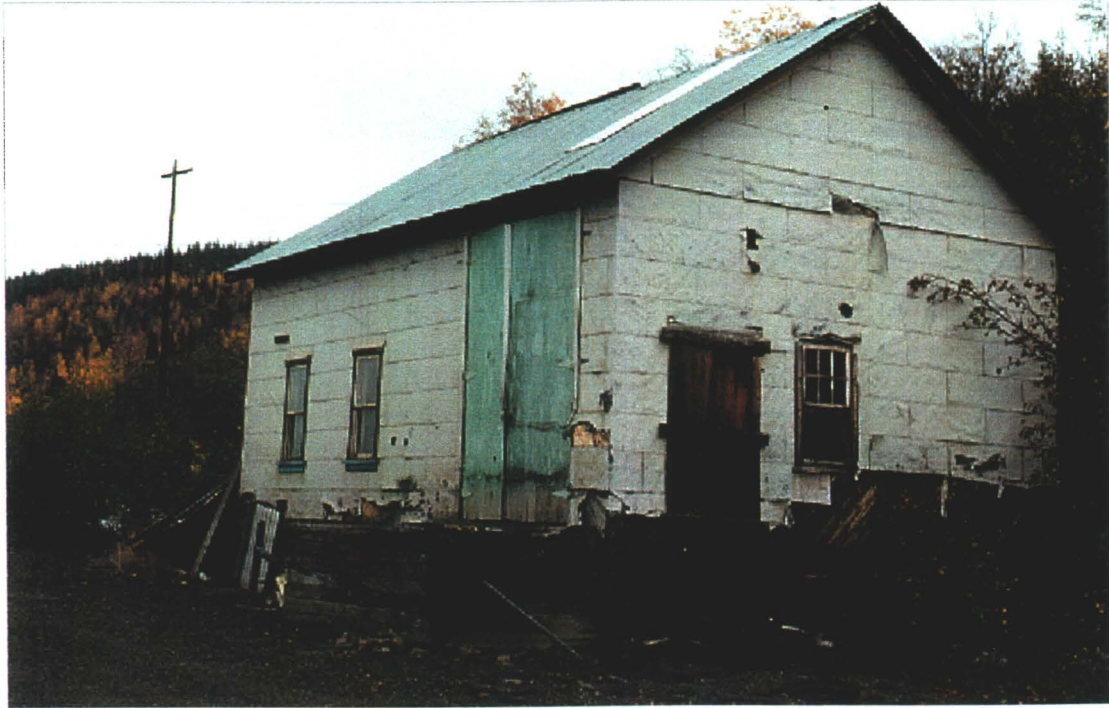
Building # 6: Wood Storage (photo 78-4)

Photo 78-4 : Elsa. Building #6, building purpose not known, but guessed to be used for construction or storage of large objects. (Azimuth 110°)

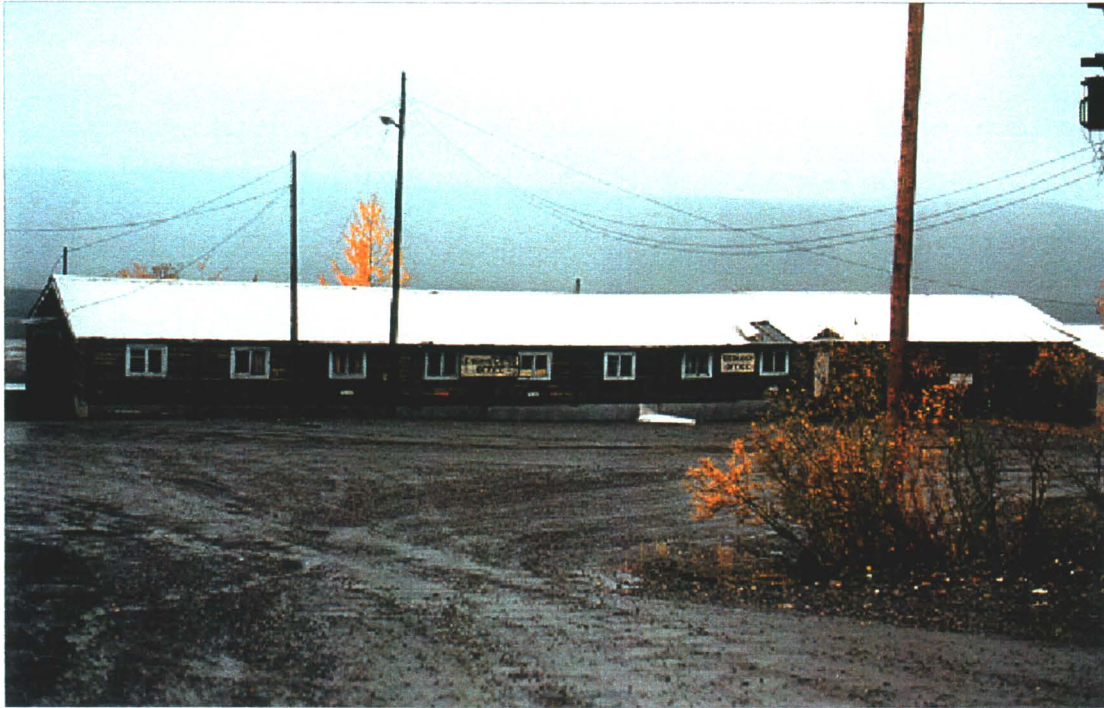
Building # 8: Geology and Engineering Office (photo 78-6)

Photo 78-6 : Elsa. Building #8 is the geology and engineering offices. (Azimuth 340°)

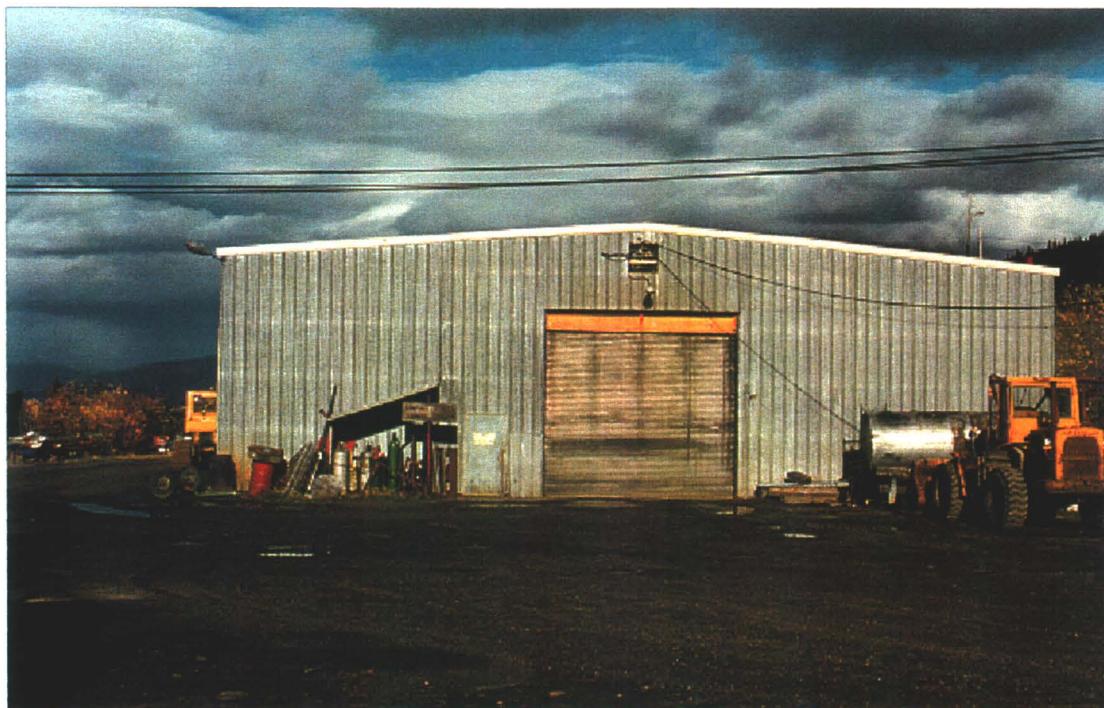
Building # 9: Main Shop (photo 78-7)

Photo 78-7 : Elsa. Building #9 is the Main Shop. (Azimuth 040°)

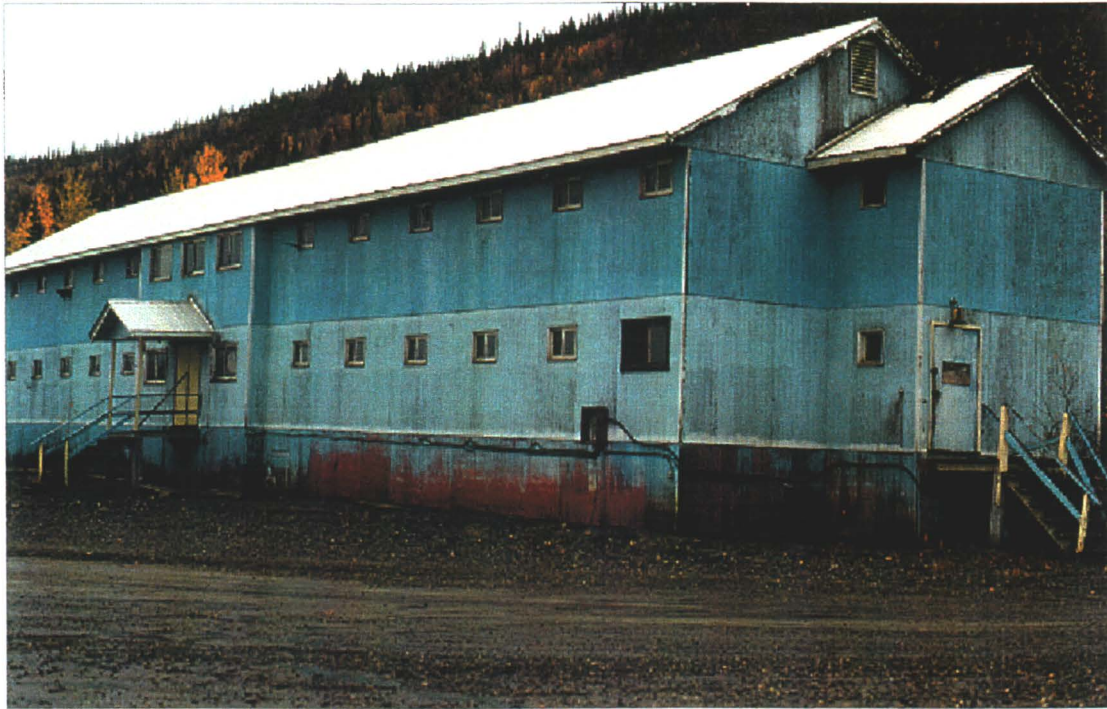
Building # 10: No. 5 Bunkhouse (photo 78-8)

Photo 78-8 : Elsa. Building #10, the No.5 Bunkhouse. (Azimuth 090°)

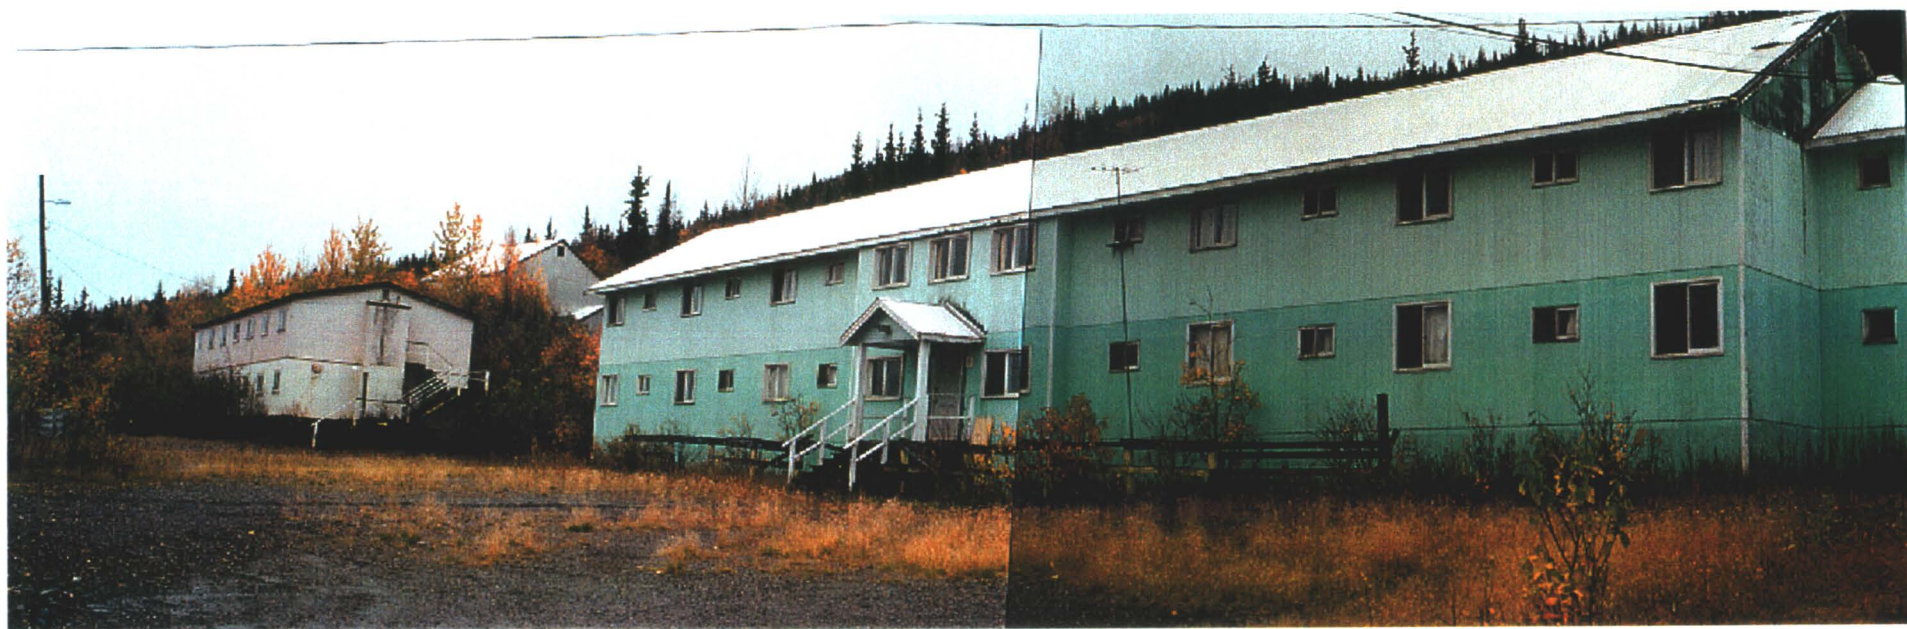
Photo 78-9 : Elsa. The pink building on the left is a bunkhouse (Building #12), the green building on the right is the No.1 Bunkhouse (Building #13).
(Azimuth 075°)

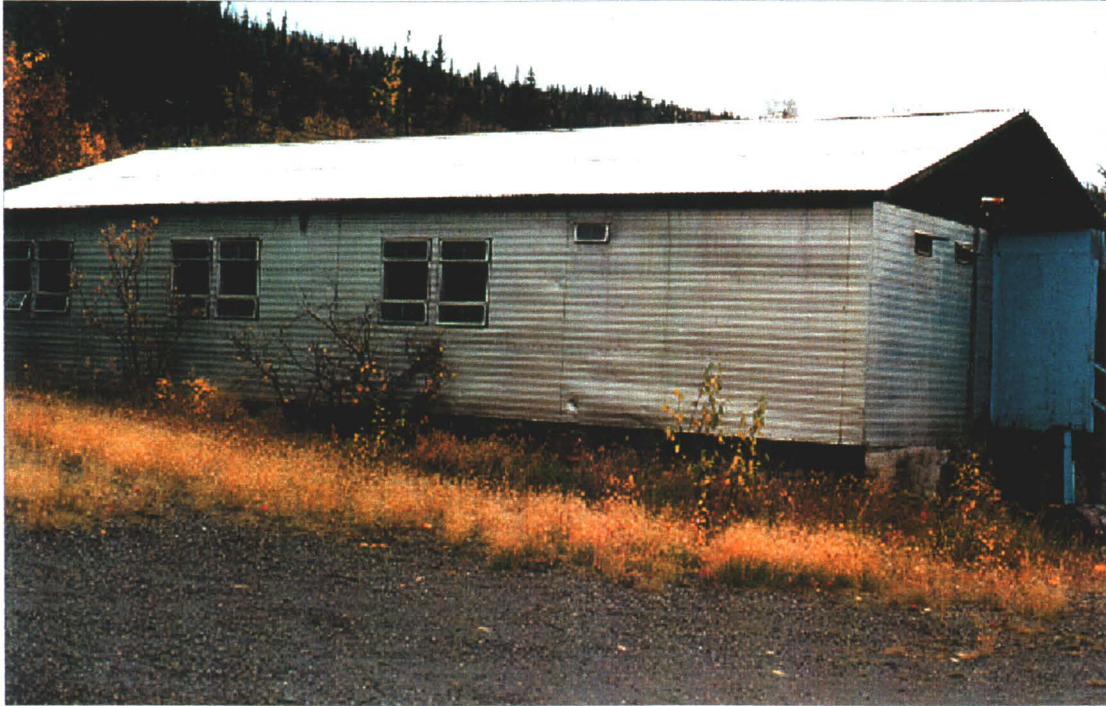
Building # 14: Union Shop (photo 78-10)

Photo 78-10 : Elsa. Building #14, the Union Shop. (Azimuth 200°)

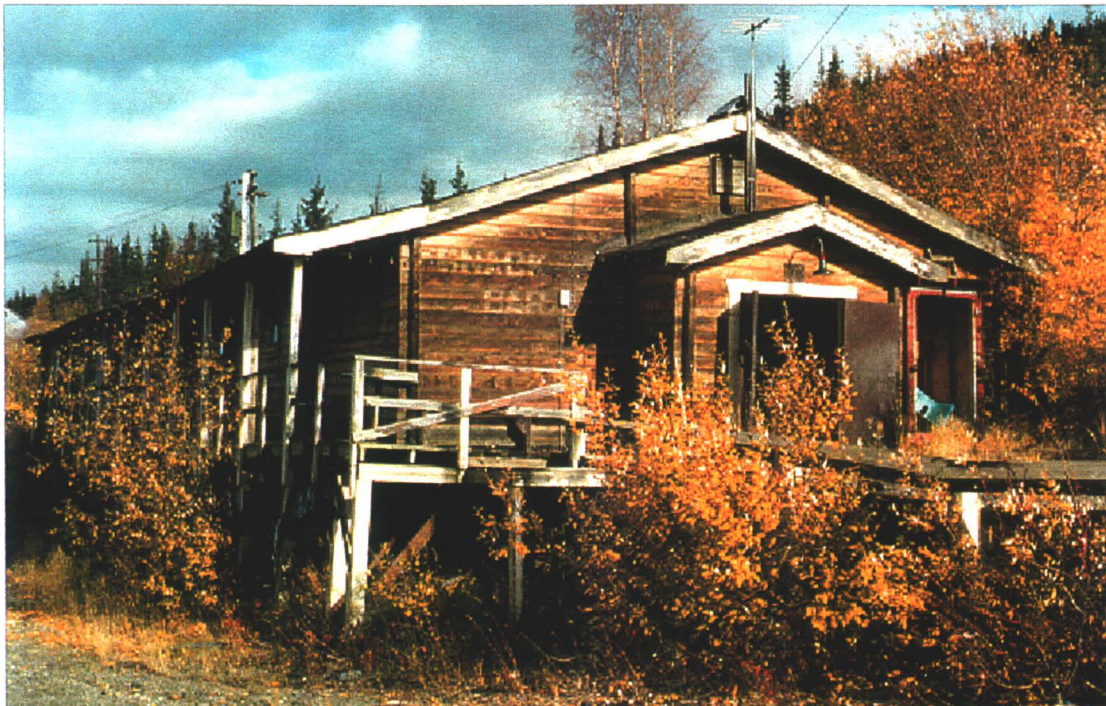
Building # 15: Snack Bar (photo 78-11)

Photo 78-11 : Elsa. Building #15 is the Snack Bar. (Azimuth 110°)

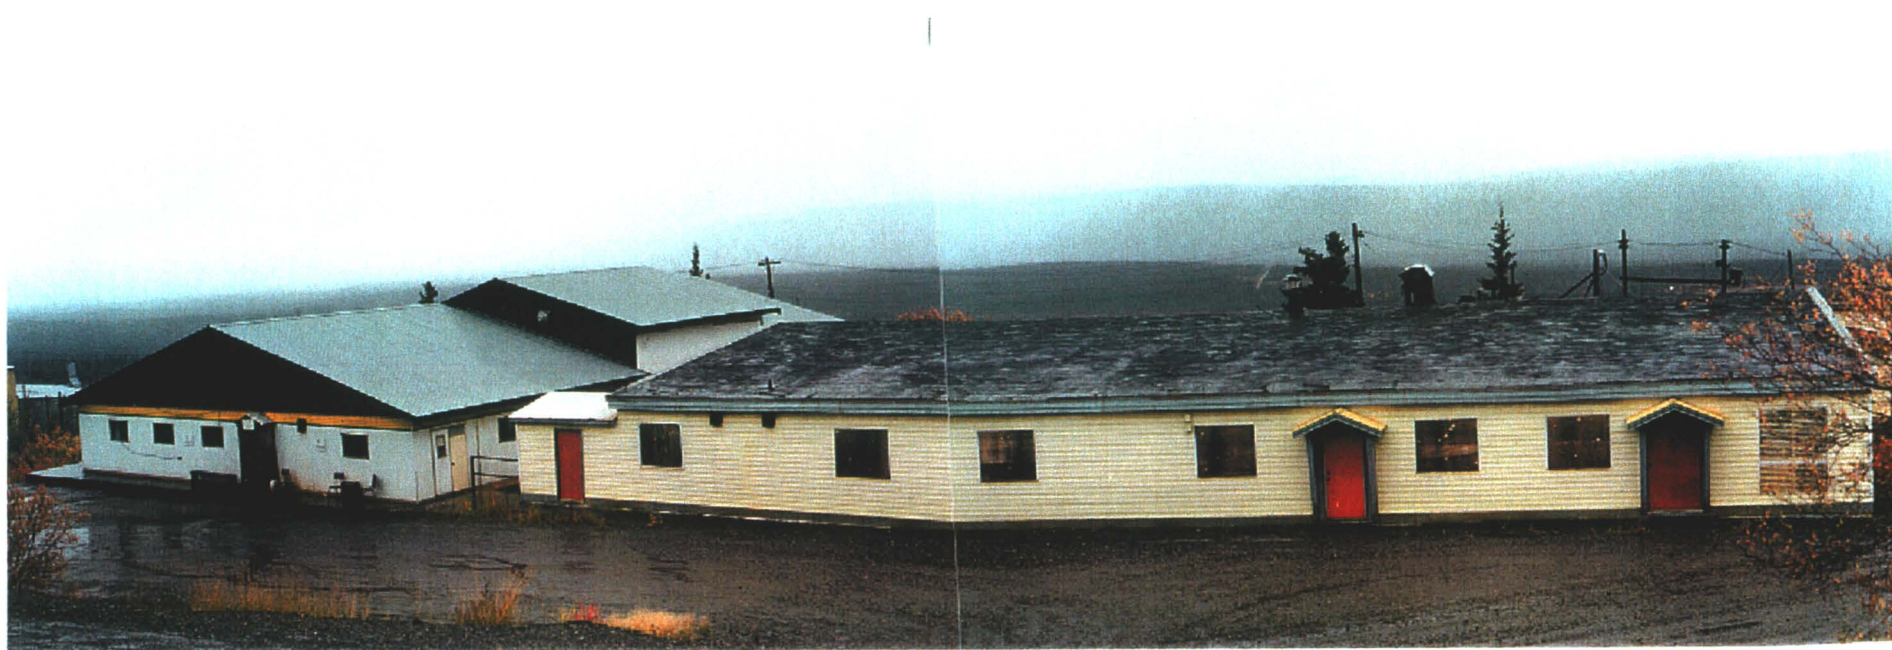
Photo 78-12 : Elsa. Building #17, the new Dry /Change Building, is on the left; and Building #16, the Dining Hall, is on the right. (Azimuth 275°)

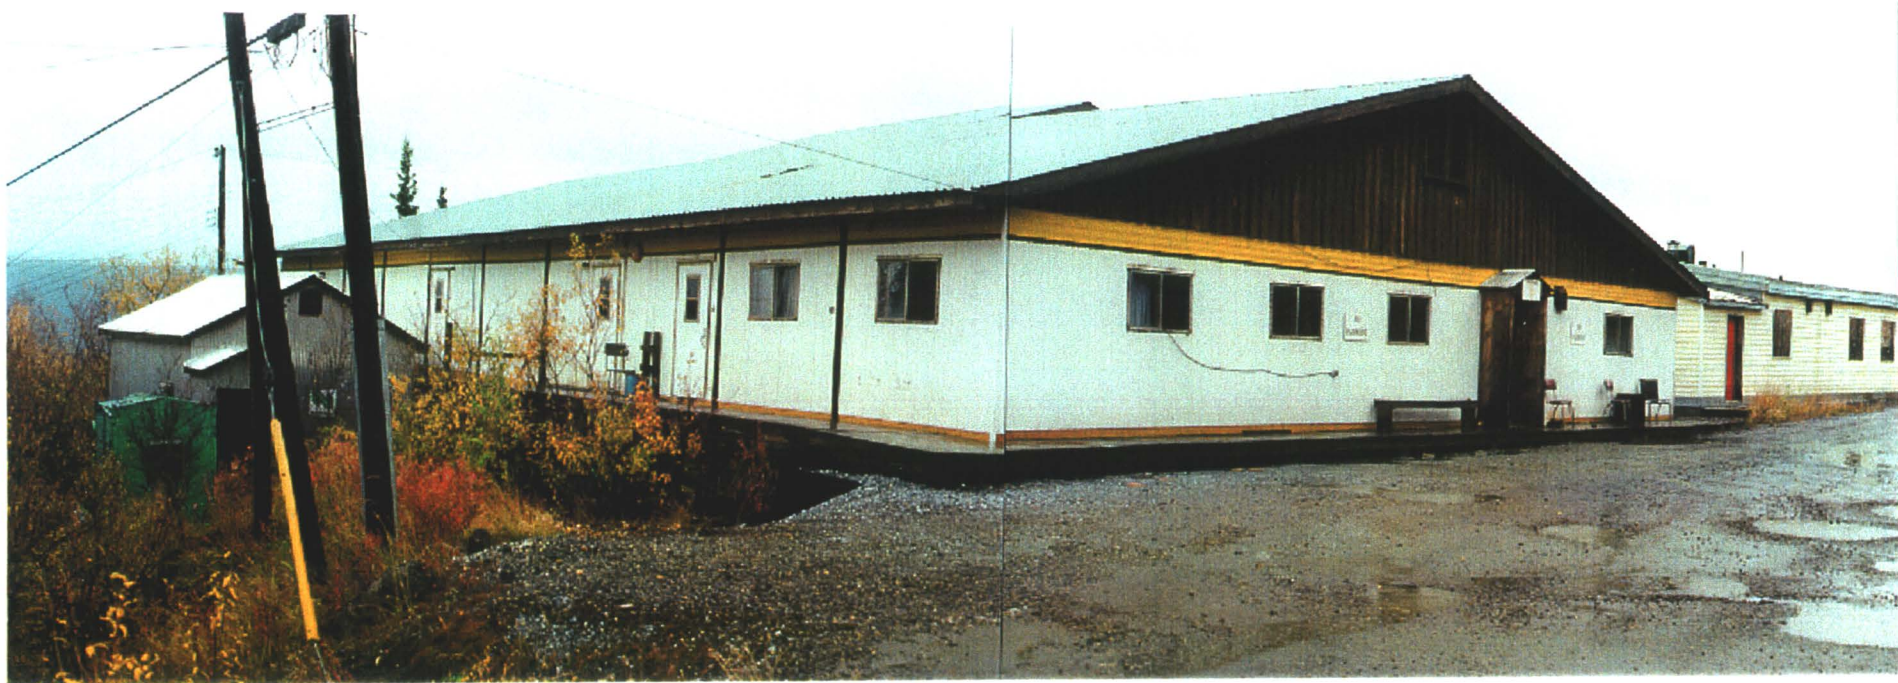
Photo 78-13 : Elsa. Building #18, the Norwest Tel Hut, is the corrugated steel building on the left, and the Dry / Change Building is on the right.
(Azimuth 350°)

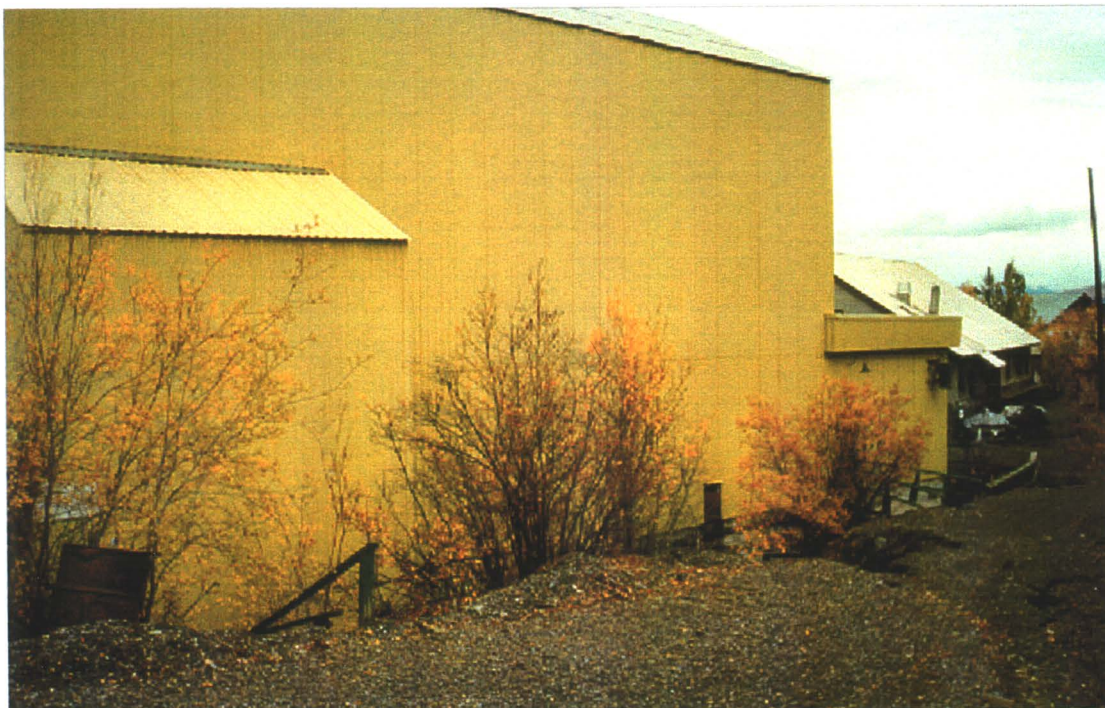
Photo 78-15 : Elsa. The yellow building on the left is the crusherhouse, (Building #20);
the light brown building on the right is the assay lab (Building #37).

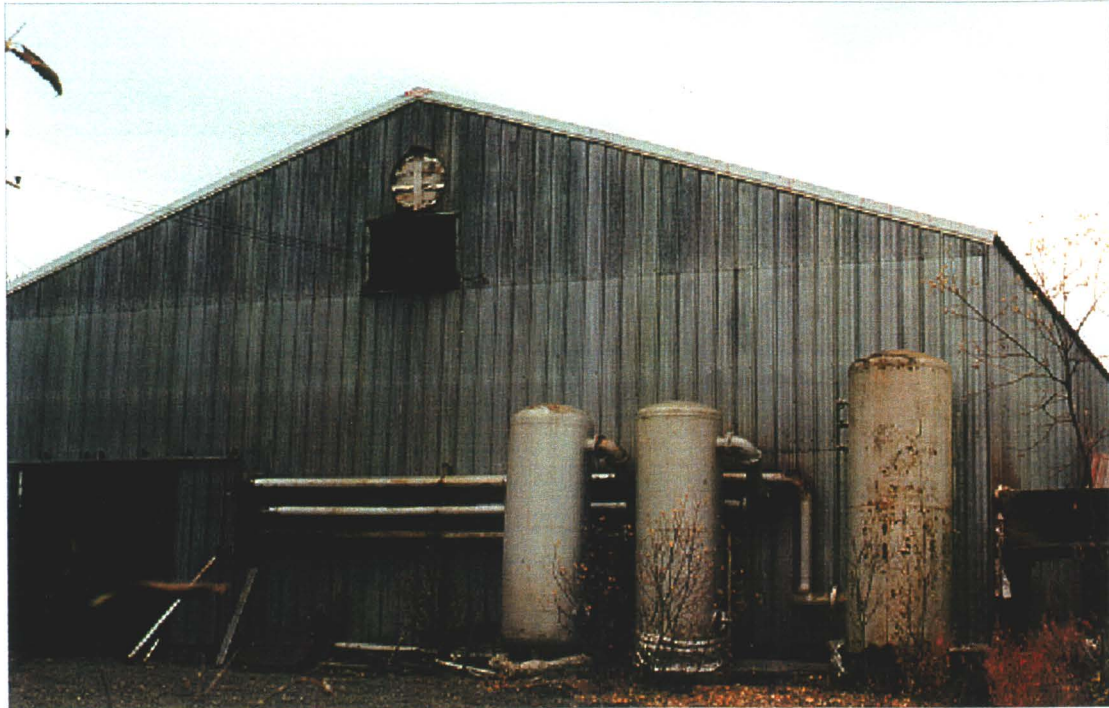
Photo 78-16 : Elsa. View of the vessels on the north end of the boiler plant (Building #21).
(Azimuth 200°)

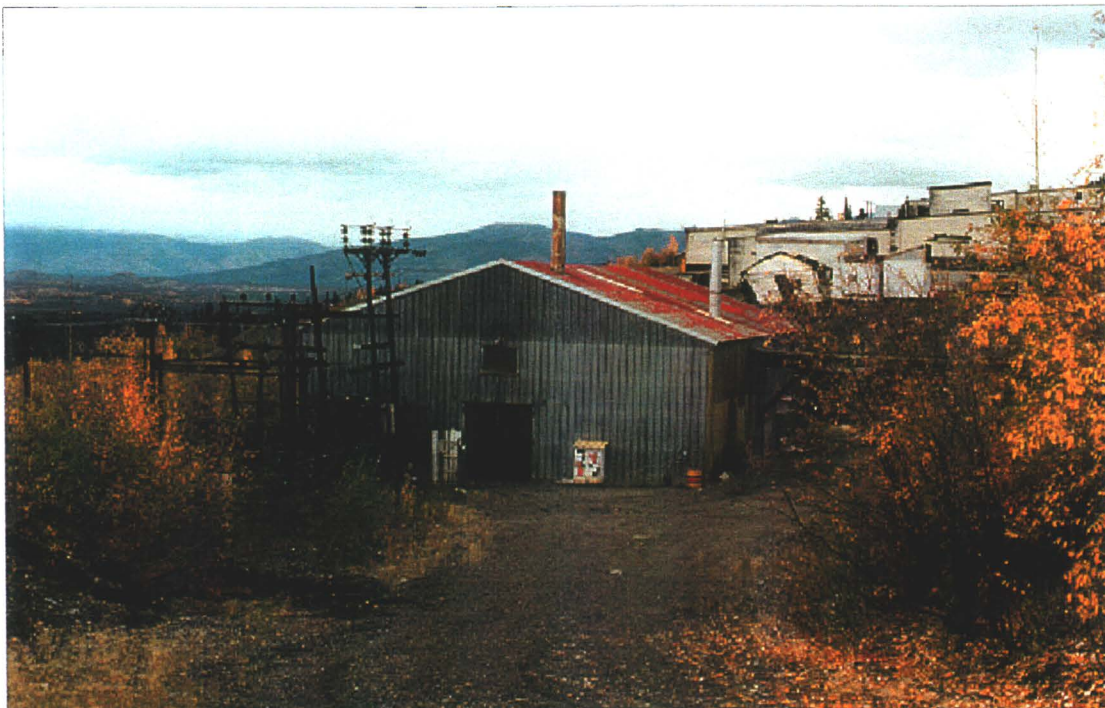
Electrical Equipment Area #2: Electrical Substation (photo 78-17)

In-Service Transformers: All seven of the various sized transformers are active and may contain PCBs. There is a concrete pad under the four larger transformers. The four larger transformers have oil stains on their drain plugs.

Photo 78-17 : Elsa. The boiler plant with an electrical substation beside it, the mill in the background. (Azimuth 020°)

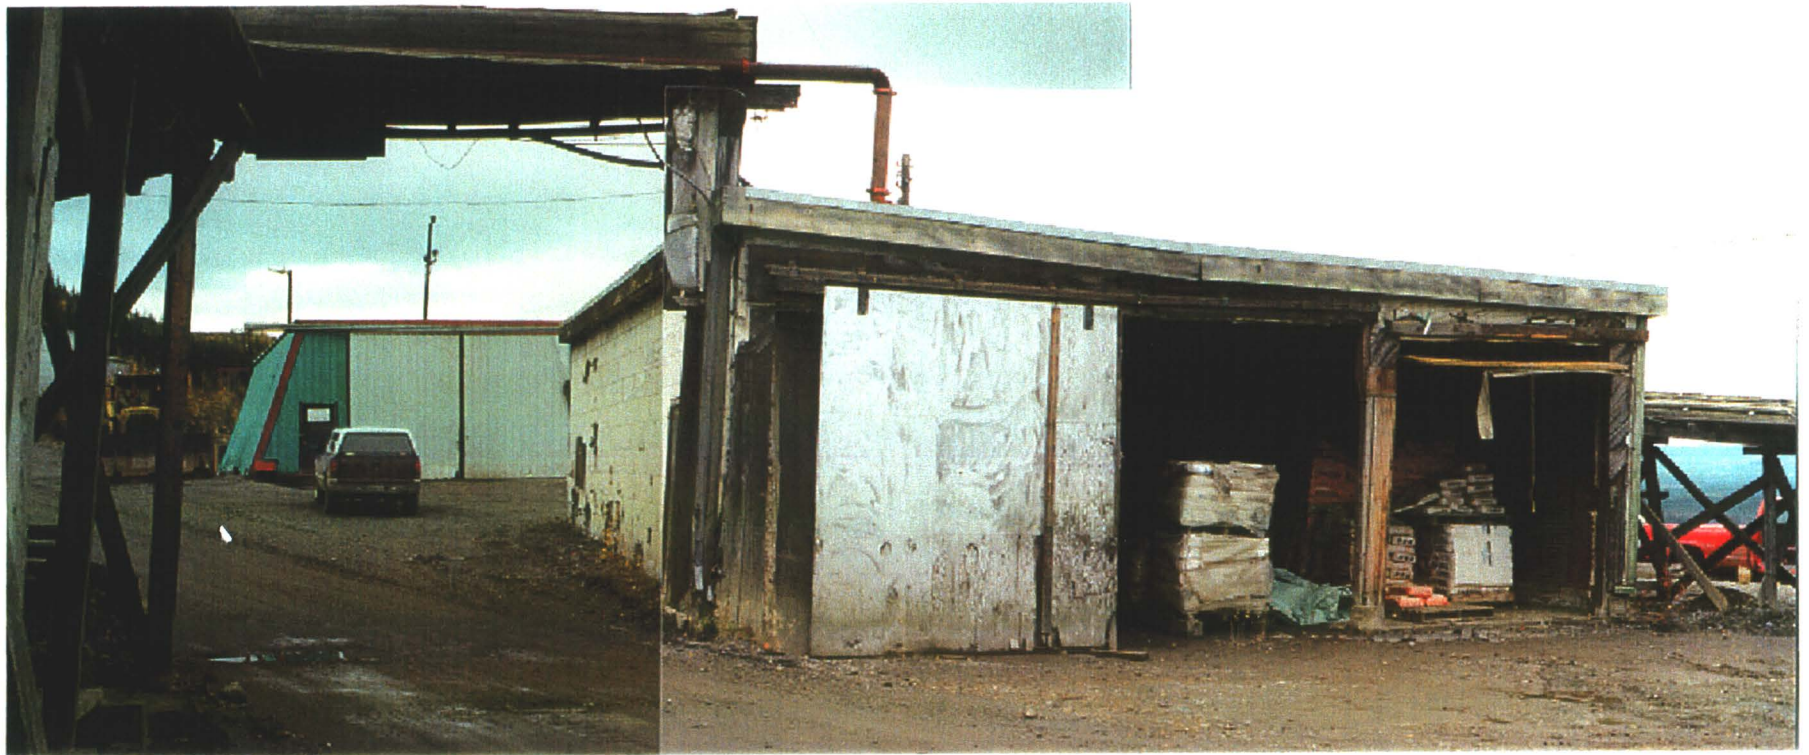
Building # 23: No. 2 Garage (photo 78-18)

Photo 78-18 : Elsa. Building #23, the No.2 Garage, is in the foreground, the Machine Shop (Building #24) is in the background. (Azimuth 260°)

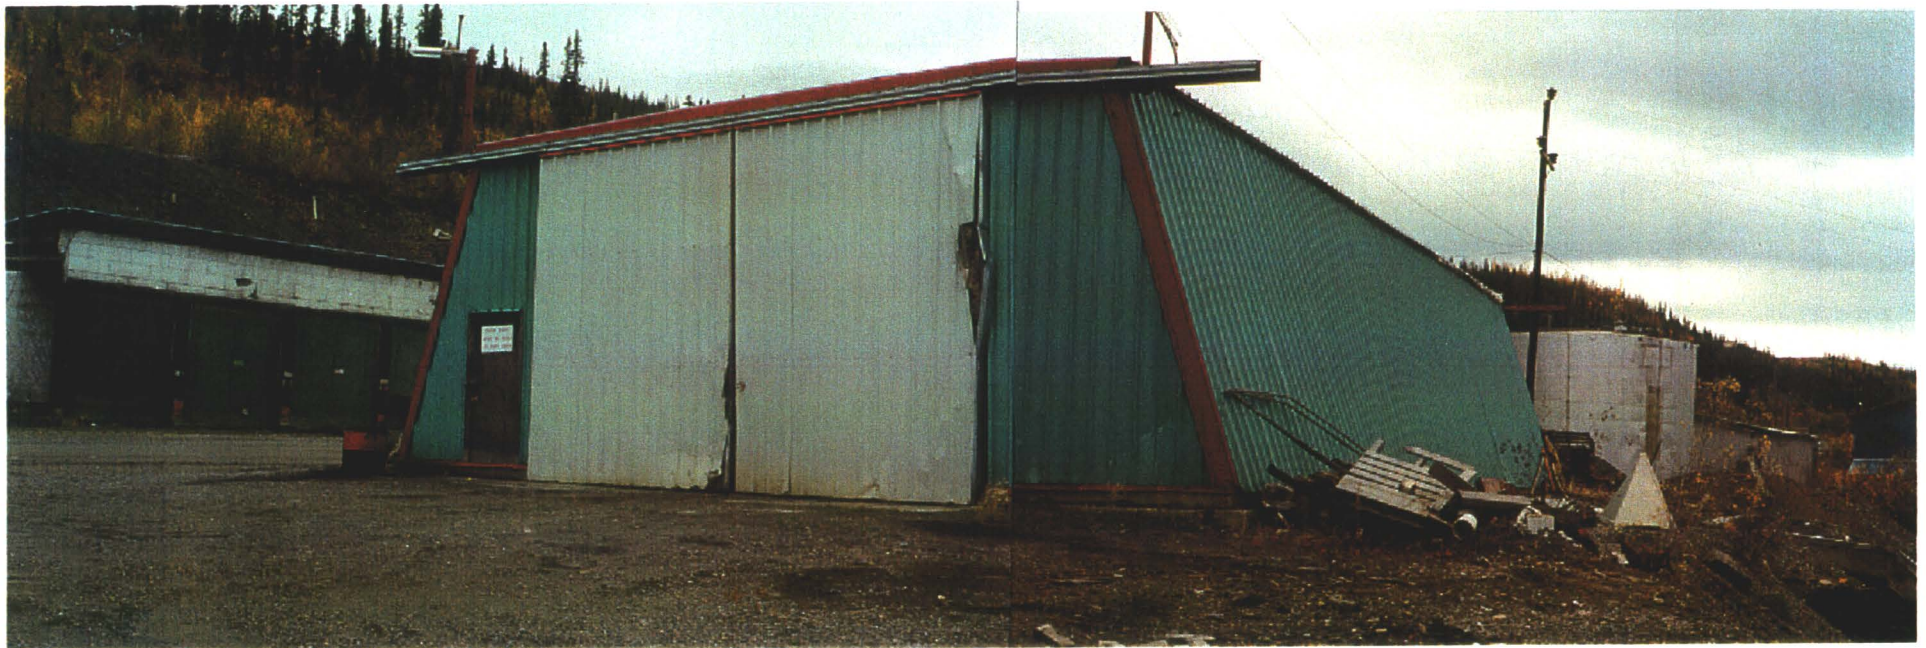
Building # 24: Machine Shop (photo 78-19)

Photo 78-19 : Elsa. The large aqua-coloured building is the Machine Shop (Building #24), the light machine shop is to the left. (Azimuth 170°)

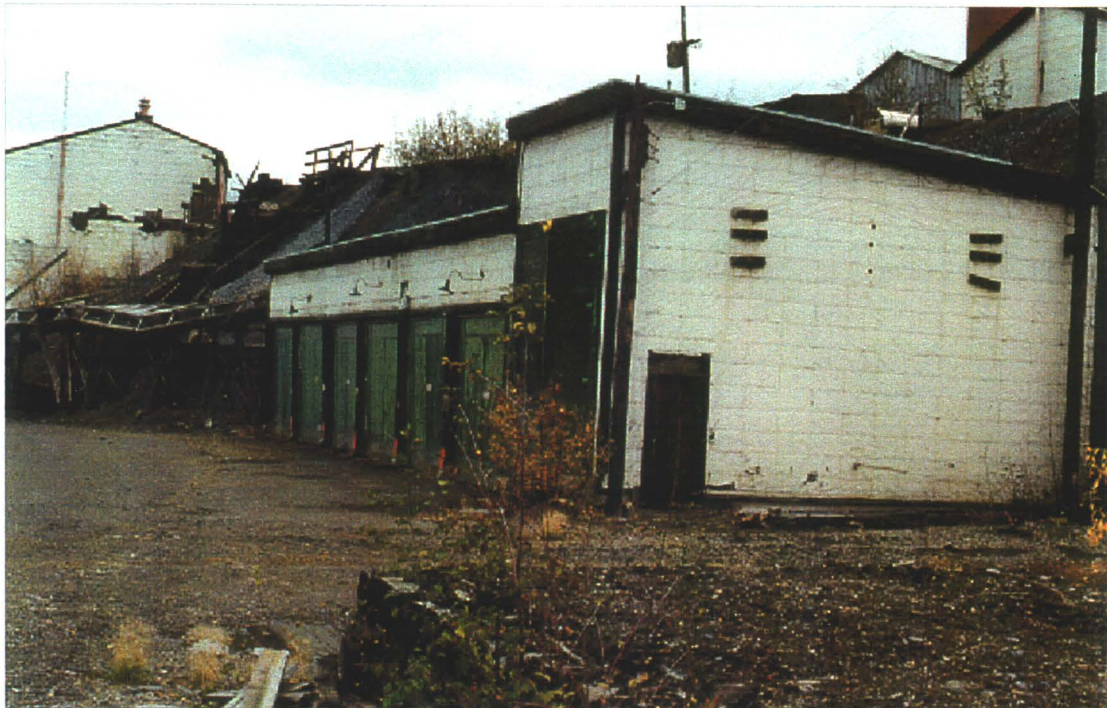
Building # 25: Light Vehicle Shop (photo 78-20)

Photo 78-20 : Elsa. Building #25, Light Vehicle Shop is in the foreground, with Building #51, the crusherhouse, in the background. (Azimuth 060°)

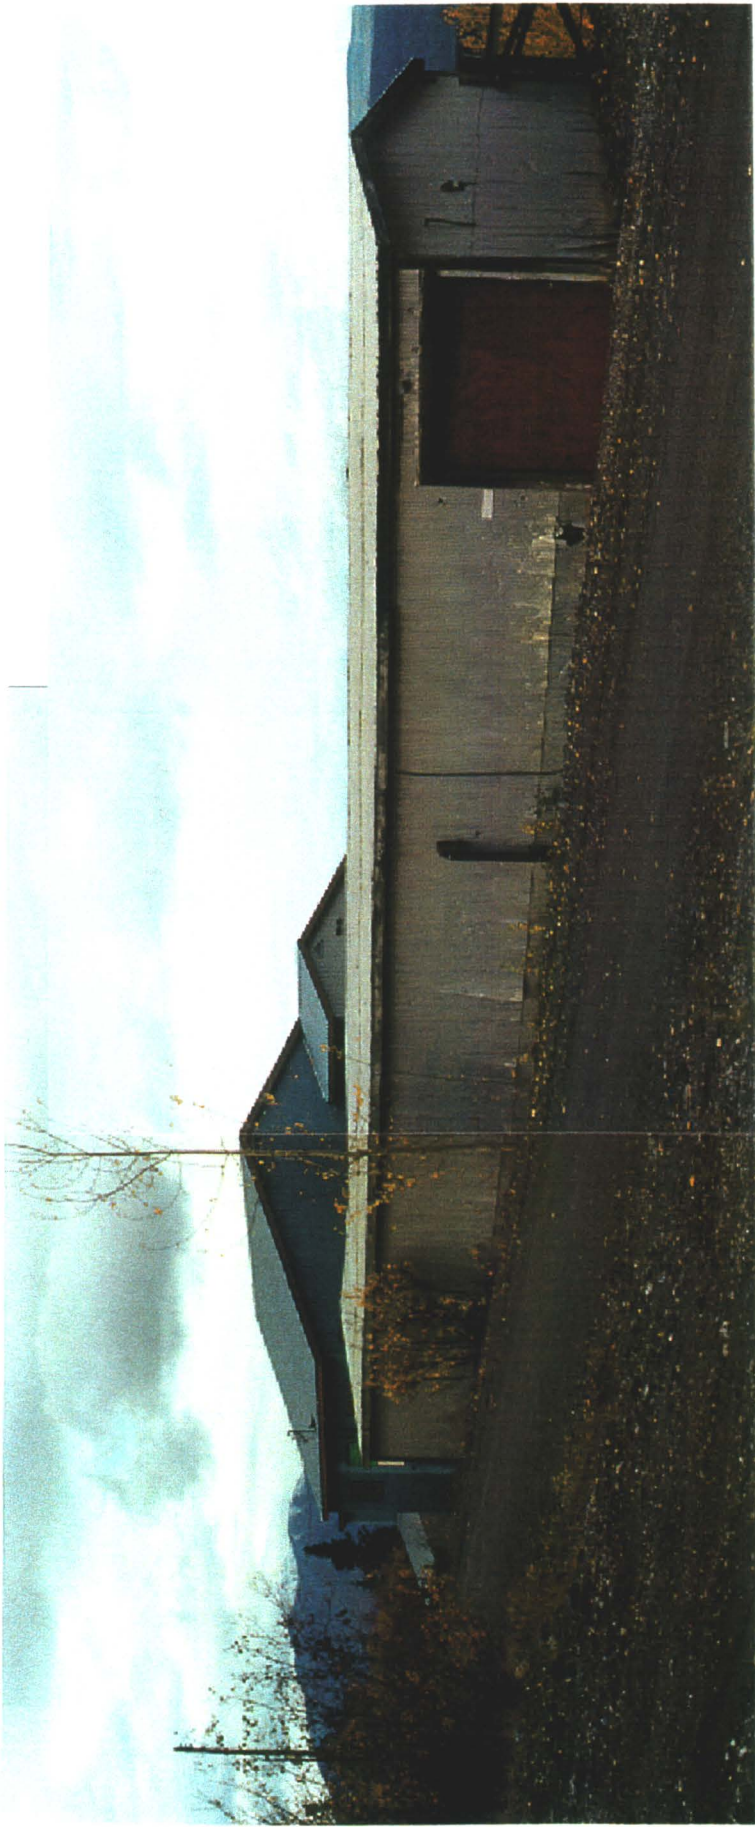
Building # 26: Rescue Building (photo 78-21)

Photo 78-21 : Elsa. Building #26, the rescue building. (Azimuth 270°)

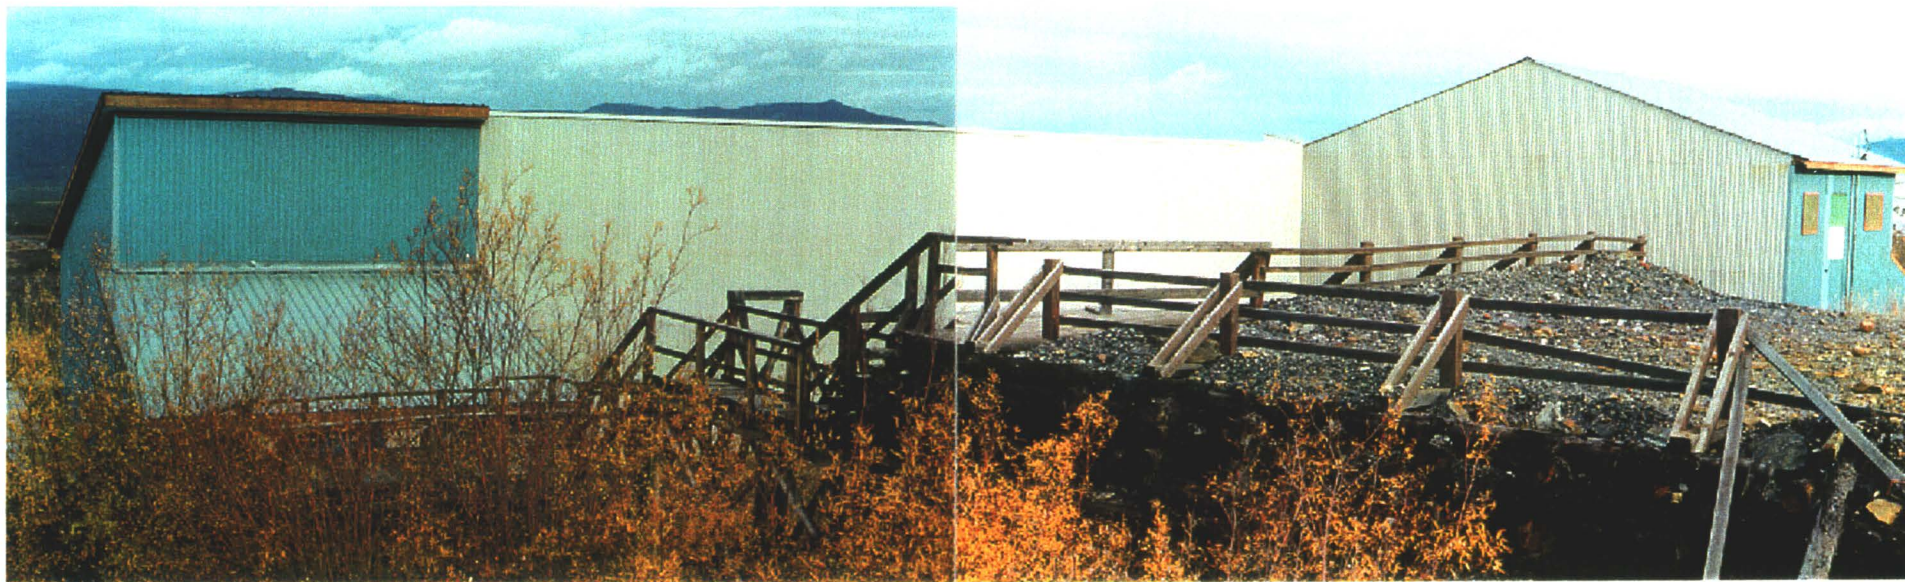
Building # 27: Recreation Centre (photo 78-22)

Photo 78-22 : Elsa. Building #27 is the Recreation Centre. (Azimuth 360°)

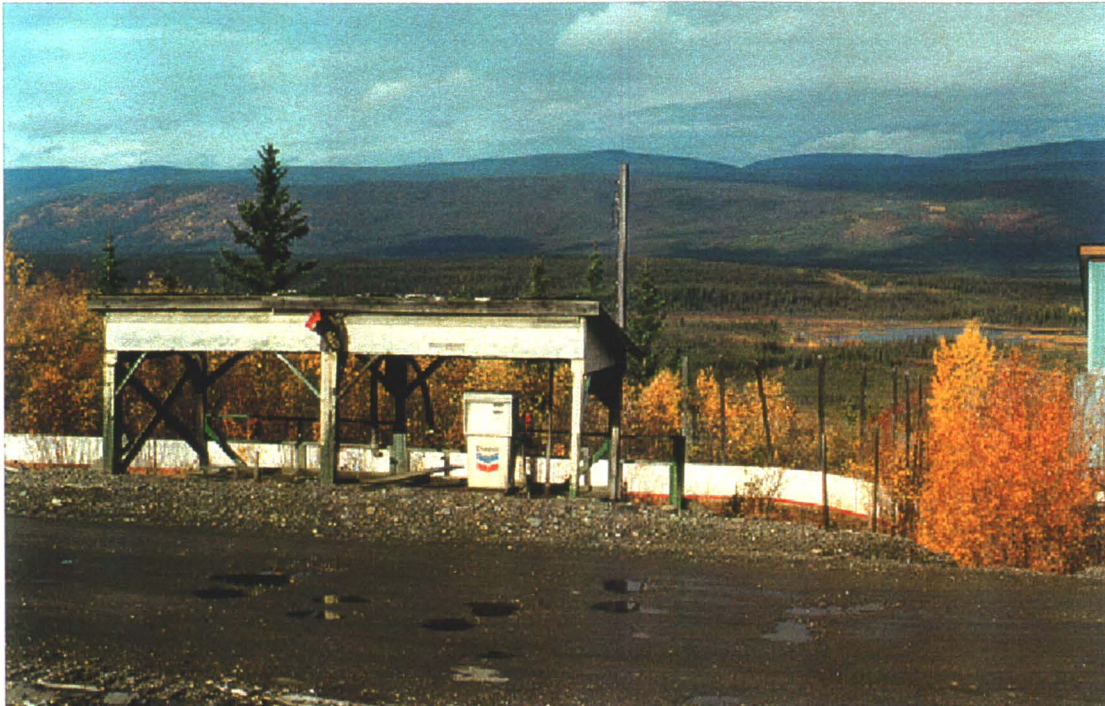
Photo 78-23 : Elsa. Fuel Storage Area #2, a single Chevron pump, located uphill from the skating rink. (Azimuth 030°)

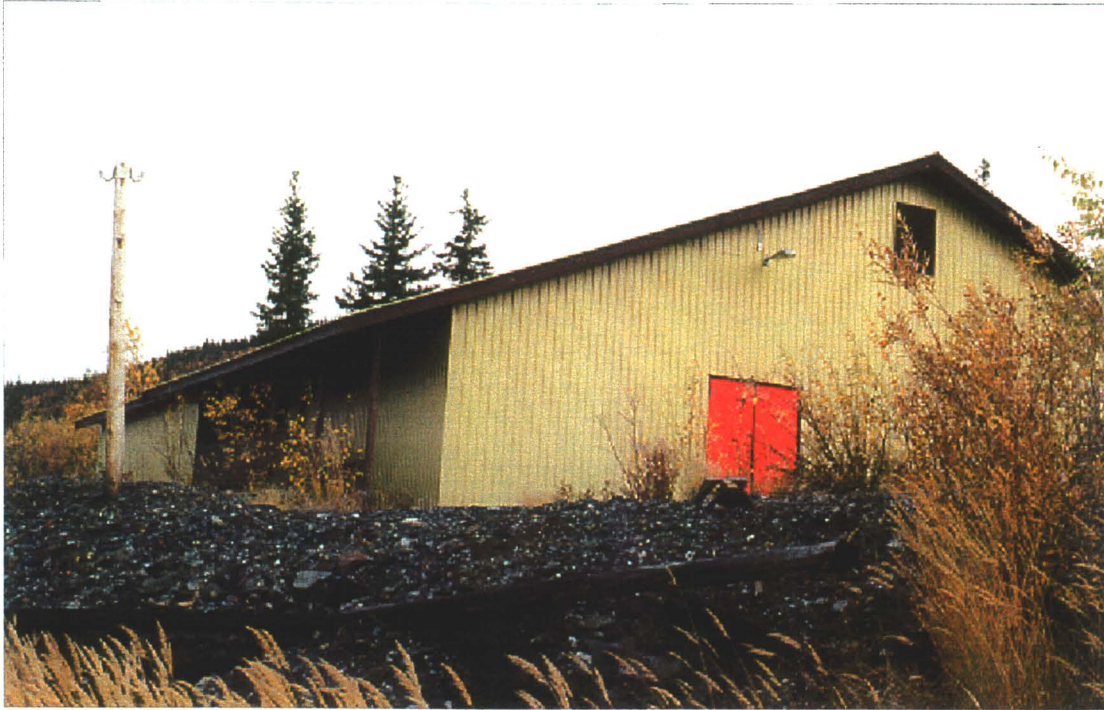
Building #29: Swimming Pool Building (photo 78-24)

Photo 78-24 : Elsa. Building #29, the swimming pool building. (Azimuth 085°)

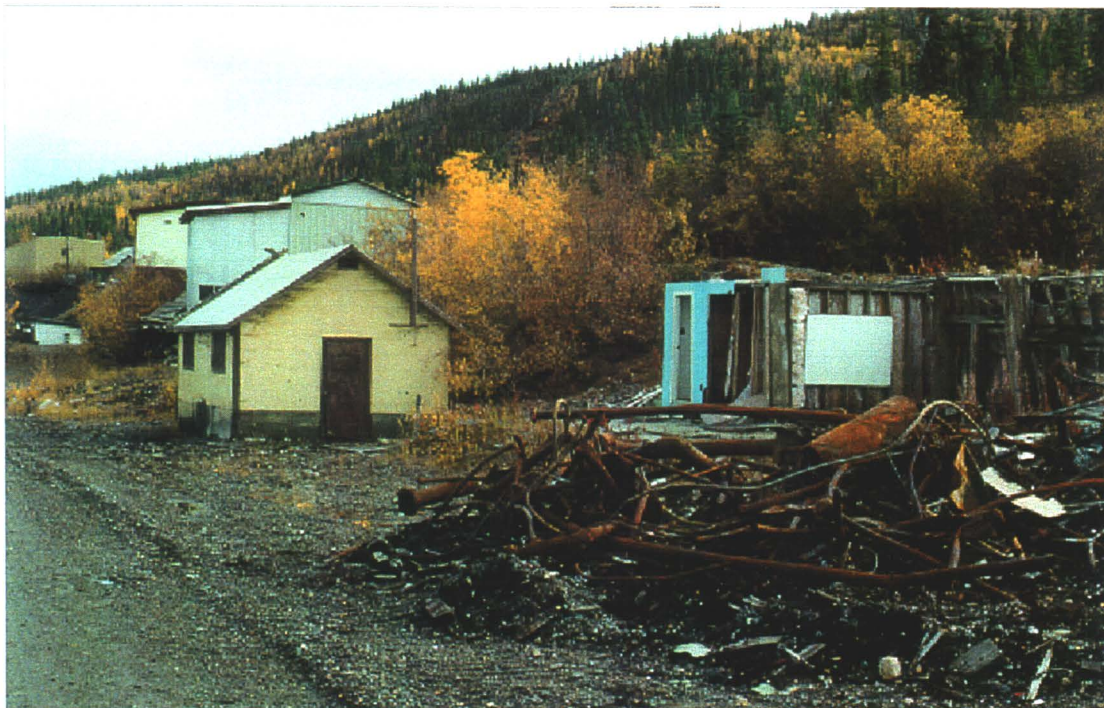
Building # 30: Yellow Exploration Building (photo 78-25)

Photo 78-25 : Elsa. The blue building on the right is the old exploration office, the yellow building (Building #30) on the left is the new exploration building. (Azimuth 080°)

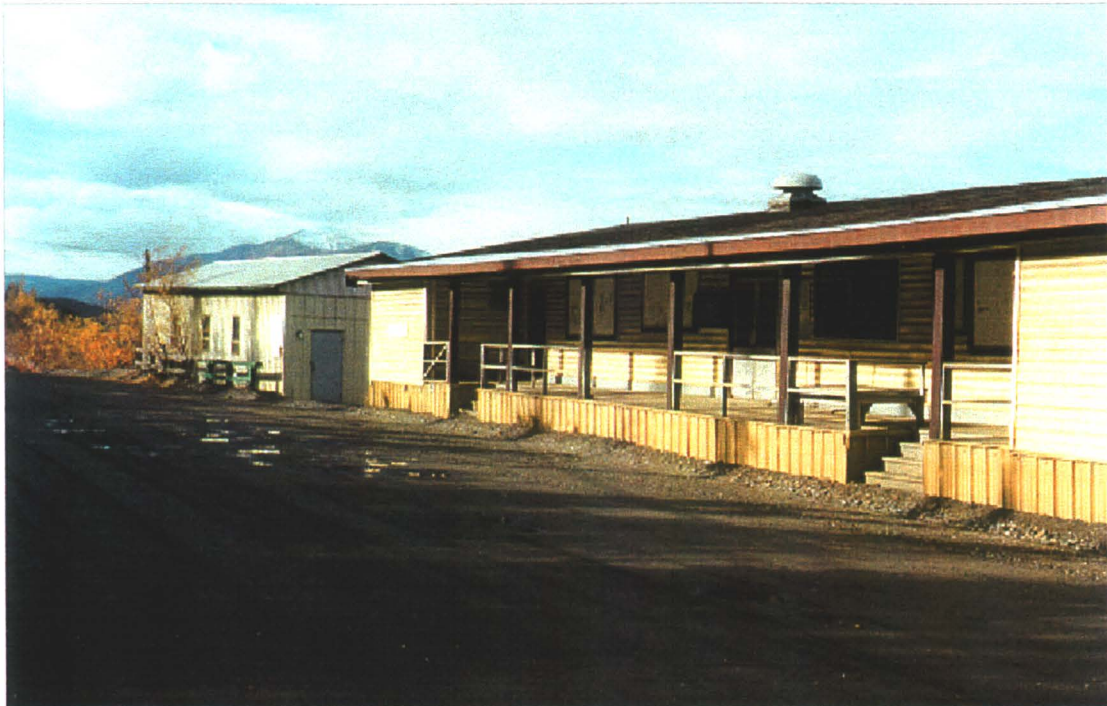
Photo 78-26 : Elsa. The Elsa Market (Building #32) is on the right, and the medical building (Building # 31) is on the left. (Azimuth 270°)

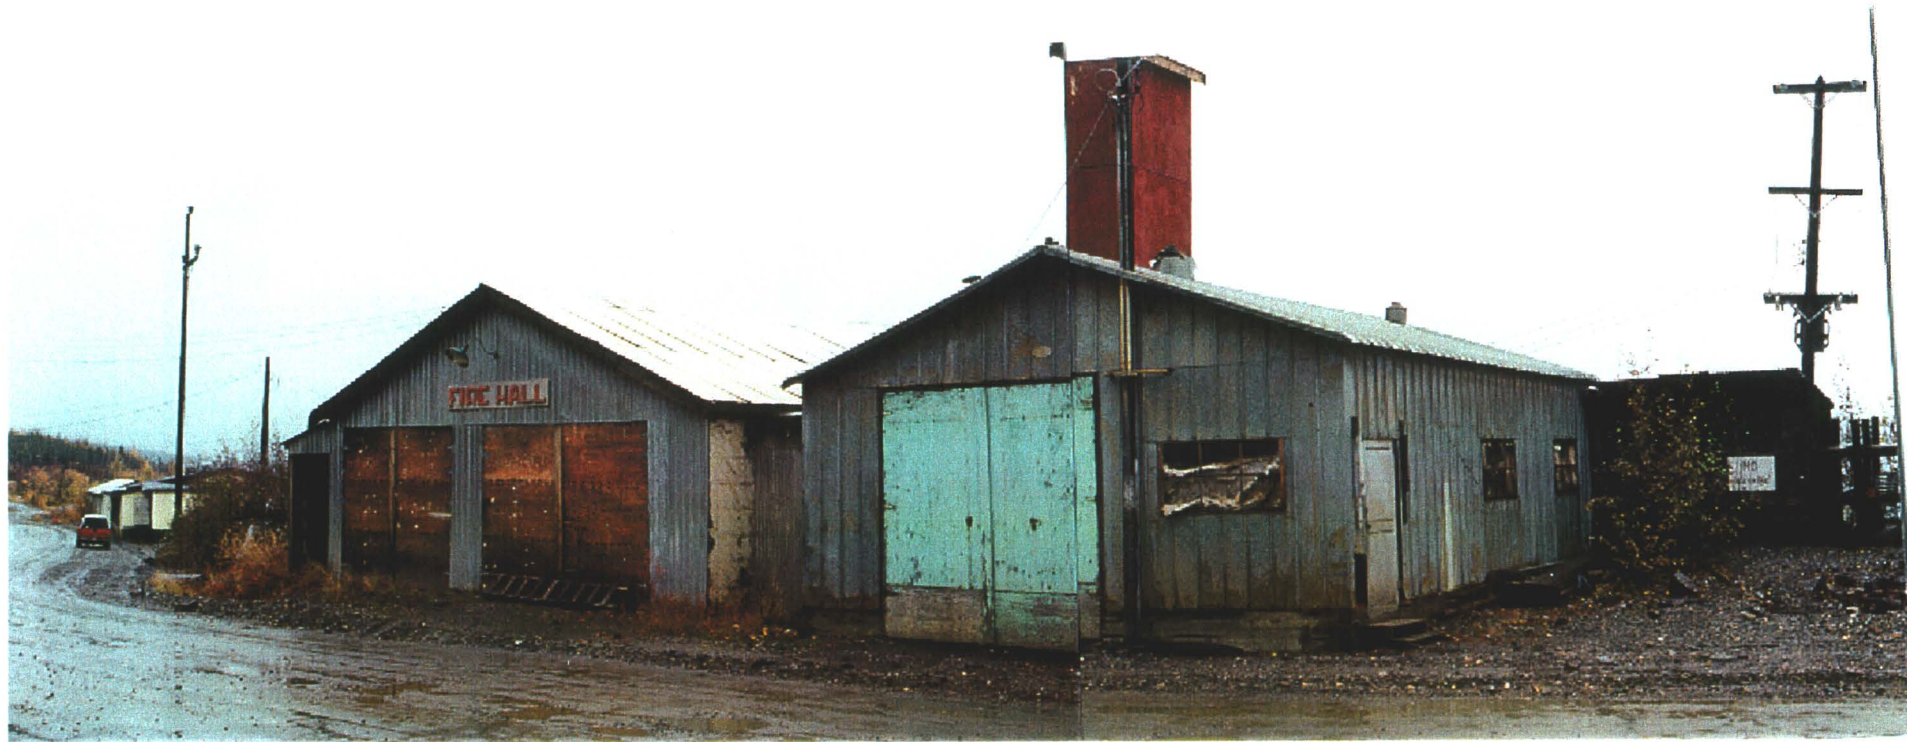
Photo 78-27 : Elsa. Building #33, the Fire Hall is on the left of the photo and Building #34, possibly the dry change house, is on the right. (Azimuth 260°)
