ELSA VILLAGE

SITE #78

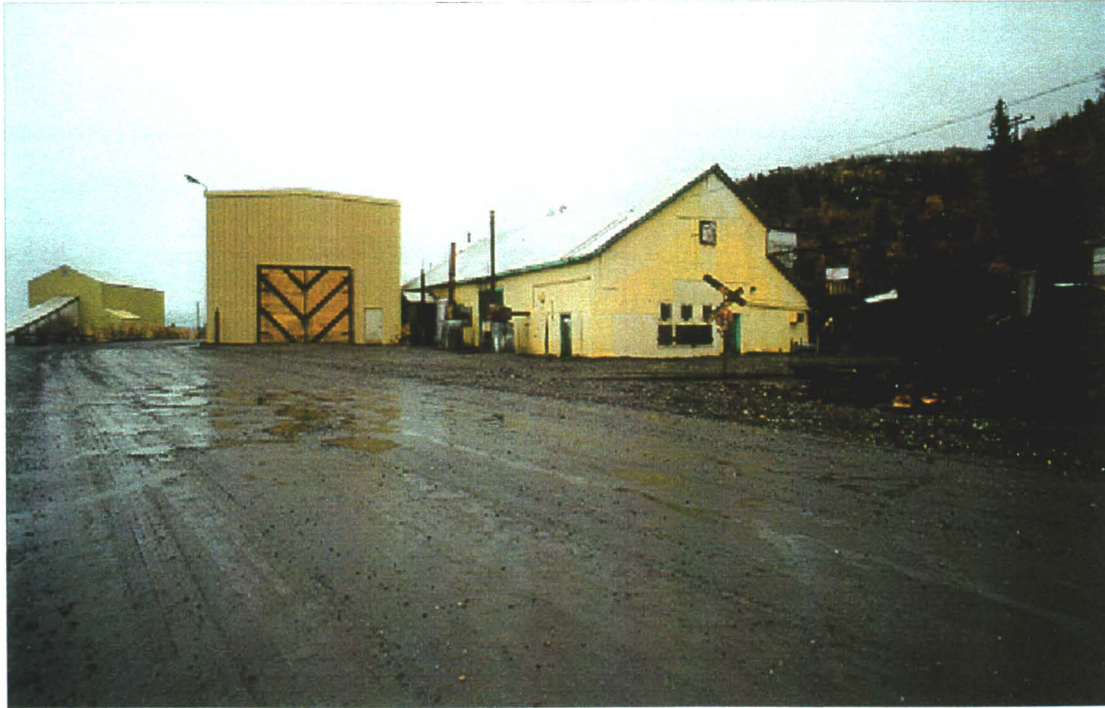
Photo 78-28 : Elsa. The generator building is on the right, the vehicle & heavy equipment warehouse is in the centre, and the building in the background is the crusher house. The 3 diesel exhaust stacks are visible on the left side of the generator building.

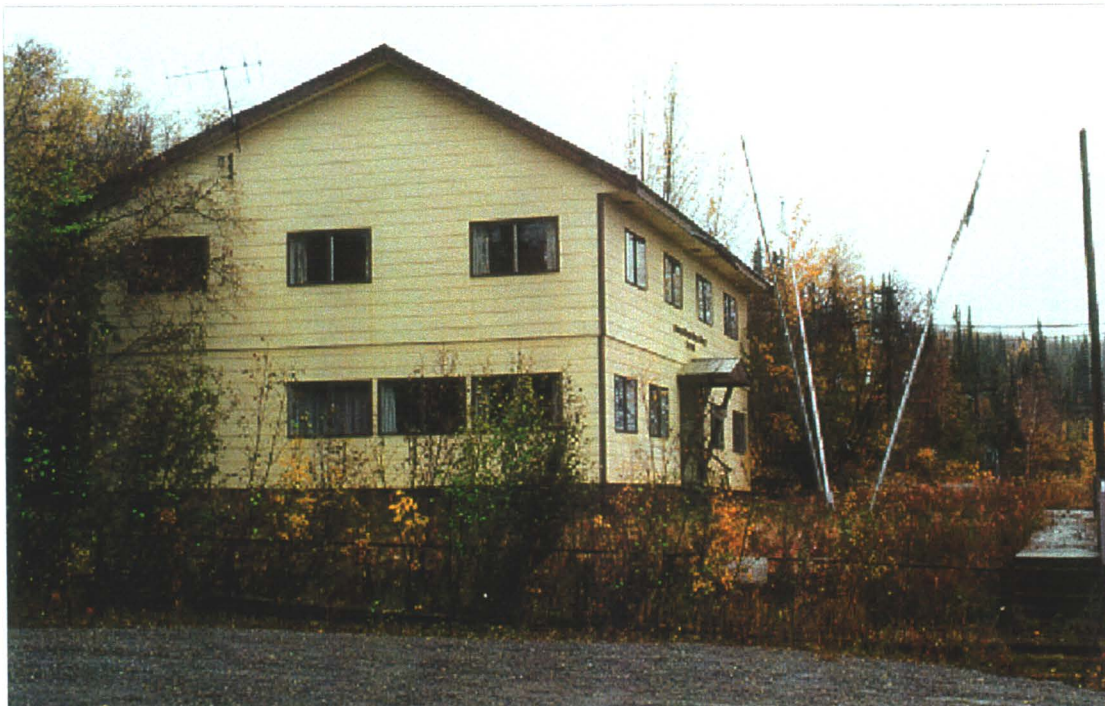
Building # 38: Administration Building (photo 78-29)

Photo 78-29 : Elsa. The Administration Building (Building #38) is located to the southeast of the floatation mill. (Azimuth 190°)

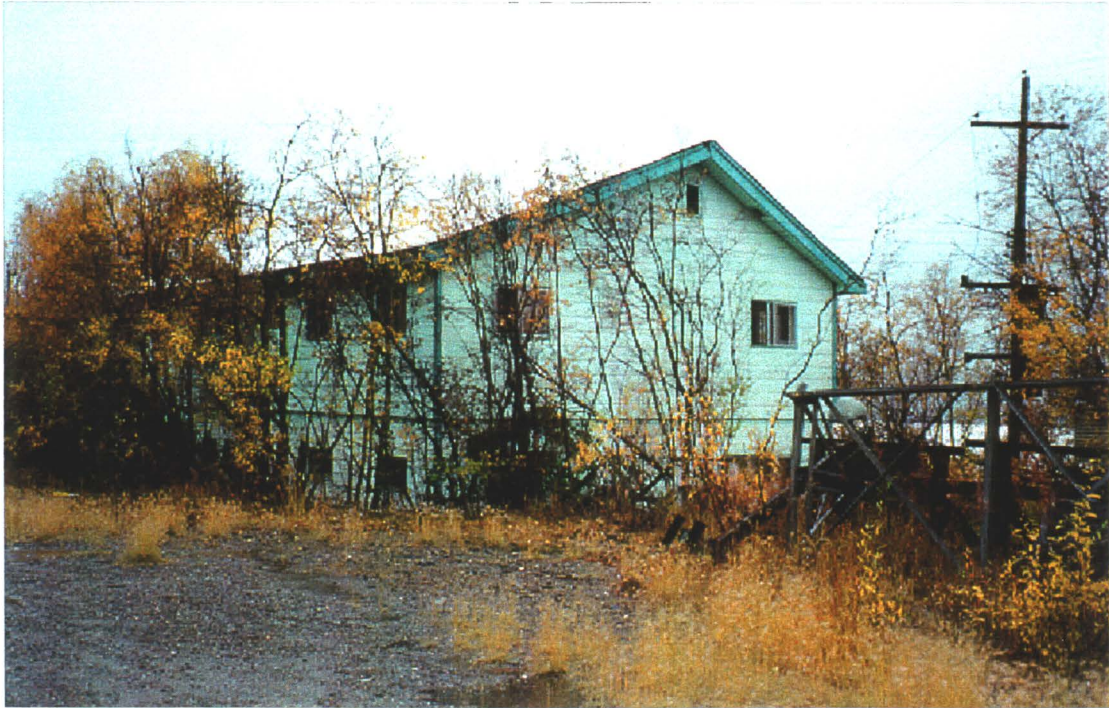
Building #39: Men's Staffhouse (photo 78-30)

Photo 78-30 : Elsa. Looking west at the Men's Staffhouse (Building #39). (Azimuth ~270°)

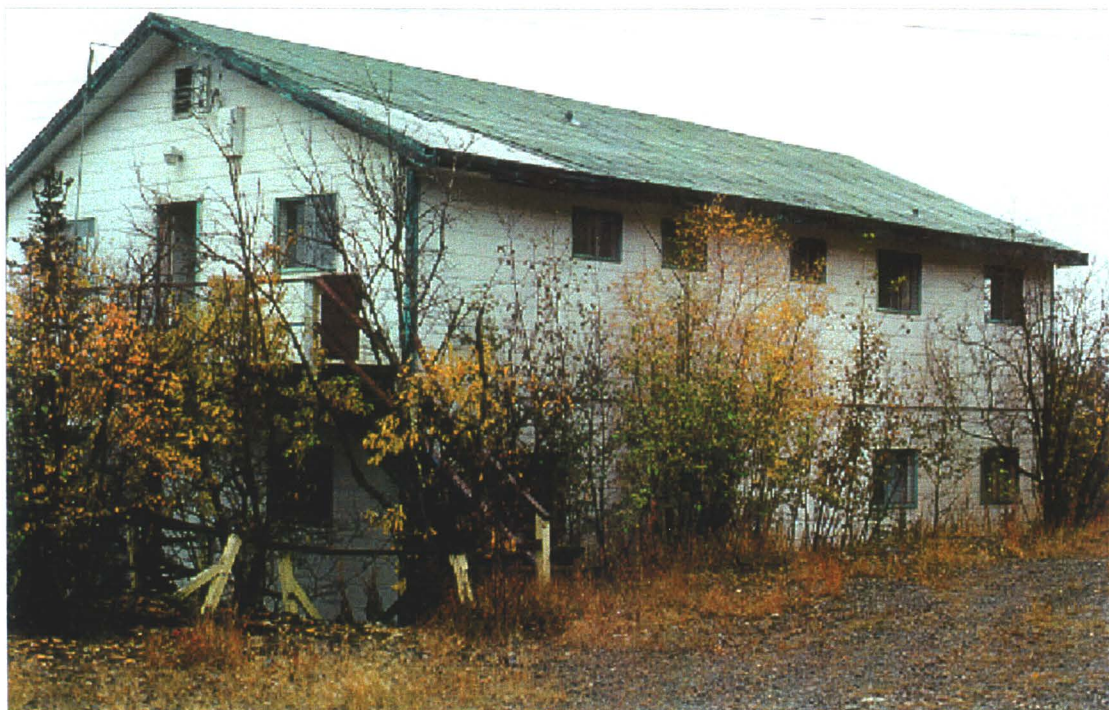
Building #41: Apartment Building (photo 78-31)

Photo 78-31 : Elsa. Building #41, a two-story apartment complex. (Azimuth 360°)

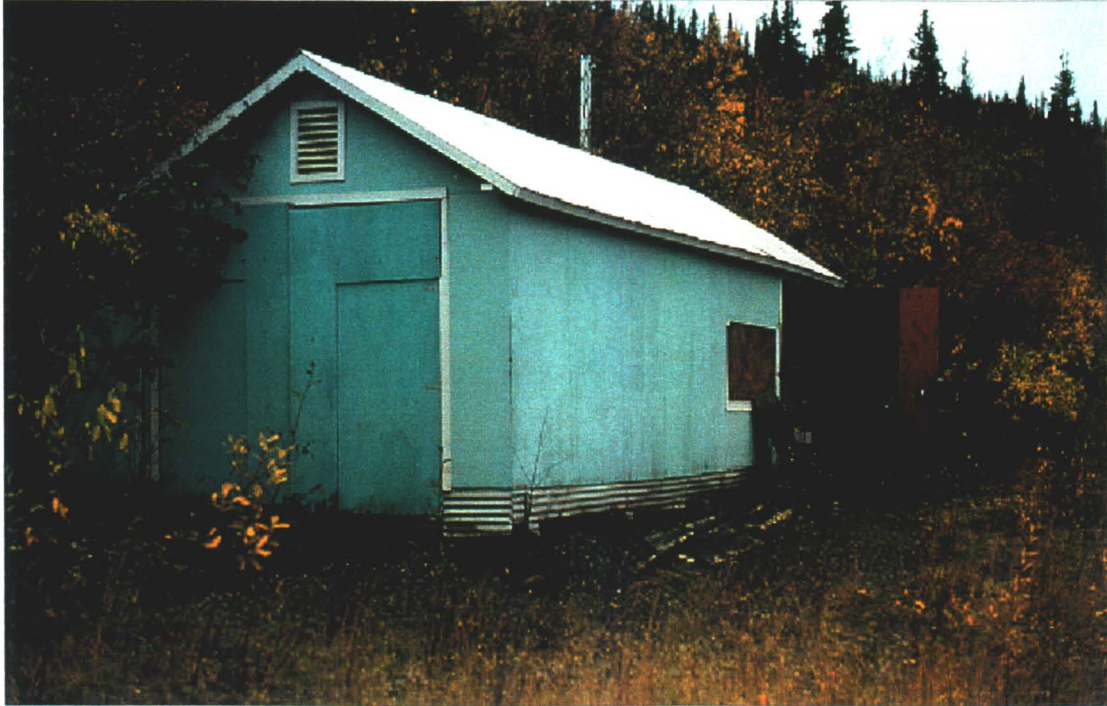
Building # 42: Garage (photo 78-32)

Photo 78-32 : Elsa. Building #42, a one car gragage. (Azimuth 190°)

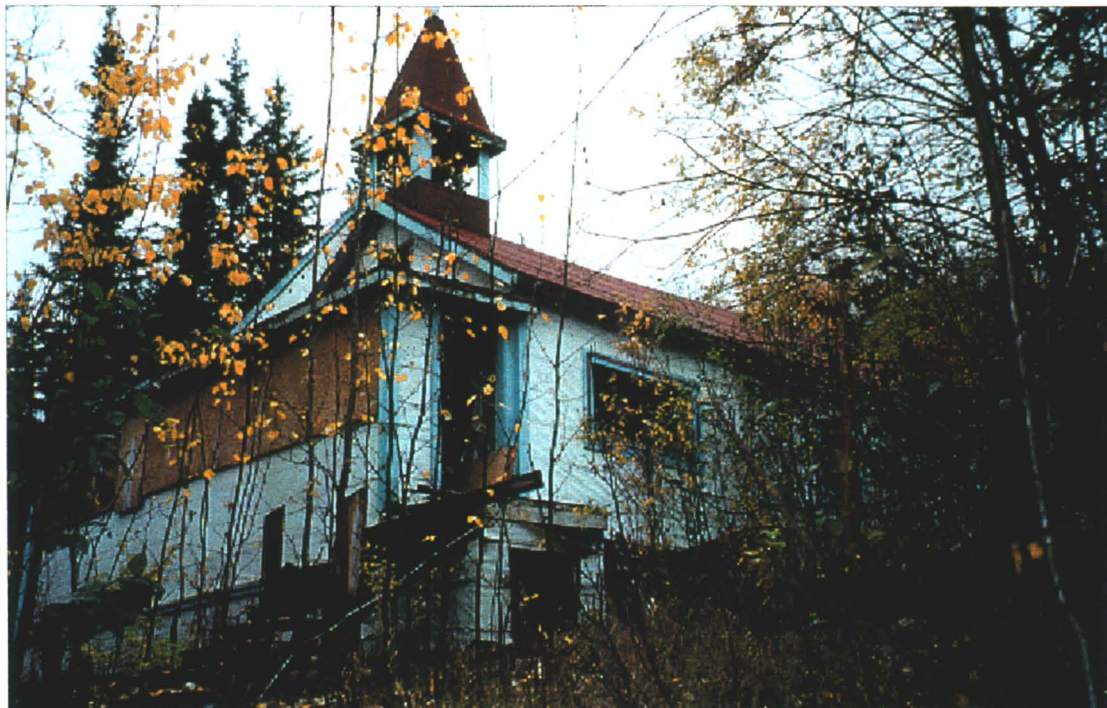
Building #43: Roman Catholic Church (photo 78-33)

Photo 78-33 : Elsa. Building #43 is the Roman Catholic church.

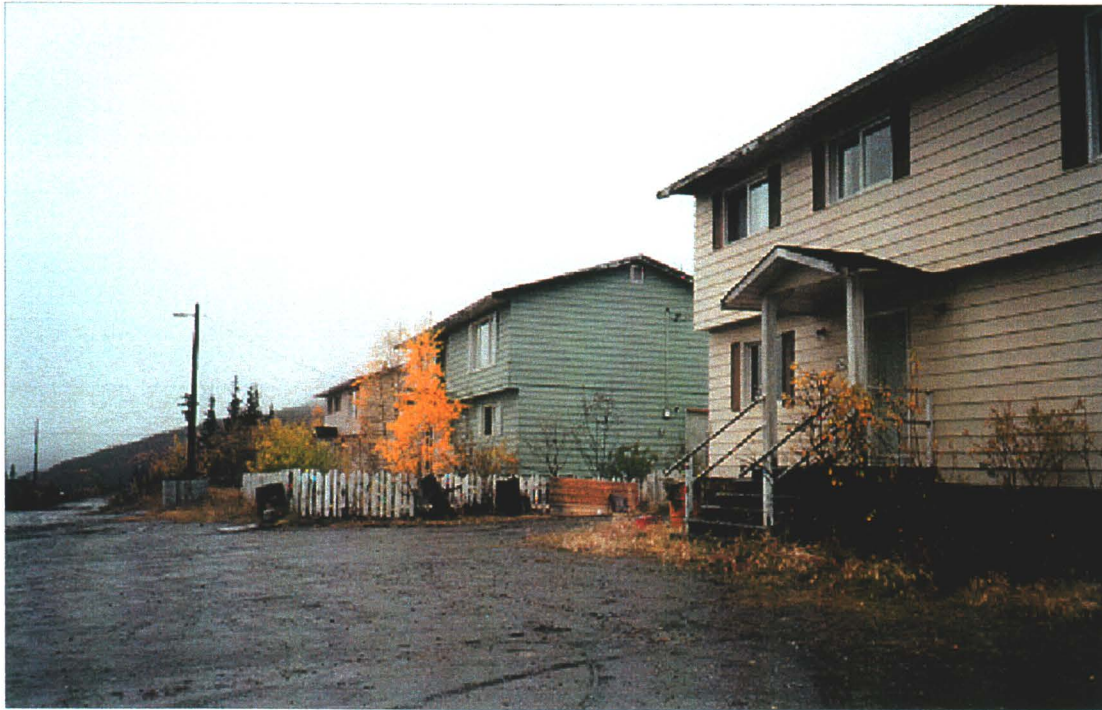
Aurora Height Residential Area, Buildings #44-51: Occupied Residences (photo 78-34)

Photo 78-34 : Elsa. Occupied mine houses. (Buildings #44 - 51)

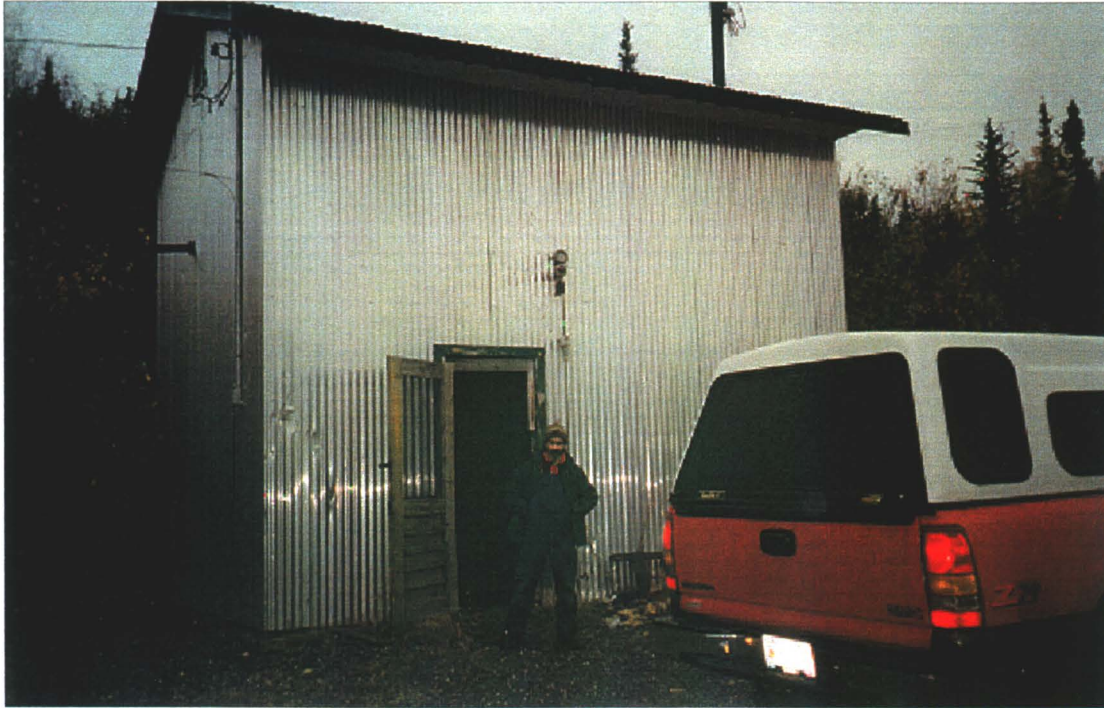
Photo 78-37 : Elsa. Elsa school. Note white probable underground fuel storage tank stand pipes at nearest corner. (Azimuth 090°)

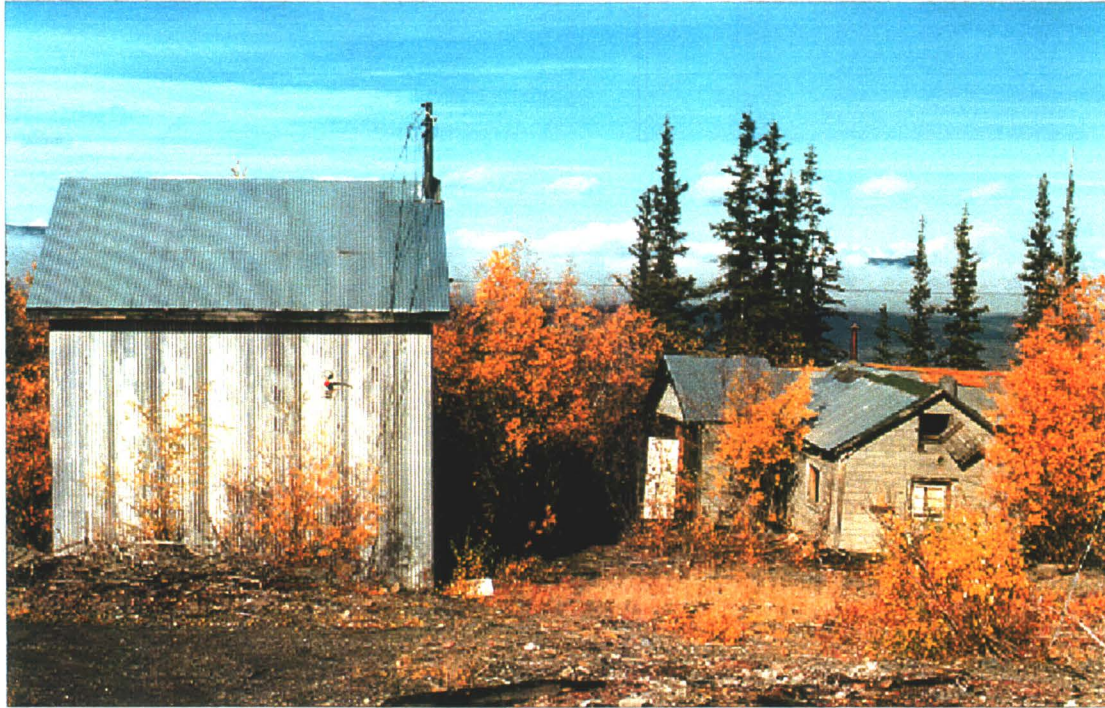
Photo 78-38 : Elsa. View of buildings in the Flat Creek area, the water pump building (Building #55) is on the left and residence #1 (Building #56) is on the right. (Azimuth 350°)

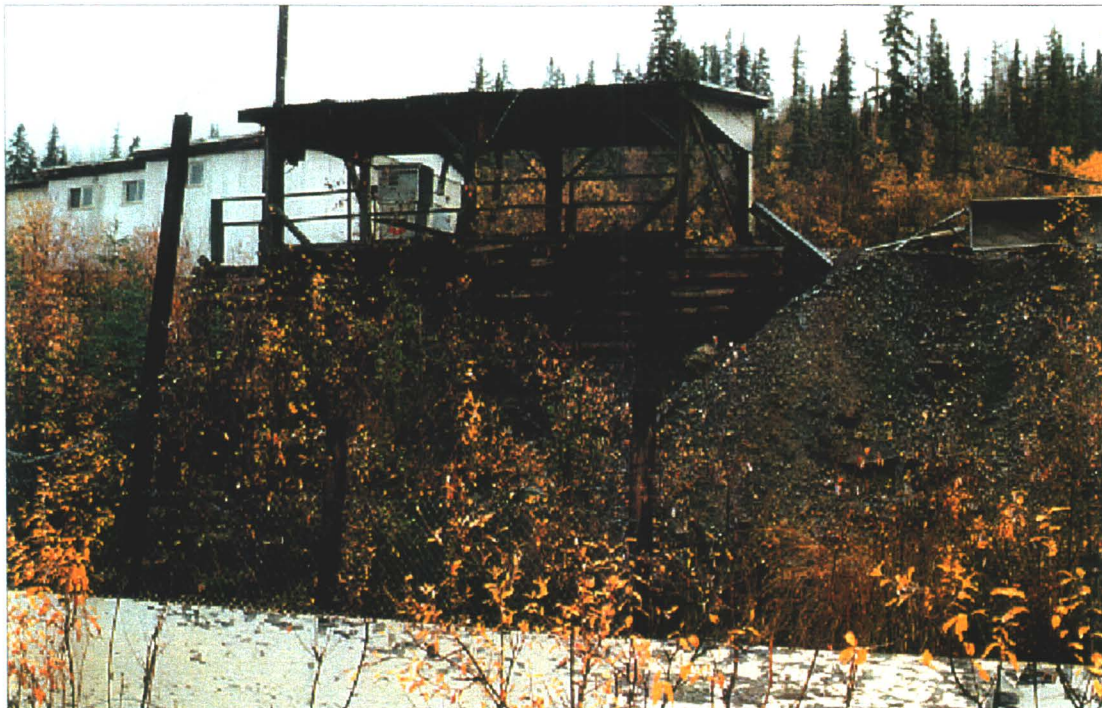
Photo 78-39 : Elsa. View of Fuel Storage Area #2, a single Chevron pump, looking uphill from the skating rink. (Azimuth 210°)

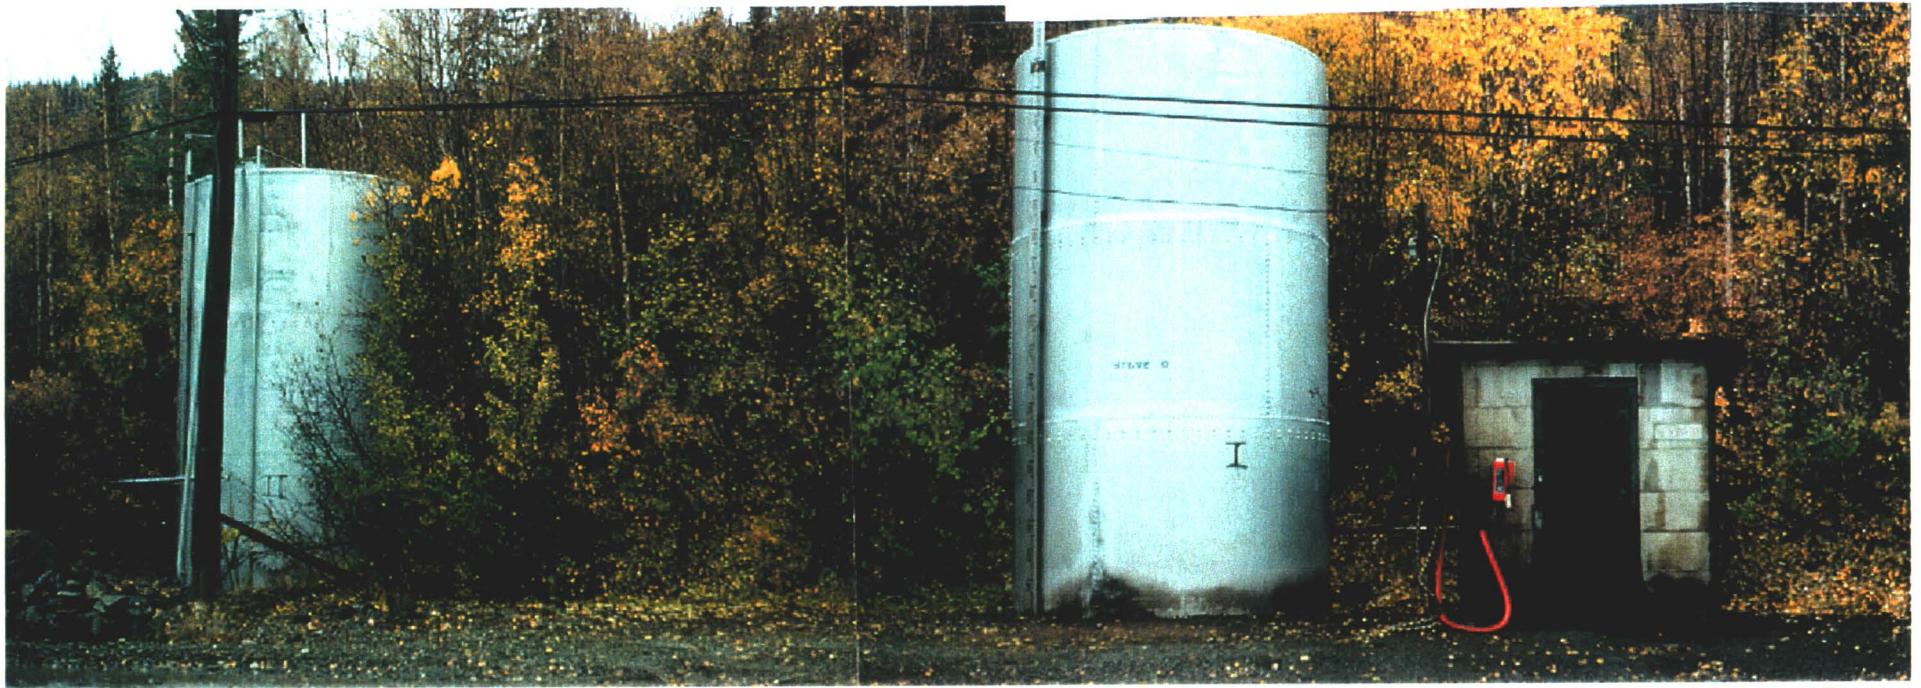
Fuel Storage Area #4: Diesel and Stove Oil Storage Tanks (photo 78-41)

Above Ground Storage Tanks: The single-wall steel tanks are both 6m in height and 2.4m in diameter (each tank volume estimated at 85,000 litres). No secondary containment was found around either AST.

Photo 78-41 : Elsa. A pair of diesel oil storage tanks at Fuel Storage Area #4, located across from the Fire Hall. (Azimuth 060°)

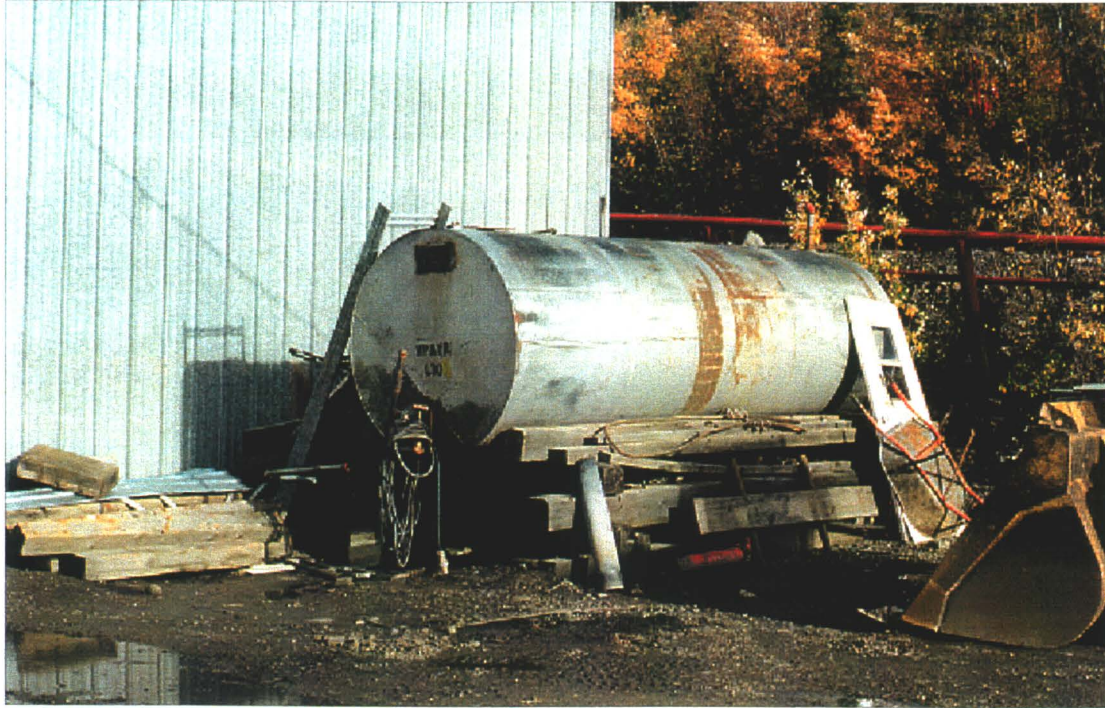
Fuel Storage Area #5: AST beside Main Shop (photo 78-42)

Photo 78-42 : Elsa. Fuel Storage Area #5. Above-ground storage tank beside the Main Shop.
(Azimuth 100°)

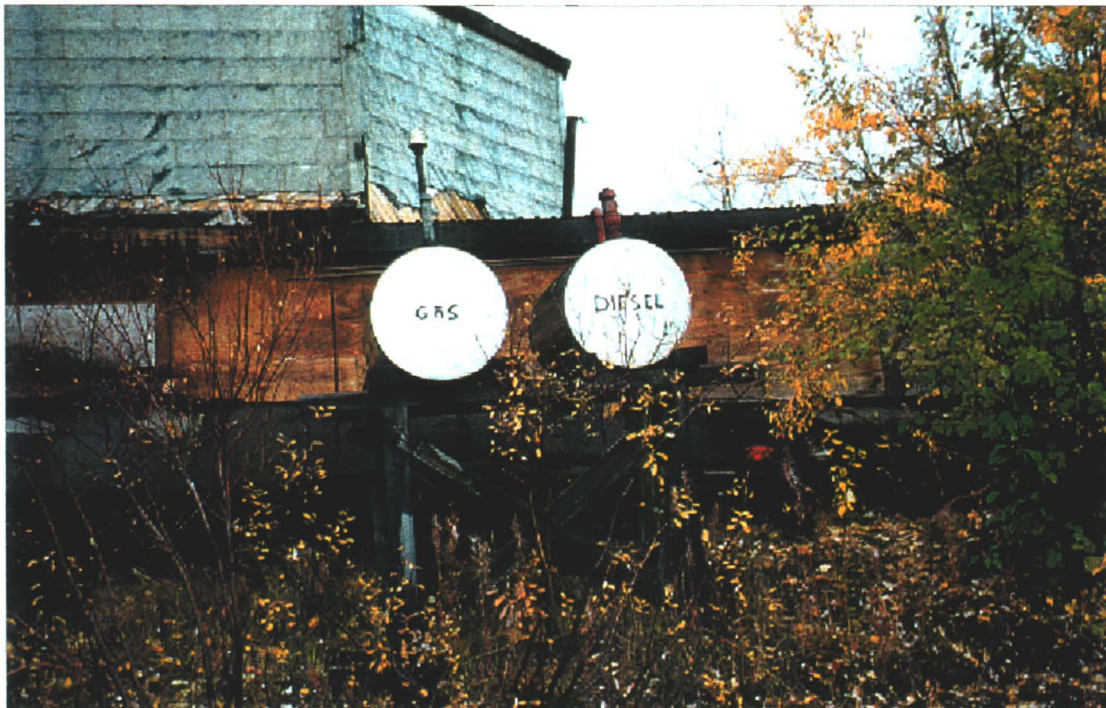
Fuel Storage Area #7: Gas and Diesel ASTs (photo 78-44)

Above Ground Storage Tanks: A wooden crib supports the two 200-gallon tanks. No staining was observed.

Photo 78-44 : Elsa. Fuel Storage Area #7, these two ASTs are located on the north side of the Mill (Building #20).

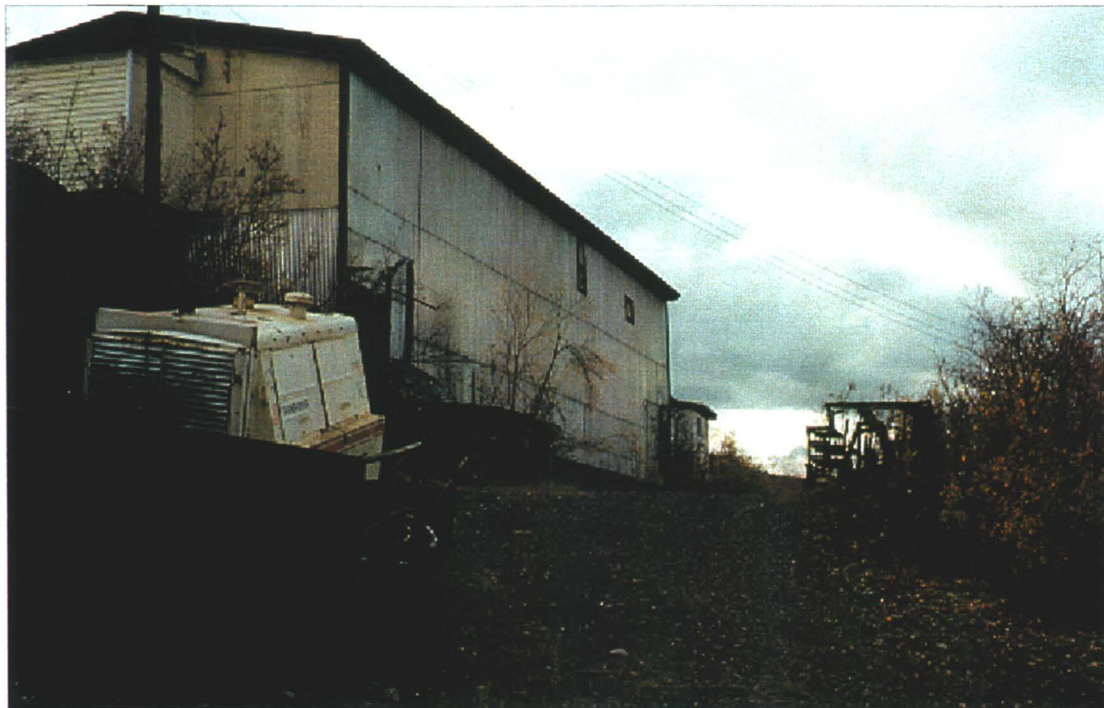
Electrical Equipment Area #1: Transformers near Carpentry Building (photo 78-47)

Out-of-Service Transformers: 32 disused transformers, filled with oil, have been seated on wooden palettes. PCB field screening indicated four of the transformers contained PCBs and oil samples were sent for confirmatory laboratory analyses (see Attachment 6 for results). Oil stains were noted around two transformers (#23 and #24) that had fallen over. No signage for PCB storage or restricted access was noted.

Photo 78-47 : Elsa. Electrical Equipment Area #1 : transformers near Carpentry Building (Building #5).

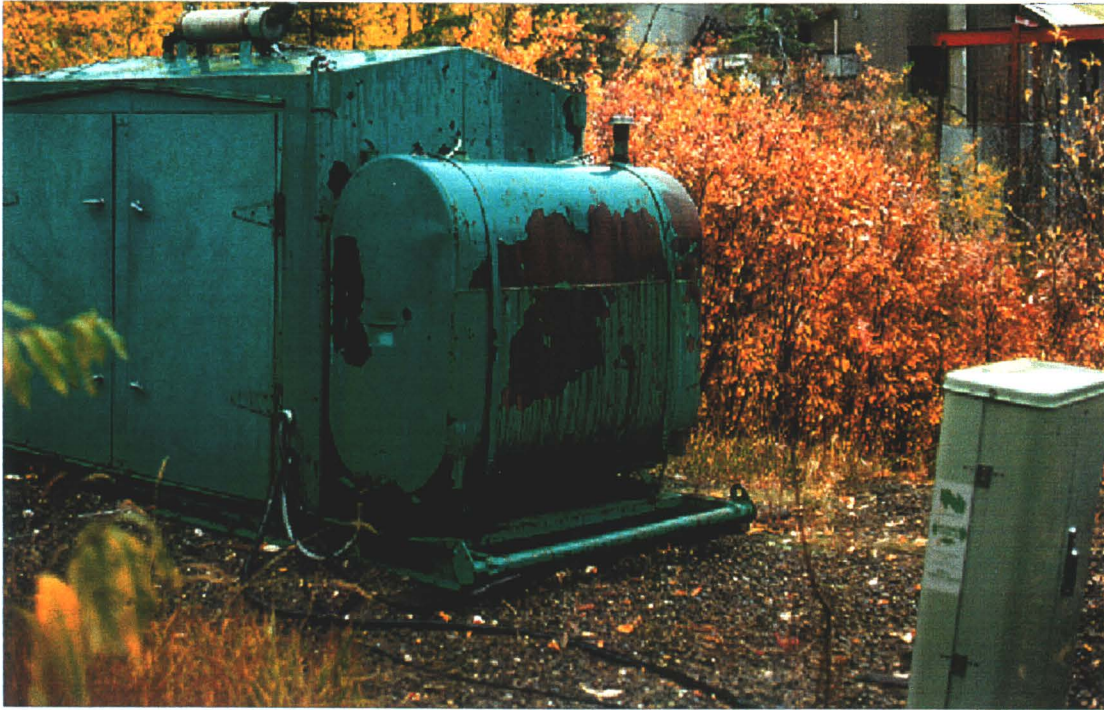
Location: One mobile generator is parked near the west wall behind the Elsa Market (#32) and the second is located beside the Norwest Tel building (#18). No impact/staining was noted near these areas.

Photo 78-48 : Elsa. Electrical Equipment Area #4a - a mobile generator parked behind the Elsa Market. (Azimuth 230°)

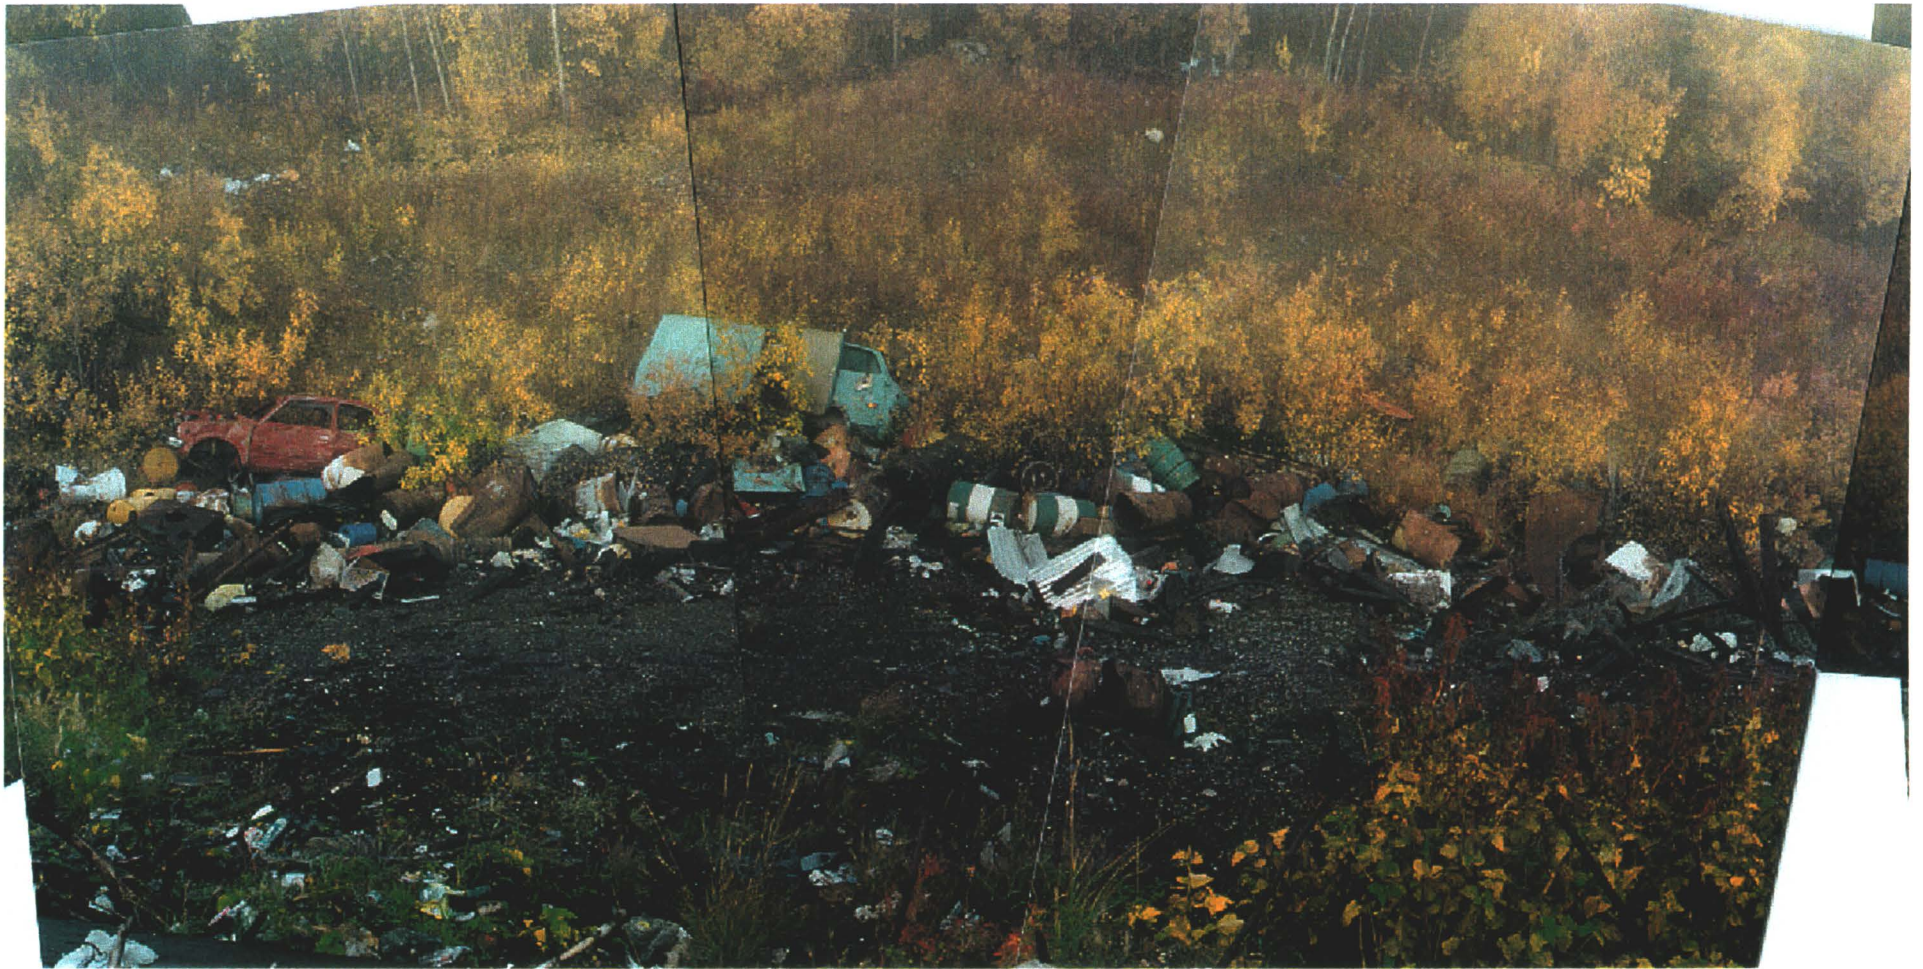
Electrical Equipment Area #5: Inactive Transformers (photo 78-50)

Photo 78-50 : Elsa. Electrical Equipment Area #5, transformers beside the adit portal.

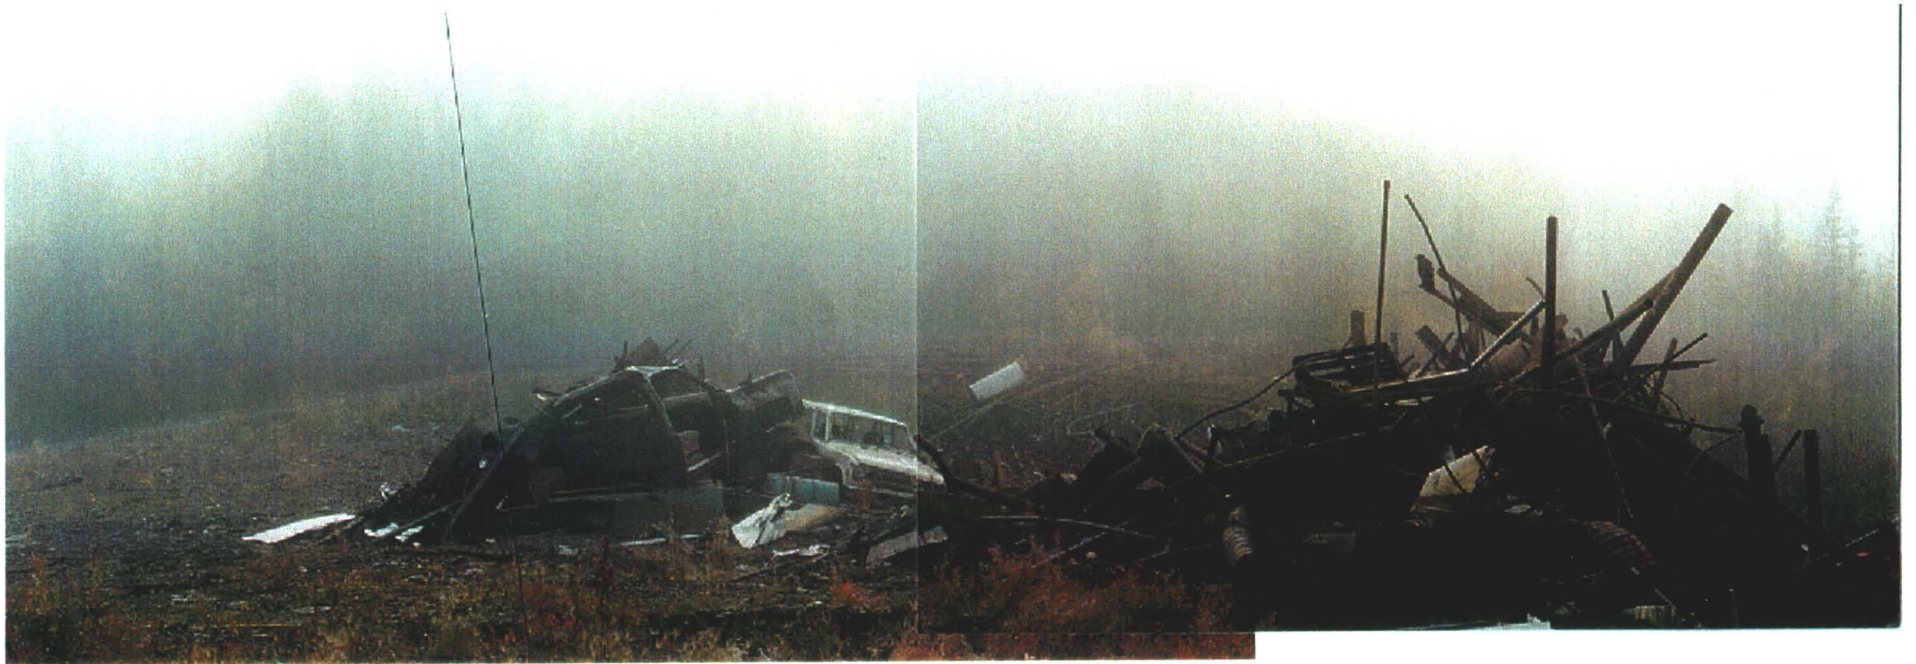
General composition: Visible waste is comprised roughly of 20% municipal waste, 20% vehicles and drums, 30% other metal debris, and 30% dirt and overburden. A ball mill with asbestos lining is located on the east edge of the dump. Anecdotal information suggests hazardous materials may have been dumped in the past.

Photo 78-52 : Elsa. Solid Waste Dump Area #1, metal debris pile. (Azimuth 130°)

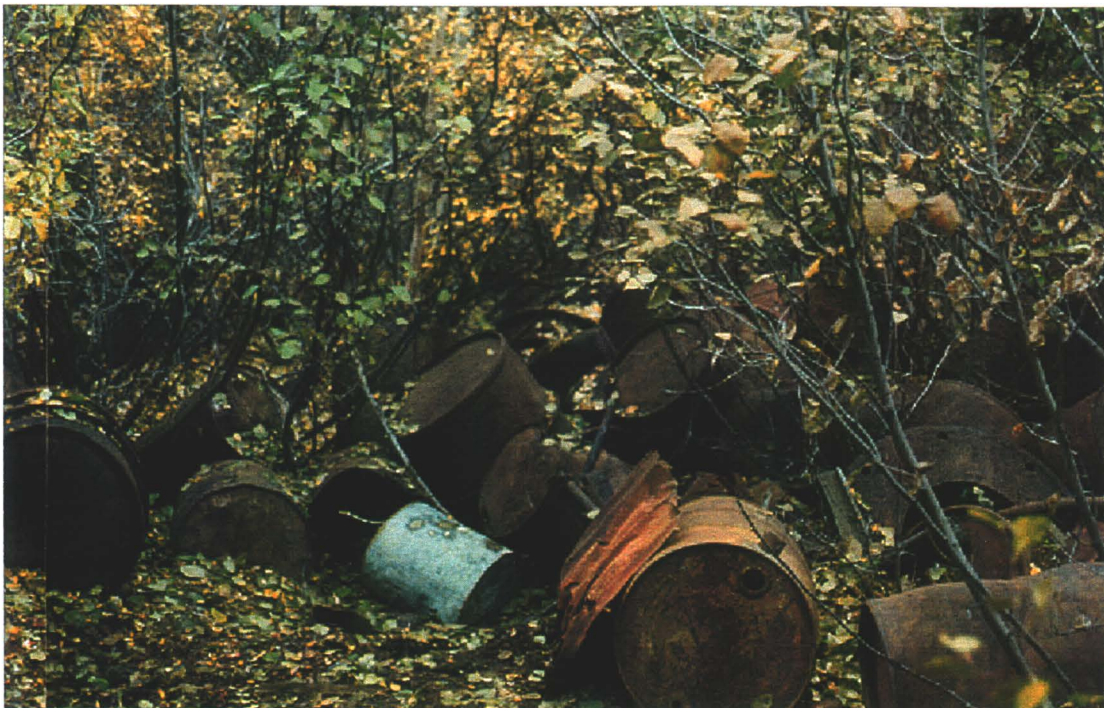
General Composition: There are roughly 15-25 crushed vehicle batteries and about 150 rusted 45-gallon drums.

Impacted Vegetation: The drums are partially buried and there is large second growth vegetation growing around them. There are signs that battery acid has leaked out. There is very little vegetation growing underneath.

Photo 78-54 : Elsa. Solid Waste Dump Area #2 : empty 45-gallon drums and other metal debris.
(Azimuth 310°)

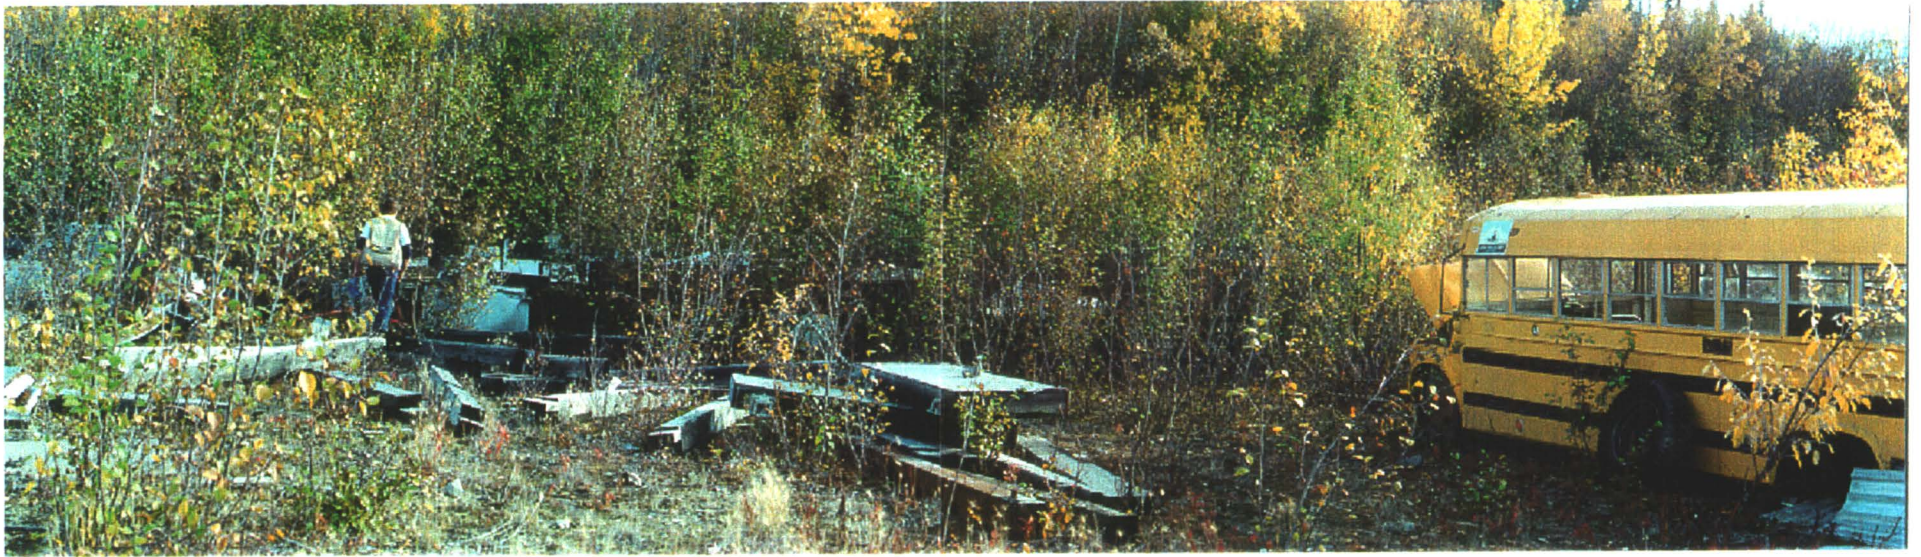
Drainage: No surface water was observed and no water seeps were observed. The nearest drainage is Porcupine Gulch.

Photo 78-55 : Elsa. Solid Waste Dump Area #3, this bone yard is just west of the sawmill, on the north side of Hwy #2. (Azimuth 140°)

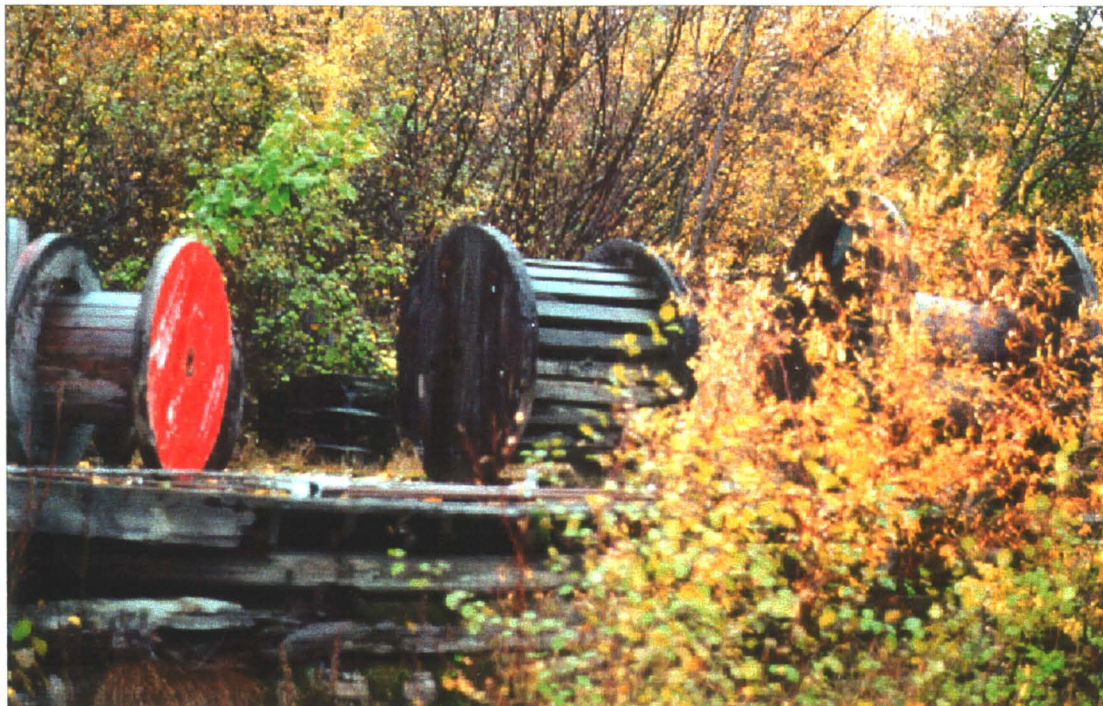
Drainage: No surface water was observed and no water seeps were observed. The nearest drainage is Porcupine Gulch.

Photo 78-57 : Elsa. Solid Waste Dump Area #4b. Large wooden spools and drums are dumped across the road from Building #7. (Azimuth 180°)

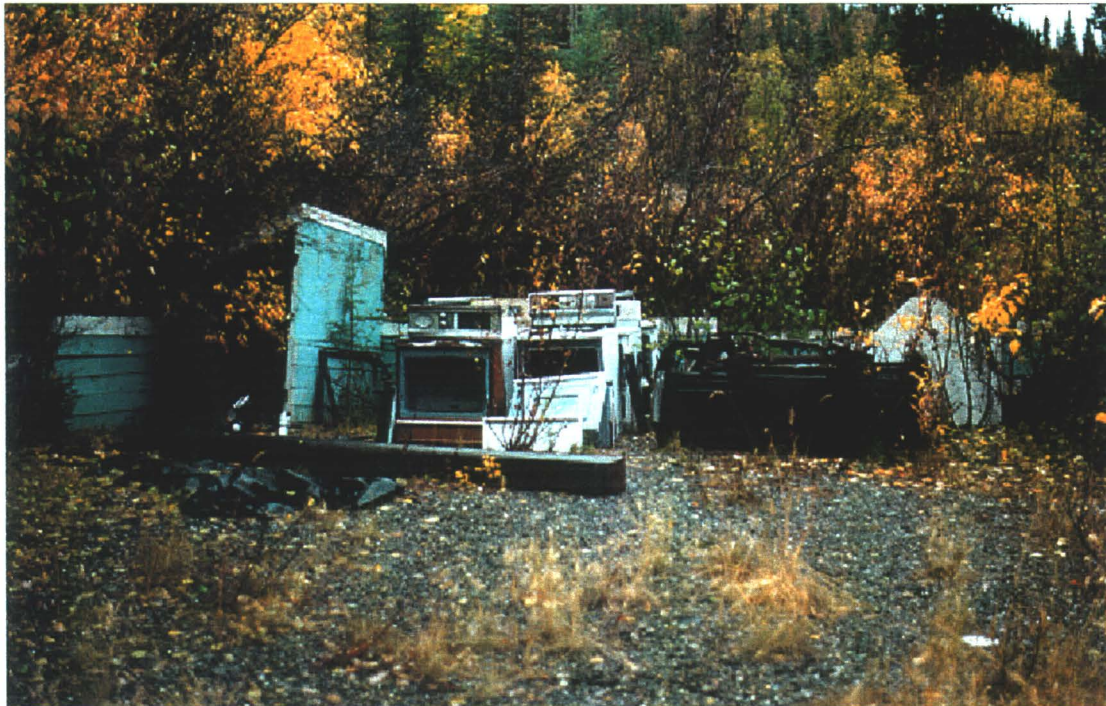
Photo 78-58 : Elsa. Solid Waste Dump Area #5. This small bone yard is located behind a garage (Building #42), in the southeastern part of Elsa. (Azimuth 170°)

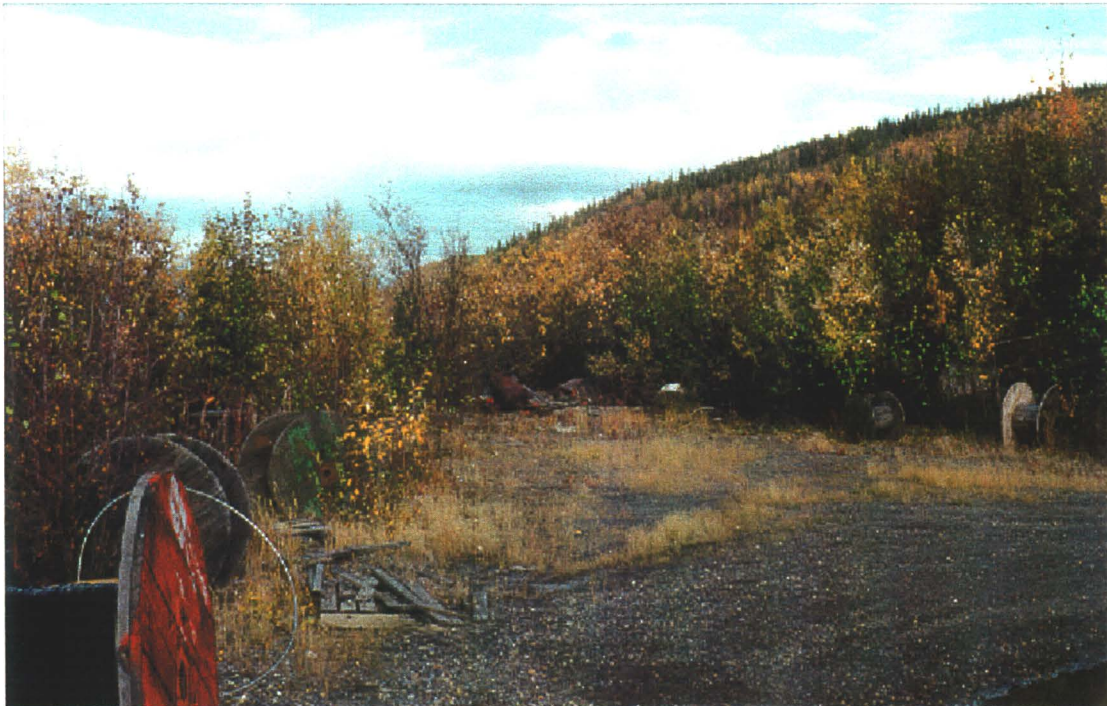
Drainage: The nearest drainage is Porcupine Gulch. No surface water or seeps were observed near the dump.

Photo 78-60 : Elsa. Solid Waste Dump Area #8 : Metal and wood debris beside the Main Shop (Building #9) (Azimuth 050^o)

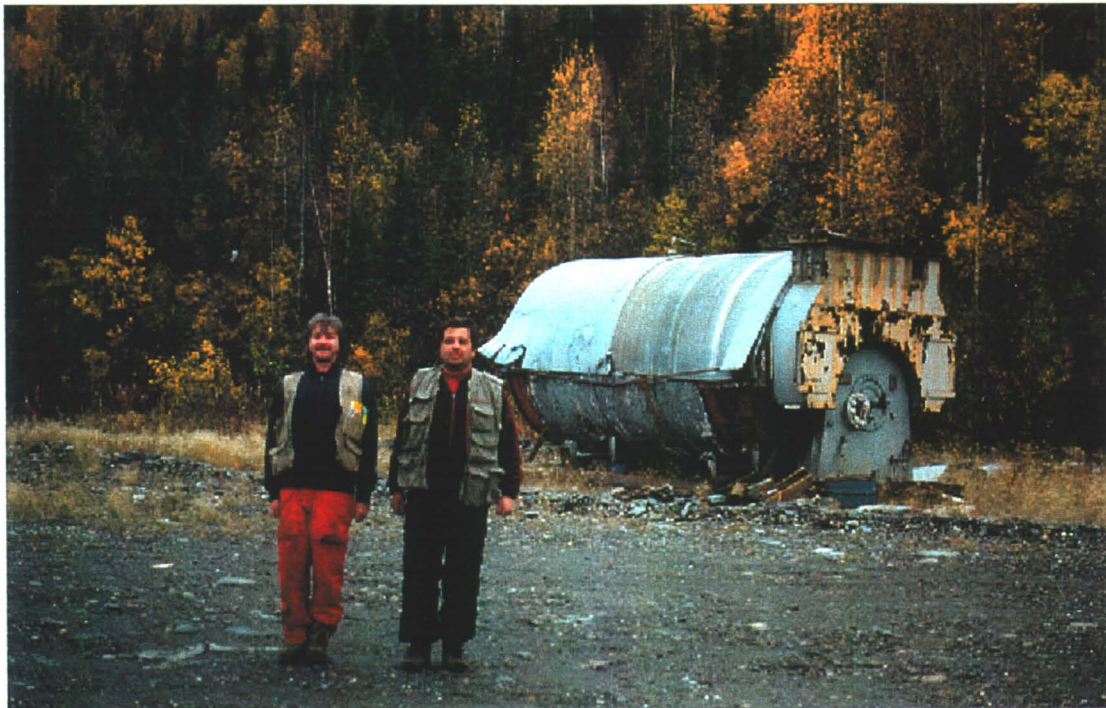
Photo 78-62 : Elsa. Ball Mill at the East side of Solid Waste Dump #1. (Azimuth 110°)
