ELSA TAILINGS
SITE 79

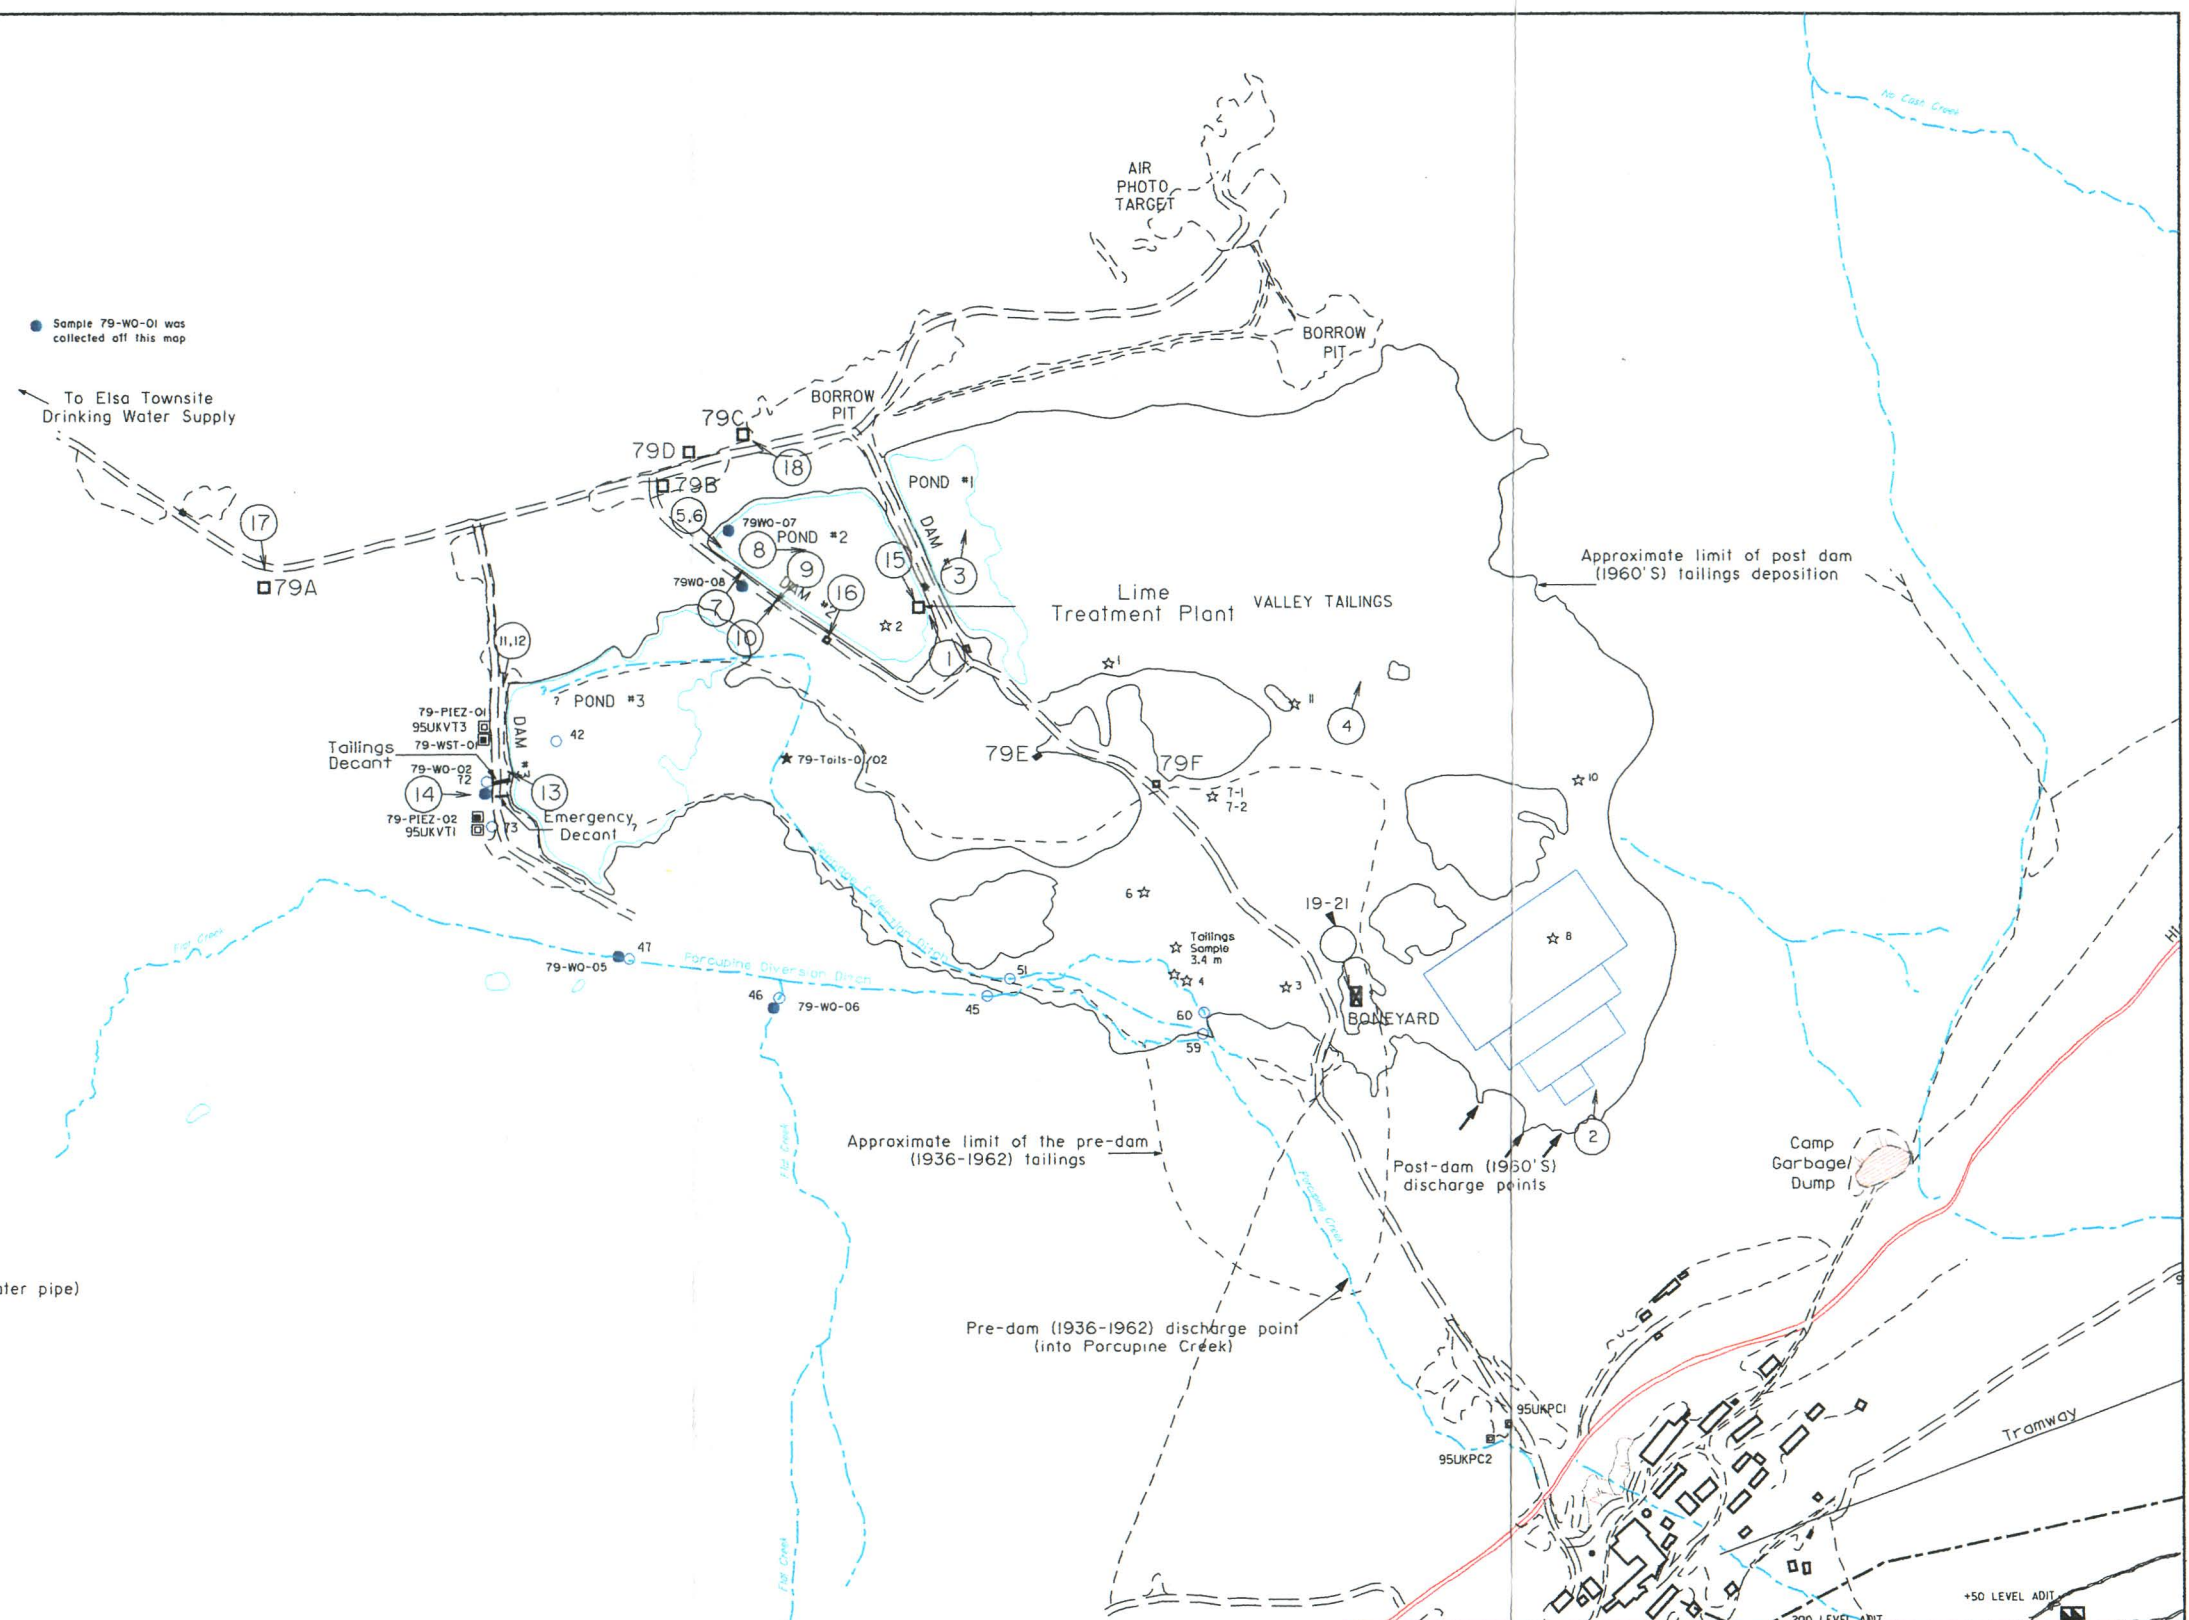
- △ Pre 1999 Waste Rock Sample (other sources)
- W0-12-06 1999 Water Sample
- Pre 1999 Water Sample
- Tension Cracks
- ⊖ Mass Movement (note: for Forms: BelleKeno)

● Sample 79-W0-01 was collected off this map
