DUBLIN GULCH - EAGLE ZONE

SITE #88

(MINFILE #106D 025a)

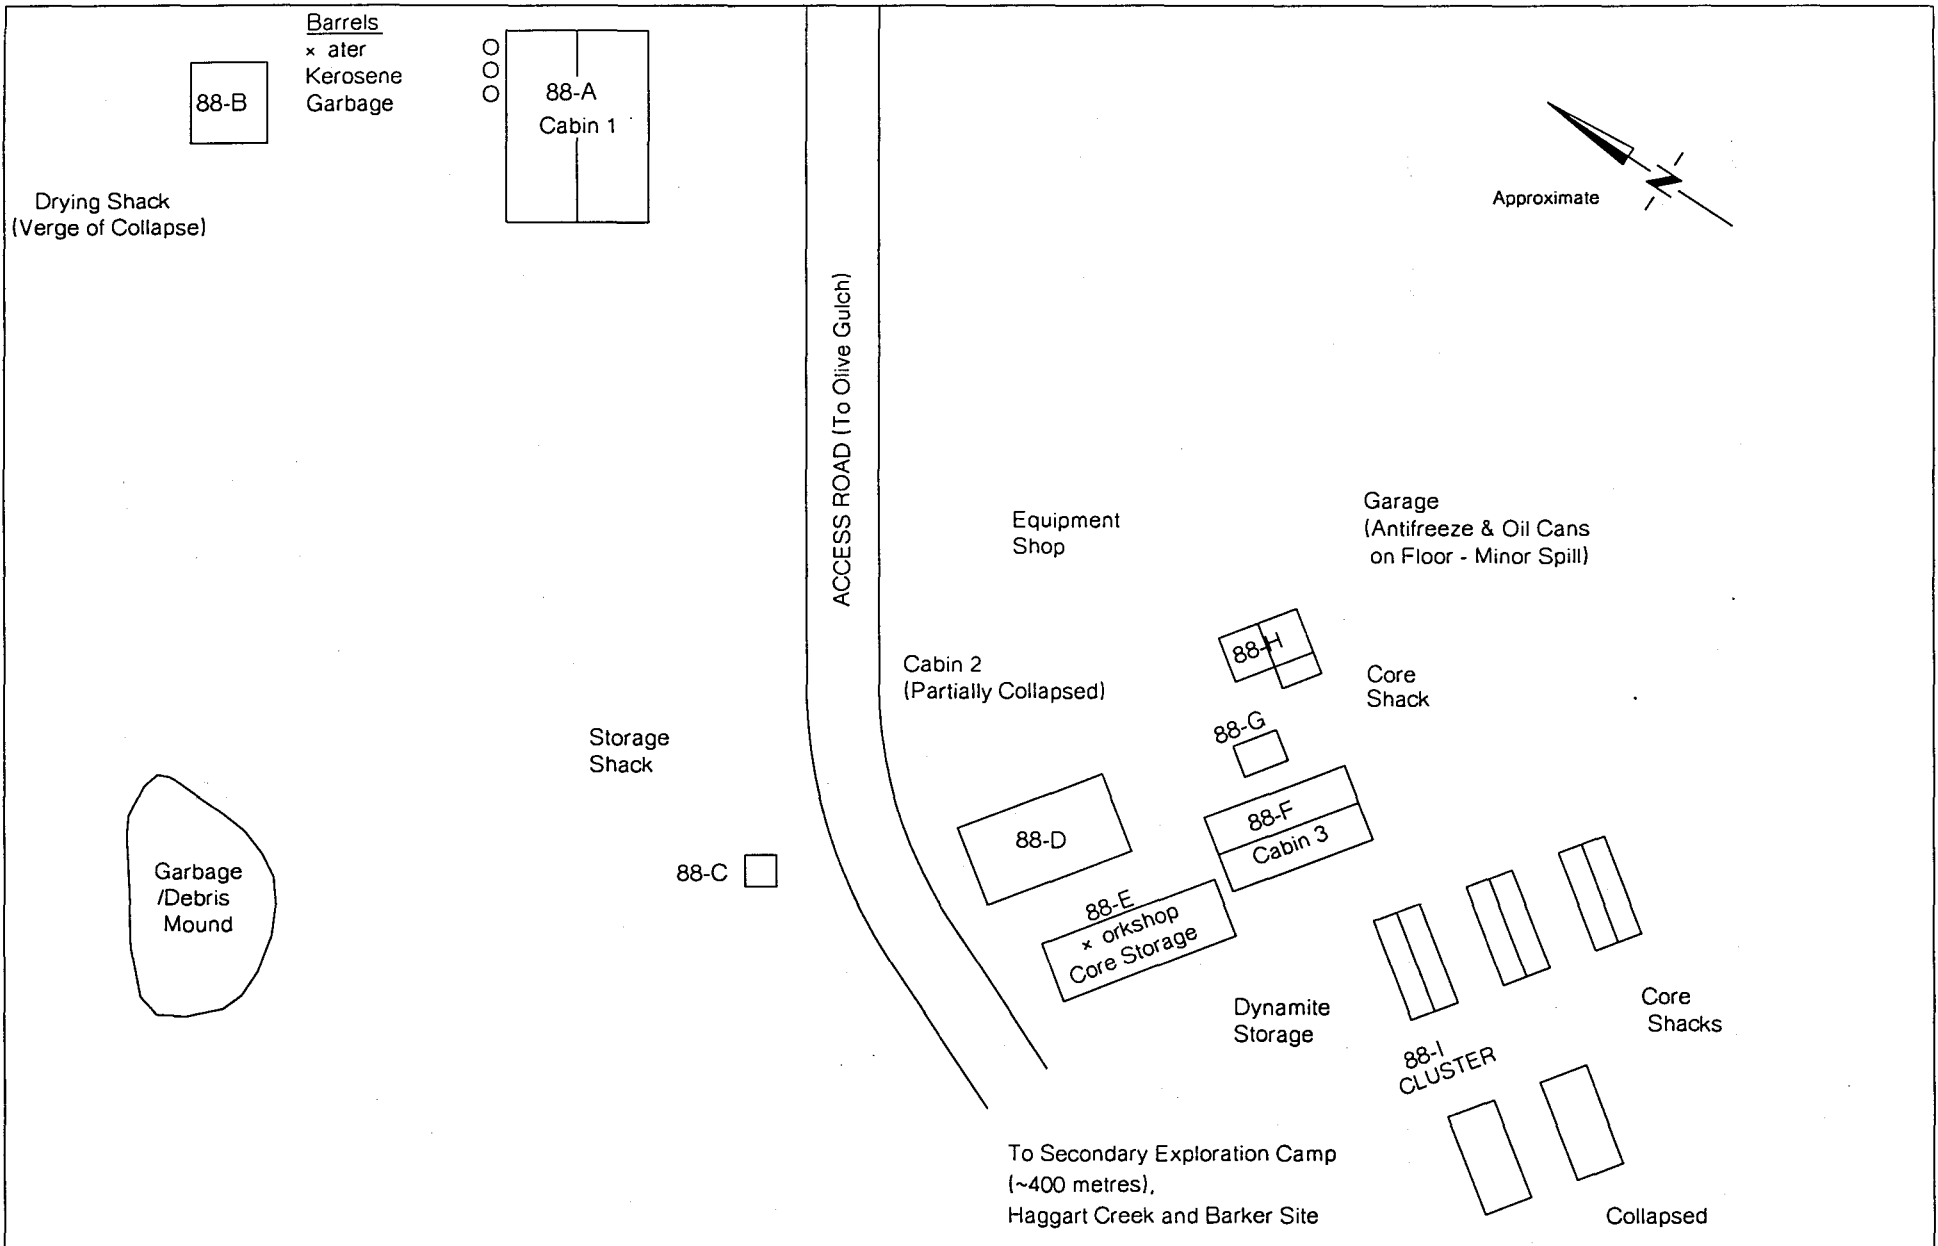
HEMMIRA RESOURCE CONSULTANTS LTD. Suite 350, 1190 Hornby Street Vancouver, BC V6Z 2K5	BASELINE STUDY		
	DUBLIN GULCH EAGLE ZONE MAIN EXPLORATION CAMP		
CLIENT:	PROJECT No. 376-007.01/DublinGulch	February 2000	FIGURE 88-2

This site was determined to be the basis of operations for exploration activities of New Millenium Ltd. in Eagle Zone based on the extensive core and rock samples at the site. A layout of the main exploration camp showing the buildings and their relative locations is provided in Figure 88-2.

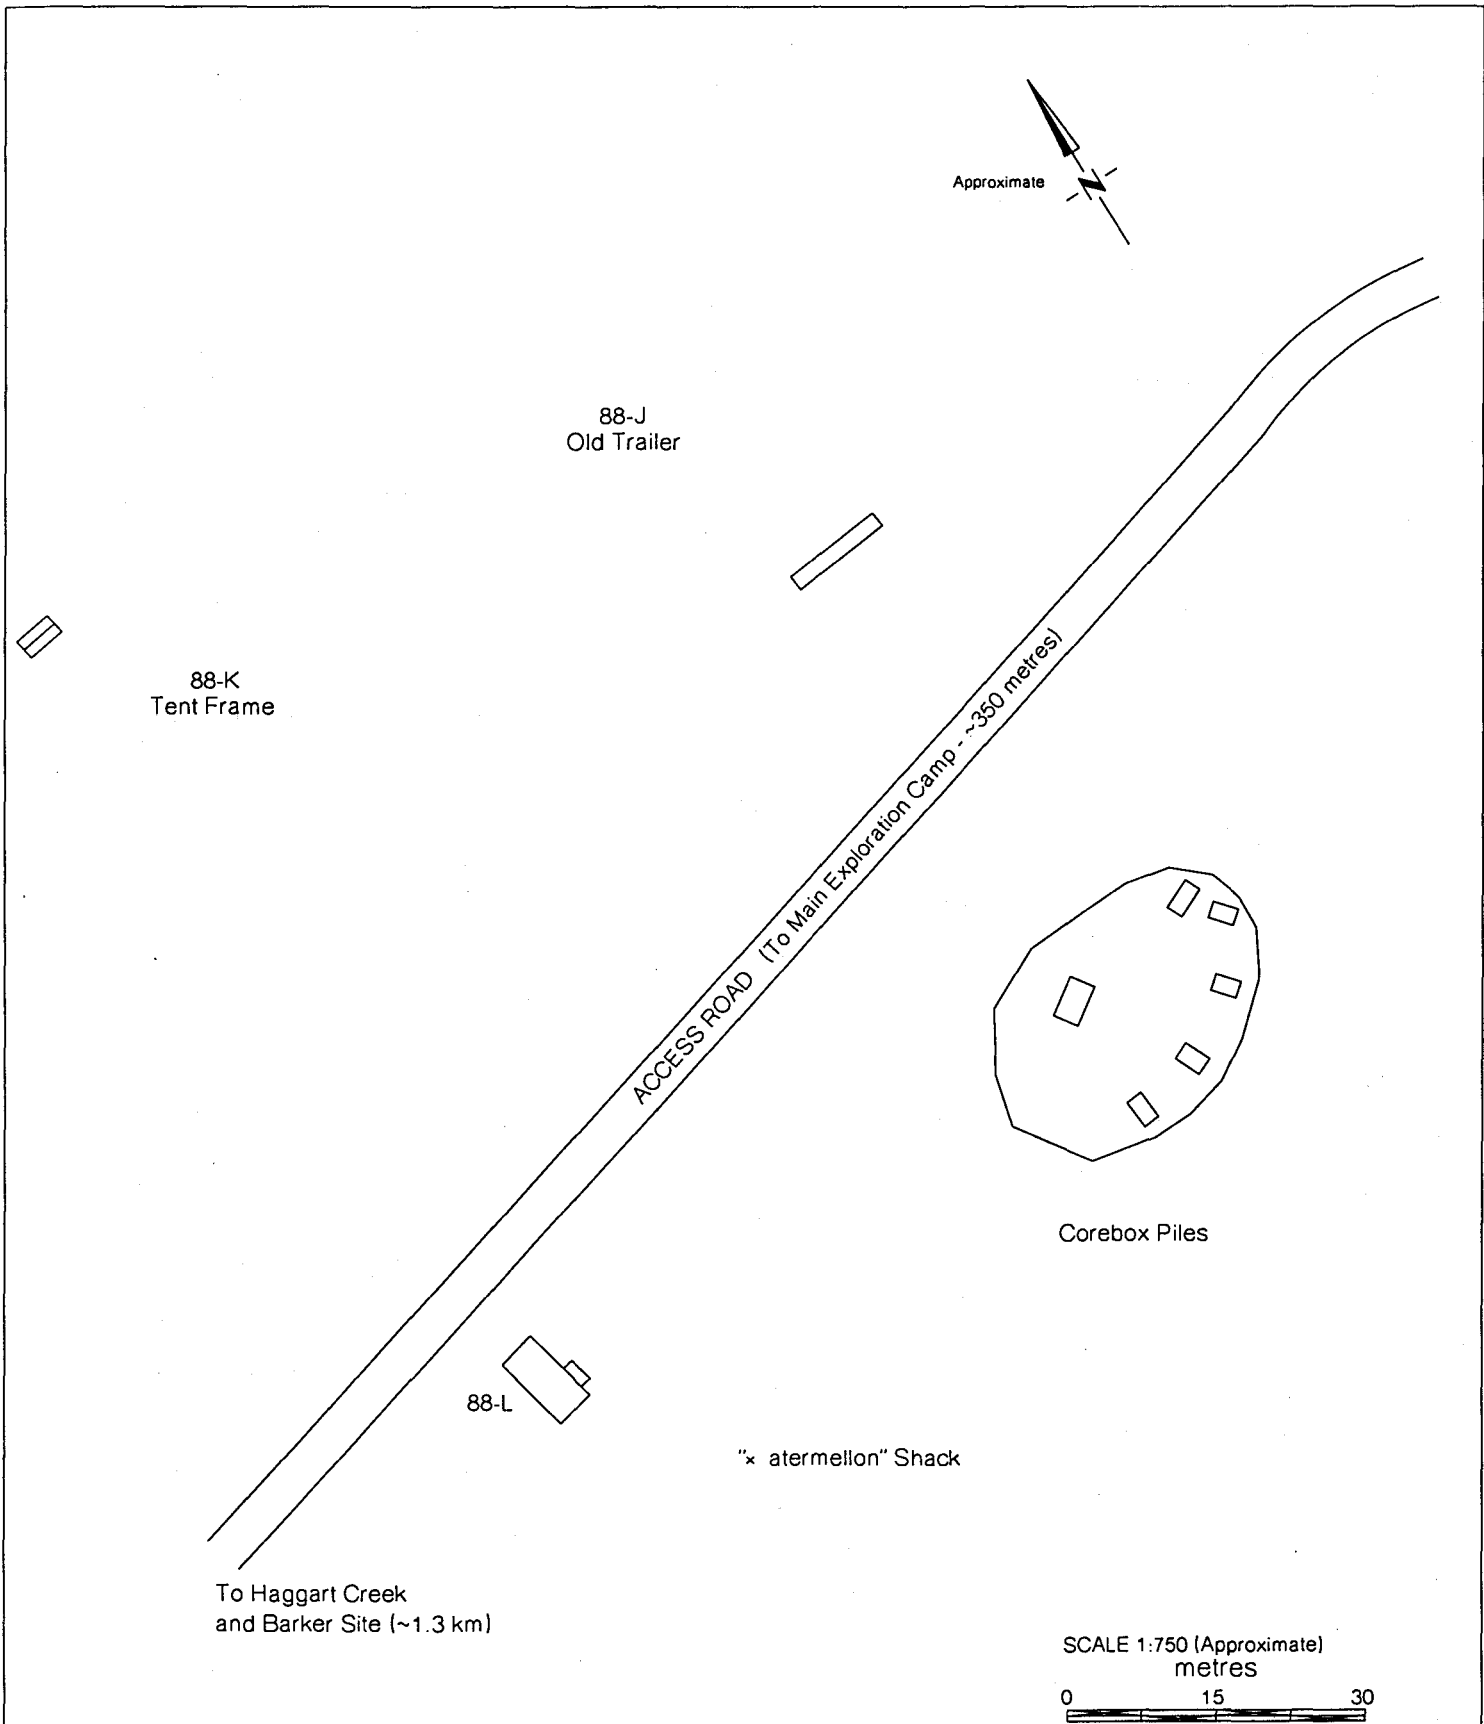
HEMERA RESOURCE CONSULTANTS LTD. Suite 350, 1190 Hornby Street Vancouver, BC V6Z 2K5	BASELINE STUDY		
	DUBLIN GULCH EAGLE ZONE SECONDARY EXPLORATION CAMP		
CLIENT:	376-007.01/CK200	February 2000	FIGURE 88-3

This small camp was located 400 m west of the main exploration camp along Dublin Gulch Road towards Haggart Creek (Figure 88-1) and may have also been used for placer mining as well as exploration activities. A layout of the camp showing the buildings and their relative locations is provided in Figure 88-3.
