APPLICATION FOR PIPELINE ABANDONMENT

**Report on an Inspection of the Deactivated Skagway, Alaska to
Whitehorse, Yukon Petroleum Products Pipeline**

**National Energy Board
June 1995**

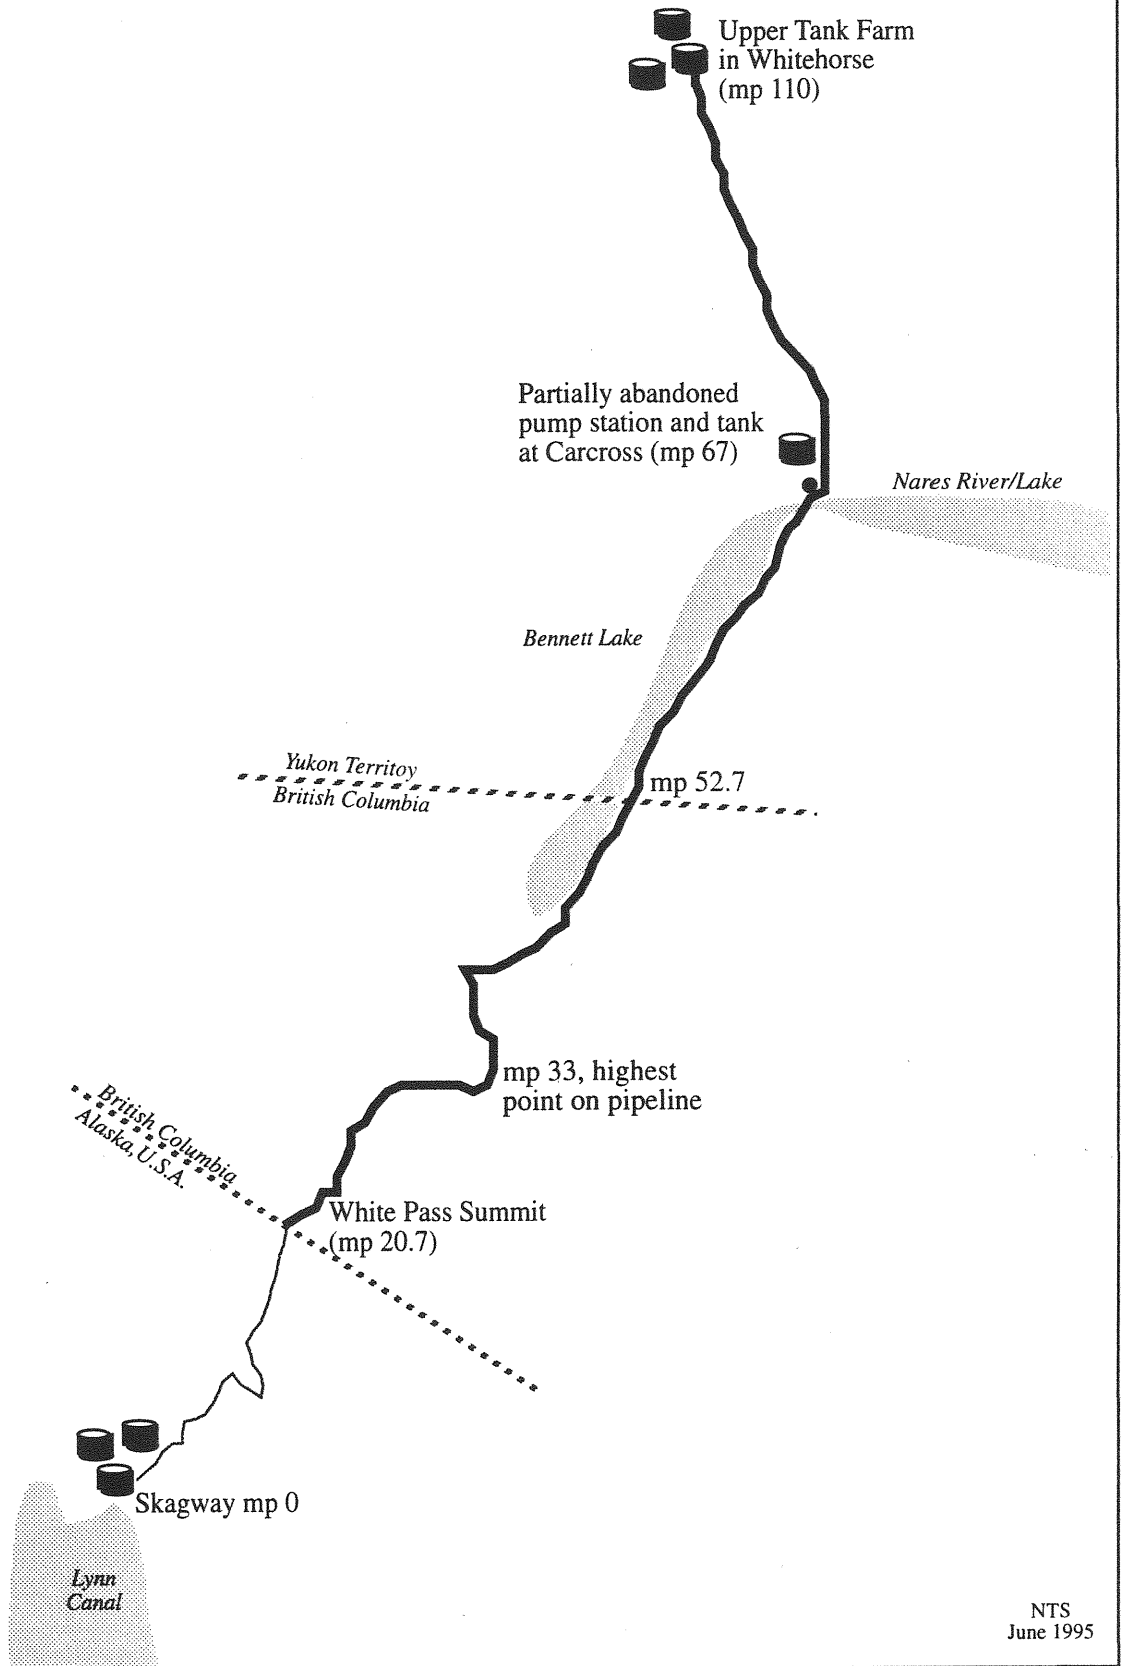
Figure 2.1: The Yukon Pipeline

The Yukon pipeline, as it exists today, consists of a 144 km long, 114.3 mm diameter pipeline from a point on the Alaska - British Columbia border to Whitehorse and a tank farm in Whitehorse, referred to as the Upper Tank Farm. Figure 2.1 illustrates the Yukon pipeline.

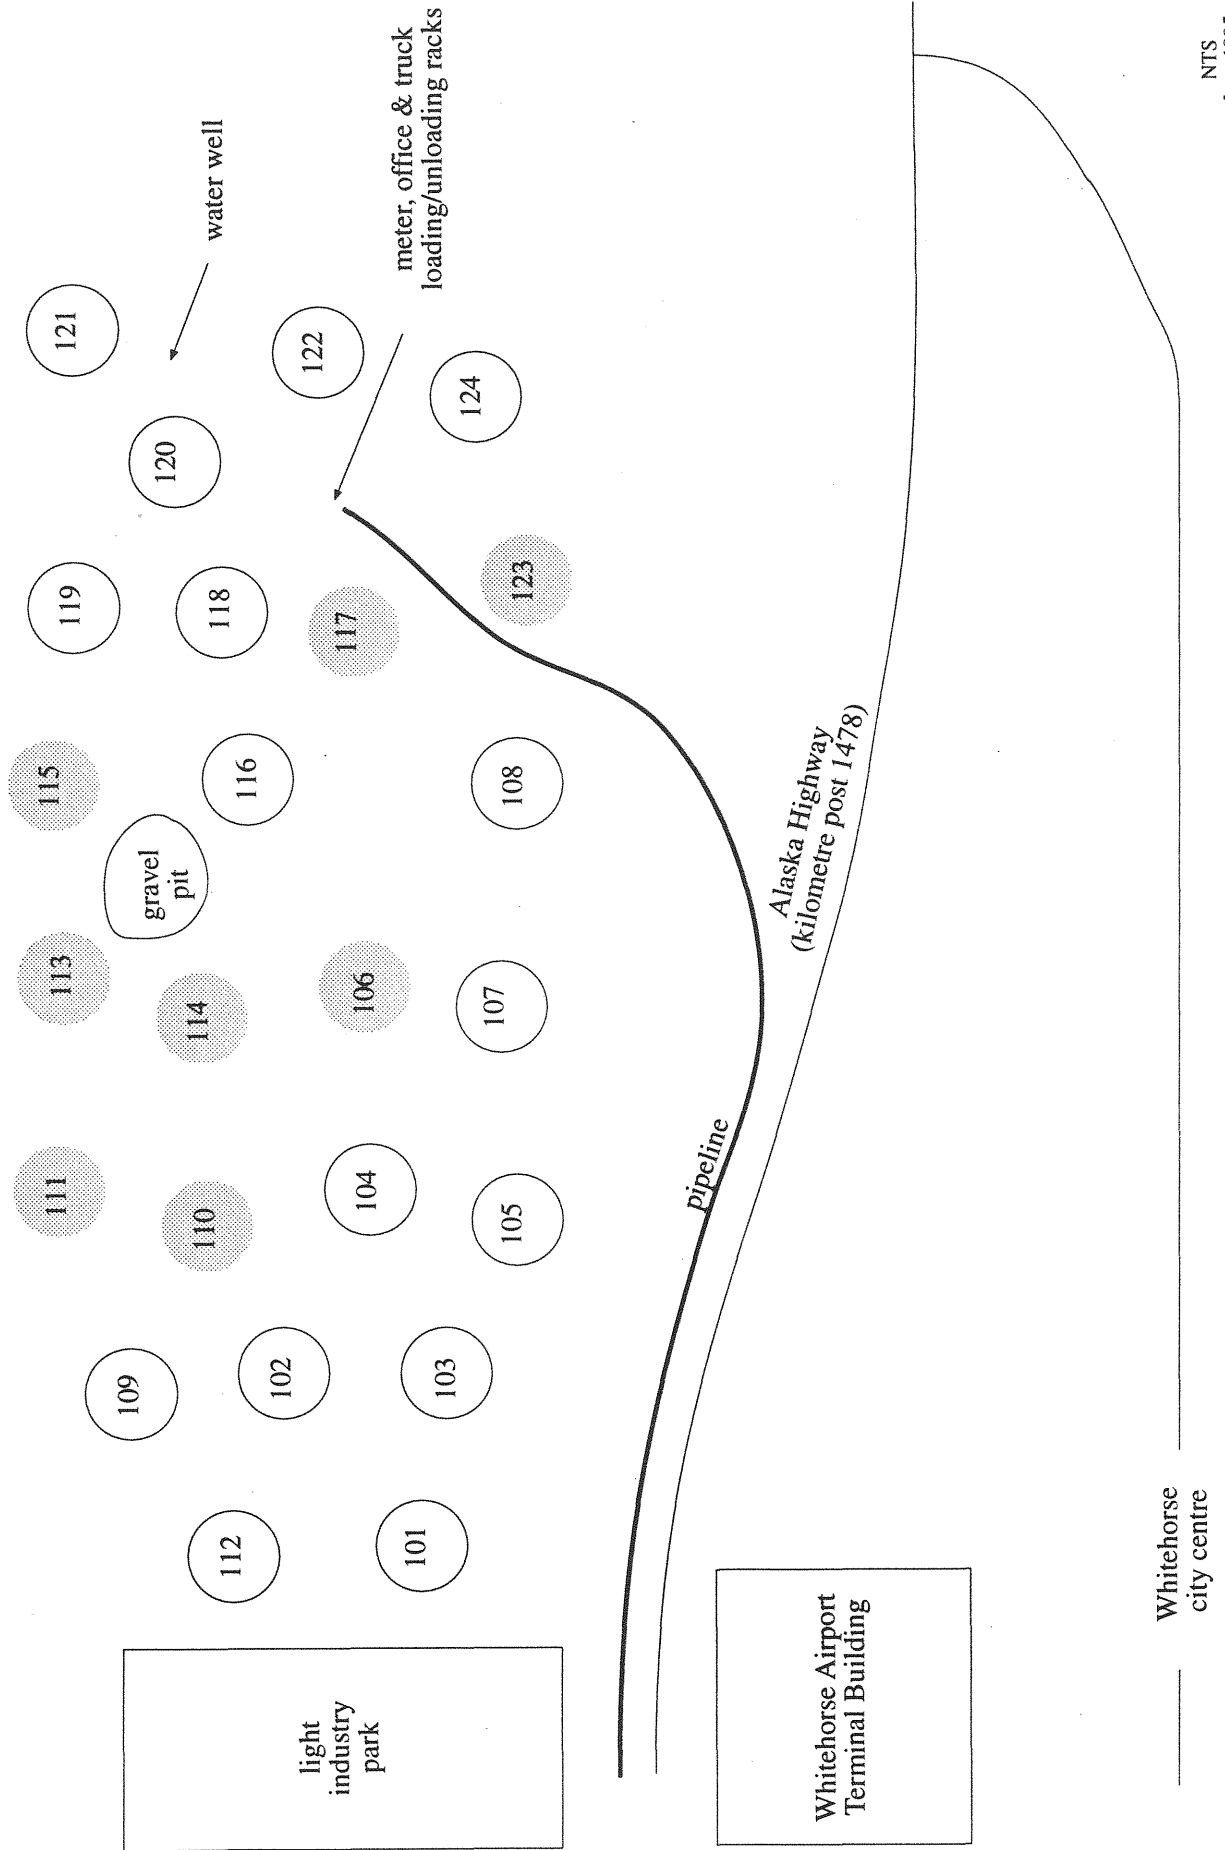
Figure 3.1: Plan View of the Upper Tank Farm

The layout of the 24 tanks at the upper tank farm is illustrated in Figure 3.1. At the time of the inspection, eight tanks were in use. These tanks are shown in Figure 3.1. Tank 123, containing fuel oil, will be used to store the fuel oil pigged from the pipeline. Other facilities at the upper tank farm include an inlet meter, densitometer, truck loading and unloading racks, booster pumps, yard piping varying in diameter from 114.3 mm to 219.1 mm and valves on the yard piping. There are also two buildings at the upper tank farm; one housing the meter and the other serving as an office for the operator. Various storage areas exist throughout the tank farm, including a site near the meter building where a number of barrels are stored. The barrels are identified as containing methanol and engine coolant. YPL stated that there are no underground tanks or buried facilities at the tank farm. YPL further stated that there are no chemicals stored on site. With respect to the existence of any soil contamination at the tank farm, YPL indicated that it was not aware of any soil contamination and that no major spills have occurred at the tank farm. YPL indicated that it did not intend to commission environmental site assessments or audits on any of its facilities.

2. The tanks at the upper tank farm have leaked over their years of service, principally from the bolted seams although leaks in the floors may also have occurred. The tanks have little or no value as storage vessels, therefore the most viable option is that they be dismantled and scrapped. Yard piping at the tank farm will contain fuel unless these lines are pigged clean. Special precautions must be implemented to avoid spilling any remaining fuel if the lines are merely to be cut up and removed. The most likely future use of the upper tank farm site would appear to be residential or as a source of sand and gravel, or both.

3. Based on the site visit, further detailed environmental studies should be undertaken at the upper tank farm, due to the amount of soil staining and obvious leaks at the site. A Phase I and II environmental site assessment should provide sufficient information on the concerns associated with these soil stained areas, including the determination of the locations, level and extent of contamination of the soil and groundwater.
