ENERGY ANALYSIS OF MILE 1202 MOTOR INN - BEAVER CREEK, CANADA

PERFORMED BY: ARCTIC TECHNICAL SERVICES
1318 WELL STREET
FAIRBANKS, ALASKA 99701
(907) 452-8368

EXECUTIVE SUMMARY

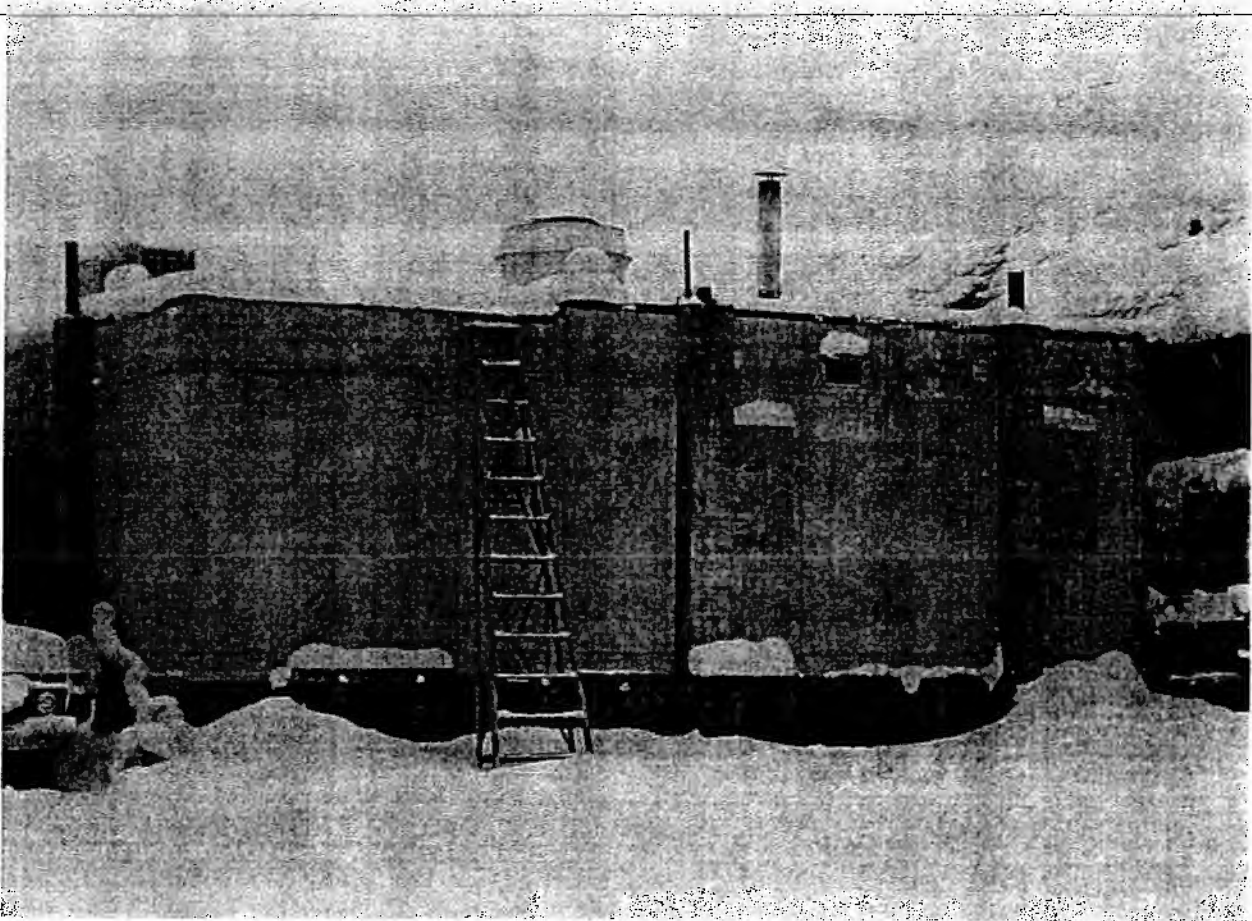
Kitchen Attachment

North wall (note glaciers on lodge roof)

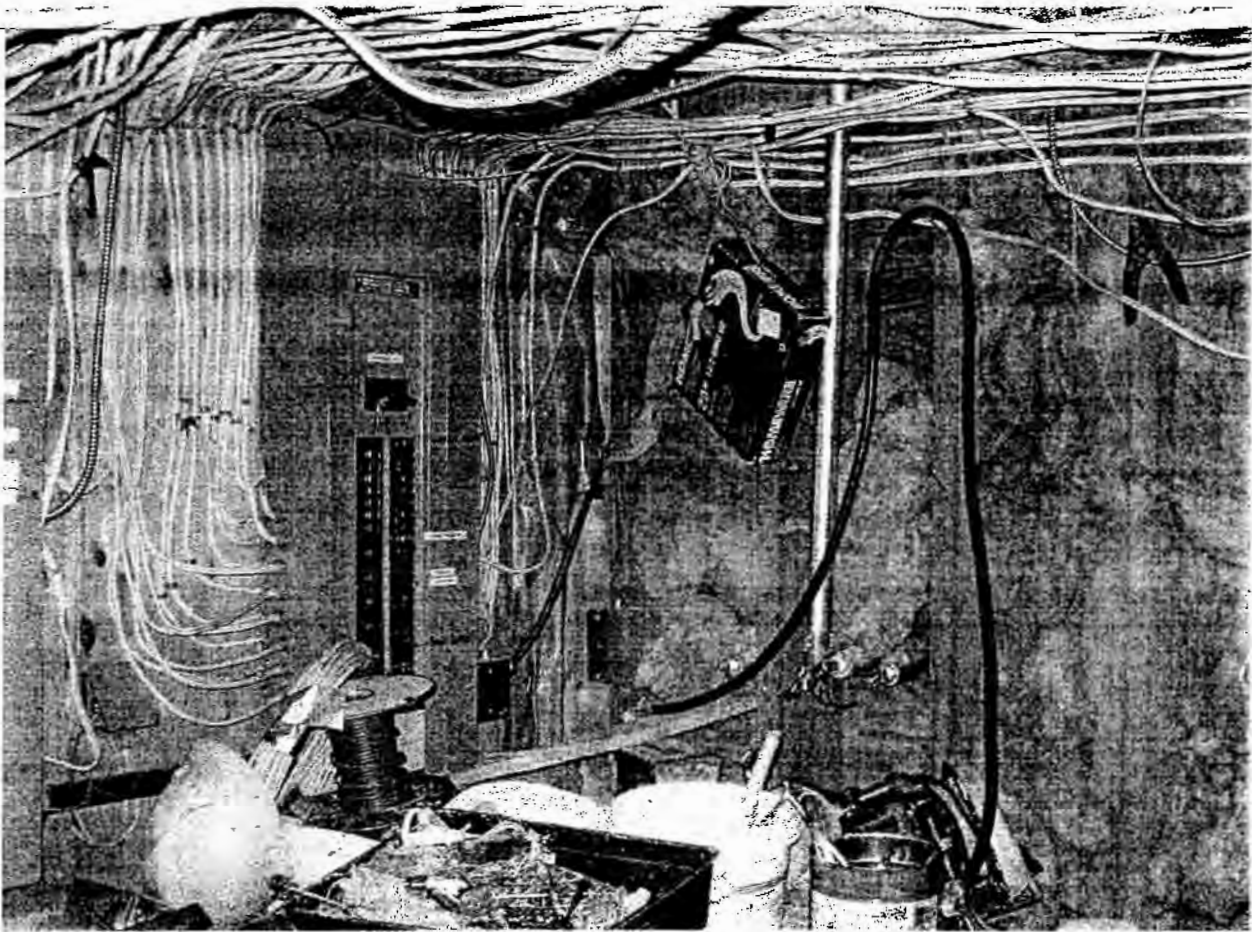
Lodge Basement

Dangerous conditions such as an overloaded circuit found in the Lodge basement and the water heater and furnace backdrafting in Building B were documented and recommendations have been made to alleviate the threats. Switching fuels from propane to oil, and from furnaces to boilers, will offer the most rapid payback and minimize the danger of backdrafting.

View of basement – electrical panel

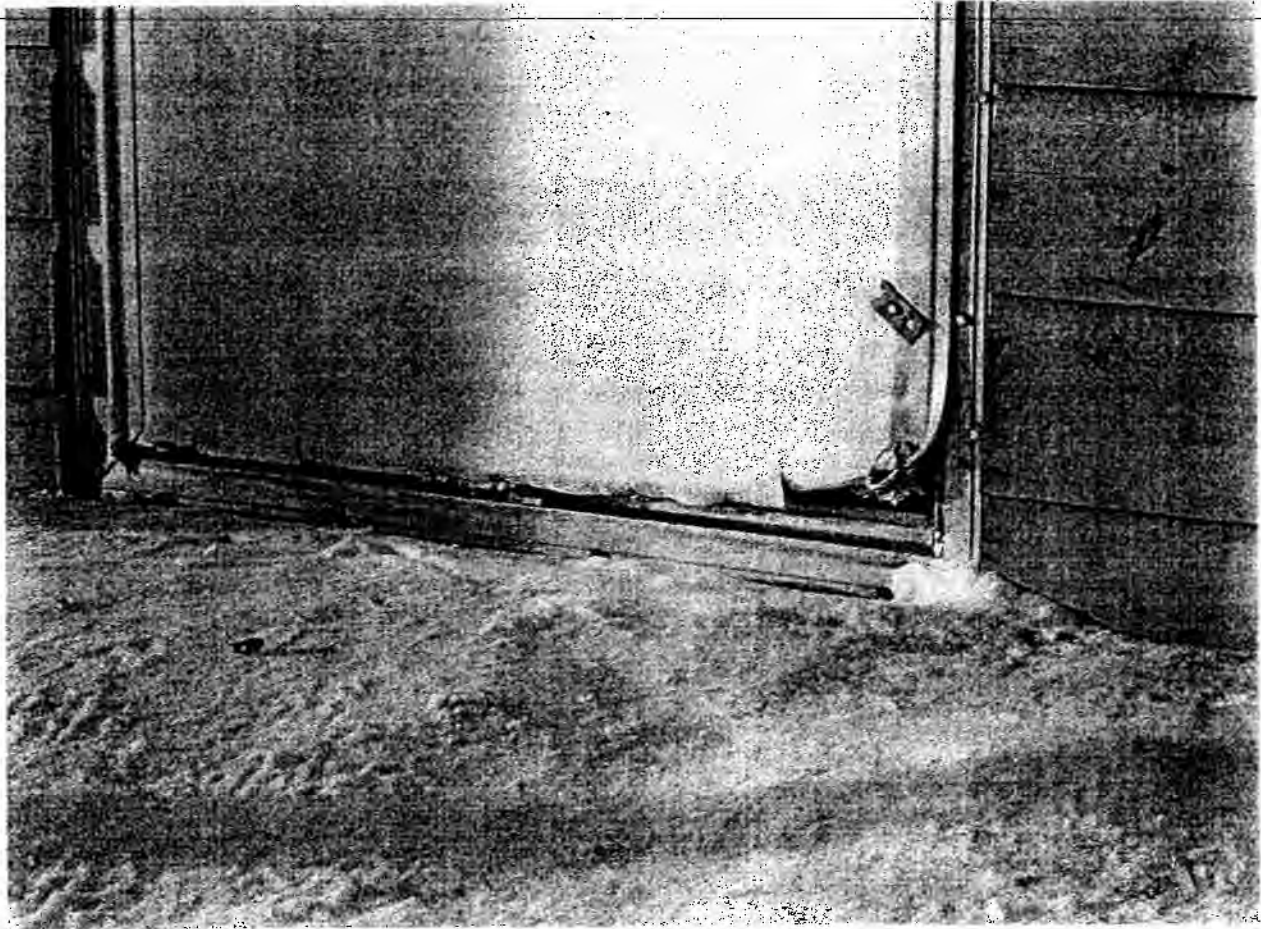
Building B

Furnace Room Door – Combustion Air?

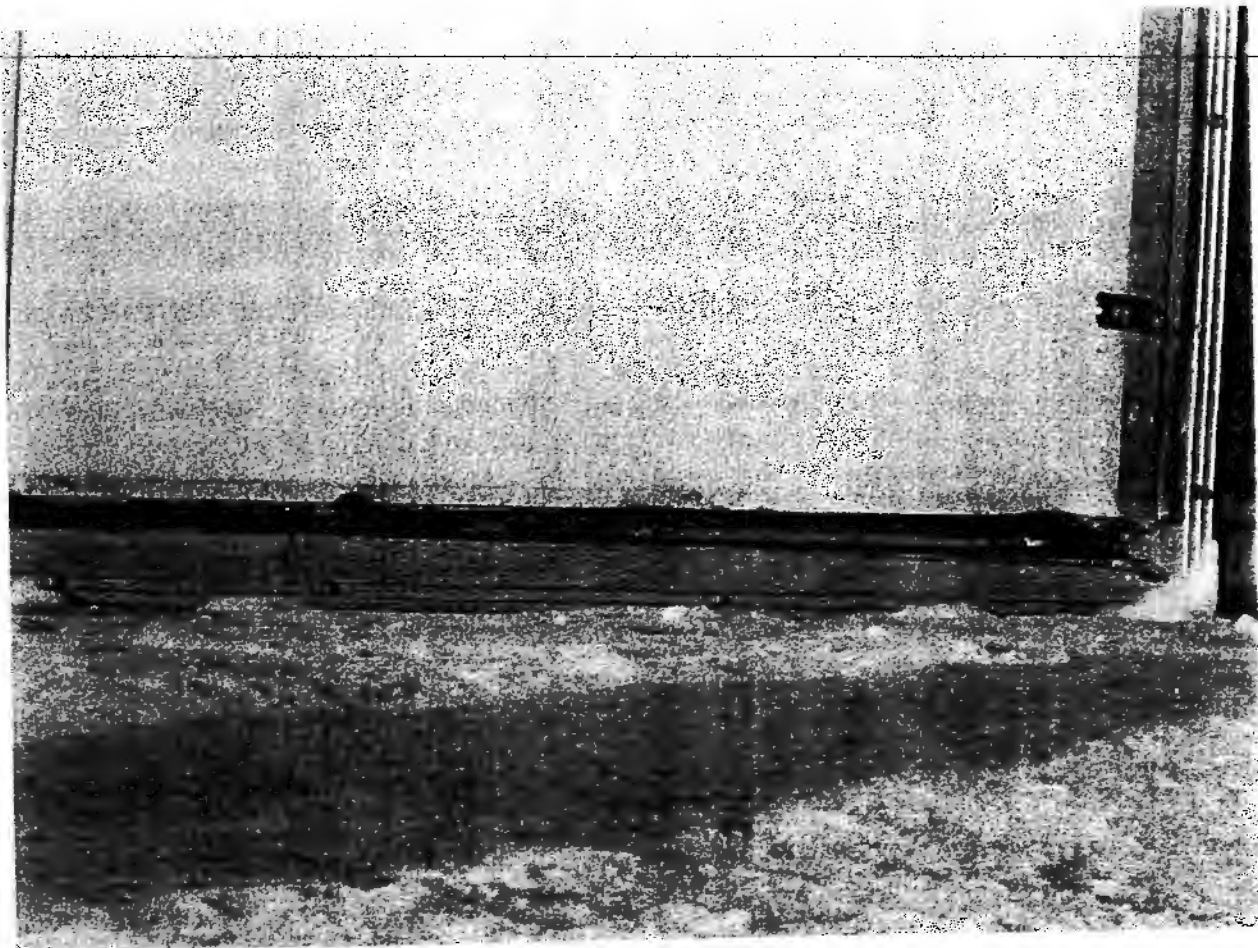
Building B

Water Heater Room Door – Combustion Air?

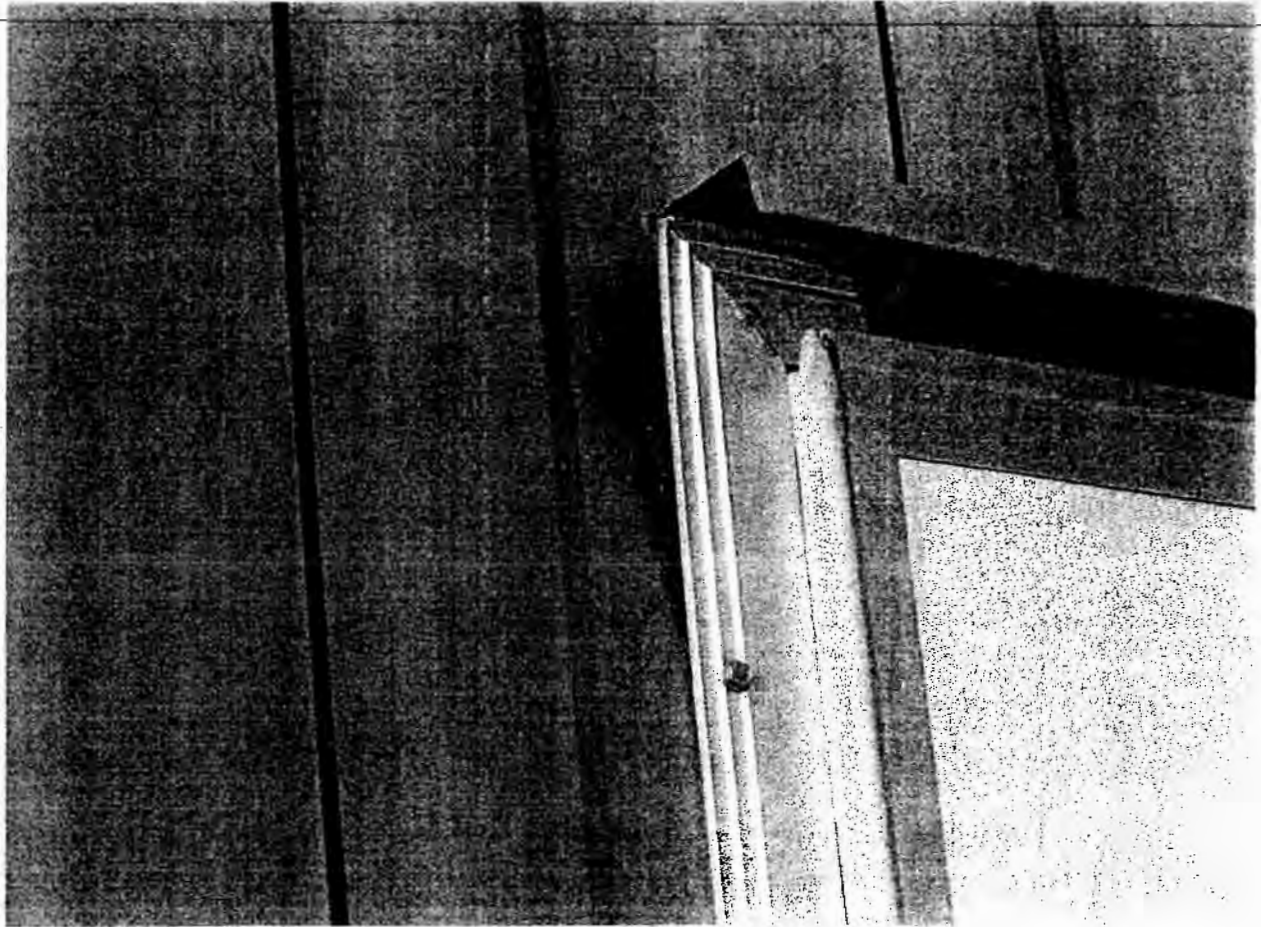
Building B

Furnace Room Door – Signs of Flue Backdrafting

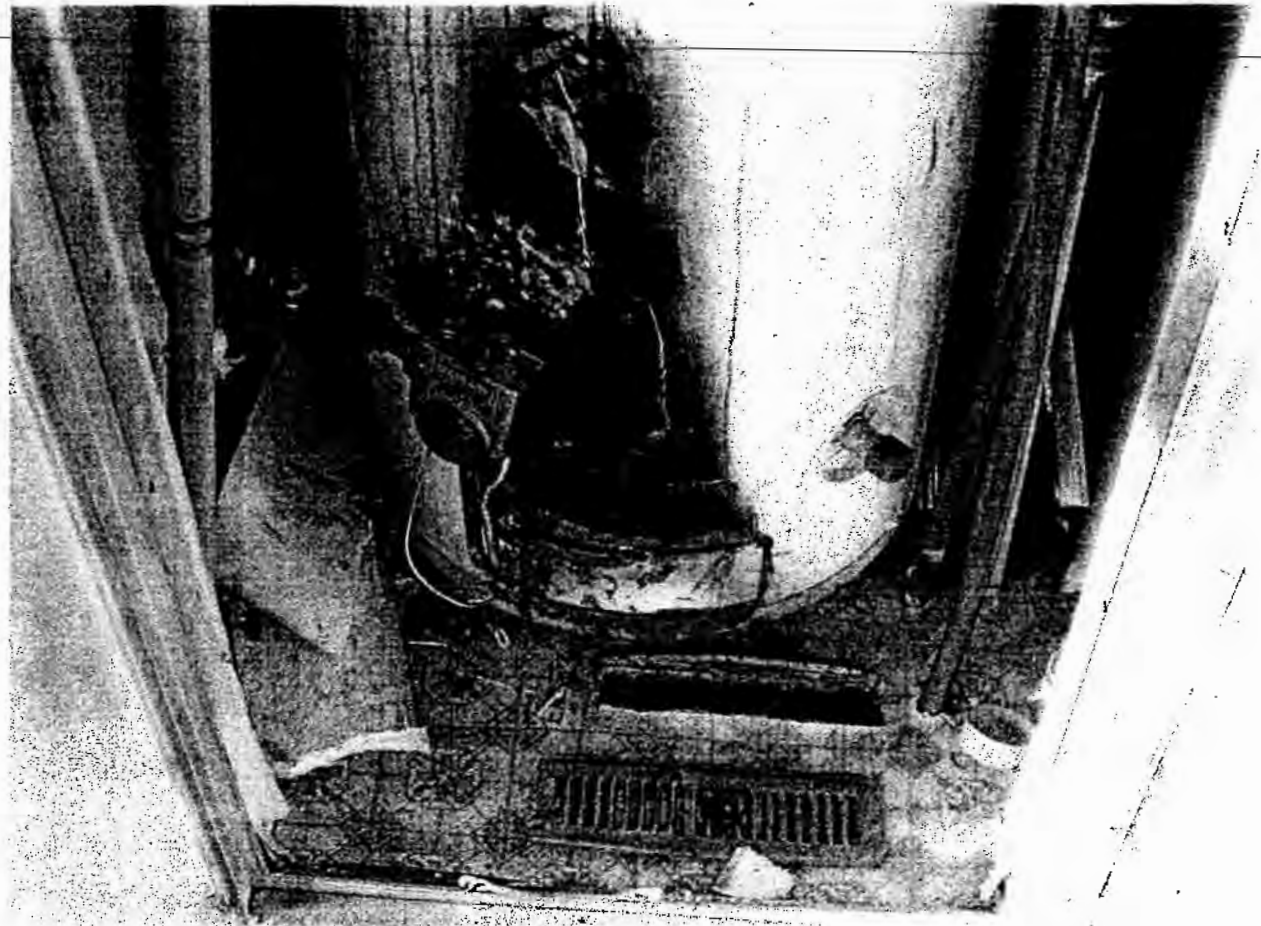
Building B

Water Heater – Propane Gas Fired - Serious Backdrafting

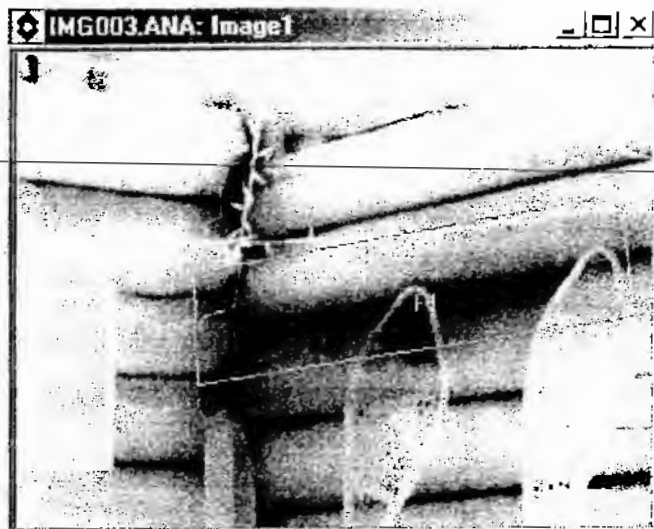
BT-03 - October 15, 2001
101 Mile Motor Inn-Beaver Creek, YT - Main Lodge
Location: Lounge - NW Corner @ Upper Wall

The analysis box F1 indicates temperatures as low as -9.1C and as high as 14.8C. Room air temperatures were at 16.5C when the image was taken. The area where log and framing meet appears to be comparatively warm.

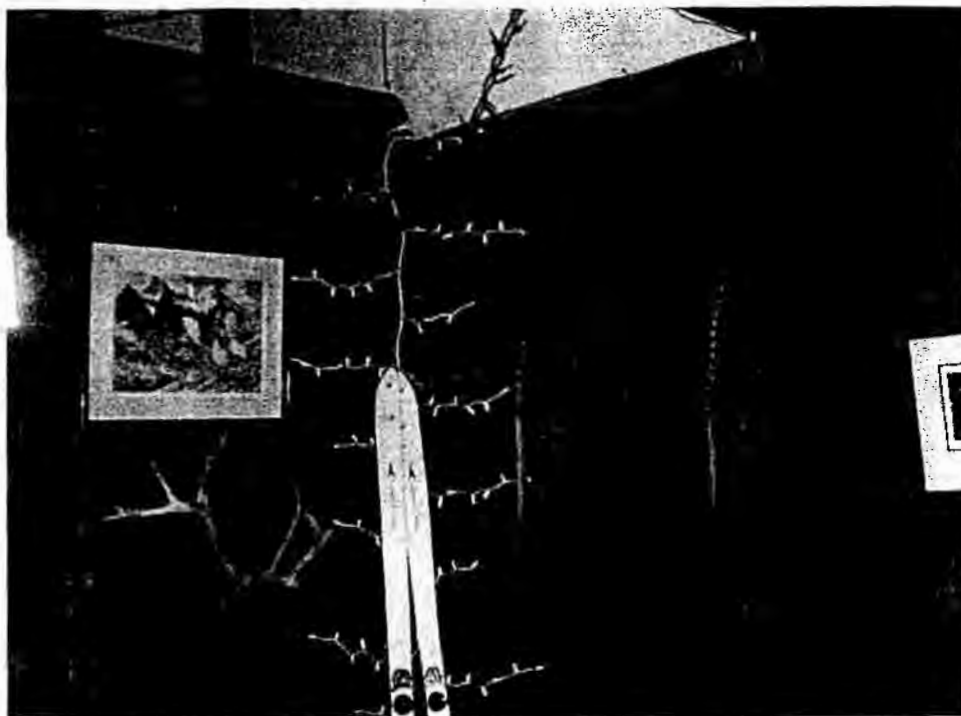
BT-04 - October 15, 2001
101 Mile Motor Inn-Beaver Creek, YT - Main Lodge
Location: Lounge - NW Wall @ Floor

Sill areas at the log wall / floor connections were found to be areas with high air leakage. Caulking this joint will greatly reduce the infiltration of cold outside air.

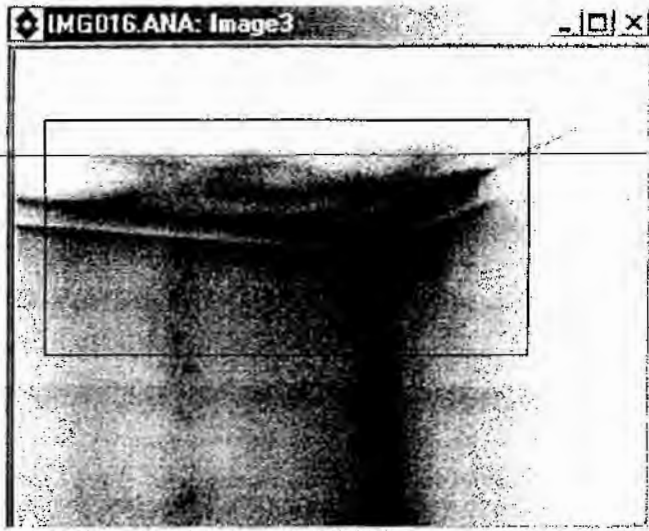
Location: Bathroom #2 @ Partition Wall Intersection

This image shows problems at the ceiling and corners. Insulation located in the ceiling was not properly installed, or has moved due to building movement/shipping. The temperature at the surface is barely above freezing.

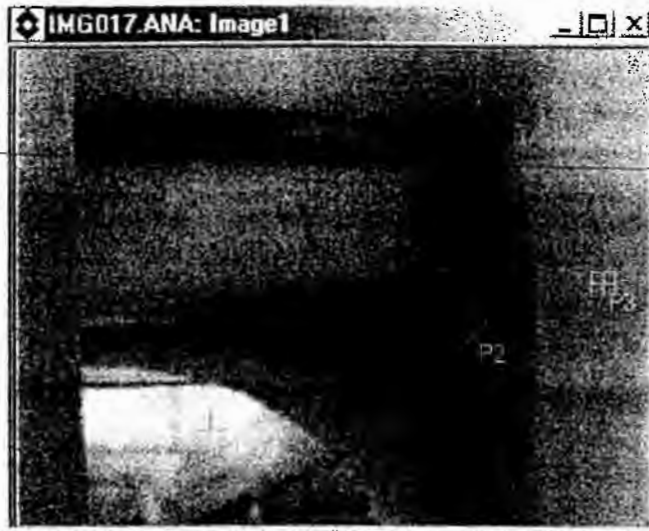
Location: Bath Hall @ Upper Wall Log / Frame Joint

Stick frame to log joints are some of the more difficult areas to seal air tight. Here we find cold air easily entering due to the uneven surfaces. Sealing from the inside is the only option.

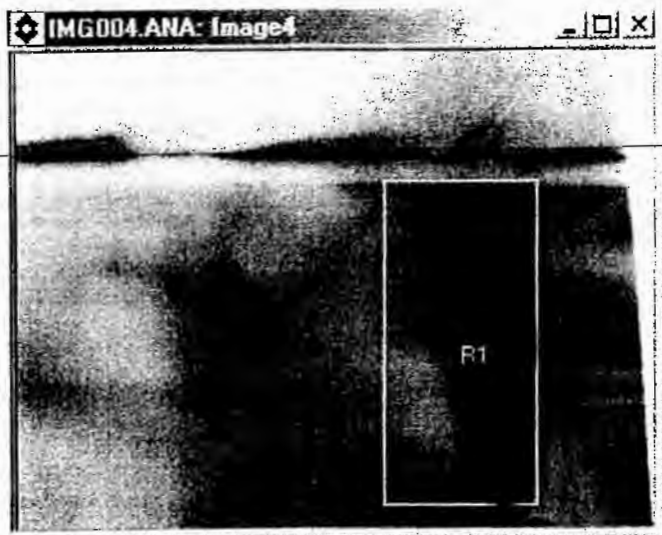
BT-20 - October 15, 2001
101 Mile Motor Inn-Beaver Creek, YT - Building A, Room 8
Location: Door Installation @ Upper South Wall

The appearance of this anomaly is usually from two deficiencies: Missing or improperly installed insulation and air leakage. Correcting it from the interior without disrupting the owners' ability to continue doing business is difficult.

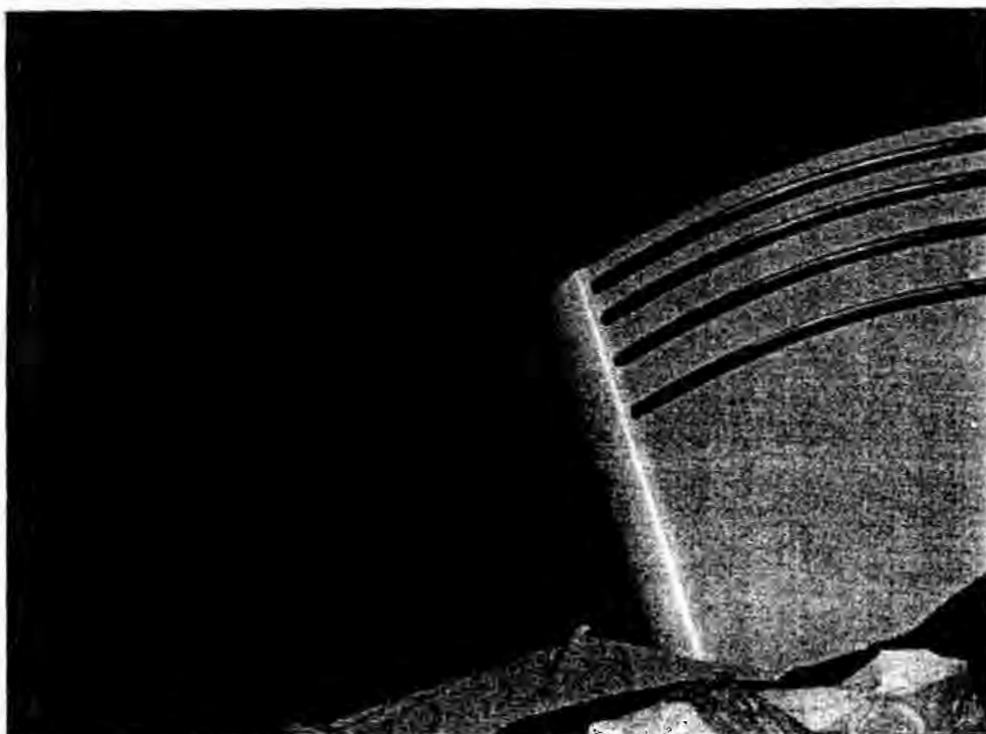
BT-24 - October 15, 2001
101 Mile Motor Inn-Beaver Creek, YT - Building B, Room 24
Location: Closet Corner @ Outside Wall

The other side of this interior partition contains the domestic water heater, yet entering air temperatures were well below that of the room. The door to the water heater was damaged and extremely leaky causing the heater to cycle frequently even though no water was being used.

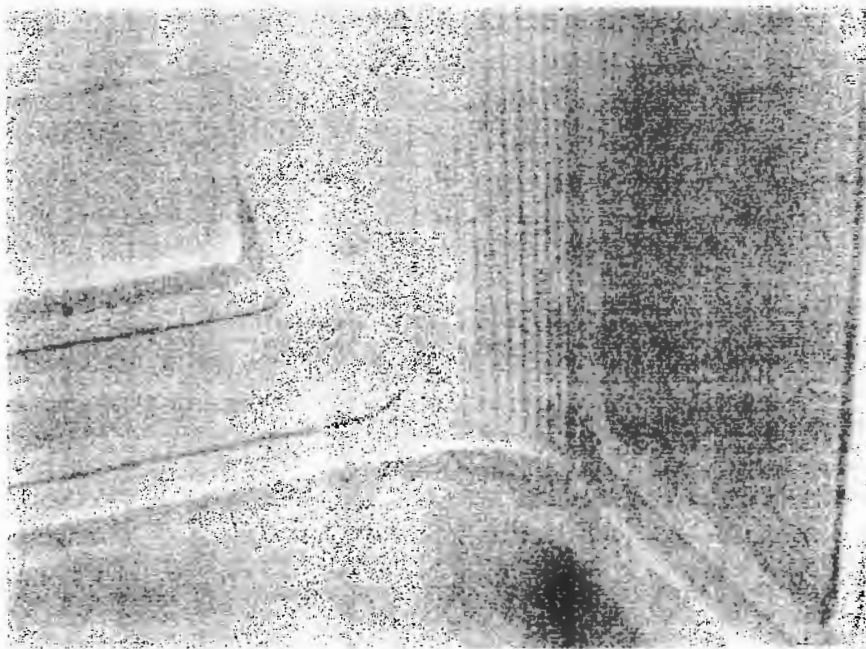
BT-29 - October 15, 2001
101 Mile Motor Inn-Beaver Creek, YT - Building B, Room 24
Location: Bathroom @ Bathtub Fixtures

Another look a the bathtub. Cold air is blasting in from behind the plumbing fixtures. This could be make-up air for the exhaust fan.

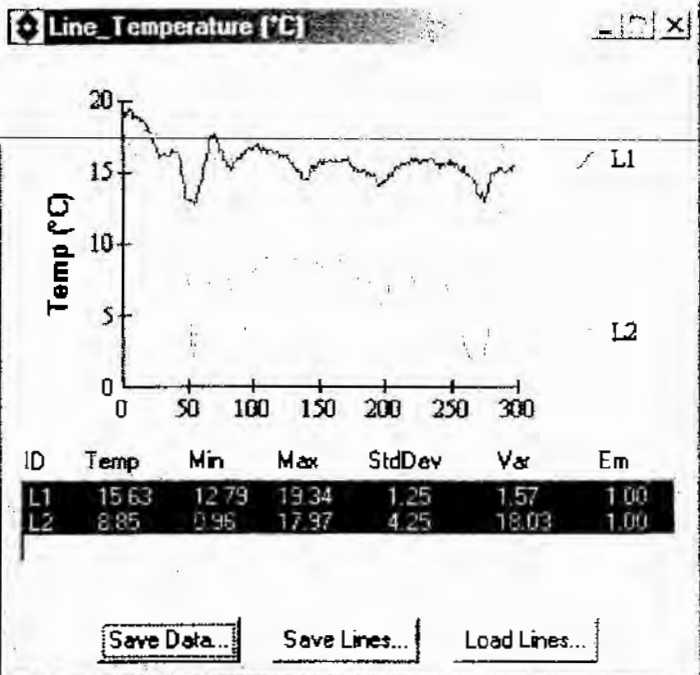
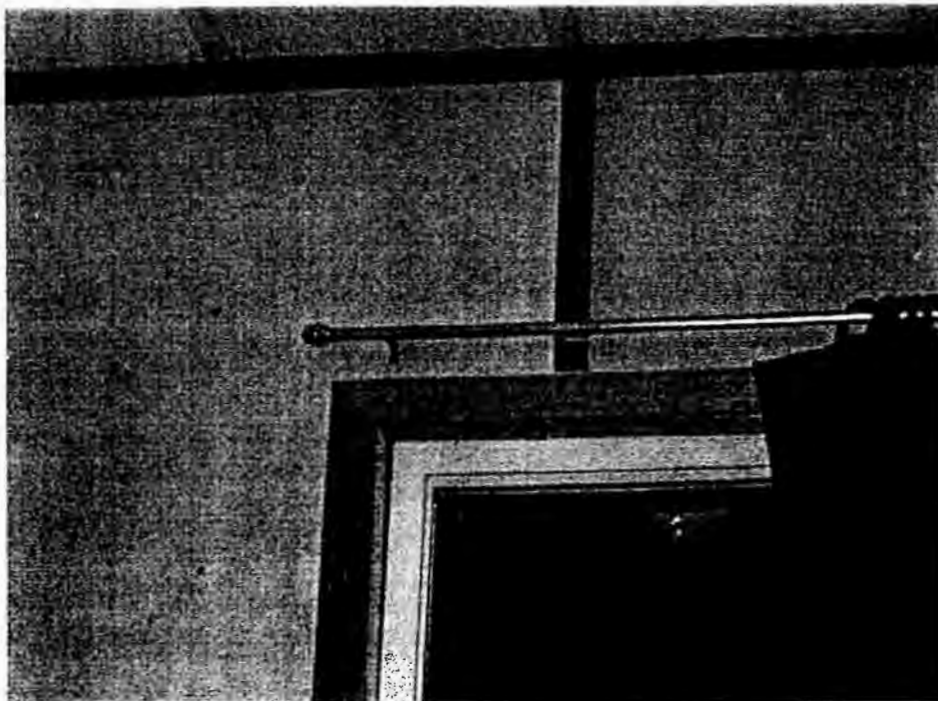
BT-31 - October 15, 2001

Air leaking in between window frame and rough opening allow this cold spot to exist. Sealing gaps using expanded polyethylene backer rod and then caulking the surface will eliminate problem areas such as is seen here.

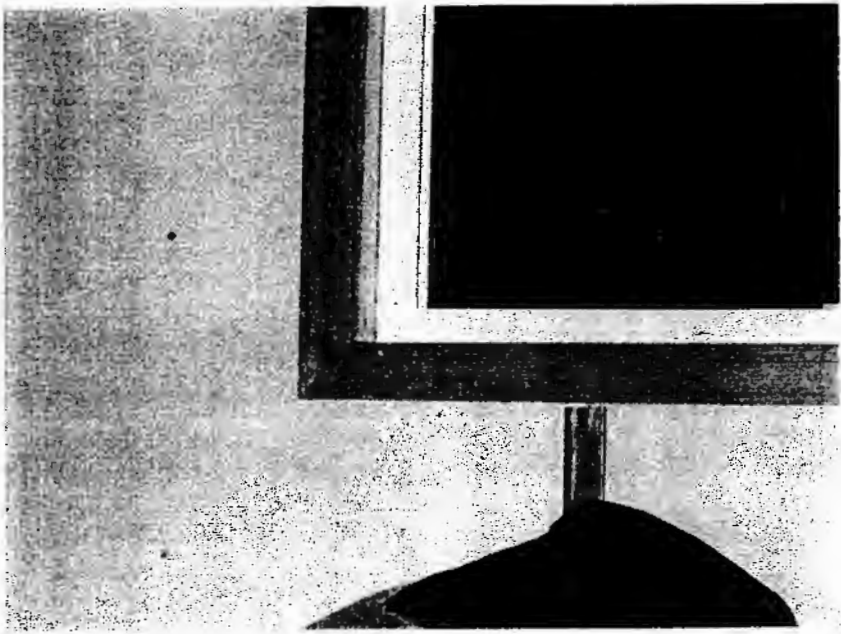
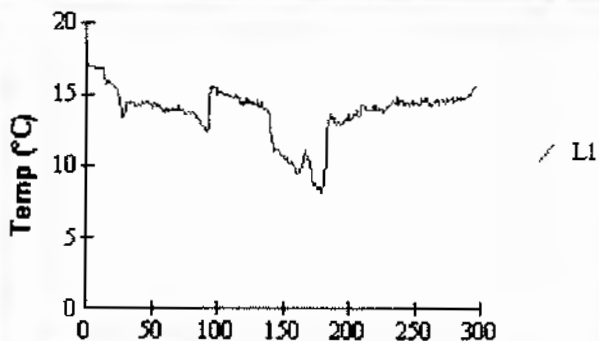
BT-32 - October 15, 2001

Cold air leaking from within the vanity cabinet and from the wall behind the toilet is visible in the below thermogram. Analysis of line L1 is shown to the right. Sealing air leaks beginning with the roof and then down the exterior walls will render these leaks relatively harmless.

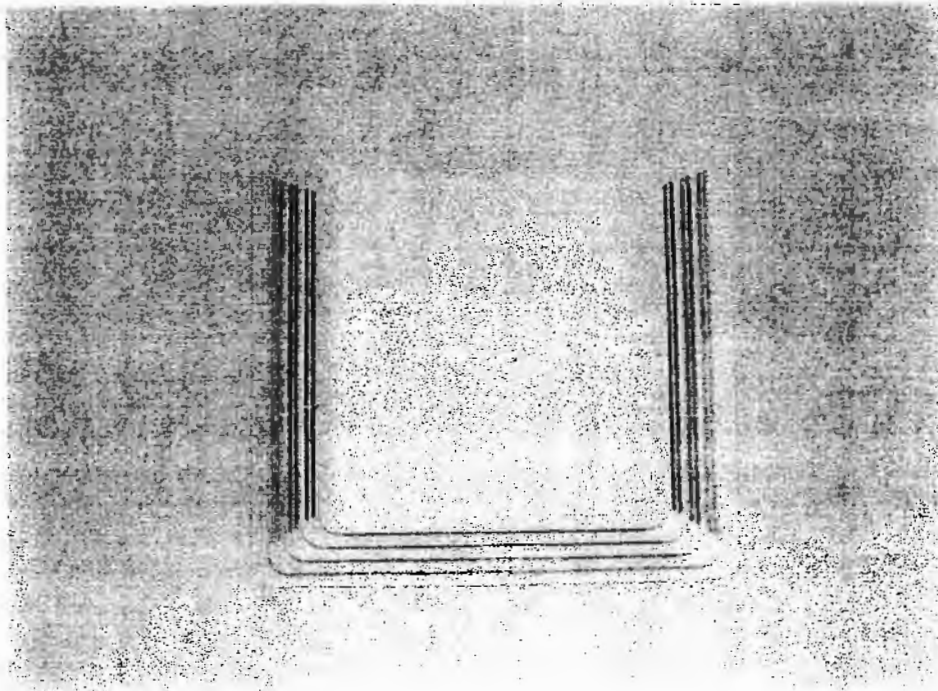
BT-37 - October 15, 2001
101 Mile Motor Inn-Beaver Creek, YT - Building C, South
Location: Bedroom @ Window Installation

Some of this is due to poorly installed insulation and some from air leaks. Again, application of a comprehensive exterior retrofit will minimize such deficiencies and allow for reductions in fuel use and maintenance expenses.

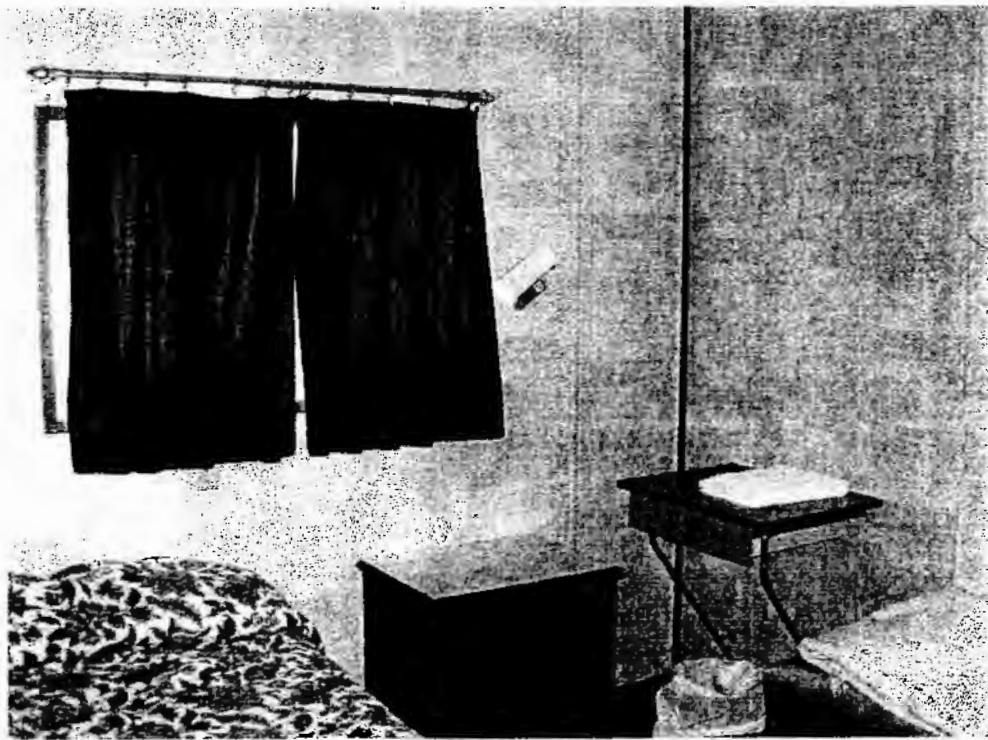
BT-38 - October 15, 2001
101 Mile Motor Inn-Beaver Creek, YT - Building C, South
Location: Bedroom @ Window Installation

One can almost hear the wind blowing just by looking at the thermogram below. Window frame to rough opening gaps are leaking air.
